Washington State School Seismic Safety Assessments Project

# SEISMIC UPGRADES CONCEPT DESIGN REPORT

South Bend High School –  
Koplitz Field House  
South Bend Public Schools

June 2019

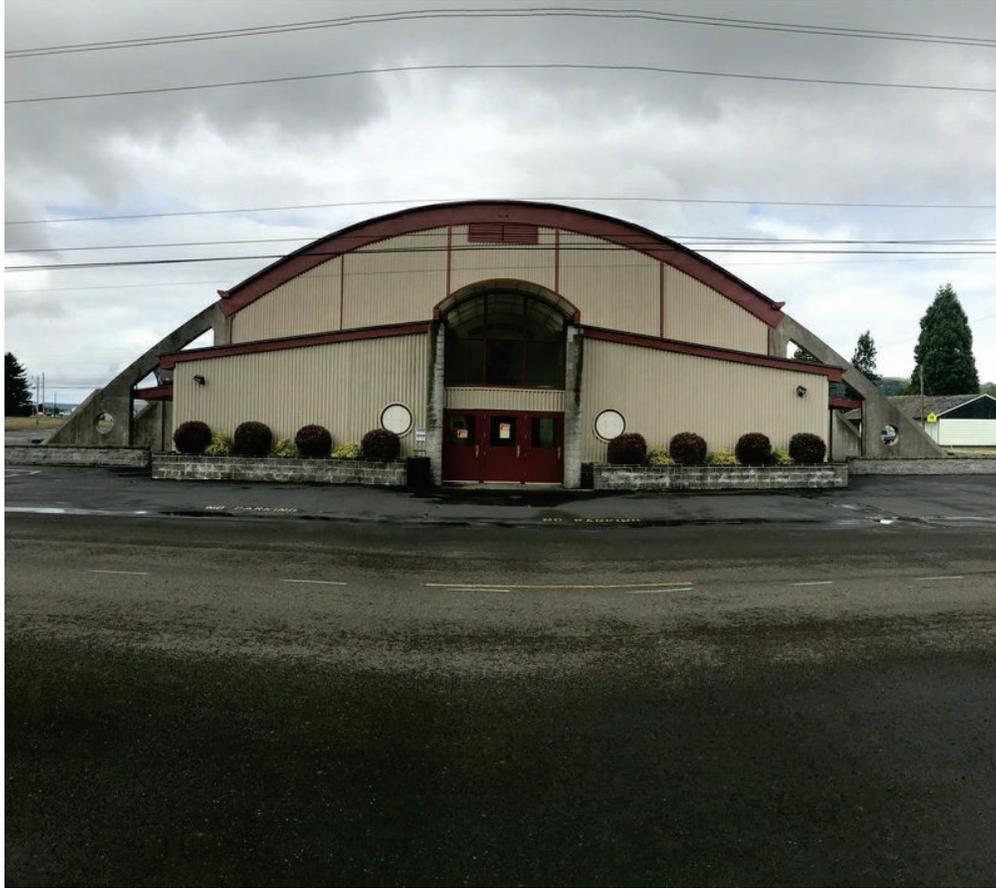
Figure 1-1. South Bend Field House - South Exterior

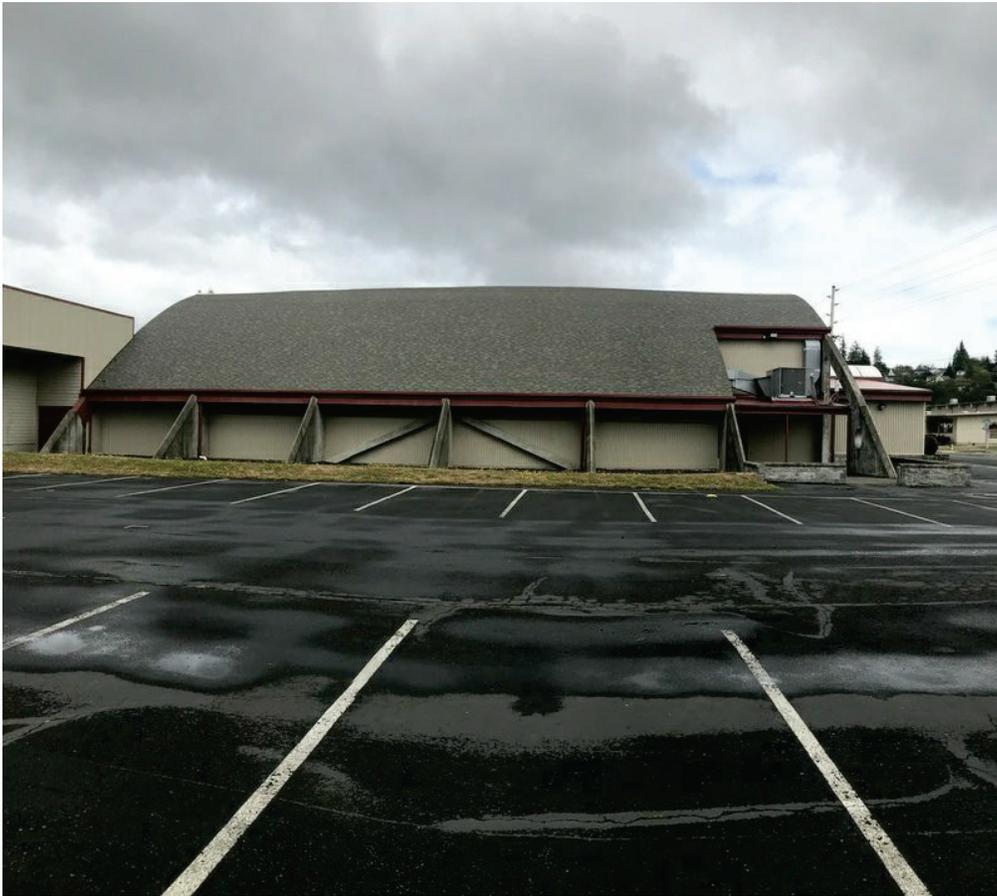
Figure 1-2. South Bend Field House - West Exterior

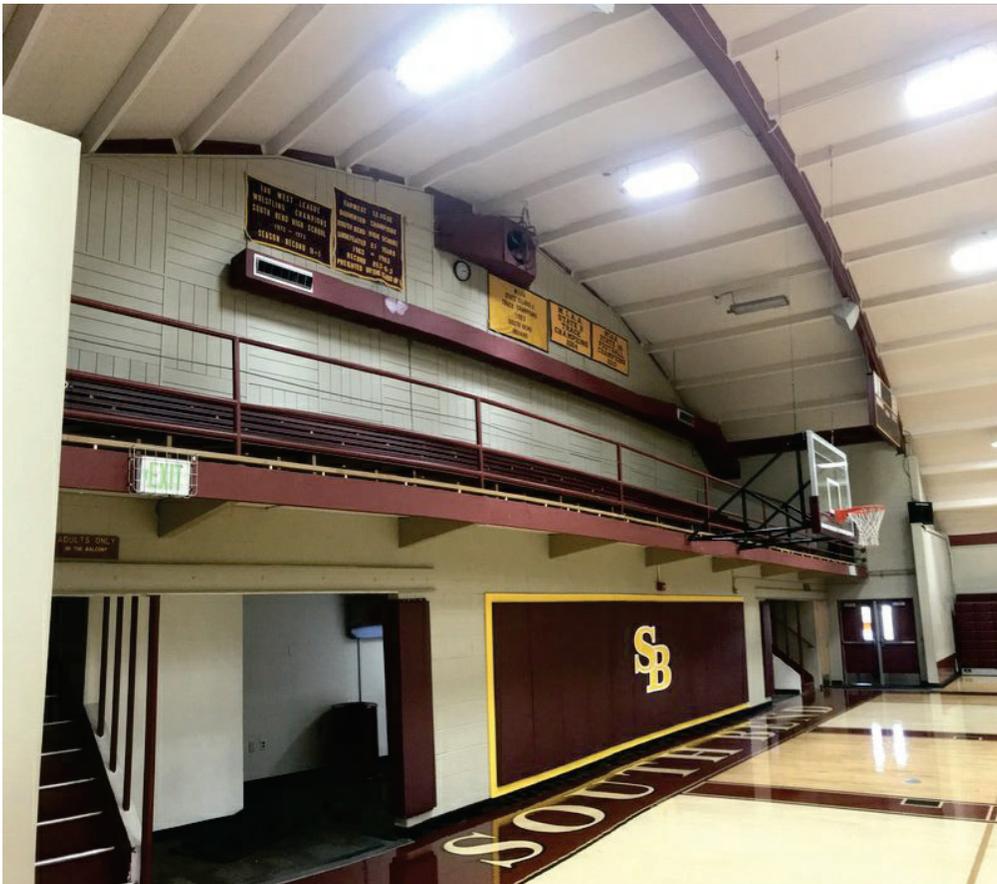
Figure 1-9. Mezzanine at South End of Gymnasium
