Washington State School Seismic Safety Assessments Project

SEISMIC UPGRADES CONCEPT DESIGN REPORT

Edison Elementary School
– Main Building
Centralia School District 401

June 2019

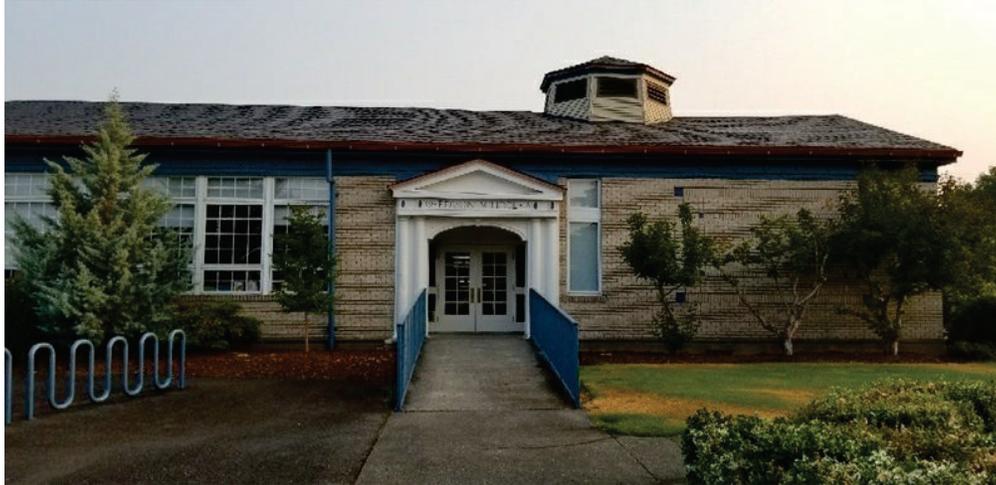
Figure 1-1. South entrance

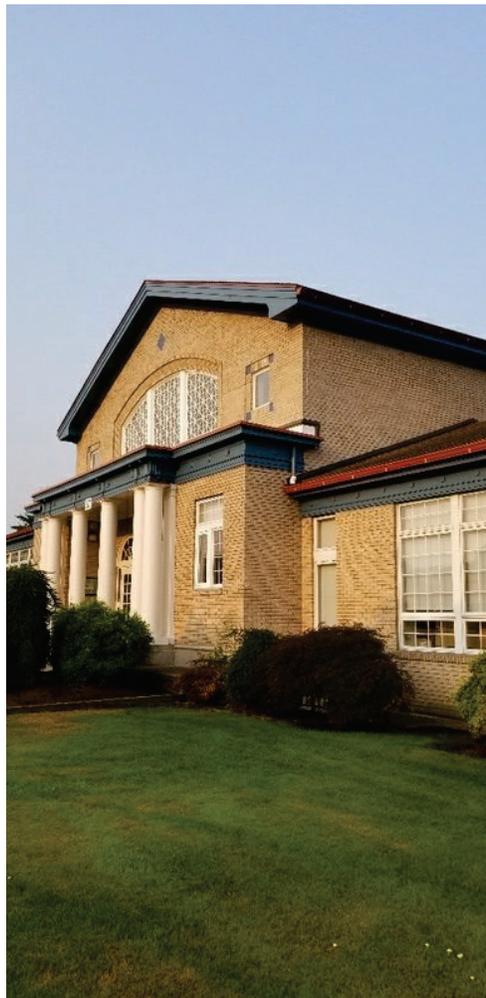
Figure 1-2. Main entrance

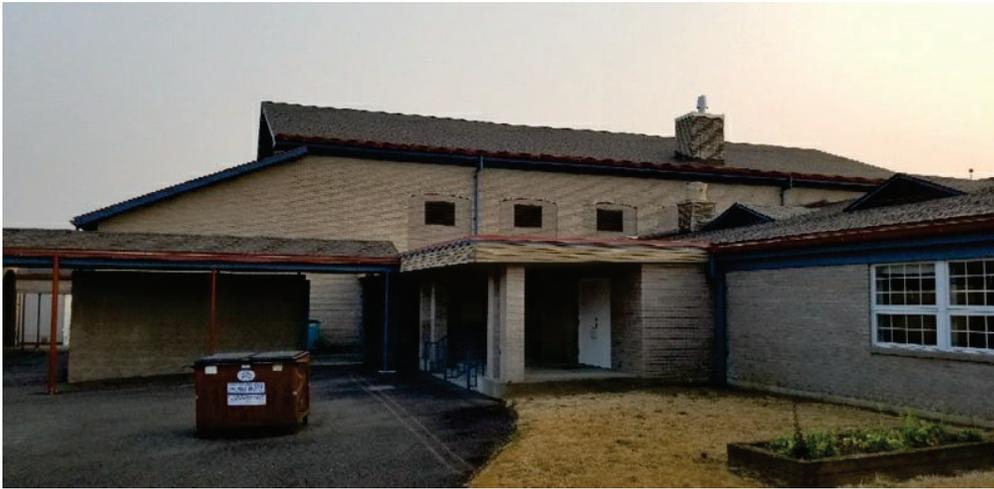
Figure 1-3. Southwest elevation of the gym/auditorium

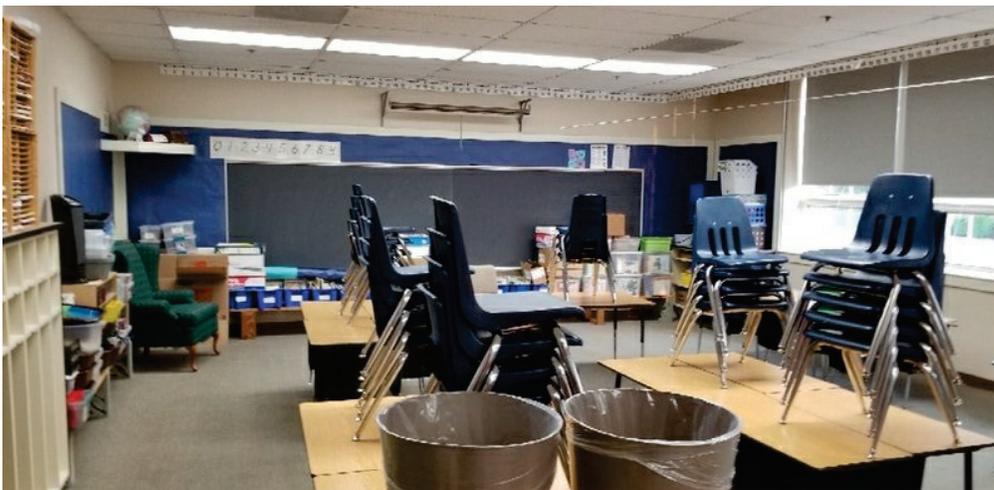
Figure 1-4. Typical classroom layout

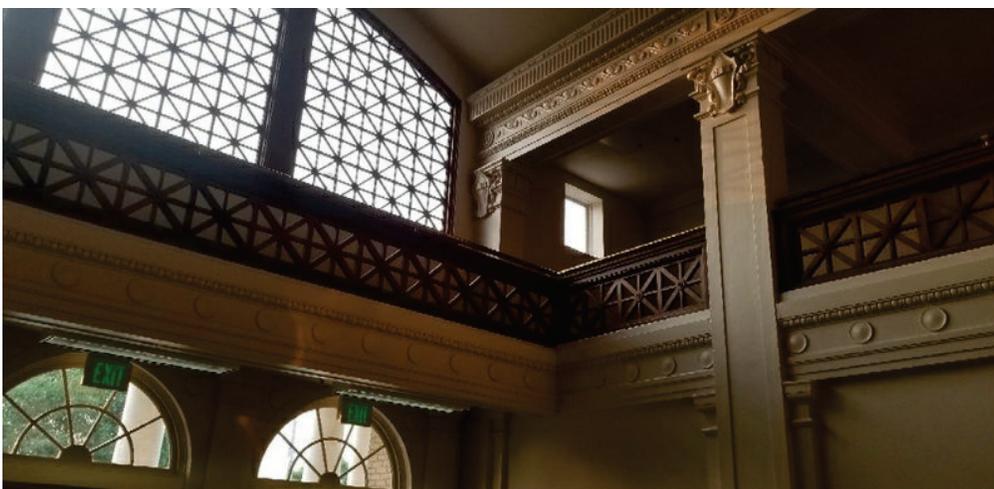
Figure 1-5. View of the lobby mezzanine at the main entrance

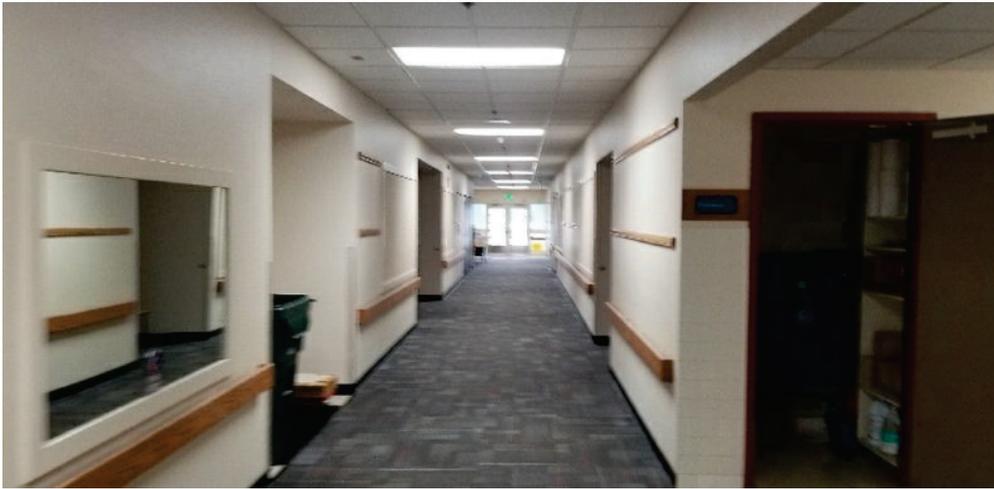
Figure 1-6. Typical hallway

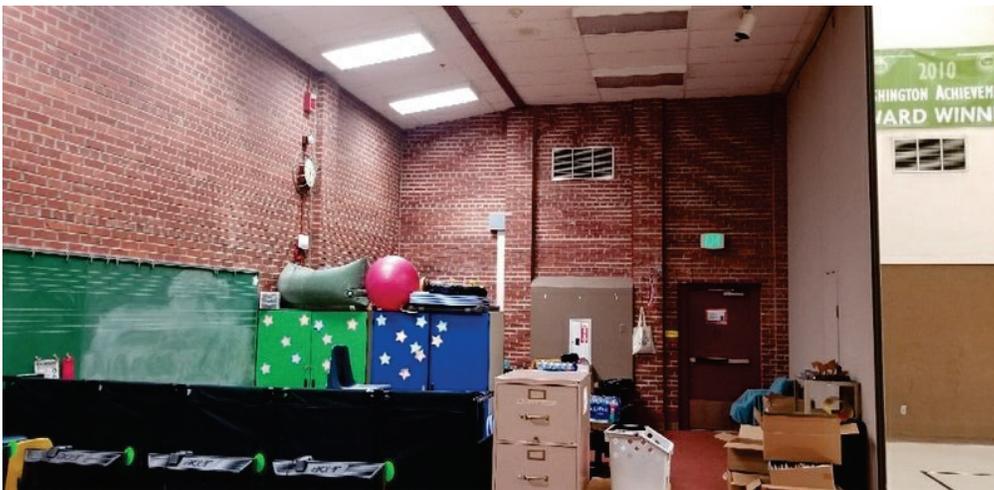
Figure 1-7. 1957 music room addition to the backside of the the gym/auditorium

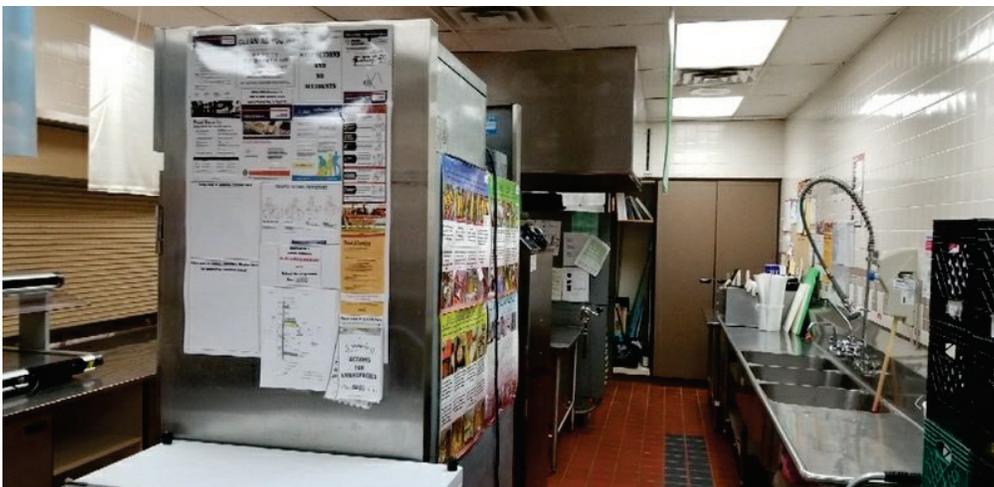
Figure 1-8. Kitchen

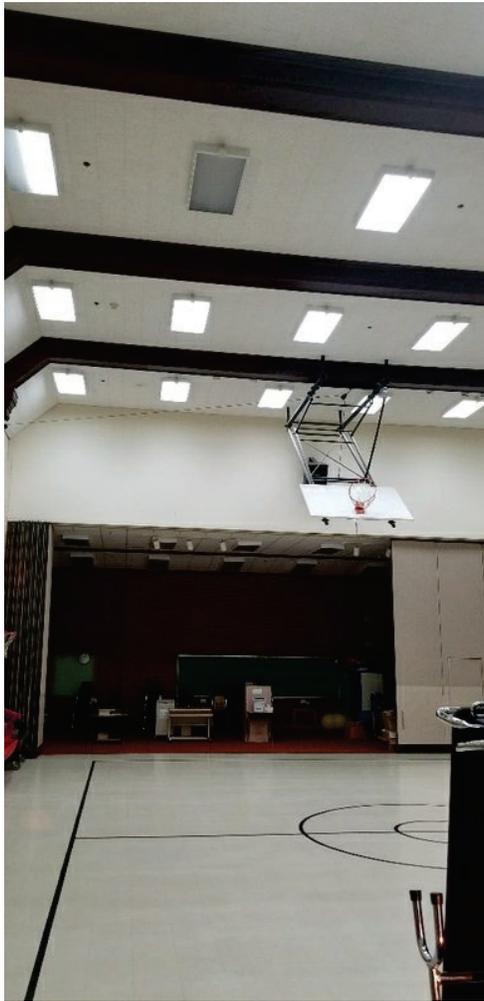
Figure 1-9. Interior view of the gym/auditorium facing the 1957 music room addition (beyond)

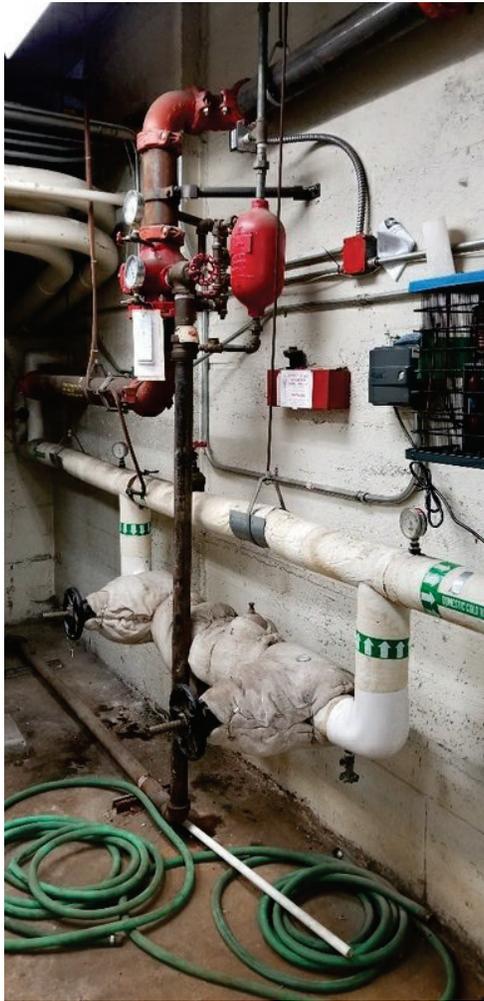
Figure 1-10. Piping in the basement mechanical space
