WASHINGTON
STATE HIGHWAY COMMISSION
DEPARTMENT OF HIGHWAYS

PSH No. 12, L-764
South Bend Vicinity
Station 19+50 to Station 32+00

General Conditions

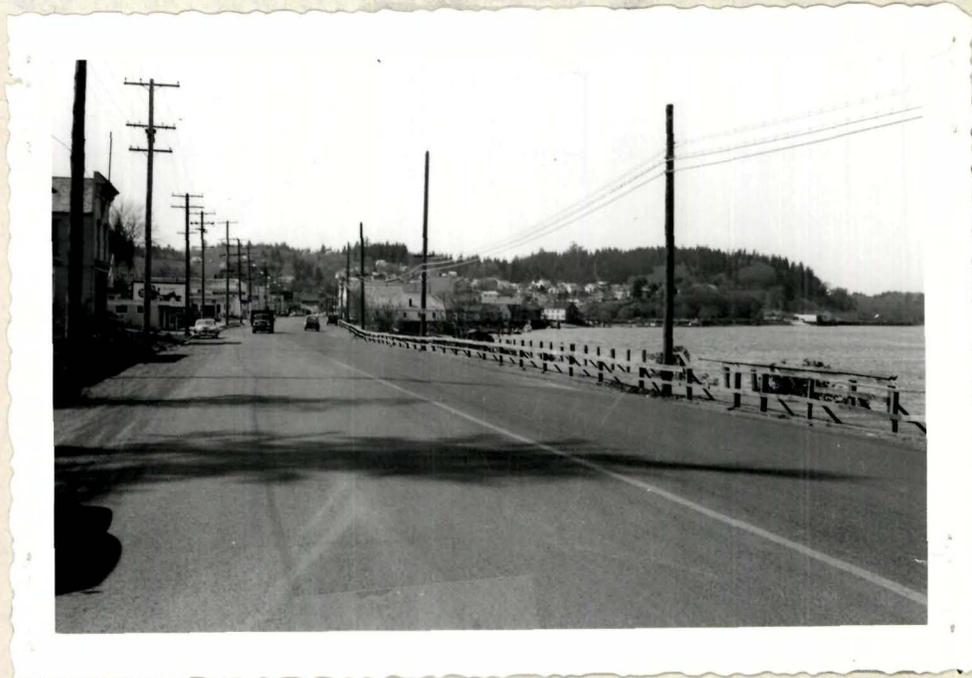
"The condition continues to grow worse, and the north side of the highway has settled to such an extent, that during the icy condition last month, it was difficult to hold a car on the highway, due to the slope toward the river.

This condition may be noted in Figure 1 if attention is directed along the right-hand curb line as shown in the picture. Present local settlements may be seen in Figure 2 and Figure 3.

Fig. 1 Looking westerly along Water Street from Sta. 31+25
Note the uneven settlements along the right-hand curb line.

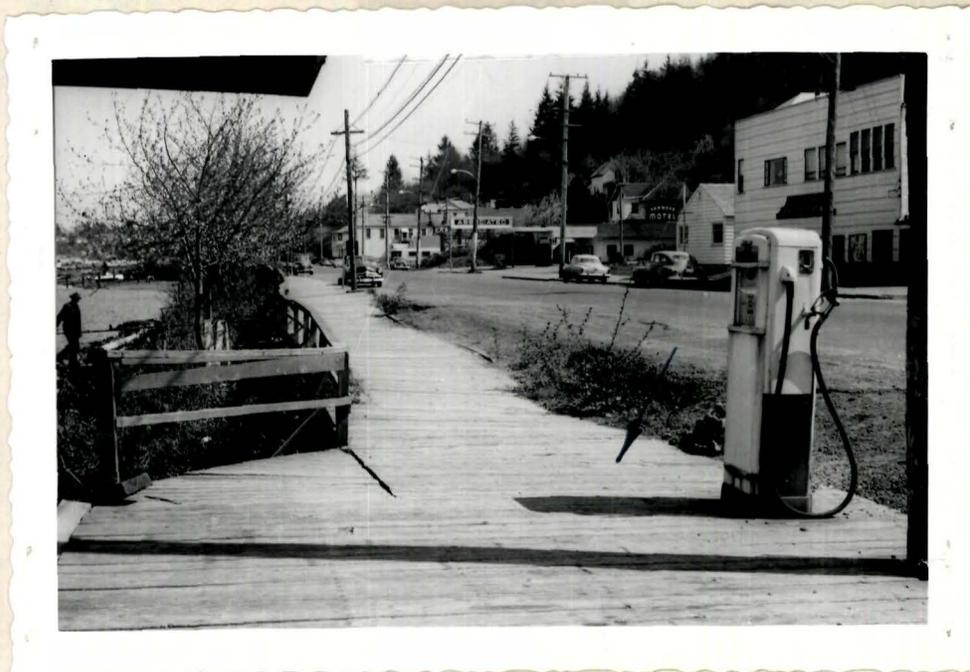
An attempt was made to determine the amount of settlement that had occurred since the year 1933 but no records could be found for the section Station 19+50 to Station 24+50 although the settlement is noticeable as noted in Figure 2 and Figure 3. Between Station 25+00 and Station 32+00 records were found that gave elevations of the top of the cement concrete curb approximately 24 feet left of center line and the amounts of settlement from the year 1933 to the present time are as follows:

Fig. 2 Settlement of wooden sidewalk out beyond curb line,
Sta. 20+70 looking easterly. Test hole #4 is located as
shown by arrow.

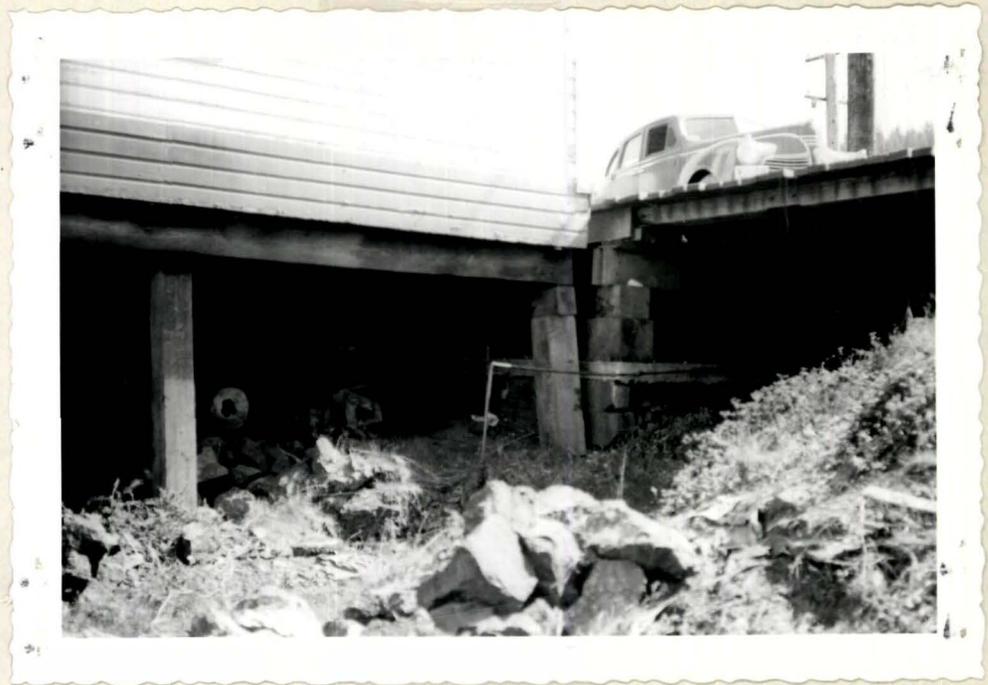
Another observation that was noted is shown in Figure 3 by the settlement of the concrete sidewalk slab and how the present wooden sidewalk is blocked up to meet the grade of the highway pavement.

Fig. 3 Settlement of concrete sidewalk and blocking-up of existing wooden sidewalk at Sta. 20+25.

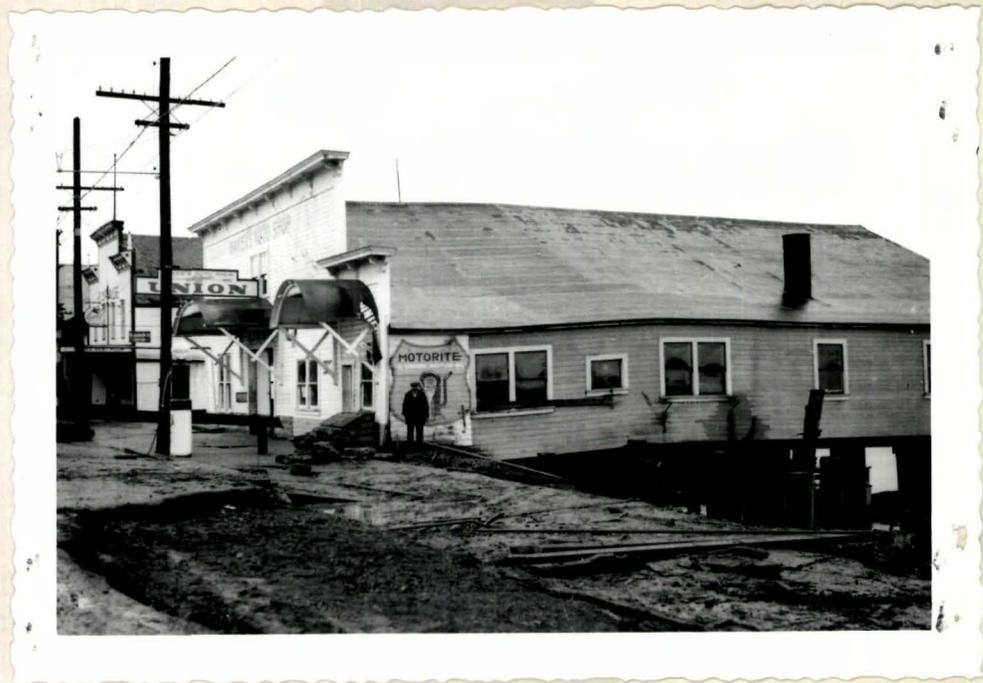
Prior to the year 1933, settlements were observed in this area at approximately the same locations as they are now. This may be seen in Figure 4 and Figure 5. Therefore, under Contract No. 1807 during the winter of 1933-1934, treated anchor piling and treated timber sheet piling was installed between Station 19+86 to Station 24+70 as well as between Station 27+19 to Station 28+01 (see Figure 6). Above the sheet piling bulkhead, riprap was placed as shown in Figure 7. In the sections not improved by this contract there already existed riprap on the slope between the River and the curbing and its condition at the present time may be noted in Figure 8.

Fig. 4 Settlement of pavement, sidewalk, and garage in the year 1933 as seen from Sta. 21+50 looking in a northwesterly direction.

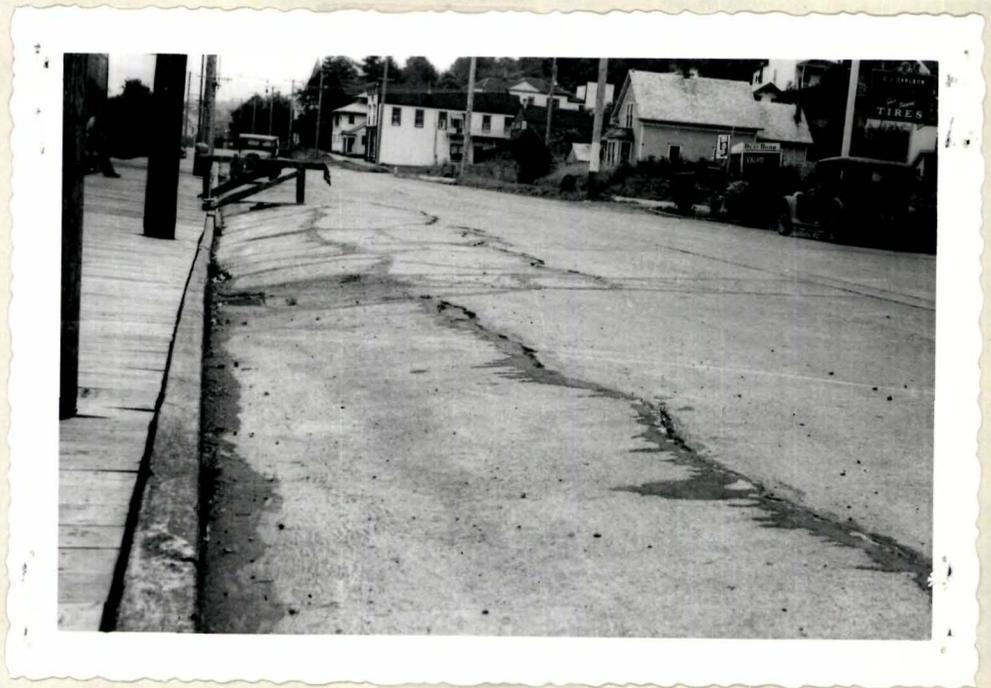
Fig. 5 Settlement of curb and pavement in the year 1933 at Sta. 23+00 looking easterly down Water Street.

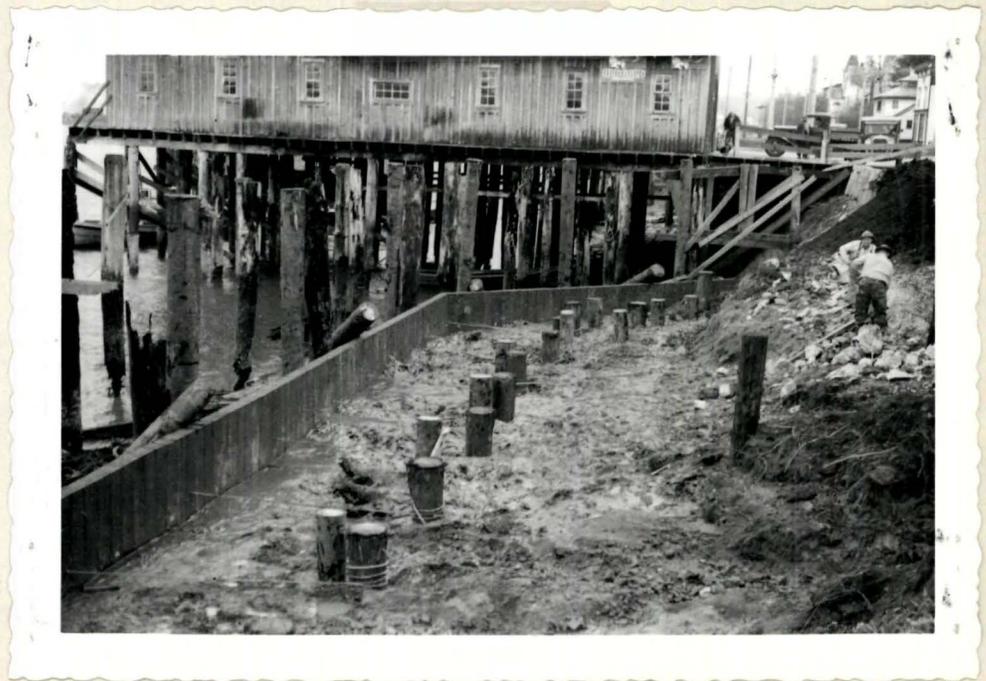
Fig. 6 Installation of treated anchor piling and treated timber sheet piling during the year 1933 as seen from Sta. 24+00 looking easterly.

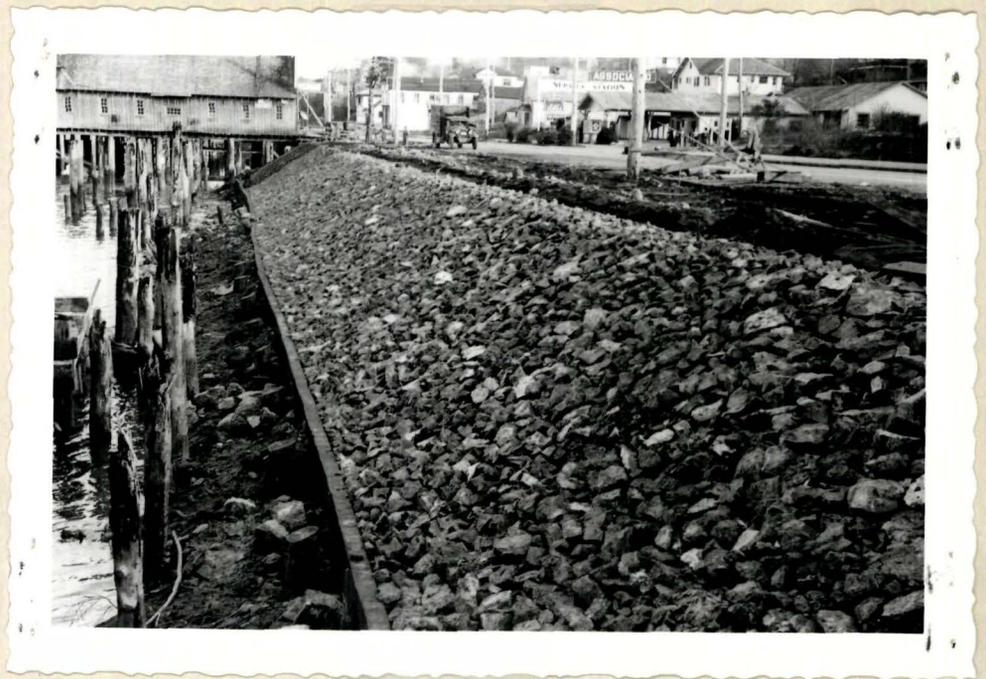
In addition to the settlement that was observed in the pavement, some side-thrust of the sheet piling bulkhead was also noted. This may be seen by comparing Figure 7 and Figure 11. The sideward movement of the bulkhead is probably due to the fact that practically all of the cables that tie the anchor piles to the sheet piling have become corroded and broken.

Also, you will note by comparing the two photographs that during the past nineteen years there has been some settlement of the riprap itself.

Fig. 7 Riprap as placed in 1933 as seen from Sta. 21+00
looking easterly.

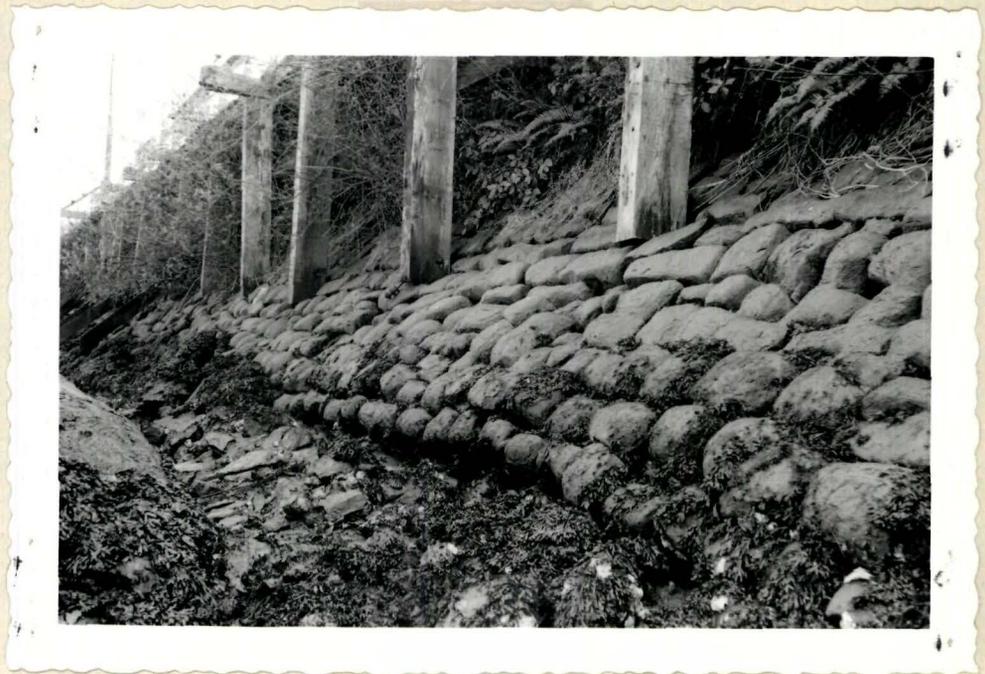
5. As shown in Figure 8, it was noted that certain areas of riprap were being undermined by wave action from the Willapa River. The improvement of this condition would also prove beneficial.

Fig. 8 Riprap as placed prior to 1933 in its present condition
as seen from Sta. 29+50 looking easterly.

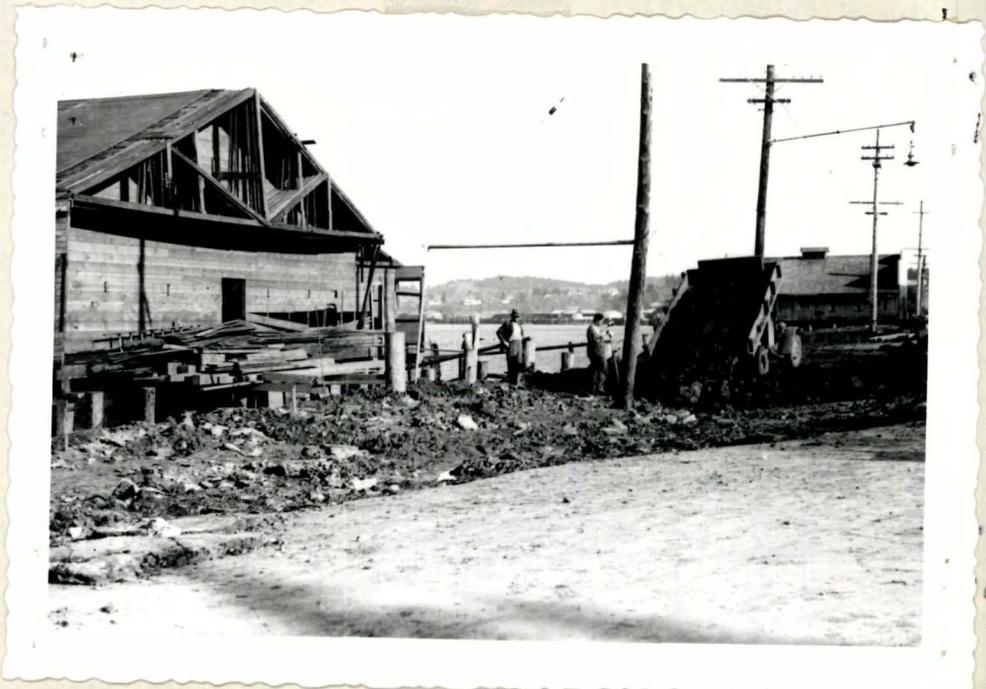
The areas that had settled were backfilled with a soft basalt having a brown gritty clay matrix as shown in Figure 9 and then paved with a Portland Concrete Cement pavement. These sections were Station 19+81 to Station 21+16, Station 21+30 to Station 21+95, and Station 23+59 to Station 24+69.

Fig. 9 Backfilling settled area with soft basalt having a brown gritty clay matrix during construction in 1933. View taken from Sta. 20+10 looking easterly.

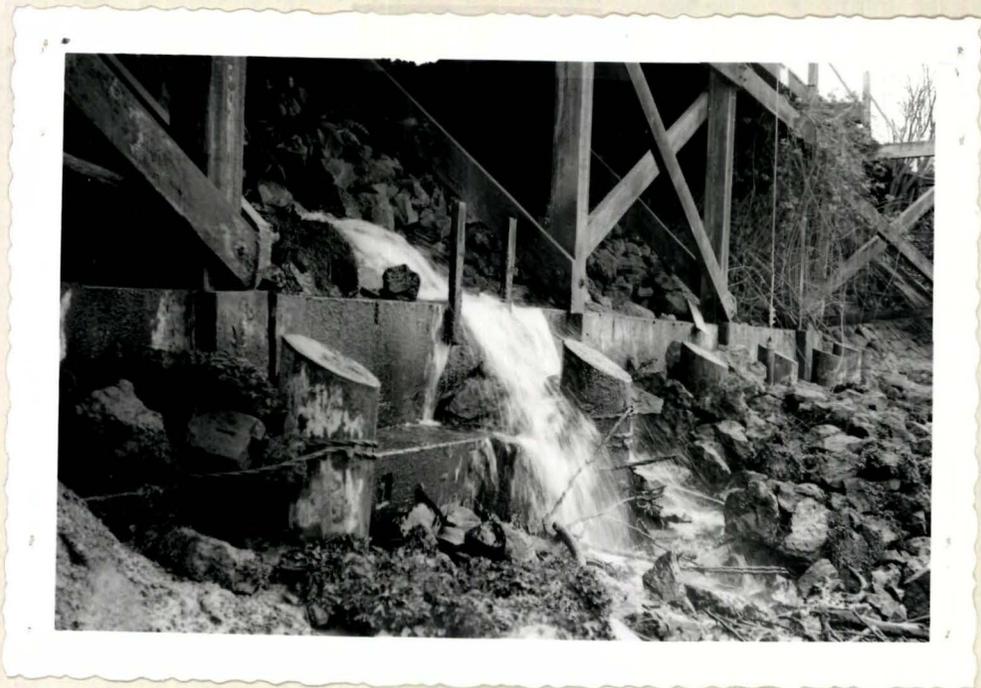
Fig. 10 Treated timber sheet piling at outfall for storm and sanitary sewer as seen from Sta. 27+50 looking westerly.

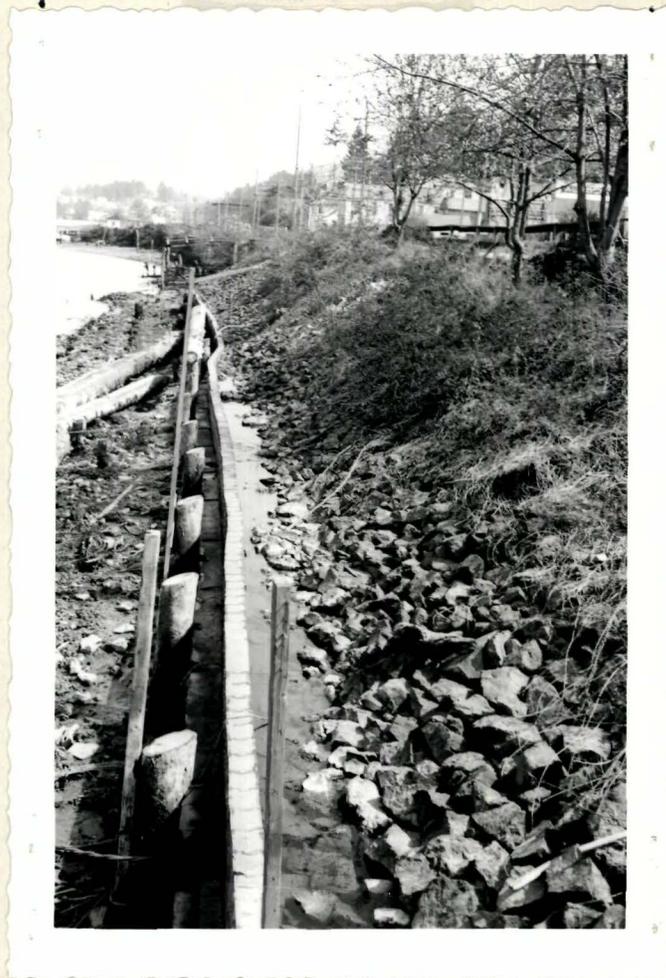
Fig. 11 View showing treated timber sheet piling and riprap in its present condition as seen from Sta. 21+75 looking easterly.

4. As mentioned previously, it was noted that in some places the sheet piling bulkhead had moved and that some of the supporting cables had broken. It is suggested that this project include the replacing of the cables where practicable and the bulkhead straightened.
