**SURFACE AND SUBSURFACE INFORMATION SUMMARY
ABERDEEN LANDSLIDES
ALDEN ROAD, BELMONT STREET,
AND COUNCIL CREST
ABERDEEN, WASHINGTON**

City of Aberdeen
200 E. Market Street
Aberdeen, Washington 98520

AGRA Earth & Environmental, Inc.
11335 N.E. 122nd Way, Suite 100
Kirkland, Washington 98034-6918

7-91M-11693-A

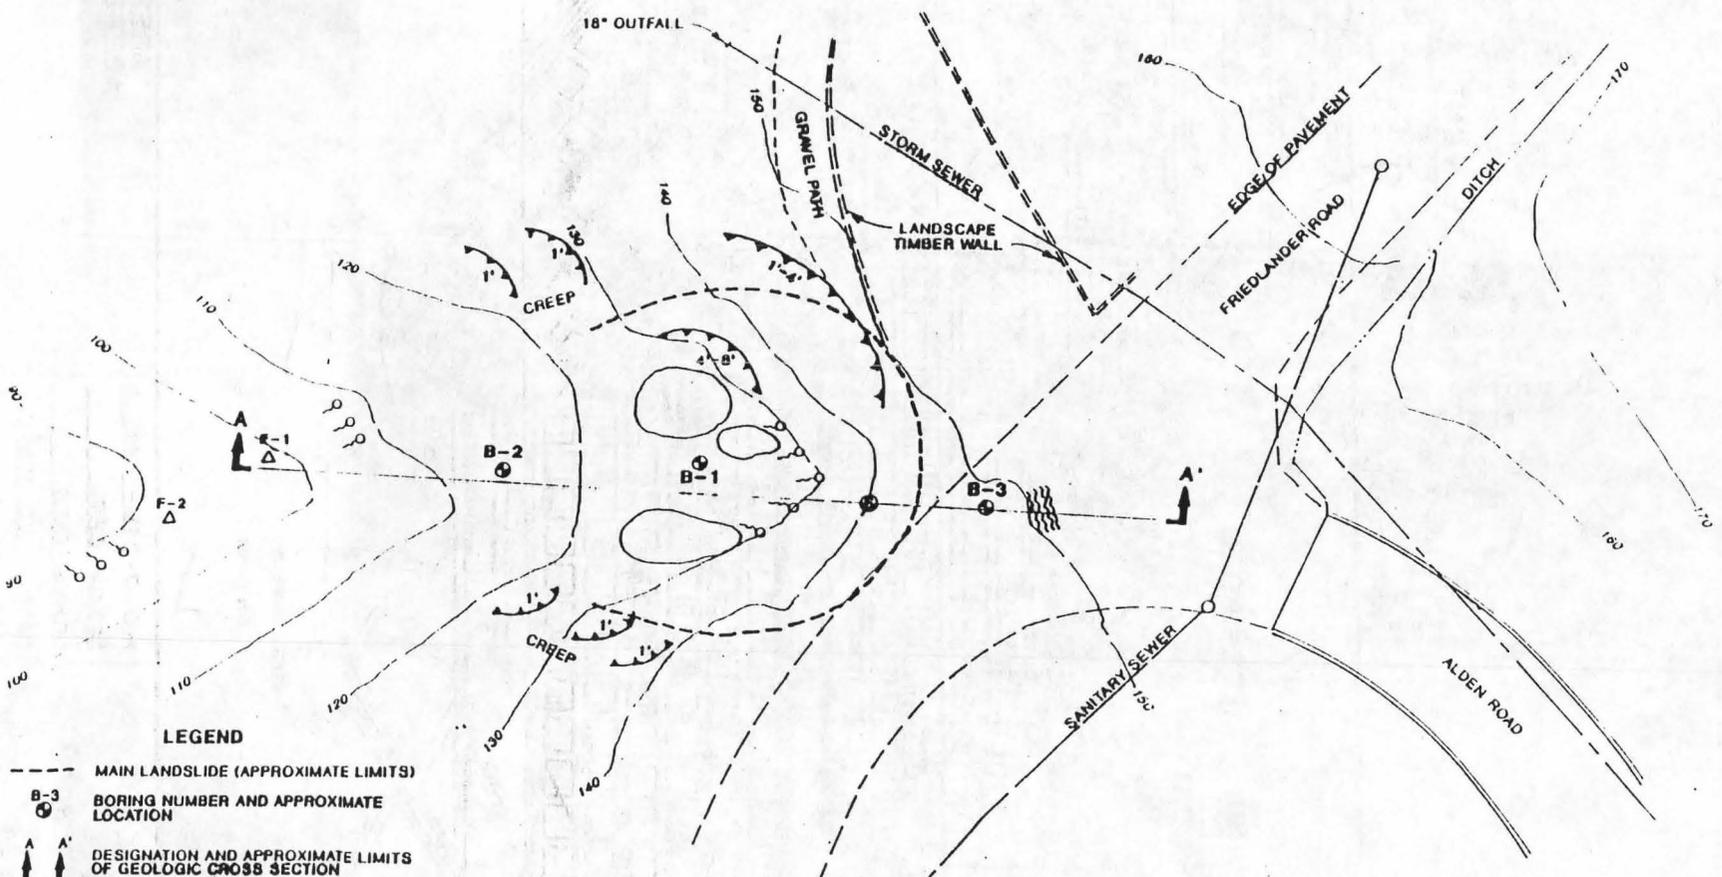
FIGURE 2

At the Alden Road site we observed open parallel cracks in the asphalt pavement atop Friedlander Road east of boring B-3 and the main landslide scarp, generally indicative of movement. An intact 3- to 4-foot-diameter stump within the upper landslide scarp approximately 10 feet below the top of the slope appears to have been filled over possibly during road construction. Moderate groundwater seepage was observed at the base of the stump near elevation 130 feet. Additional seepage was observed atop the sandstone bedrock at approximate elevations of 108 and 94 feet. We also observed additional ongoing creep on the slopes on the north and south sides of the landslide scar with scarps of 1 to 4 feet. Trees growing in a skewed manner, generally indicative of ongoing movement, were noted on the slopes. Sandstone bedrock exposures were observed downslope with bedding dipping generally downslope to the west from 37 to 55 degrees. At approximately elevation 80 feet a near vertical 35 foot high sandstone bluff extends downward to the base of the ravine at elevation 40 feet.

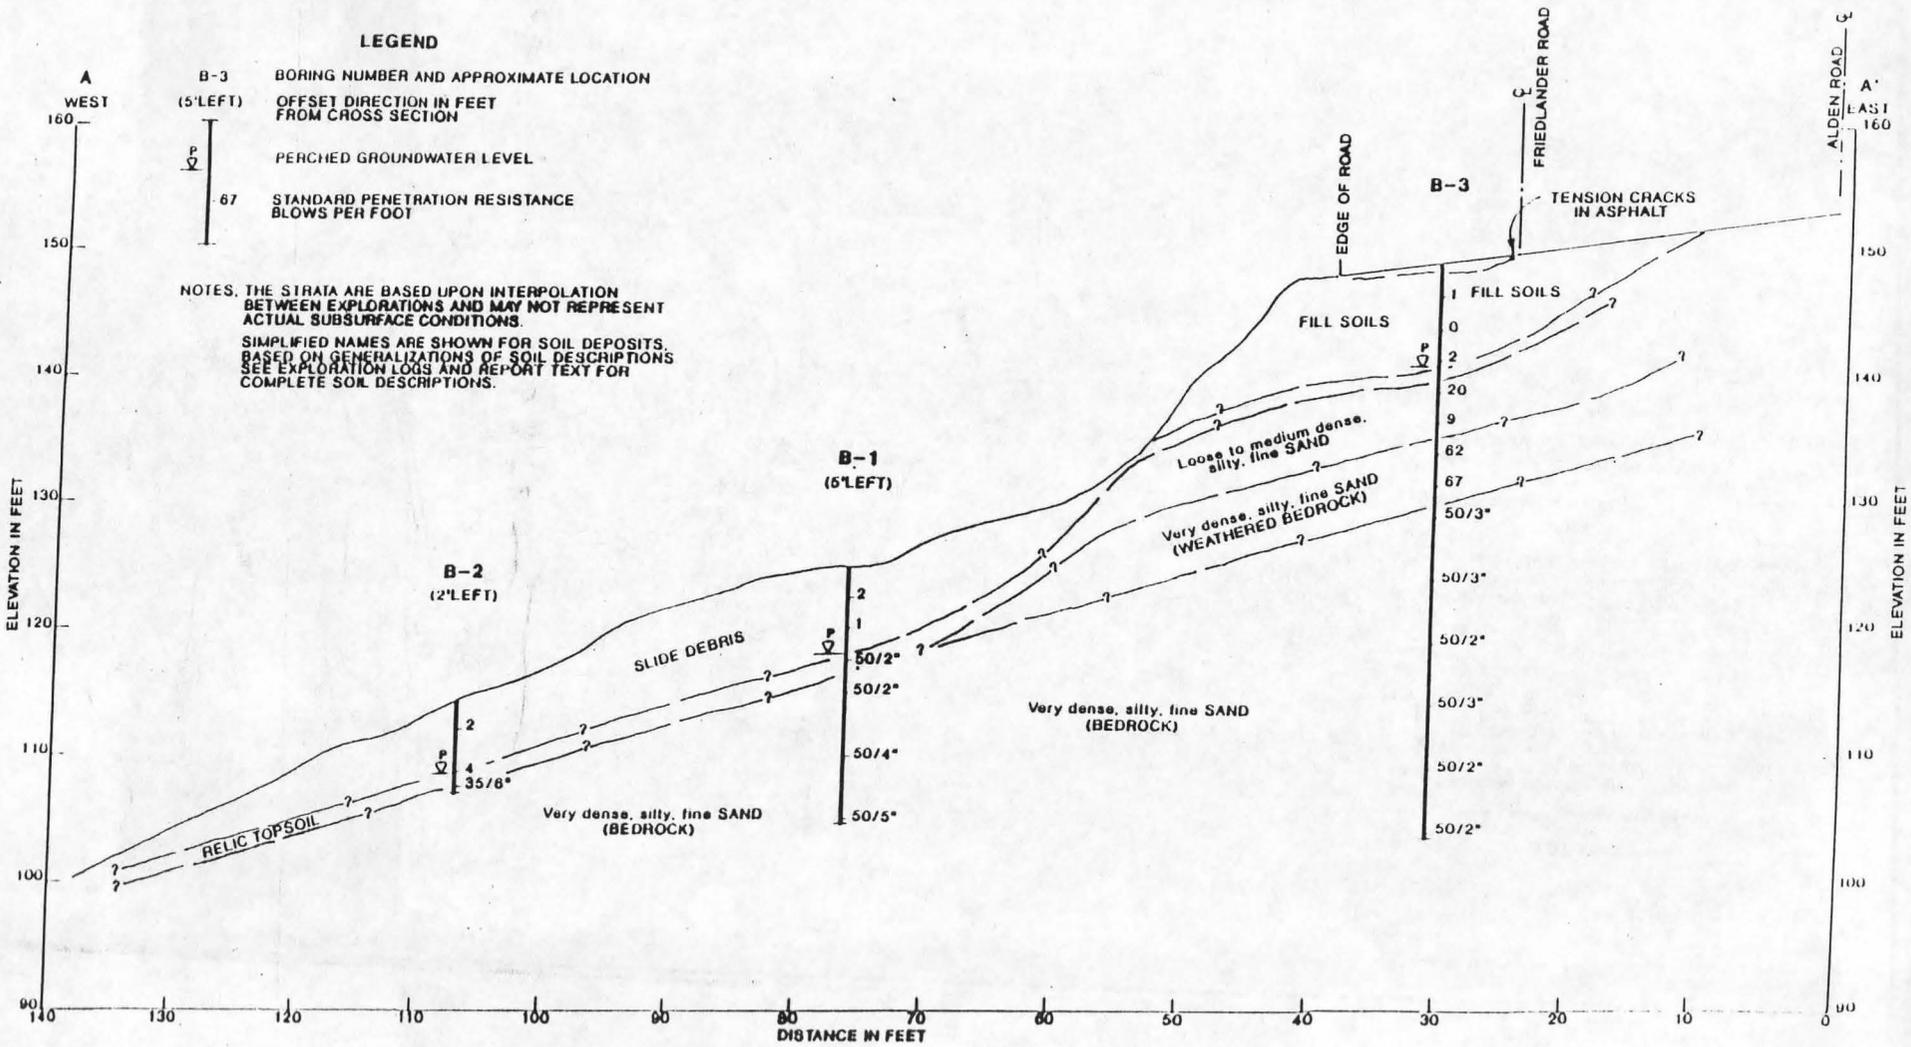
<p>AGRA Earth & Environmental 11335 NE 122nd Way, Suite 100 Kirkland, Washington, U.S.A. 98034-6918</p>	W.O. 7-21M-11883-A DESIGN HWB DRAWN DMW DATE JUL 1997 SCALE 1"=10'	ABERDEEN LANDSLIDES ALDEN ROAD (TASK 01) ABERDEEN, WASHINGTON GEOLGIC CROSS SECTION A-A' FIGURE 3
---	--	---

Our on-site explorations, borings B-1 through B-3, revealed fairly uniform soils conditions (Figure 3). Borings B-1 and B-2 encountered very soft, saturated, sandy silt with some organics, landslide debris to depths of 7 and 5 feet, respectively. In boring B-1 these soils mantled 1 foot of medium-dense, wet, gray silty sand before encountering the dense to very dense, moist, silty fine sand (weathered sandstone). Boring B-1 penetrated 6 feet of weathered bedrock before encountering a very dense, moist, silty fine sand (sandstone) to the full depth of our exploration of 20½ feet. In boring B-2 the landslide debris soils overlaid 1½ feet of very loose, saturated bluish-gray, silty sand followed by ½ foot of soft, wet, black sandy silt with some organics (relic topsoil) to a depth of 7 feet before encountering the dense to very dense, silty fine sand (weathered sandstone). Boring B-2 was terminated in the weathered bedrock at 7½ feet.

In boring B-3 our exploration encountered 6 inches of asphalt over 2 inches of base course mantling, very soft, wet, sandy silt with some clay and organics to 3 feet in depth. These soils overlaid a very loose, moist, silty fine sand to 10½ feet in depth. These upper soils are interpreted to be fill. Between 10½ to 14½ feet our boring penetrated a loose to medium-dense, moist, silty fine sand with some clay (weathered sandstone) before encountering the very dense, moist, silty fine sand with some clay (sandstone) to the full depth of our exploration of 45½ feet. A saturated, silty sand zone was encountered roughly between 36 and 38 feet within this stratum.

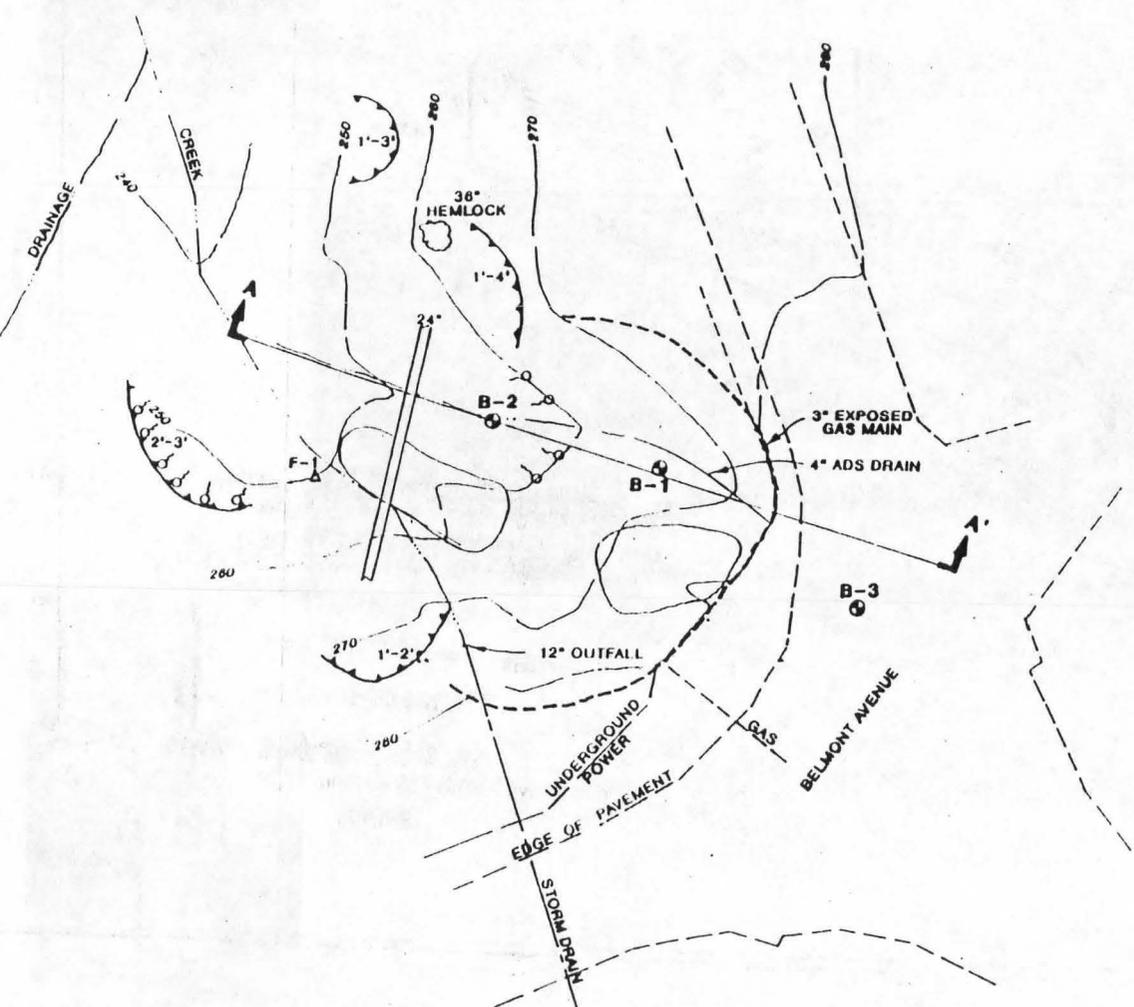
FIGURE 5

At the Belmont Street site two storm water lines drain surface water into the ravine area including a 12-inch diameter corrugated metal pipe (CMP) and a 4-inch ADS pipe. As previously mentioned, an exposed gas line was observed in the bank of the upper scarp area

and should be rerouted prior to any work on the slope. Moderate groundwater seepage was observed at approximate elevations of 260 and 252 feet along the ravine area. Landslide scarps (up to 4 feet in height) and surficial creep was observed on the east and west sides of the main landslide scar. Downed trees and rootballs and skewed tree growth were observed along the slope areas. Sandstone bedrock exposures were observed downslope with bedding dipping generally downslope to the north approximately 15 degrees. A drainage channel was observed further downslope to the north which merges with the main creek at approximately elevation 233 feet.

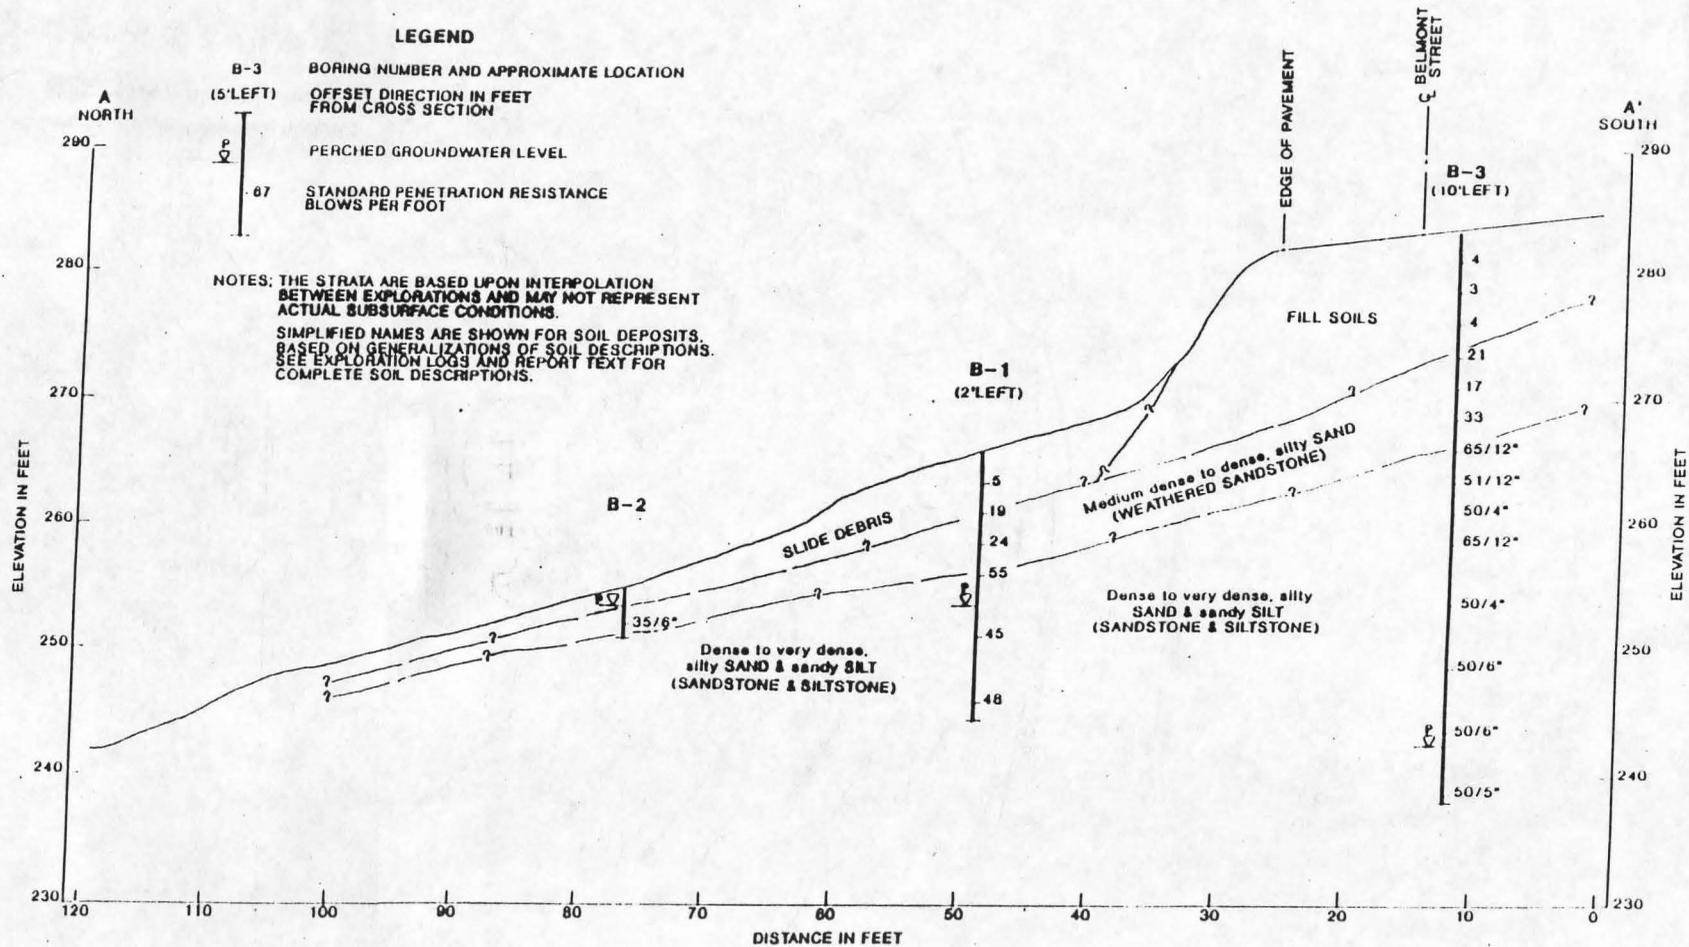
<p>AGRA Earth & Environmental 11335 NE 122nd Way, Suite 100 Kirkland, Washington, U.S.A. 98034 6918</p>	W.O. 7-91M-11693-A	<p>ABERDEEN LANDSLIDES BELMONT STREET (TASK 02) ABERDEEN, WASHINGTON</p> <p>CROSS SECTION A-A'</p> <p>FIGURE 0</p>
	DESIGN CRT	
	DRAWN DMW	
	DATE JUL 1997	
	SCALE 1" = 10'

Our on-site explorations, borings B-1 through B-3, revealed fairly uniform soil conditions (Figure 6). Boring B-1 encountered medium-stiff to stiff, moist to wet, sandy silt with organics to 6 feet in depth. These soils overlie a medium-dense to dense, silty sand with some clay (weathered sandstone) to 12½ feet in depth. The boring then penetrated 1½ feet of hard, wet, silt to 14 feet. These soils overlie a dense, moist to wet, silty sand with some clay (weathered sandstone) to the full depth of our exploration of 21½ feet. In boring B-2, a very soft, wet to saturated, silty sand with some organics (slide debris) at 2 feet mantles 1 foot of loose, wet, silty sand. Our exploration encountered a dense to very dense, wet, silty fine sand with some clay (weathered sandstone) to the full depth of our exploration of 4 feet.

In boring B-3 we encountered 6 inches of asphalt overlying 6 inches of base course which mantled a very loose to loose, wet, silty fine sand with some clay to 9½ feet in depth, interpreted as fill. These soils overlie a medium-dense, moist to wet, silty fine sand with some

clay (weathered sandstone) to a depth of 18 feet. Below this depth our exploration encountered interbeds of very dense, moist, silty fine sand with some silt and hard moist silt with some sand to sandy (sandstone/siltstone) to the full depth of our exploration, 45½ feet. A saturated, silty sand zone was encountered roughly between 41 to 44 feet within this stratum.

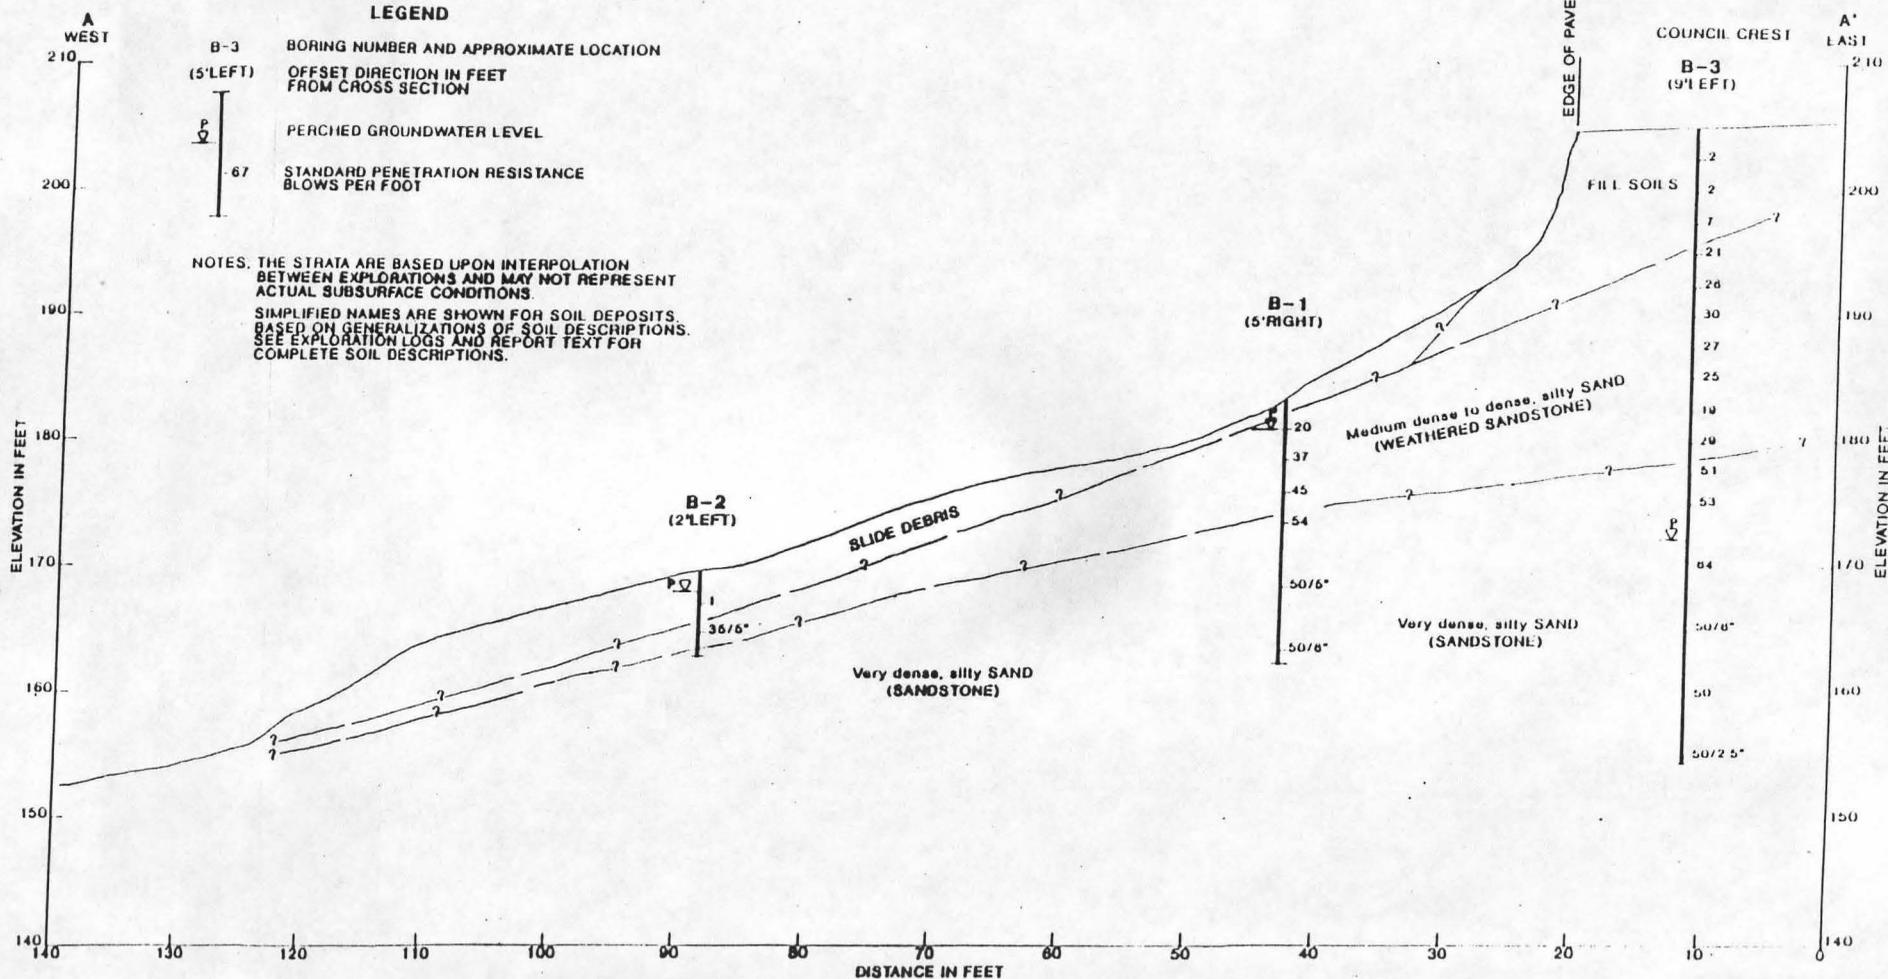
FIGURE 9

Our on-site explorations, borings B-1 through B-3, revealed fairly uniform soil conditions (Figure 9). Borings B-1 and B-2 encountered a very soft to soft sandy silt with some organics (landslide debris) to depths of 1 foot and 4 feet, respectively. These soils mantled a medium-dense, moist to wet, silty fine sand with some clay to depths of 5 and 5½ feet, respectively, before encountering dense, moist, silty fine sand with some clay (weathered sandstone). Boring B-2 was terminated in these dense soils a depth of 6½ feet. In boring B-1 these dense soils continued to a depth of 9½ feet where they overlie a very dense, moist, silty fine sand with some clay (sandstone) to the full depth of our exploration of 21½ feet.

In boring B-3 we encountered 6 inches of asphalt over 9 inches of base course mantling, very soft, wet sandy silt to 4½ feet in depth. These soils overlie a very loose to loose, damp to moist, silty fine sand with some clay to a depth of 9½ feet. These upper soils are interpreted to be fill. Beneath these soils we penetrated a medium-dense, damp to moist, silty fine sand with some clay (weathered sandstone) to 27 feet in depth where we encountered a very dense, moist silty fine sand with some clay (sandstone) to the full depth of our exploration, 50½ feet. A saturated silty sand zone was encountered roughly between 32 to 34 feet within this stratum.
