To: John Glynn
From: Sharon Chase *SC*
Subject: Lynden Sewage Treatment Plant Class II Inspection

On January 13 and 14, 1981 a Class II inspection was conducted at the Lynden Sewage Treatment Plant (STP). Additional samples were collected on January 25 and 26. A receiving water study, conducted from January 12 to 14, 1981 on the Nooksack River, will be discussed in a memorandum by Lynn Singleton and Joseph Joy.

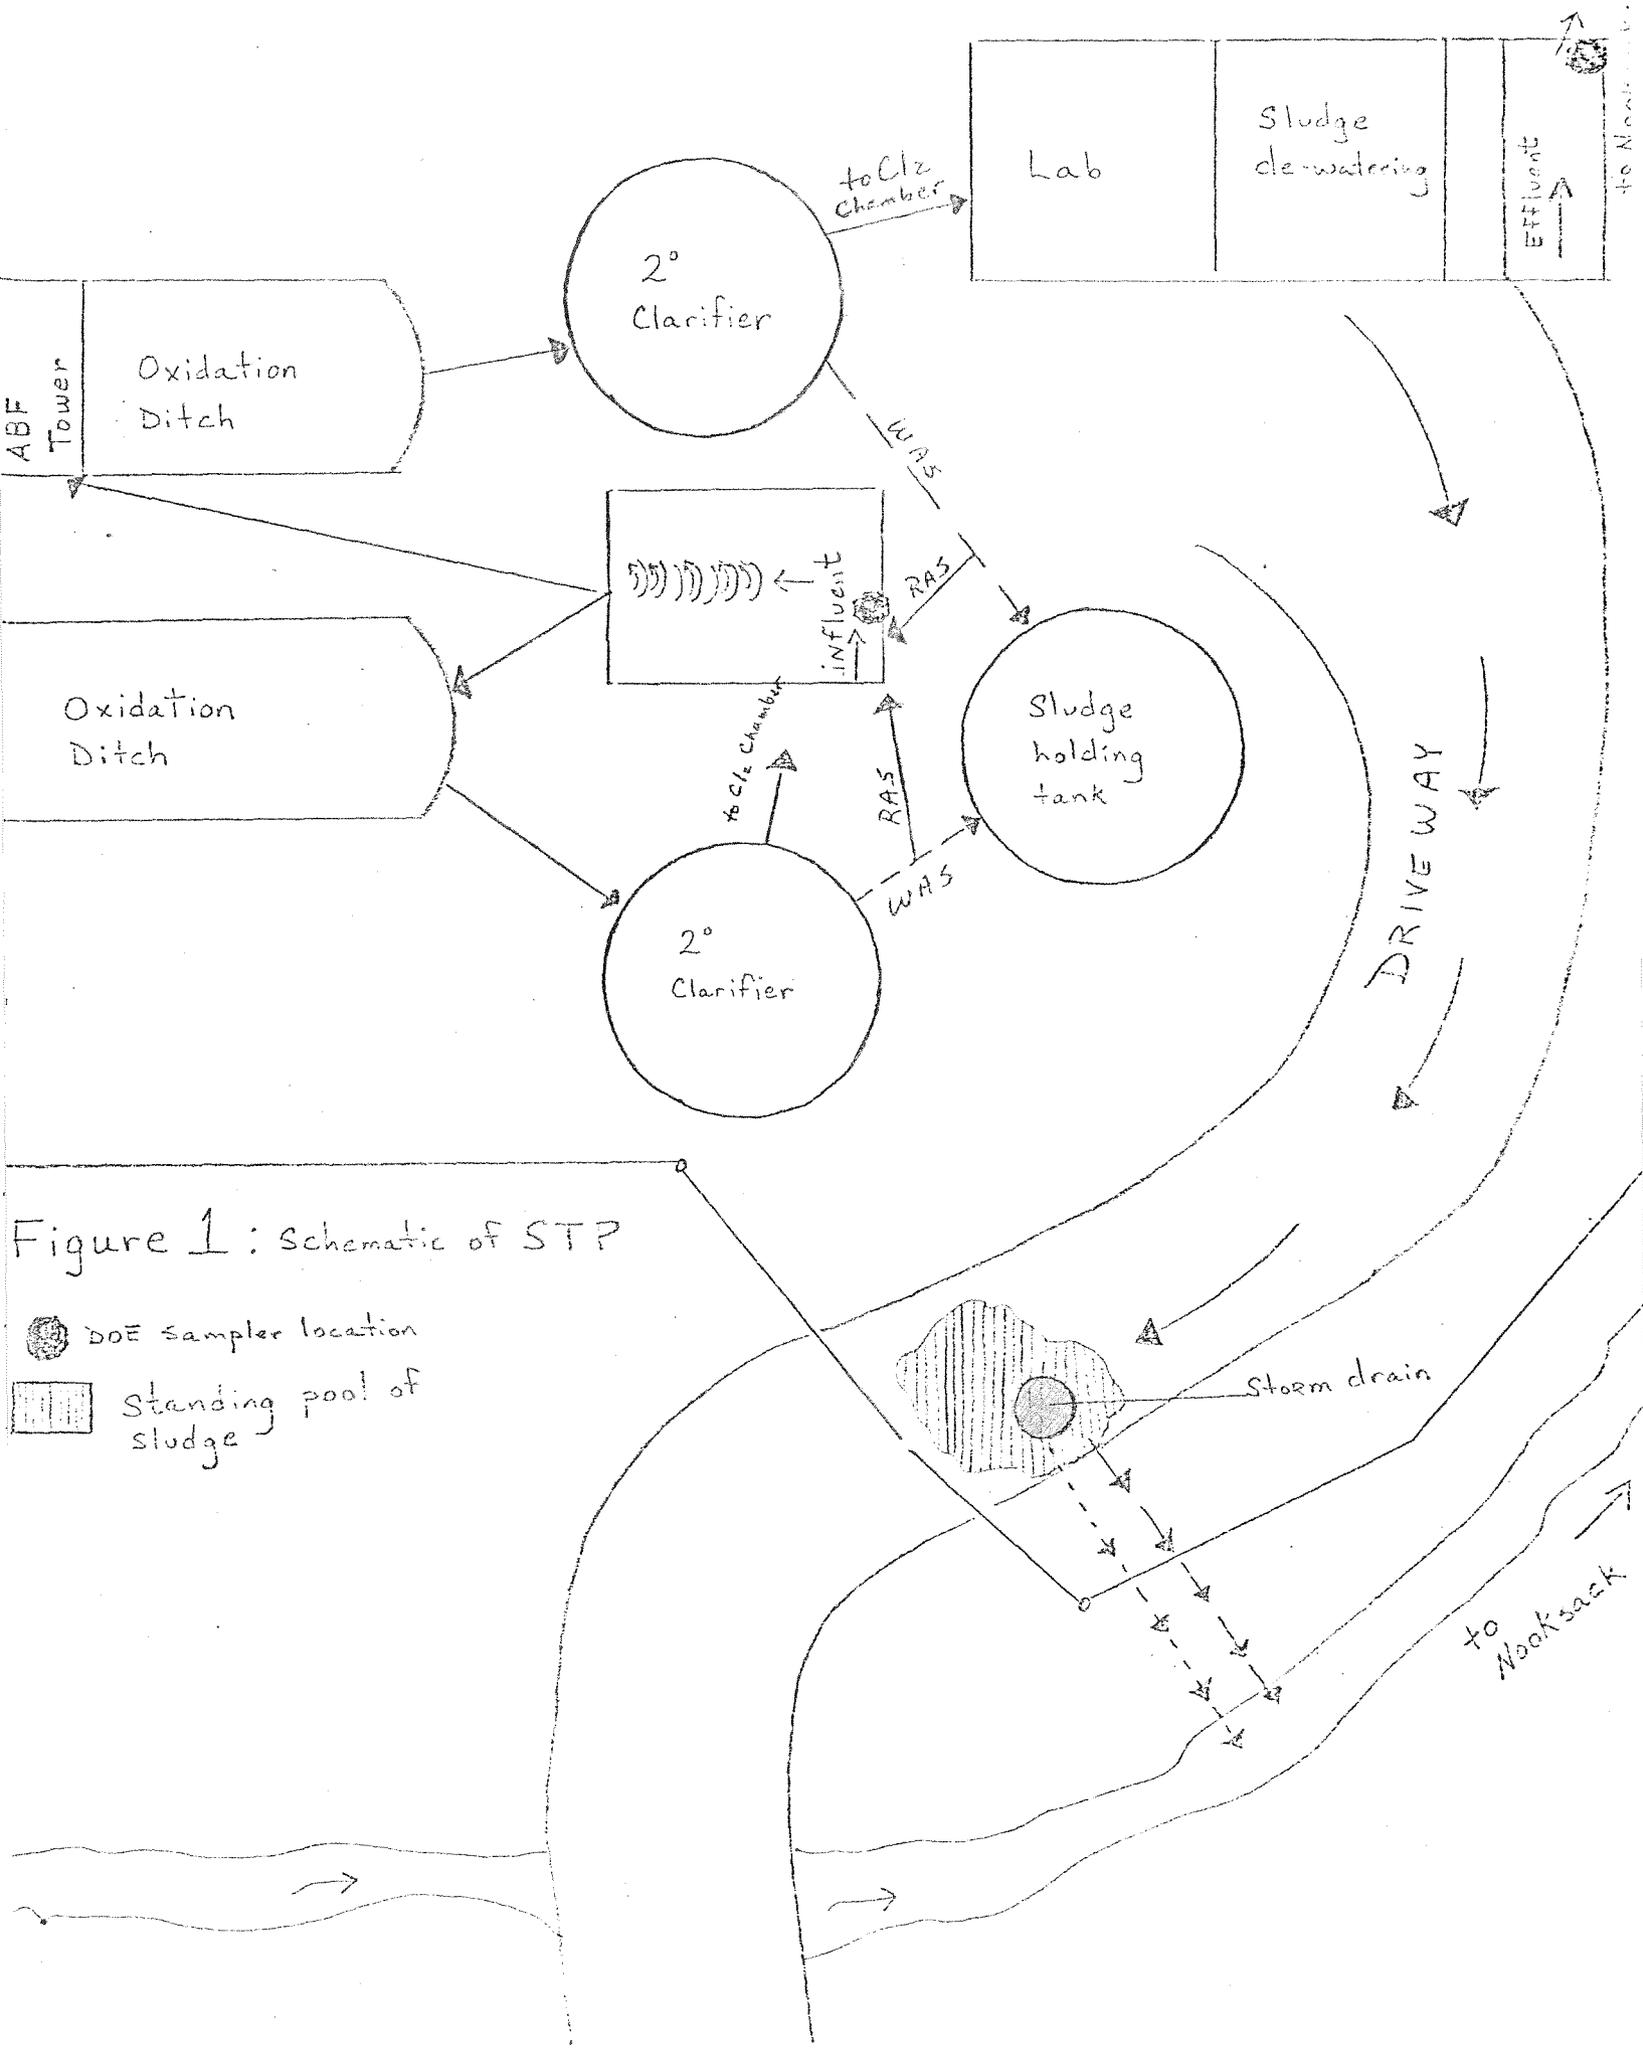
Figure 1: Schematic of STP

Standing pool of sludge

The plant's disposal practices are in clear violation of this permit requirement. Sludge that spills from the truck and the conveyor belt as well as sludge washed off the sludge dewatering machine is hosed down the plant's driveway where it forms a large pool. This pool was several inches deep and approximately 8 to 10 feet in diameter during our inspection. The pool covered a storm drain which, according to the operator, discharges directly into a flowing drainage ditch which empties into the Nooksack. This normal plant "clean-up" procedure, carried out at least once daily according to plant personnel, results in discharge of sludge to a state surface water. Some means must be found to contain this sludge and prevent it from entering the surface water via runoff or the storm drain. The sludge should be diked and pumped back into the system or the spillage problem itself remedied. It must be noted here that the plant is, in general, quite lax about sludge handling. The sludge truck used to transport sludge to the landfill was observed leaking sludge onto the streets of Lynden. The fecal coliform count of the sludge was 540,000 colonies/100 ml. Application of this sludge to the streets could present a health risk.
