**DAWN LAKE DAM
HYDROLOGIC ANALYSIS**

Douglas L. Johnson, P.E.
Dam Safety Section
December, 1993

OFTR 93-9

DAWN LAKE DAM HYDROLOGIC ANALYSIS

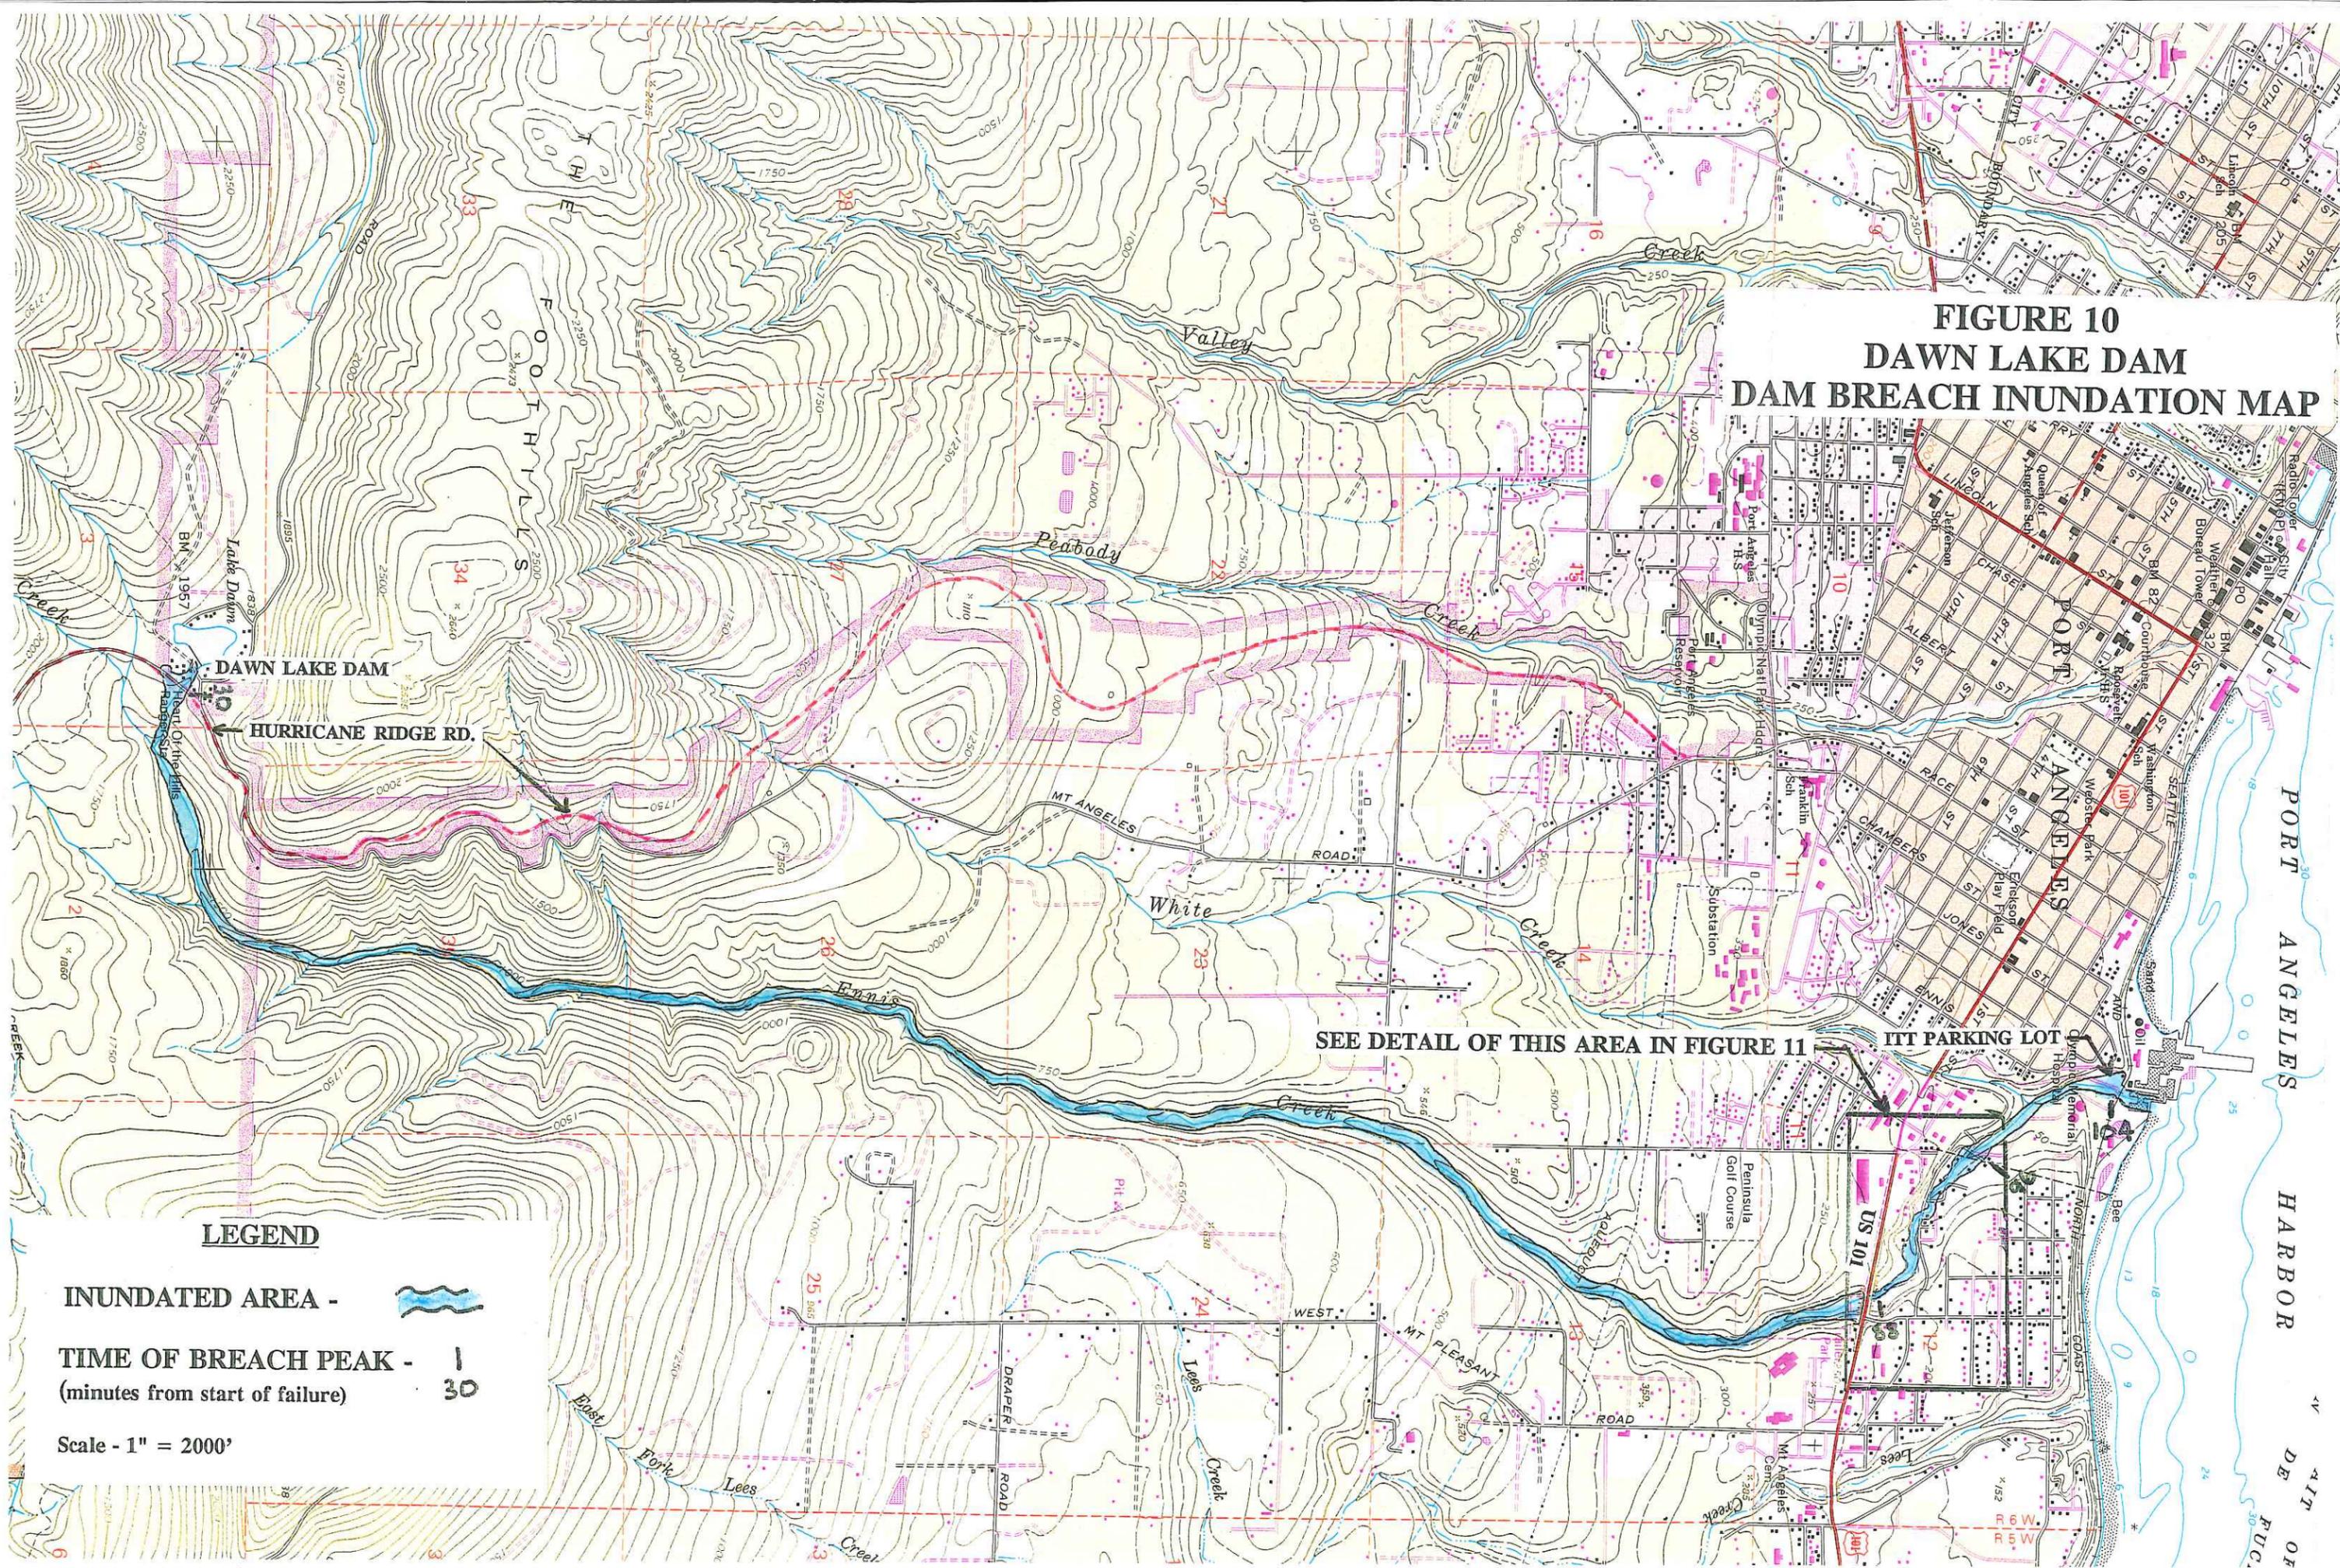
**FIGURE 10
DAWN LAKE DAM
DAM BREACH INUNDATION MAP**

The analysis showed that the dam break floods would spread across the lower Ennis Creek valley below U.S. 101. Under the "sunny day" scenario, a total of three houses would be inundated. Under the IDF, a total of five houses would be inundated. A detailed inundation map of the populated area for both cases is provided in Figure 11.

Downstream from the residential area, the dam break floods would partially inundate the sewage treatment plant, then would flood the ITT Rayonier parking lot upstream from an old railroad bridge. Beyond the railroad, the flood would likely cause some damage at the ITT mill before dumping into the Straits of Juan de Fuca.

Figures 10 and 11 provide inundation maps of the downstream area based on the preceding analysis.
