ROCHESTER GROUND WATER QUALITY INVESTIGATION

by
Denis Erickson

Washington State Department of Ecology
Environmental Investigations and Laboratory Services Program
Toxics Investigations/Ground Water Monitoring Section
Olympia, Washington 98504-8711

November 1990

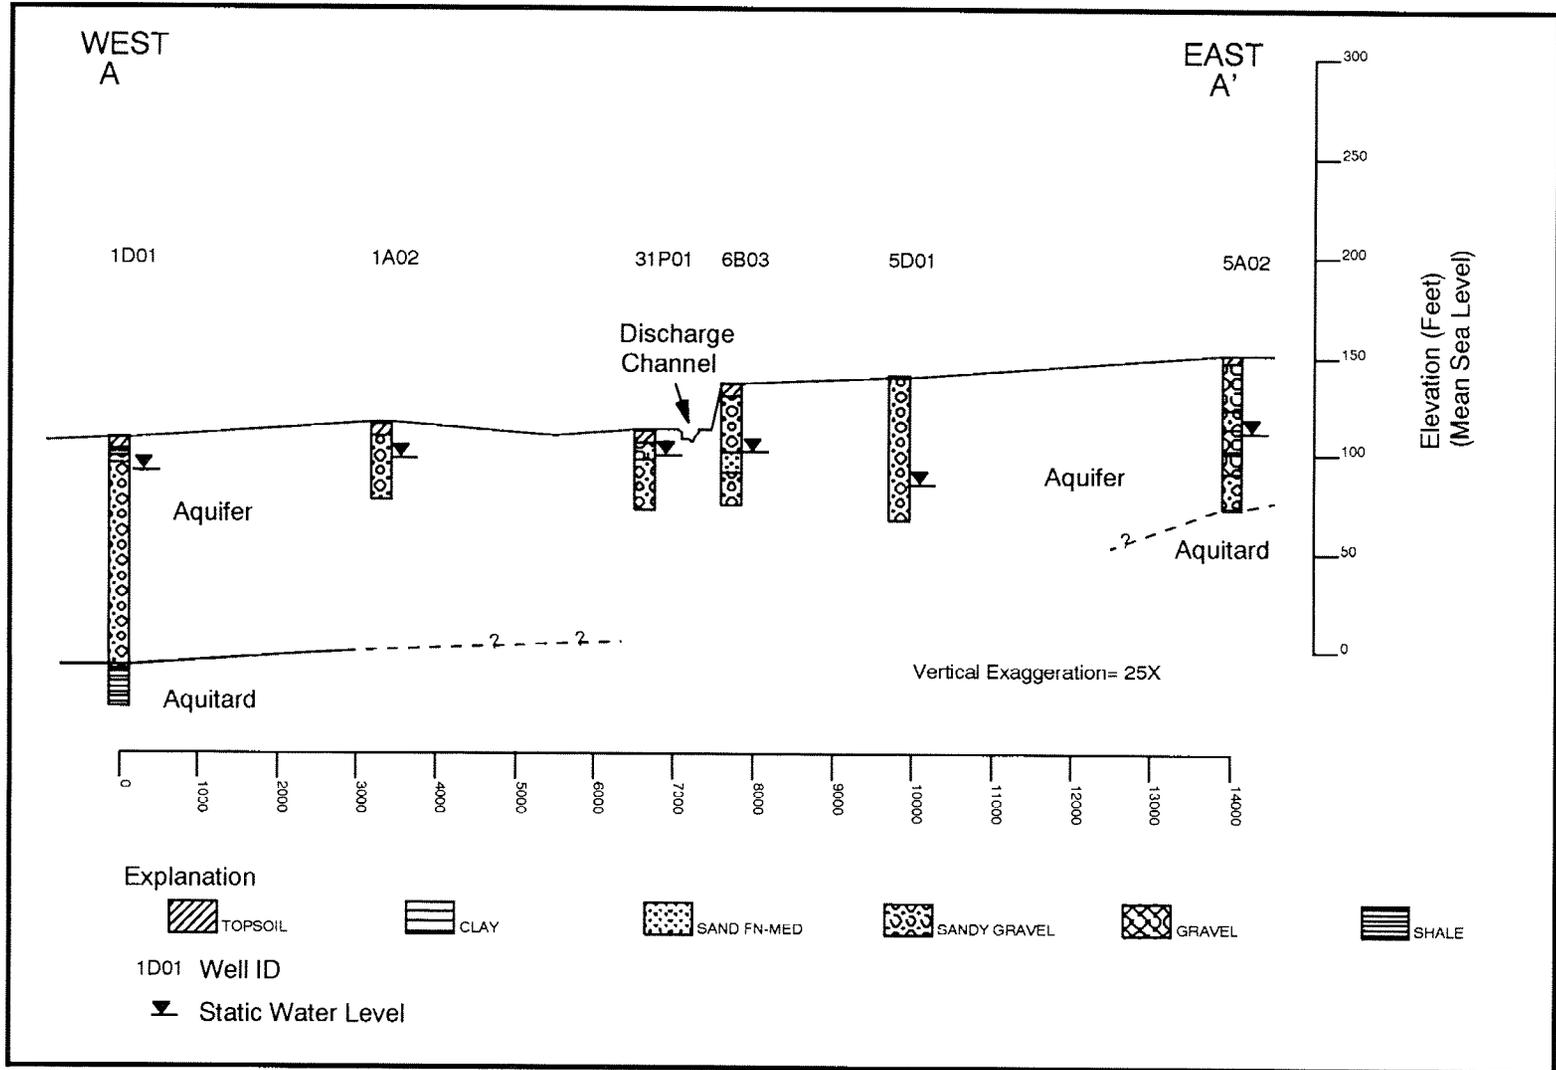
Figure 2: Hydrogeologic Profile A-A'

The study area is underlain by glacial outwash and alluvial sediments (Wallace and Molenaar, 1961). A west-east hydrogeologic profile (Figure 2) shows the subsurface relationship of the unconsolidated deposits to the discharge channel and selected wells. The glacial outwash is continuous beneath the study area and consists of unconsolidated sand and gravel deposits. Alluvial deposits overlie the outwash deposits on the west side of the study area and consist of mixtures of clay, silt, sand, and gravel. The alluvial sediments are floodplain deposits of the modern Chehalis and Black Rivers. The study area surficial soils consist of loamy sand and gravelly sandy loam east of the Steelhammer facility and silty clay loam west of the facility. The sandier soils are associated with the outwash deposits and the silty clay loam soils are associated with the alluvium and modern floodplain. The discharge channel appears to have been underlain in most locations by silty clay loam (Ness, 1958). Sedimentary bedrock crops out in the low hill on the east side of the study area. Because of the low permeability of the bedrock relative to the outwash and alluvial sediments, it is considered a no-flow boundary for this assessment.

The alluvial and outwash deposits are hydraulically connected and represent a single aquifer system. The aquifer is unconfined and the depth to the water table ranges from 10 to 45 feet. The aquifer thickness is 100 feet about one-and-a-half miles west of the facility (Well 1D01) and about 50 feet thick one mile east of the facility. The thickness of the aquifer beneath the facility is not known because no facility wells penetrate the entire thickness of the aquifer. Two of the production wells at the Steelhammer facility with available well logs are completed at a depth of 62 and 75 feet. One other production well is reportedly completed at a depth of 31 feet (Fish Pro, 1989). The water-table contour map (Figure 3) shows the ground water flow pattern based on water levels obtained October 2 to 4, 1989. The regional ground water flow is toward the west. The hydraulic gradient appears to be fairly steep on the eastern one-third of the study area and flattens on the western two-thirds. Because the aquifer system is unconfined, it is affected by the major drainages: namely, the Black and Chehalis Rivers and Scatter Creek and locally by the discharge channel near the ponded area near Highway 12.

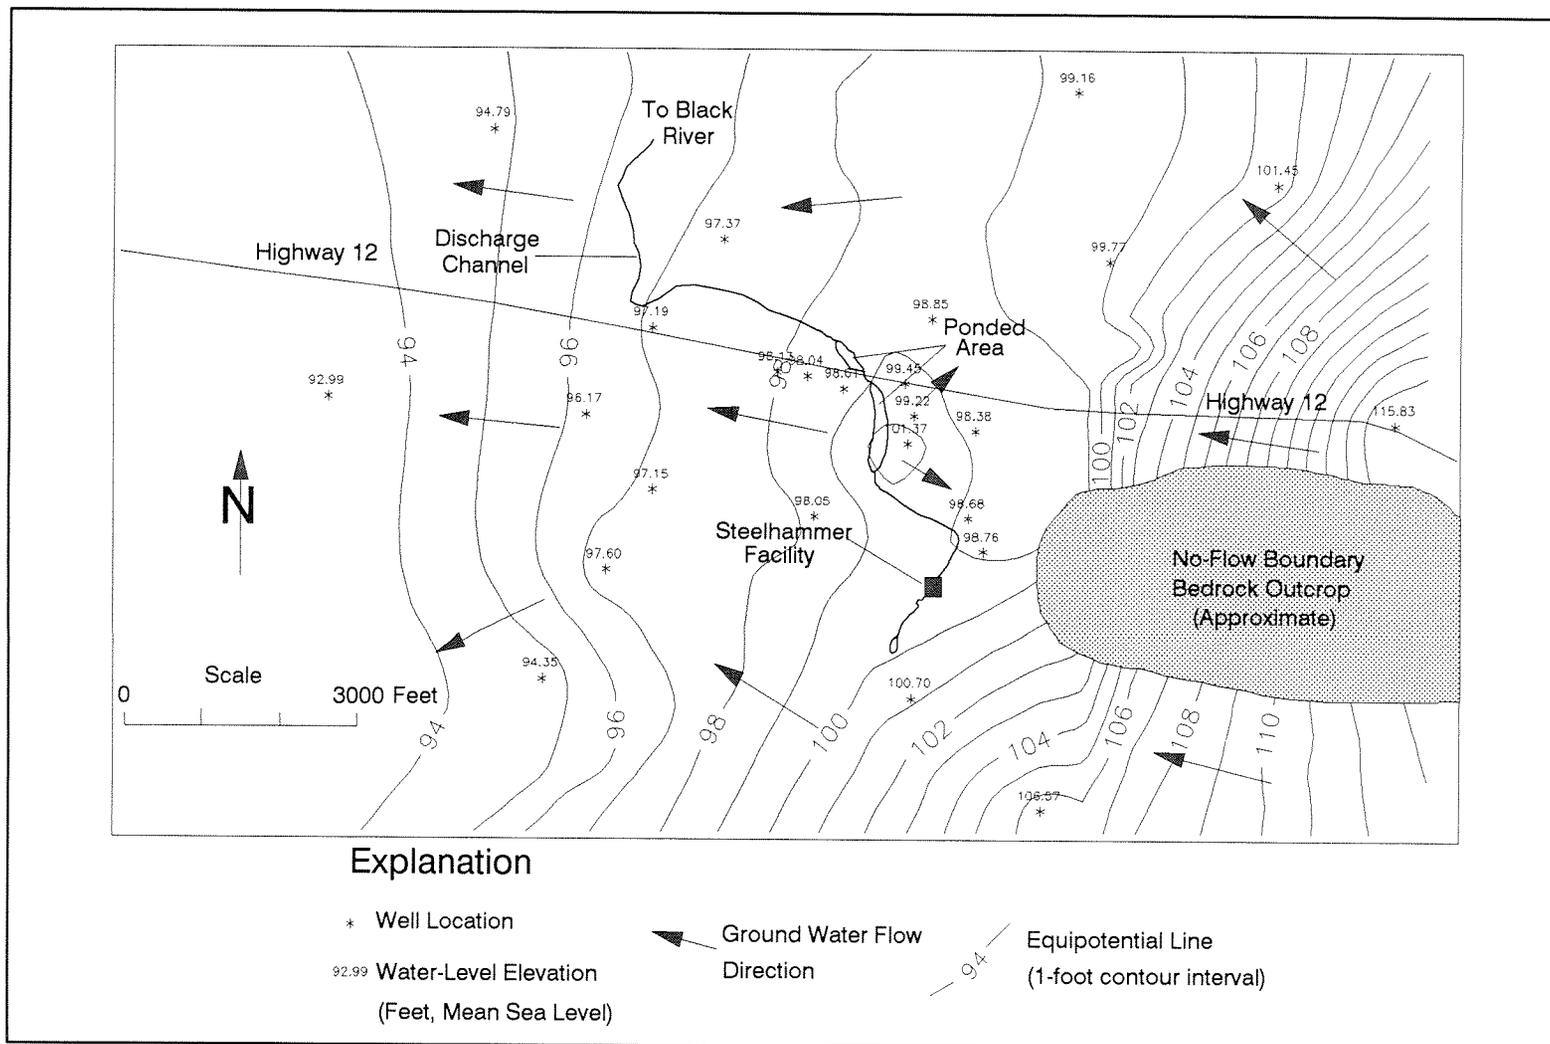
Figure 3: Water-Table Contour Map, October 1989

The water level in the discharge channel as determined at the three surface water stations is about ten feet above the water table. Therefore the channel provides a downward driving force for water and dissolved contaminants. The water table contour map (Figure 3) shows a distortion of the equipotential lines, in particular the 99- and 100-foot contours, in the vicinity of the ponded area of the channel near Highway 12. Leakage from the channel is likely occurring which results in localized mounding of the water table. It appears that the leakage rate from the channel is enough to cause mounding, but it would also suggest that there may not be a direct hydraulic connection (i.e. the entire thickness of sediments underlying the channel may not be saturated). The water table is mounded about two feet at one well (06B02) about 200 feet from the channel. Unfortunately, the amount of mounding and the degree of hydraulic connection with the channel and the water table can only be estimated with the existing data.

Based on the ground water flow direction shown in Figure 3, only one well, the trailer court water supply well (06H04), is located downgradient of part of the trailer court. Unfortunately the trailer court is also downgradient of the ponded area near Highway 12 and, therefore, may not be a good measure of potential loading from septic tanks. The nitrate+nitrite as N (3.7 mg/L), chloride (6.1 mg/L), and total dissolved solid (150 mg/L) concentrations, parameters associated with septic tank effluent, are slightly elevated above background concentrations. However, these slight elevations do not, at present, represent a significant threat to ground water quality.

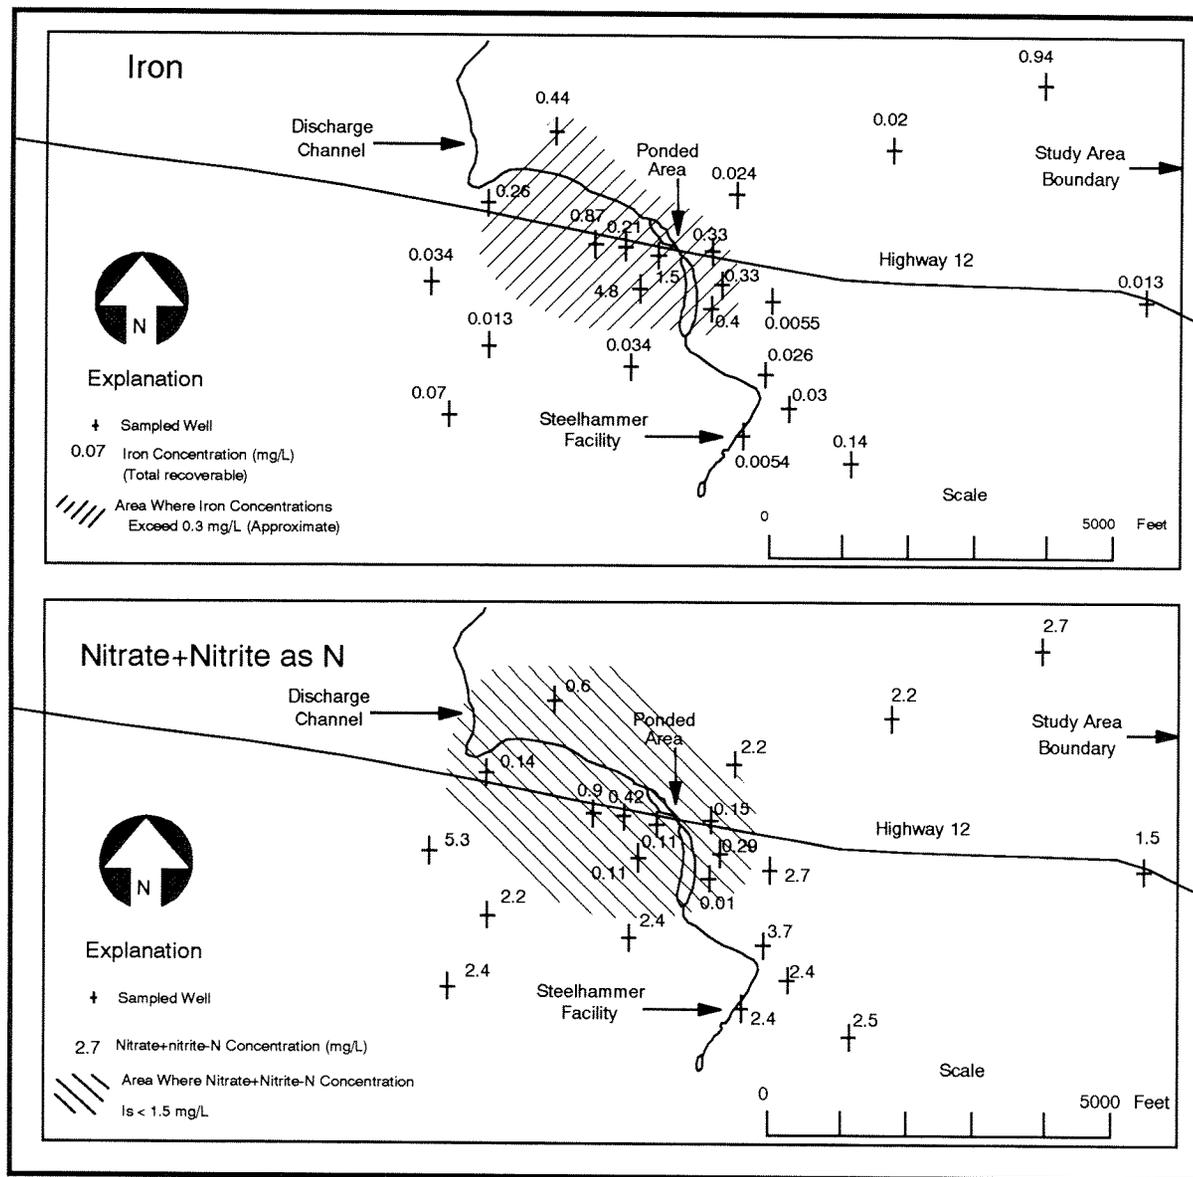
Figure 5. Iron and Nitrate-Nitrite as N Concentrations (mg/L)

Two other parameters, iron (total recoverable) and nitrate-nitrite as N, have concentration distributions (Figure 5) that appear to be affected by the discharge channel and are discussed below. Iron was present in the effluent and the discharge channel at concentrations of about 0.01 to 0.05 mg/L. Upgradient concentrations of iron generally ranged from 0.01 to 0.02 mg/L with the exception of one upgradient well, 32G03, which showed a concentration of 0.94 mg/L. Seven wells in the vicinity of the ponded area near Highway 12 showed substantially elevated concentrations of iron that ranged from 0.2 to 4.7 mg/L.

Nitrate-nitrite as N distribution shows a different pattern. Nitrate-nitrite as N was present in the effluent at 0.68 mg/L and in the discharge channel at concentrations ranging from less than the detection limit, 0.01 mg/L, to 0.81 mg/L. The concentration in the discharge channel decreased

downstream of the facility. Nitrate-nitrite as N concentrations in wells ranged from less than the detection limit (0.01 mg/L) to 5.3 mg/L. Upgradient concentrations ranged from 2 to 3 mg/L. Concentrations less than 1 mg/L occurred in the area immediately downgradient of the ponded area near Highway 12. The maximum concentration, 5.3 mg/L, occurred at a well (01A02) at the far west side of the study area.

3. Iron exceeded the secondary MCL, 0.3 mg/L, in eight of the wells tested. The concentrations in the eight wells ranged from 0.33 to 4.77 mg/L. Six of these wells are near the ponded area near Highway 12. The mobilization of iron is due to the reducing and probably acidic conditions that exist beneath the discharge channel.
