The ANADYR

PREVENTION BULLETIN 99-01

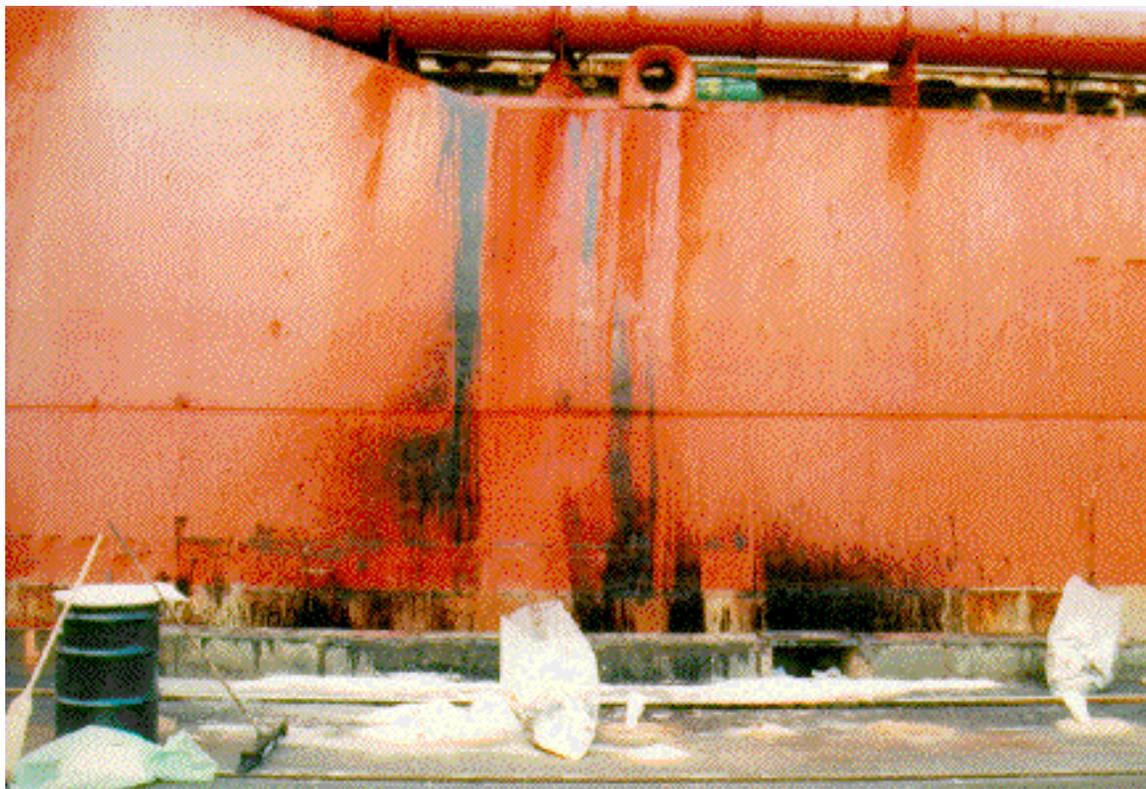
On January 1, 1998, the M/V ANADYR spilled about 7,500 gallons of fuel oil into the Sitcum Waterway, in Tacoma, Washington. The spill occurred while the ship was taking bunkers from the tank barge DAVID-120. A side-by-side set of port and starboard double-bottom tanks were overfilled. Fuel oil spilled from the double-bottom tank vents located forward on the ship's main deck, overflowed fixed containment, and flowed aft down the deck of the ship. The oil subsequently made its way to the water triggering a significant containment and clean-up effort.

ANADYR's starboard side showing deck edge where oil flowed over the side.
