The MONCHEGORSK

On September 5, 1998, at about 1830, the M/V MONCHEGORSK ran aground under power at the entrance to Amsterdam Bay, Anderson Island, Washington. The grounding occurred in daylight with clear weather, under the direction of a pilot who intended to take the ship north around Anderson Island via Drayton and Balch Passages on its outbound passage from Olympia, Washington. No oil spilled as the result of this grounding and the vessel was refloated with the assistance of tugs at about 0500 the next morning.

Prevention Bulletin

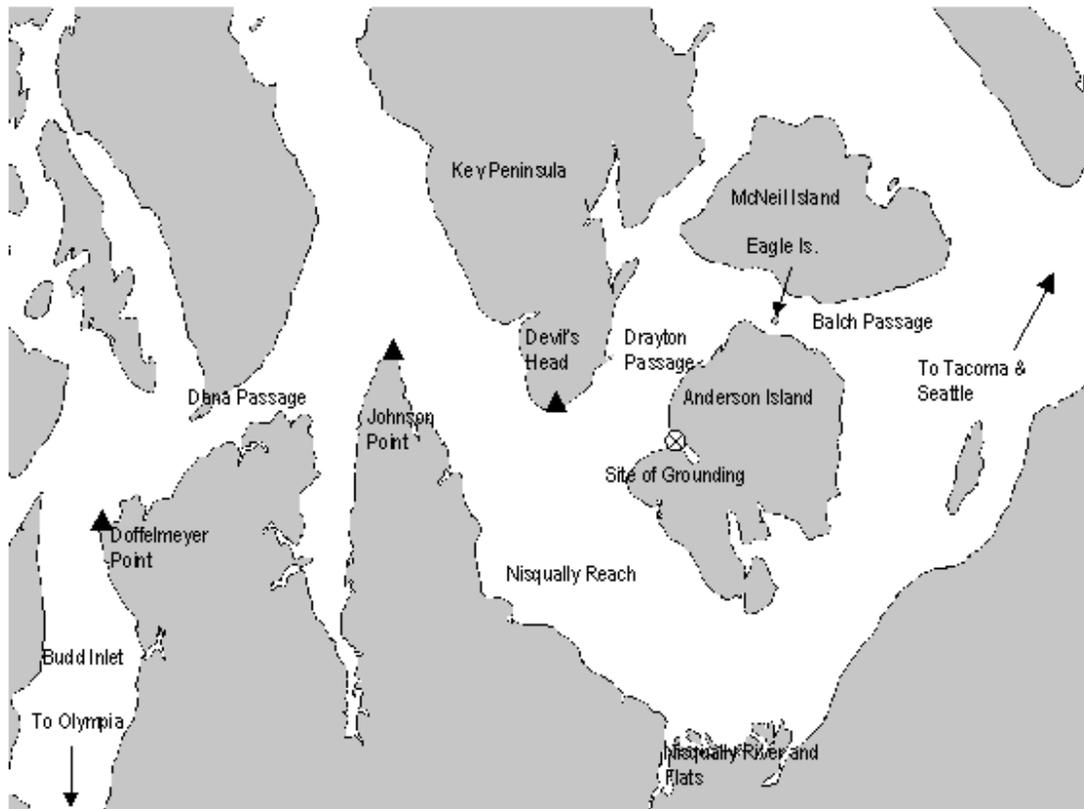
Area transited by the MONCHEGORSK. (Not for navigational use.)
