## Olympia Brewery transformer spill lake sediment cleanup Summer 2019

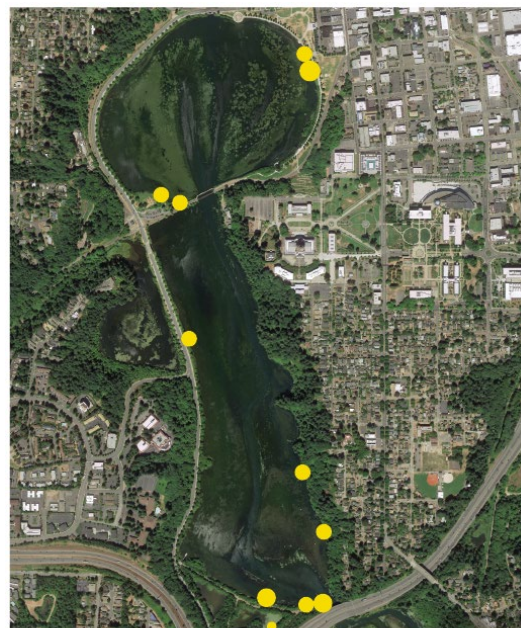
ABOVE: Sediment removal areas, marked in yellow.  
Map: Google Earth.

1. A mesh barrier keeps fish and wildlife from entering areas where the divers are working. The mesh allows water, but not sediments, to pass through.
2. In contaminated areas, divers vacuum up the top layer of lake sediments. Divers access contaminated areas from the shoreline wearing protective diving suits.
3. The contaminated lake sediments removed by divers are pumped into large settling tanks to allow the sediments to separate from the water.
4. The contaminated sediments will be taken off site by tank truck for proper disposal at a landfill. The water will be filtered.
