Washington State School Seismic Safety Assessments Project

# SEISMIC UPGRADES CONCEPT DESIGN REPORT

Cosmopolis Elementary  
School – Main Building  
Cosmopolis School District 099

June 2019

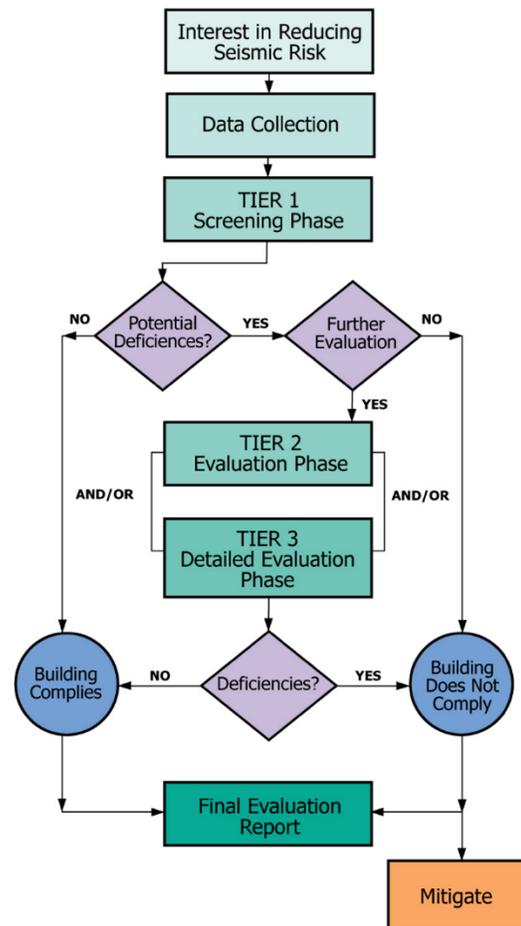
Figure 2-1. Flow Chart and Description of ASCE 41 Seismic Evaluation Procedure.

The current standard for seismic evaluation and retrofit (upgrades) of existing buildings is ASCE 41-17. ASCE 41 provides screening and evaluation procedures used to identify potential seismic deficiencies that may require further investigation or hazard mitigation. It presents a three-tiered review process, implemented by first following a series of predefined checklists and “quick check” structural calculations. Each successive tier is designed to perform an increasingly refined evaluation procedure for seismic deficiencies identified in previous tiers in the process. The flow chart in Figure 2.1 illustrates the evaluation process.

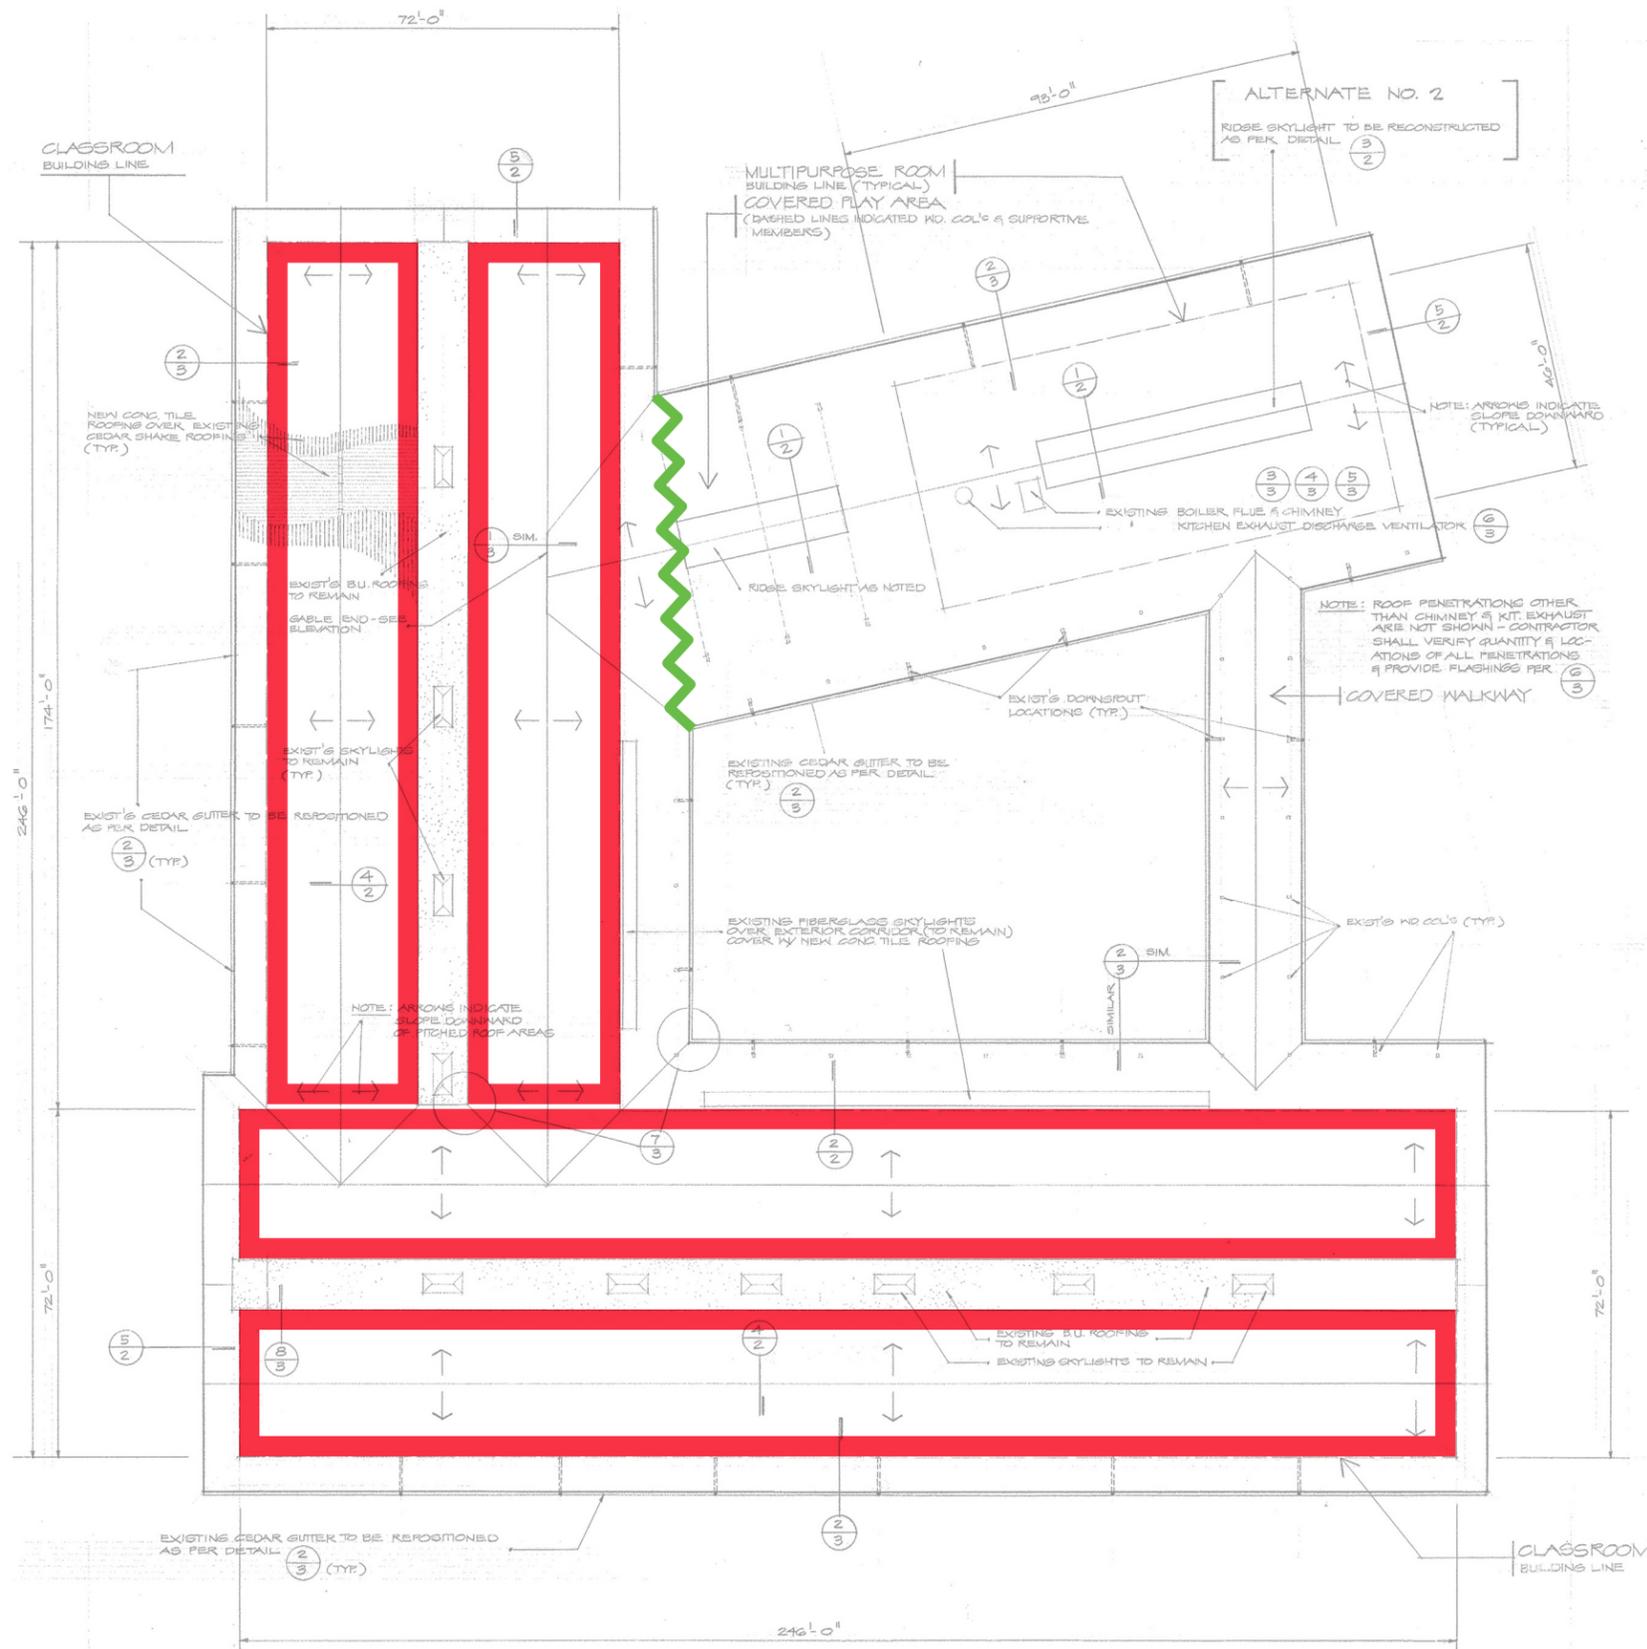
**Figure 1 - Main Floor Strengthening Plan**

█ Existing Diaphragm Orientation  
█ Seismic Joint

Conceptual seismic upgrade recommendations for structural and nonstructural systems are provided to improve the performance of the building to meet the designated performance criteria of ASCE 41. Sketches for the concept-level seismic upgrades are provided in Appendix B. Structural upgrades would include sheathing the roof and detailing for shear transfer to the exterior, interior hallways, and transverse shear walls. Moment frames or braced frames should be added at the exterior walls to increase the lateral load capacity; this would alleviate the need for strapping around the windows. Finally, the lateral system improvements would need to be positively connected to the foundation.

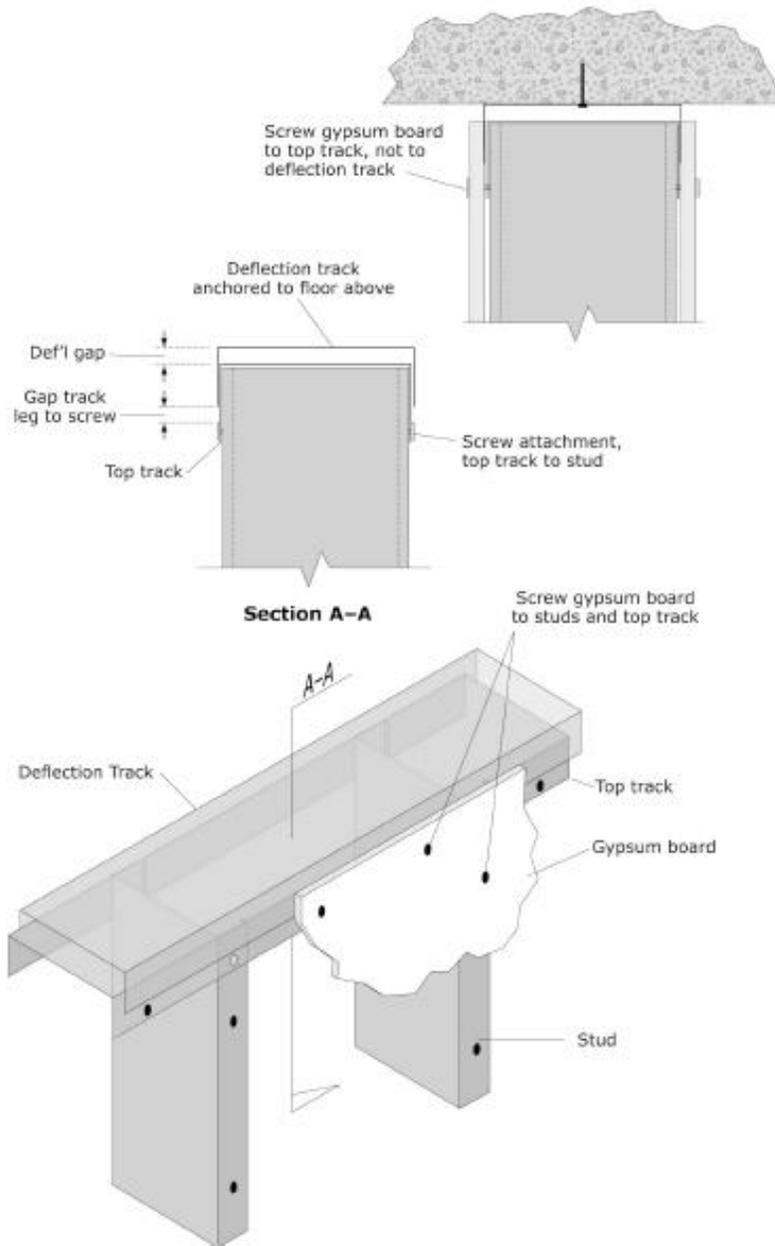
**Figure G-3. Mitigation Schemes for Bracing the Tops of Metal Stud Partition Walls.**  
*(FEMA E-74, 2012, Reducing the Risks of Nonstructural Earthquake Damage)*

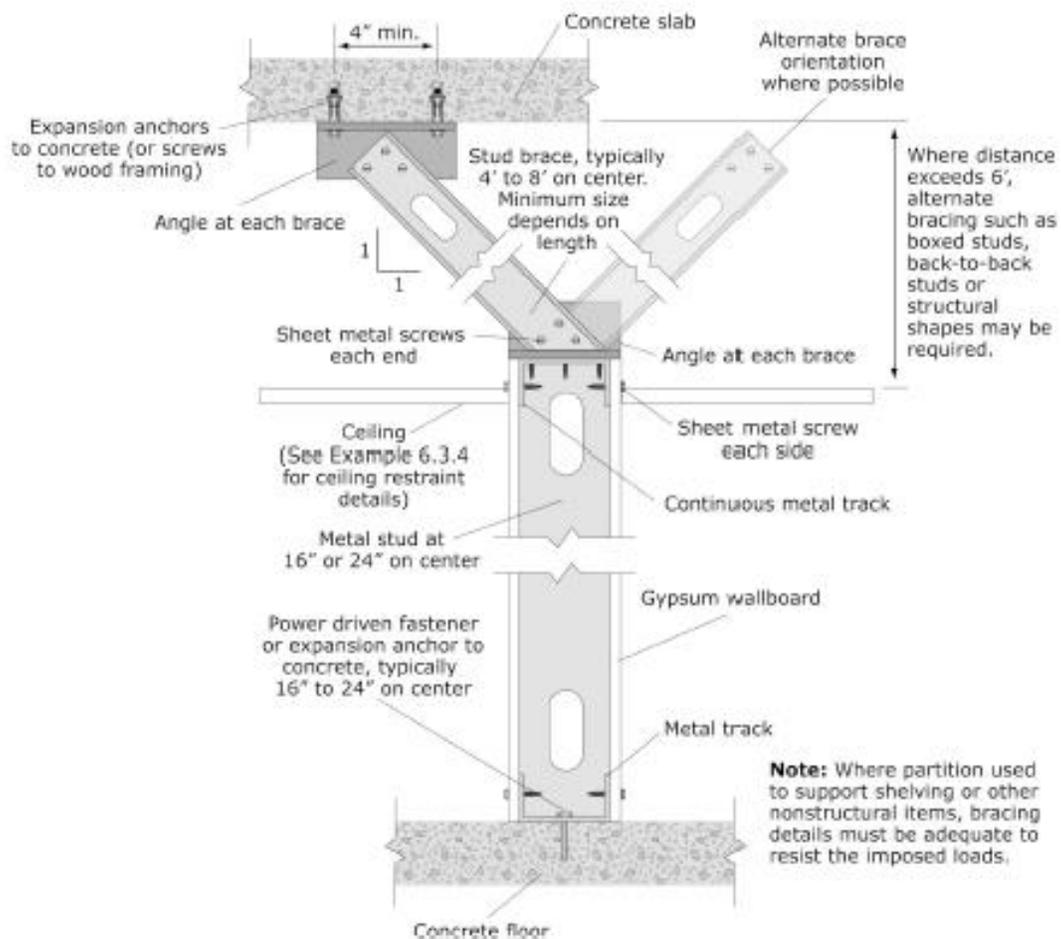
**Figure G-4. Mitigation Schemes for Bracing the Tops of Metal Stud Partitions Walls.**  
*(FEMA E-74, 2012, Reducing the Risks of Nonstructural Earthquake Damage)*

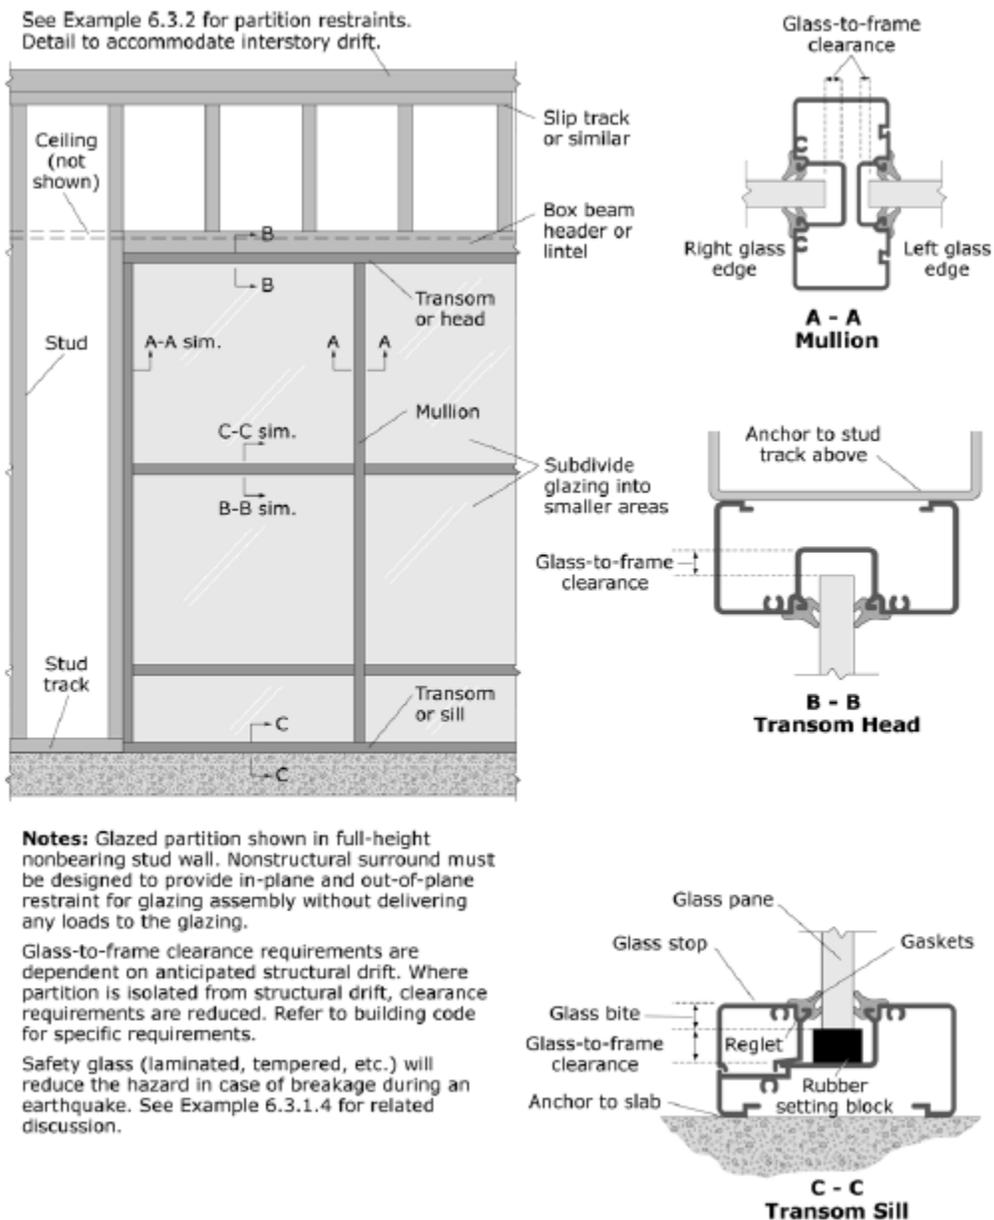
**Figure G-5. Full-height Glazed Partition.**

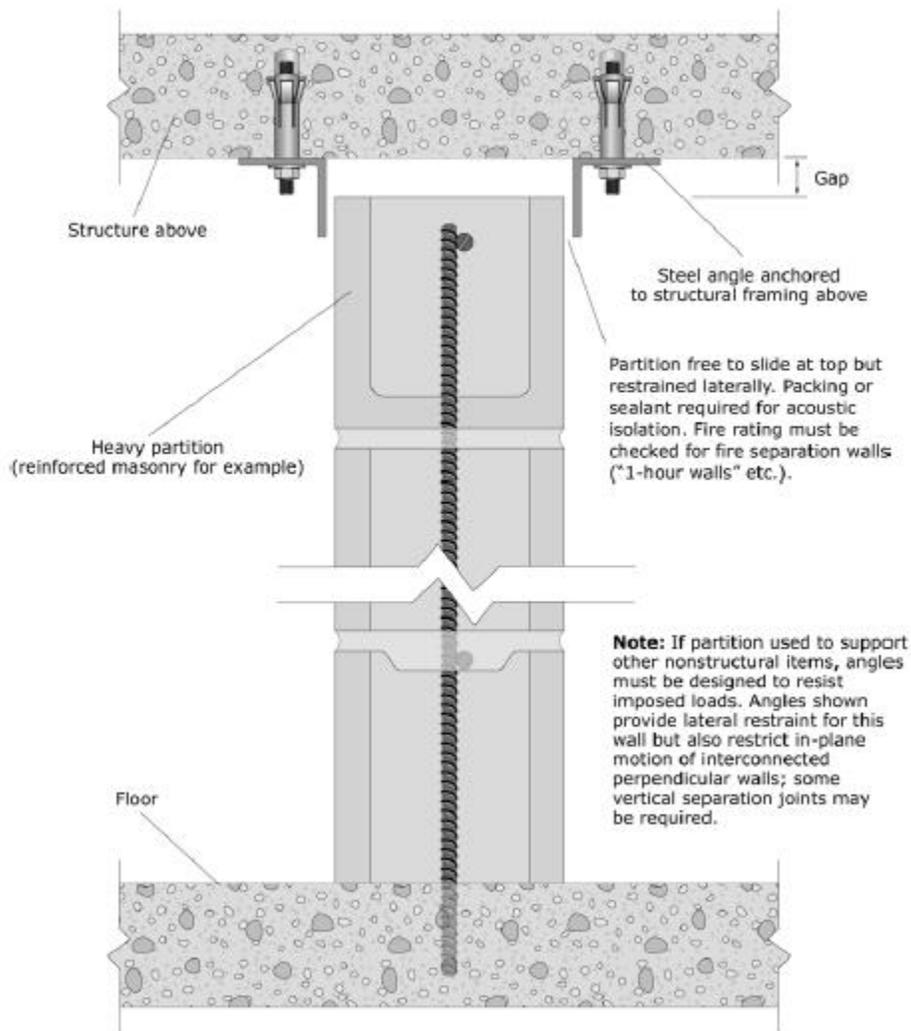
**Figure G-6. Full-height Heavy Partition.**

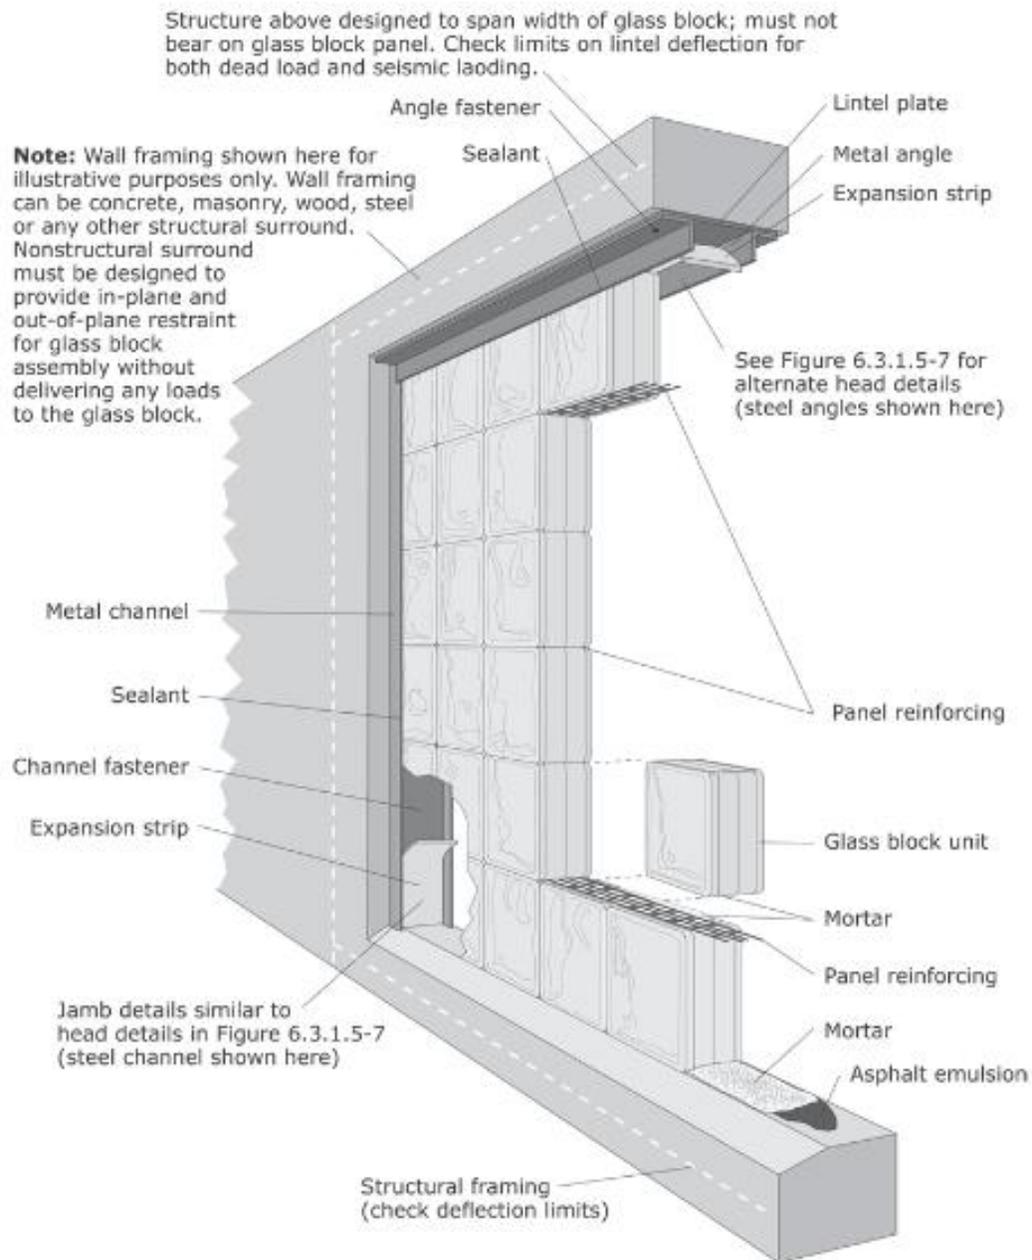
**Figure G-7. Typical Glass Block Panel Details.**  
*(FEMA E-74, 2012, Reducing the Risks of Nonstructural Earthquake Damage)*

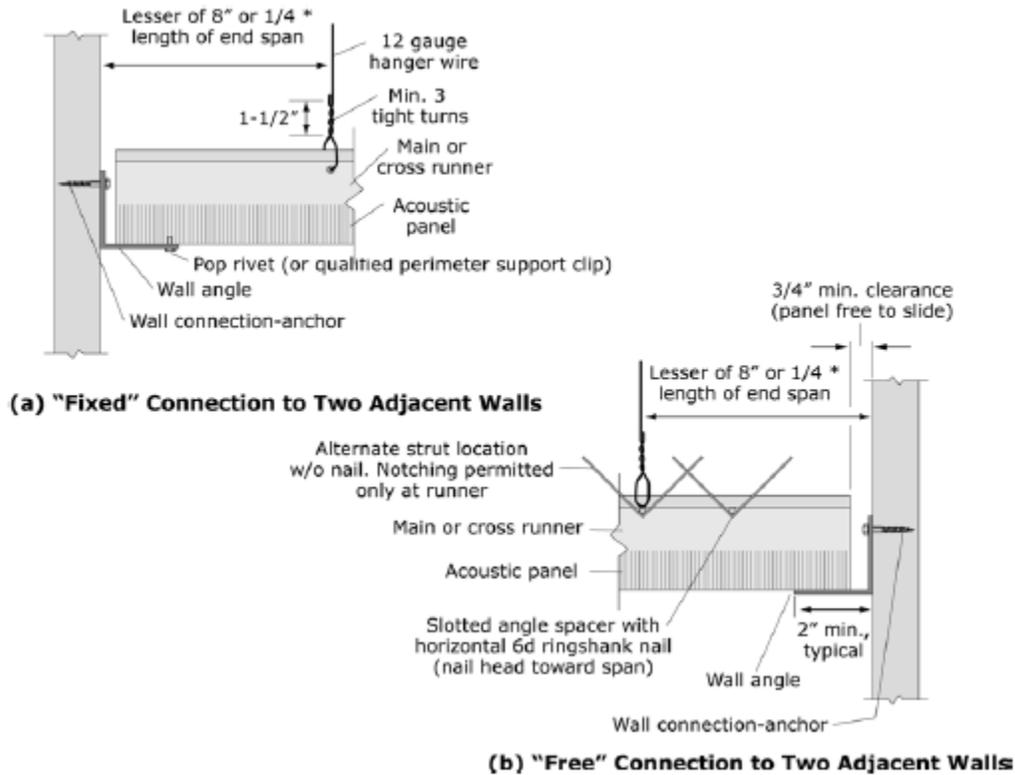
**Figure G-8. Suspension System for Acoustic Lay-in Panel Ceilings – Edge Conditions.**  
*(FEMA E-74, 2012, Reducing the Risks of Nonstructural Earthquake Damage)*

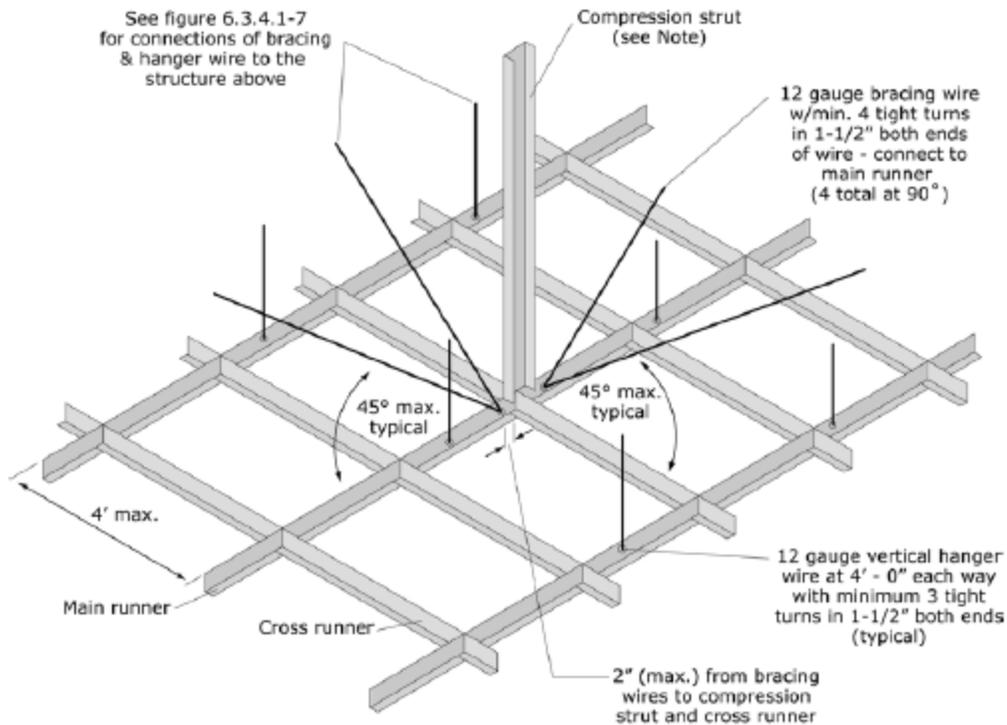
**Note:** Compression strut shall not replace hanger wire. Compression strut consists of a steel section attached to main runner with 2 - #12 sheet metal screws and to structure with 2 - #12 screws to wood or 1/4" min. expansion anchor to structure. Size of strut is dependent on distance between ceiling and structure ( $l/r \leq 200$ ). A 1" diameter conduit can be used for up to 6'; a 1-5/8" X 1-1/4" metal stud can be used for up to 10'

**Figure G-9. Suspension System for Acoustic Lay-in Panel Ceilings – General Bracing Assembly.**  
*(FEMA E-74, 2012, Reducing the Risks of Nonstructural Earthquake Damage)*

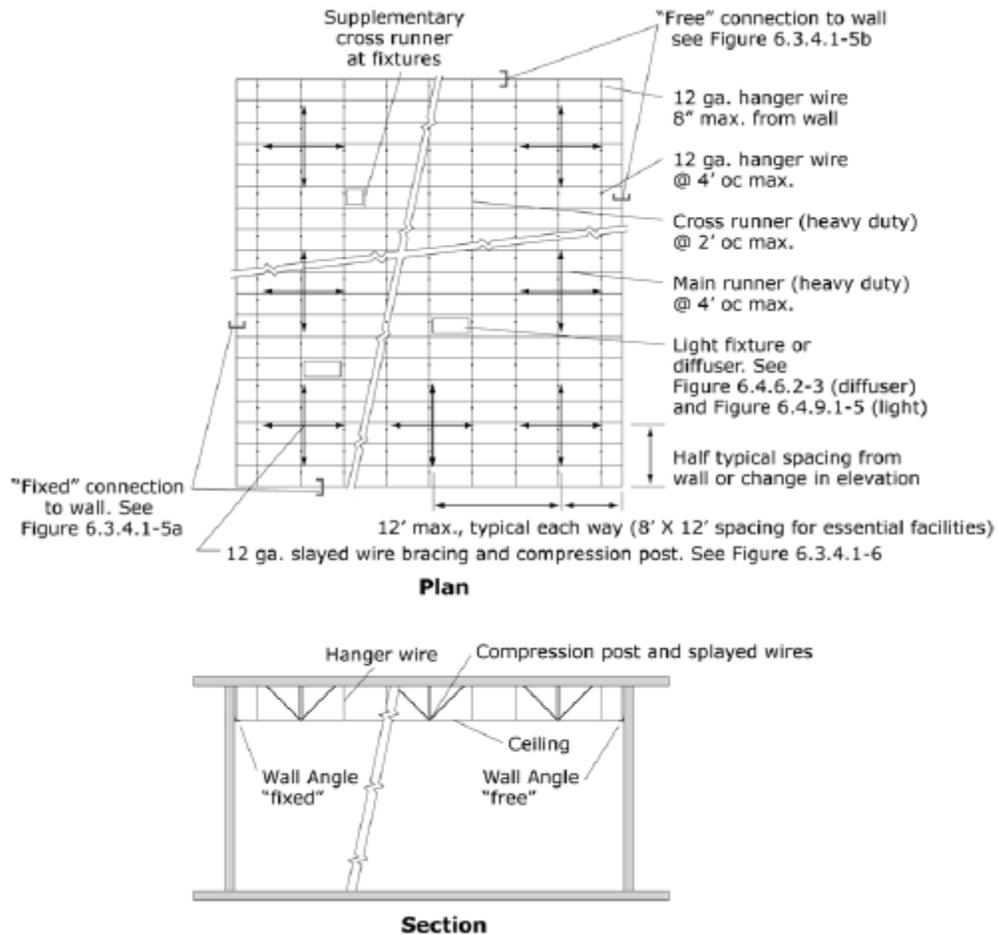
**Figure G-10. Suspension System for Acoustic Lay-in Panel Ceilings – General Bracing Layout.**  
*(FEMA E-74, 2012, Reducing the Risks of Nonstructural Earthquake Damage)*

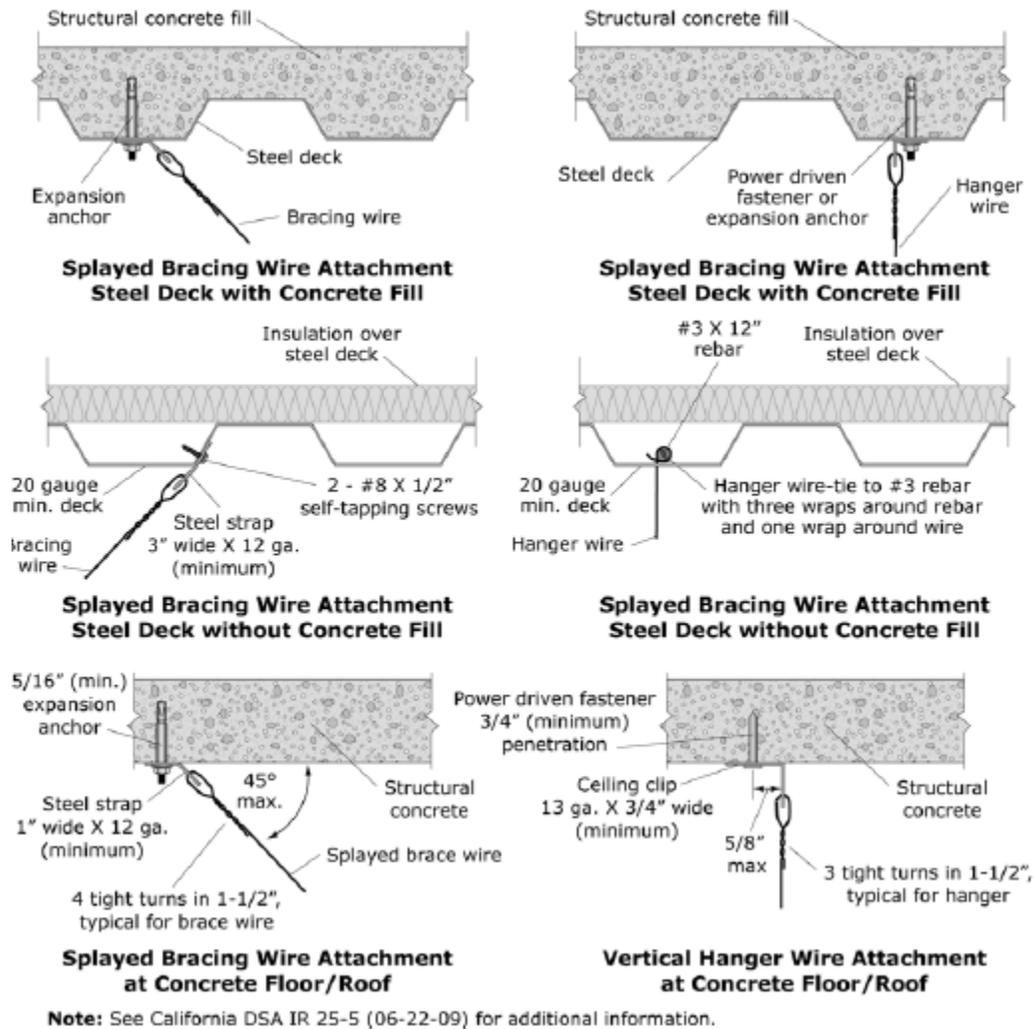
**Figure G-11. Suspension System for Acoustic Lay-in Panel Ceilings – Overhead Attachment Details.**

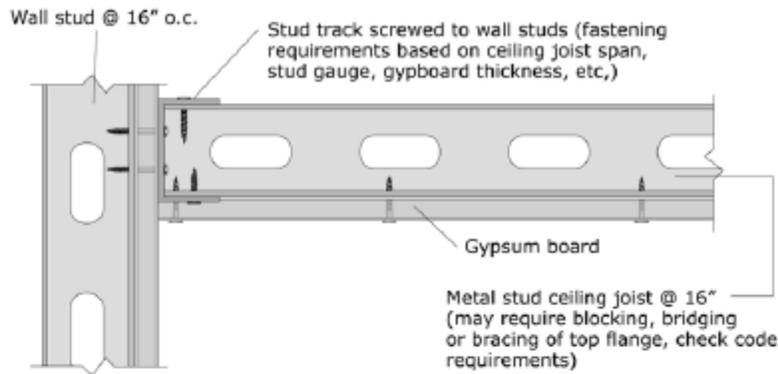
**a) Gypsum board attached directly to ceiling joists**

**Figure G-12. Gypsum Board Ceiling Applied Directly to Structure.**  
*(FEMA E-74, 2012, Reducing the Risks of Nonstructural Earthquake Damage)*

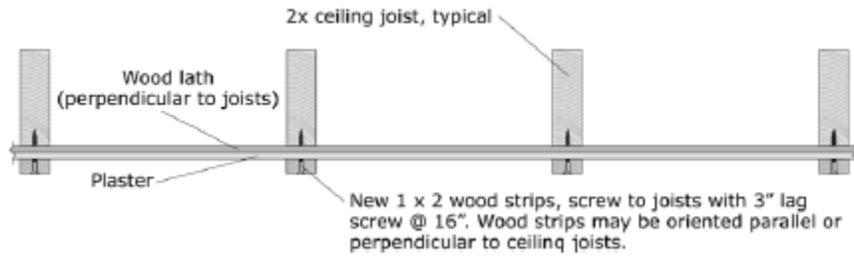
**Figure G-13. Retrofit Detail for Existing Lath and Plaster.**  
*(FEMA E-74, 2012, Reducing the Risks of Nonstructural Earthquake Damage)*

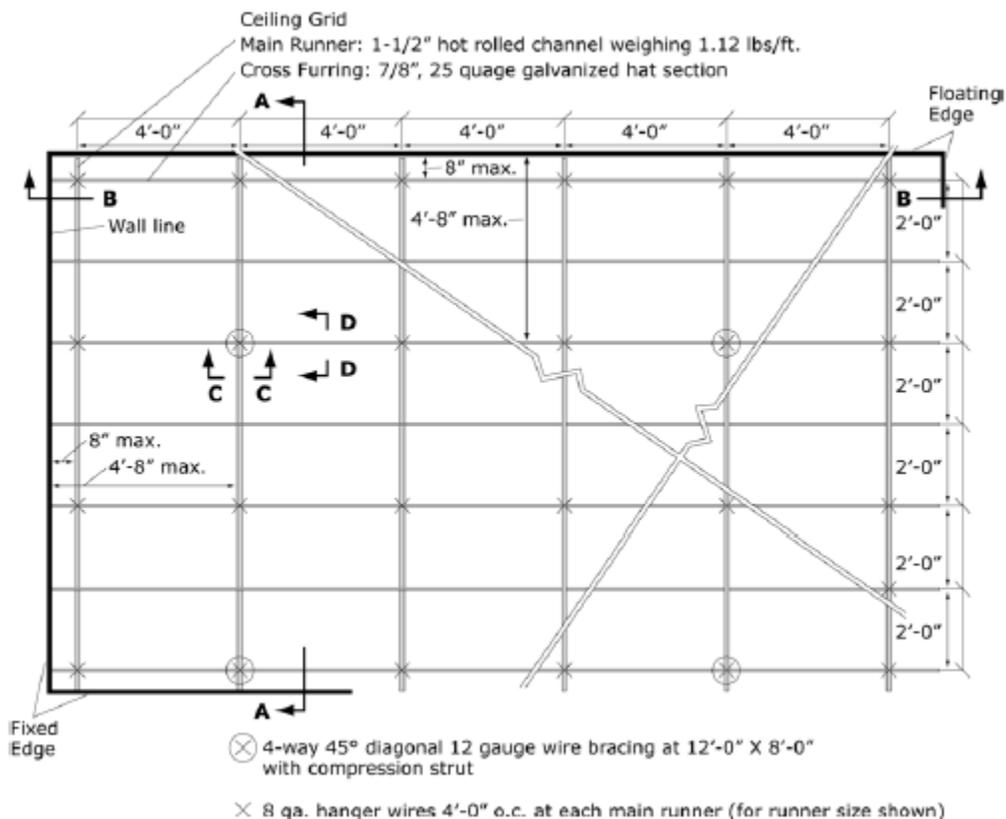
**Figure G-14. Diagrammatic View of Suspended Heavy Ceiling Grid and Lateral Bracing.**  
*(FEMA E-74, 2012, Reducing the Risks of Nonstructural Earthquake Damage)*

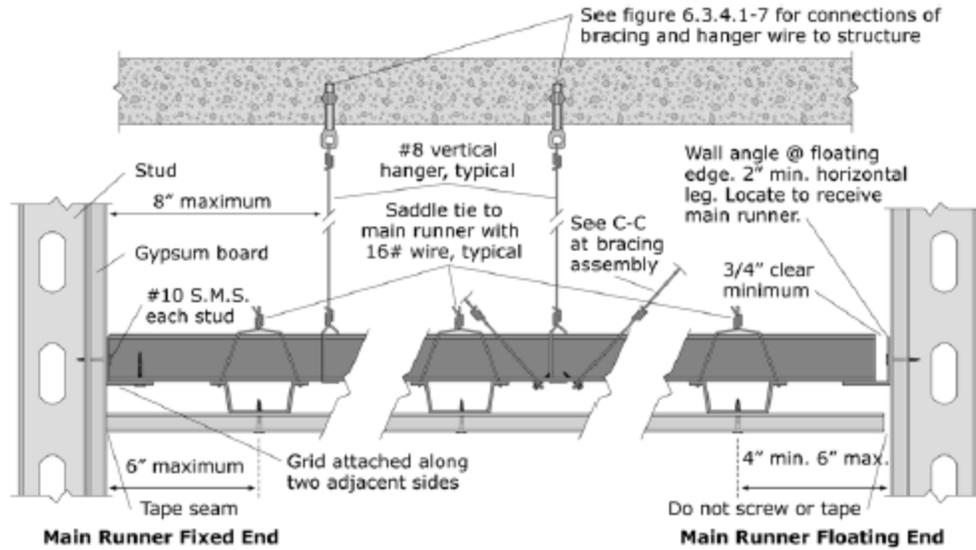
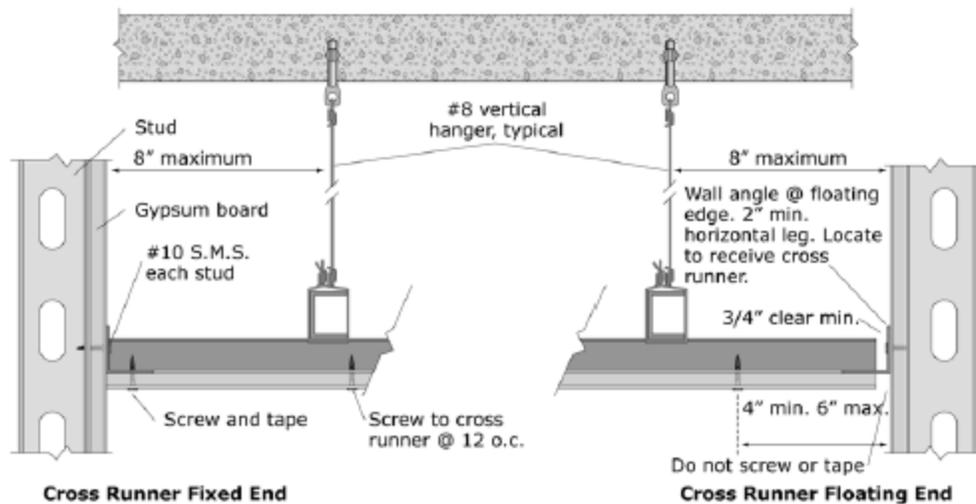
**A-A Main Runner at Perimeter**

**B-B Cross Runner at Perimeter**

**Figure G-15. Perimeter Details for Suspended Gypsum Board Ceiling.**  
*(FEMA E-74, 2012, Reducing the Risks of Nonstructural Earthquake Damage)*

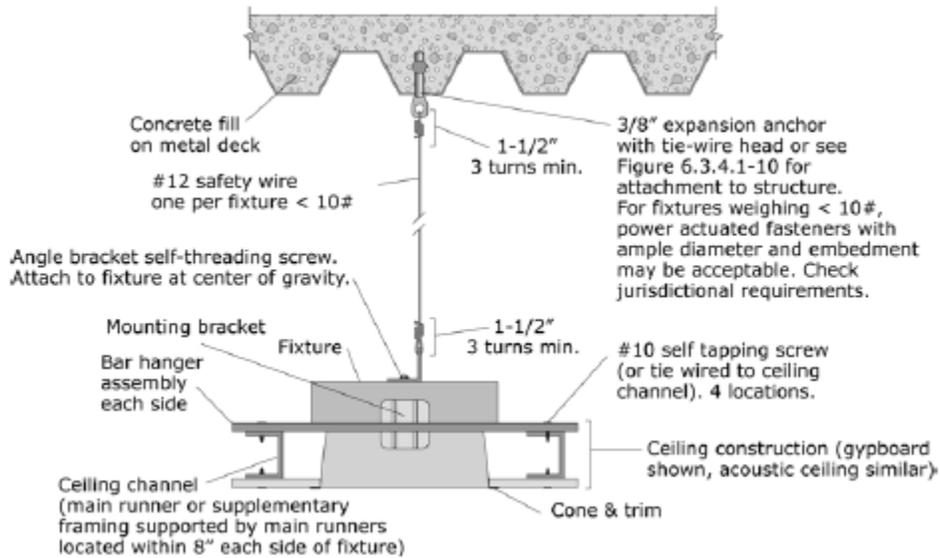
**Figure G-17. Recessed Light Fixture in suspended Ceiling (Fixture Weight < 10 pounds).**  
*(FEMA E-74, 2012, Reducing the Risks of Nonstructural Earthquake Damage)*

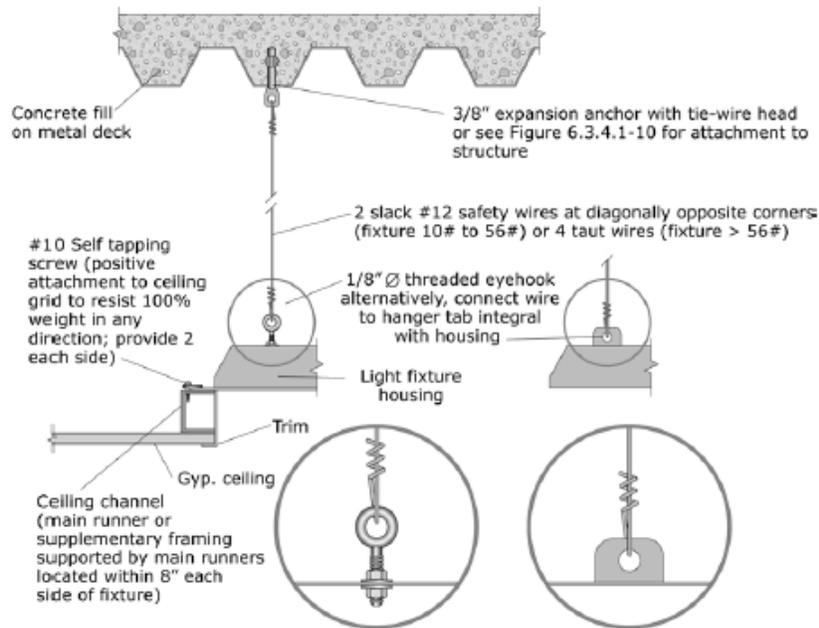
**Figure G-18. Recessed Light Fixture in suspended Ceiling (Fixture Weight 10 to 56 pounds).**  
*(FEMA E-74, 2012, Reducing the Risks of Nonstructural Earthquake Damage)*

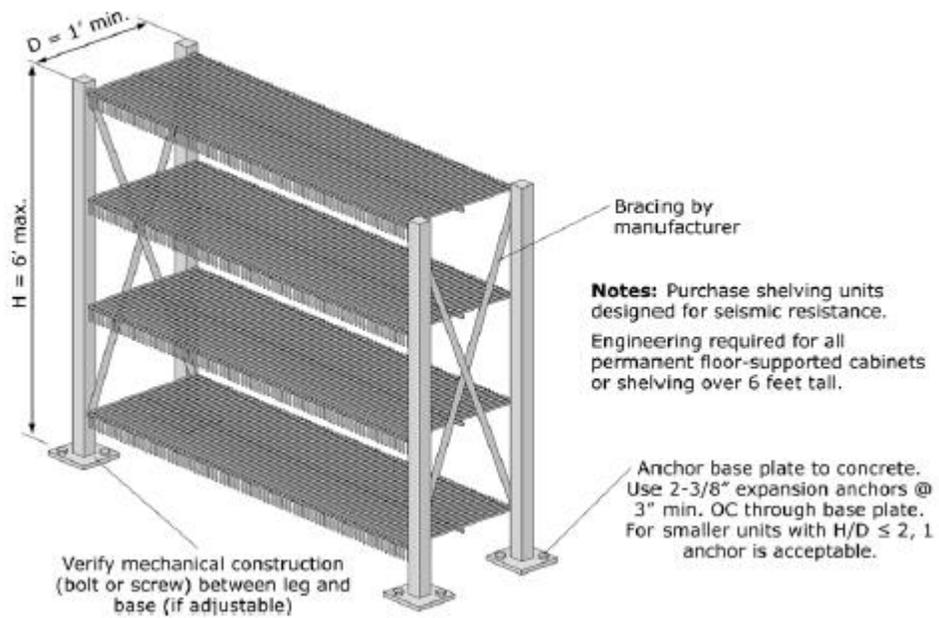
**Figure G-19. Light Storage Racks.**  
*(FEMA E-74, 2012, Reducing the Risks of Nonstructural Earthquake Damage)*

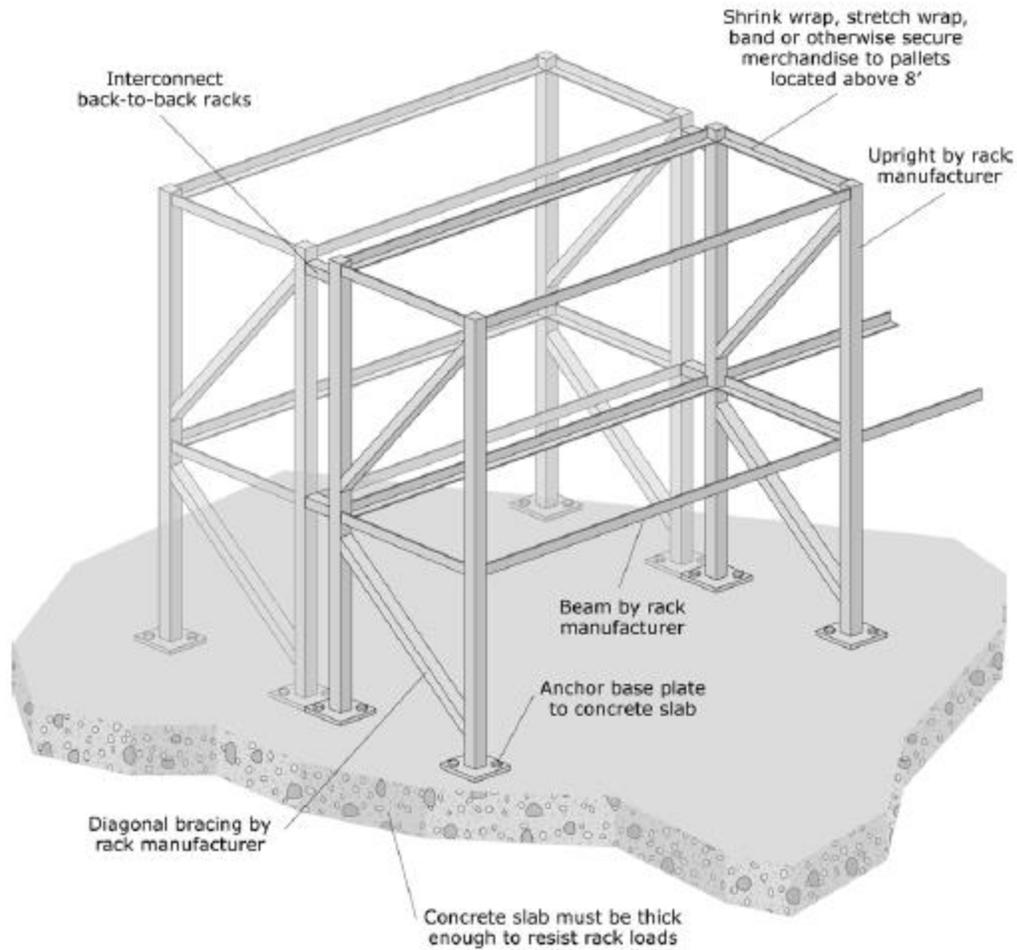
**Note:** Purchase storage racks designed for seismic resistance. Storage racks may be classified as either nonstructural elements or nonbuilding structures depending upon their size and support conditions. Check the applicable code to see which provisions apply.

**Figure G-20. Industrial Storage Racks.**  
*(FEMA E-74, 2012, Reducing the Risks of Nonstructural Earthquake Damage)*

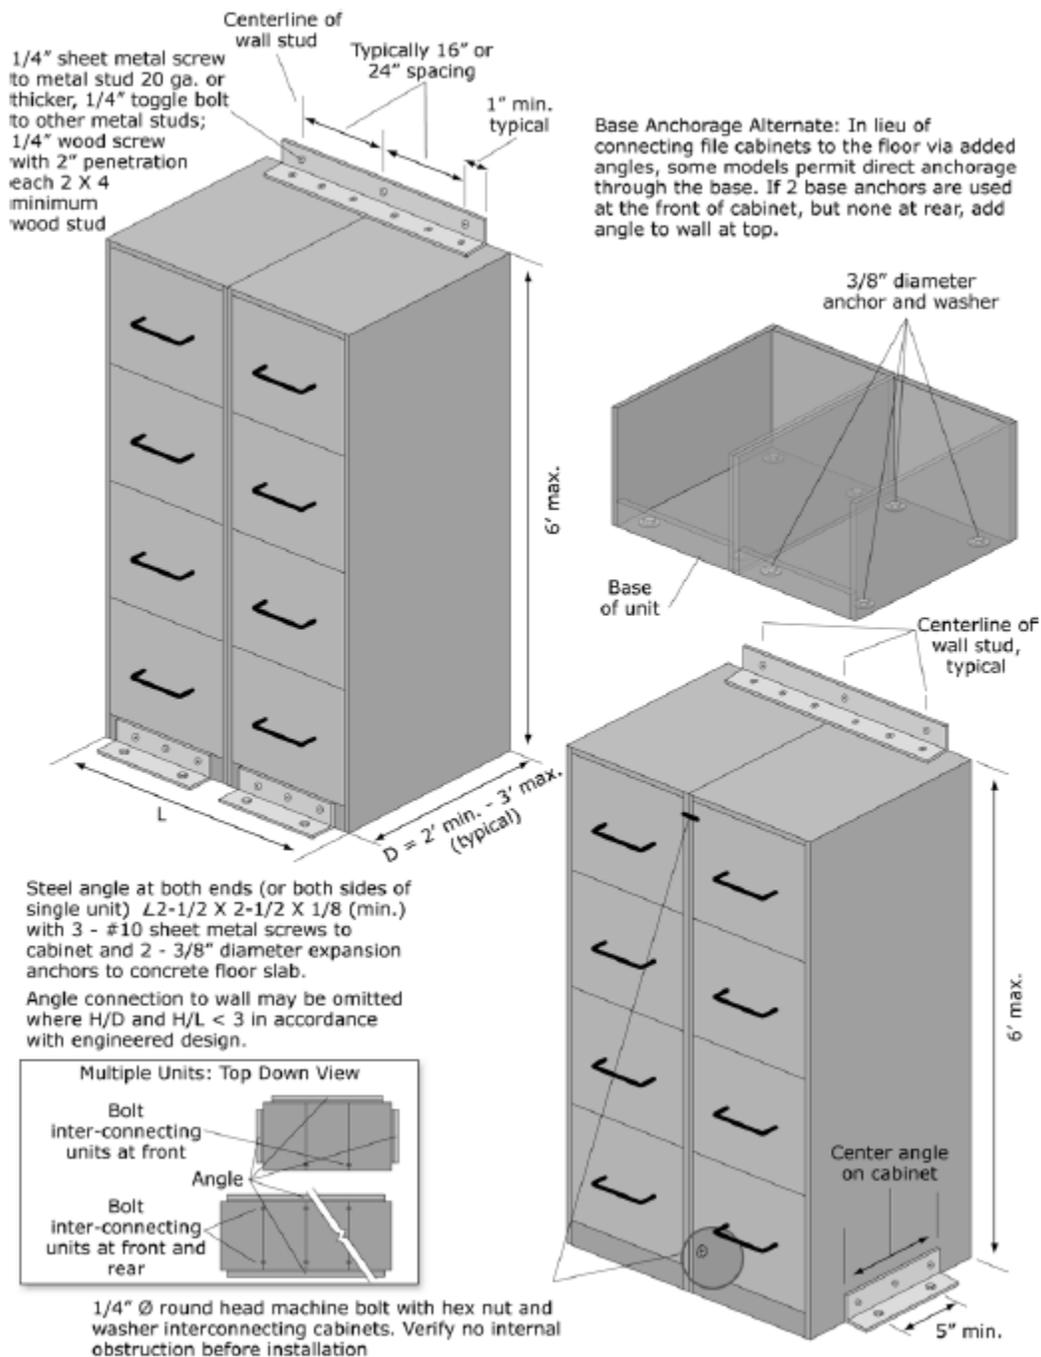
**Figure G-21. Wall-mounted File Cabinets.**

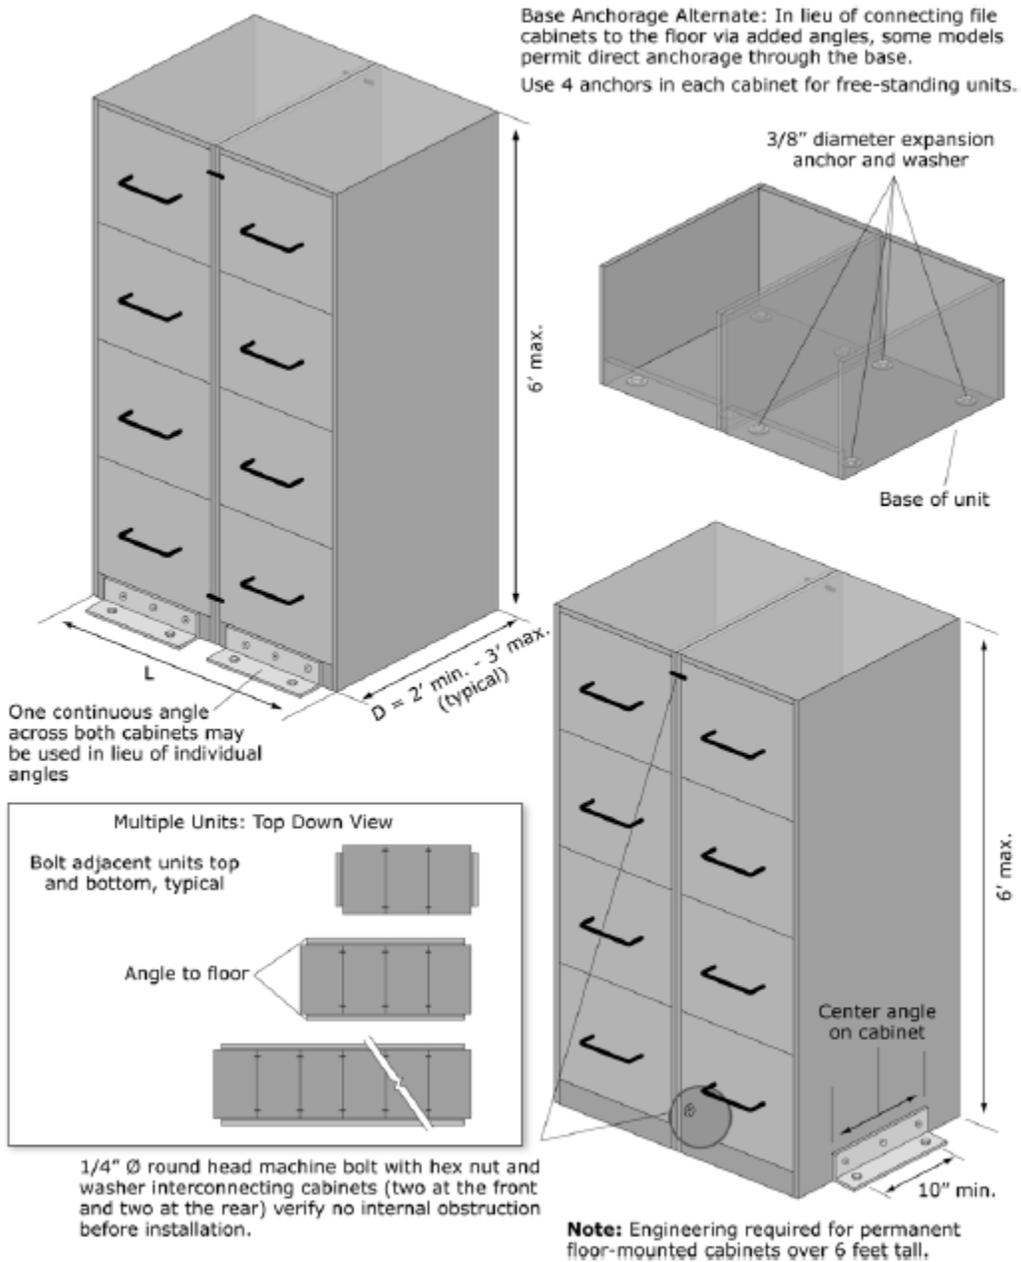
**Figure G-22. Base Anchored File Cabinets.**  
*(FEMA E-74, 2012, Reducing the Risks of Nonstructural Earthquake Damage)*

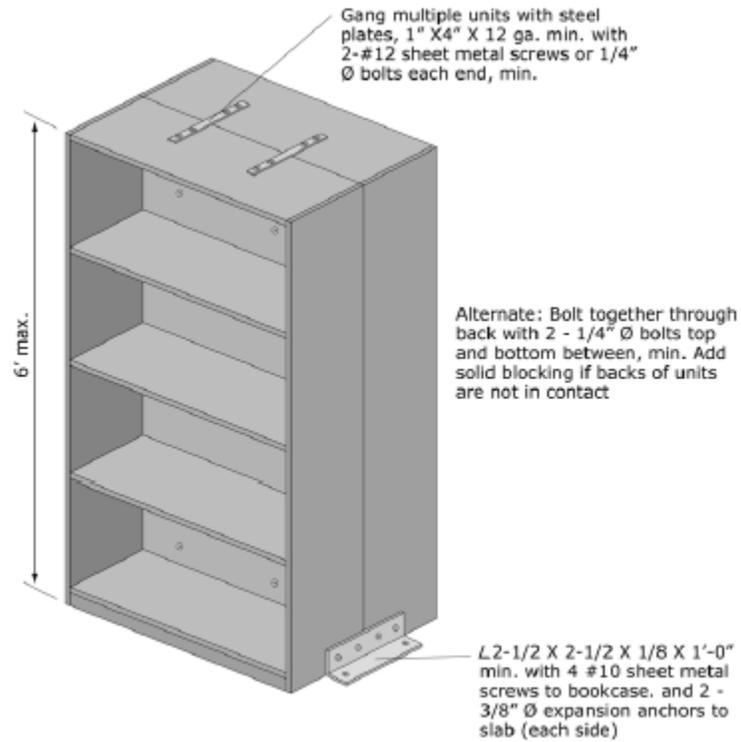
**Note:** Engineering required for all permanent floor-supported cabinets or shelving over 6 feet tall. Details shown are adequate for typical shelving 6 feet or less in height.

**Figure G-23. Anchorage of Freestanding Book Cases Arranged Back to Back.**  
*(FEMA E-74, 2012, Reducing the Risks of Nonstructural Earthquake Damage)*

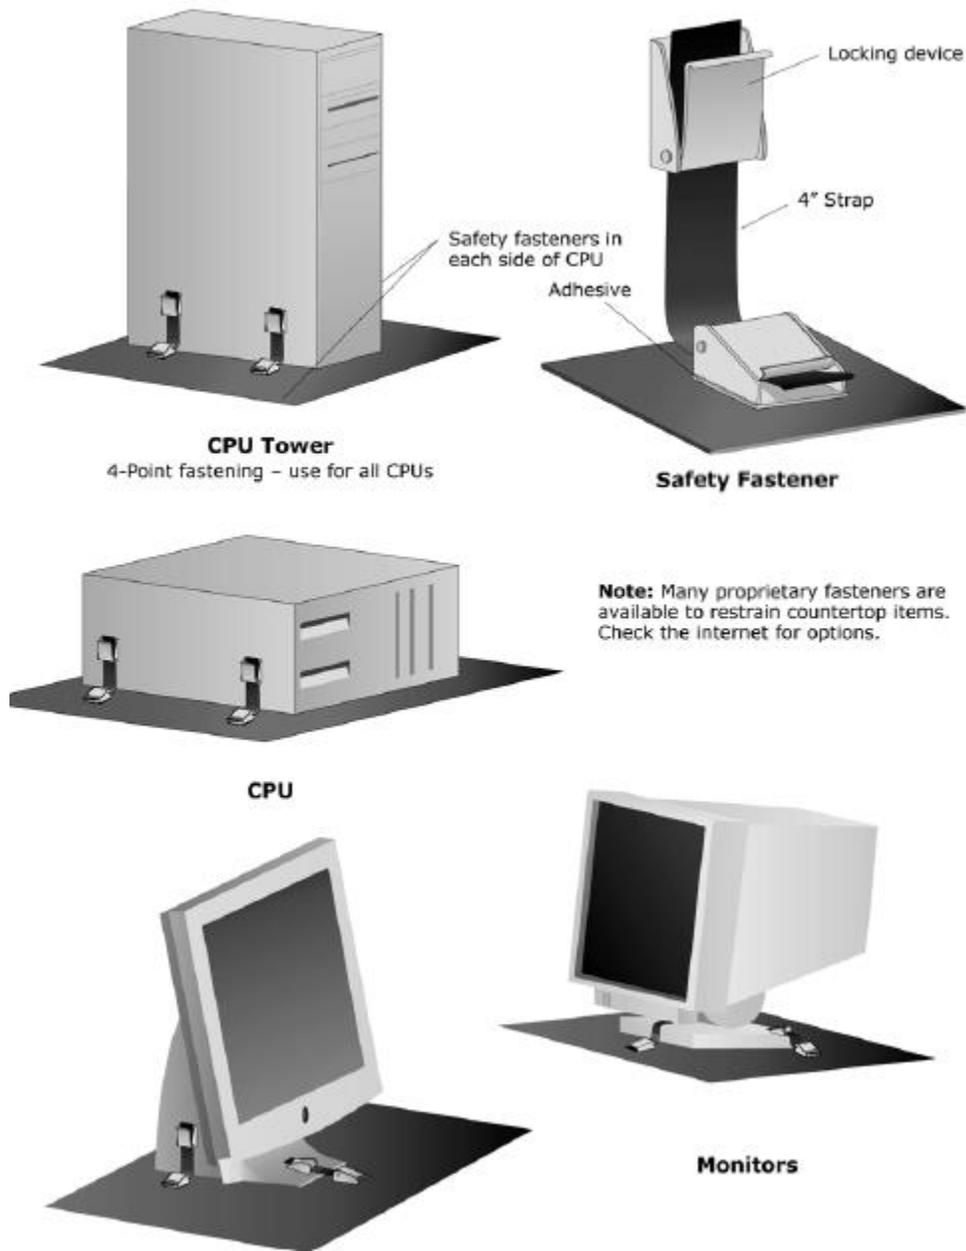
**Figure G-24. Desktop Computers and Accessories.**  
*(FEMA E-74, 2012, Reducing the Risks of Nonstructural Earthquake Damage)*
