Washington State School Seismic Safety Assessments Project

# SEISMIC UPGRADES CONCEPT DESIGN REPORT

Cosmopolis Elementary  
School – Main Building  
Cosmopolis School District 099

June 2019

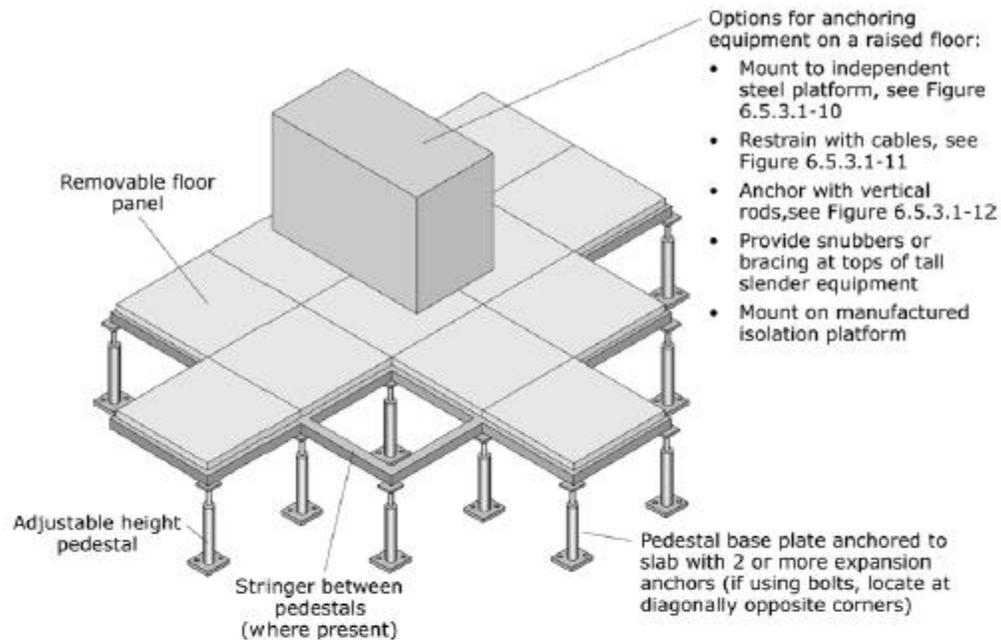
**Cantilevered Access Floor Pedestal**

**Figure G-25. Equipment Mounted on Access Floor.**  
*(FEMA E-74, 2012, Reducing the Risks of Nonstructural Earthquake Damage)*

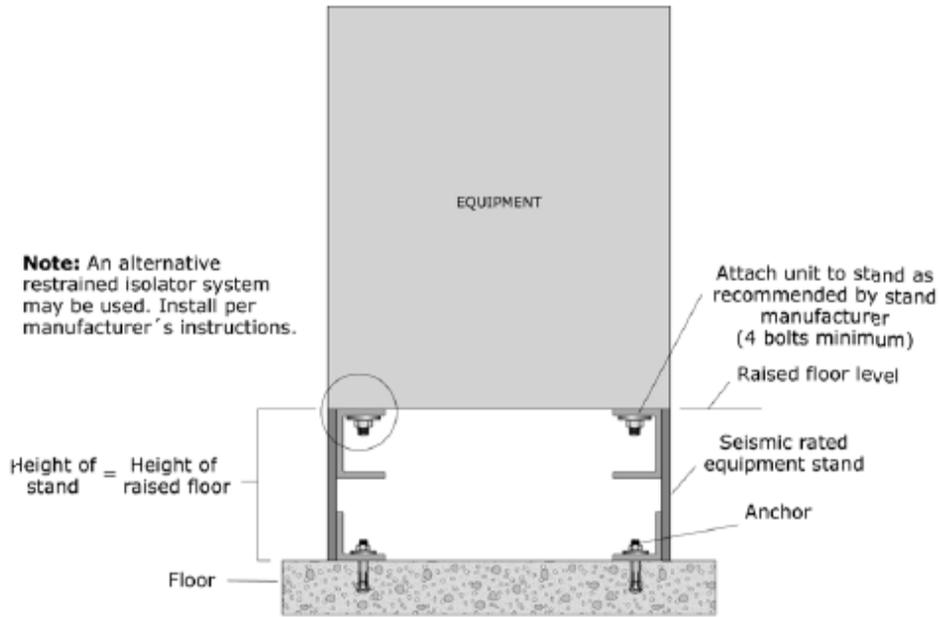
**Equipment installed on an independent steel platform within a raised floor**

**Figure G-26. Equipment Mounted on Access Floor – Independent Base.**  
*(FEMA E-74, 2012, Reducing the Risks of Nonstructural Earthquake Damage)*

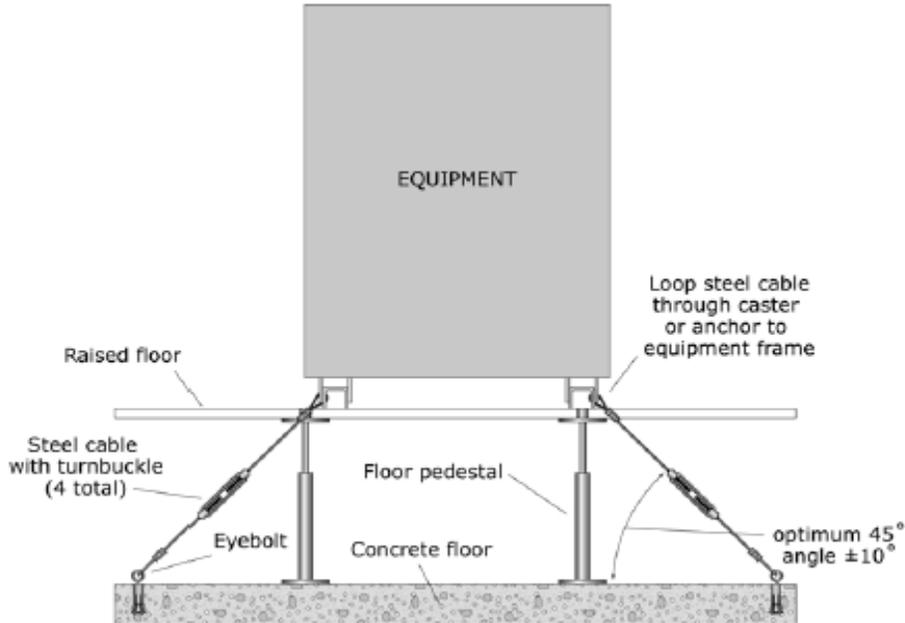
**Equipment restrained with cables beneath a raised floor**

**Figure G-27. Equipment Mounted on Access Floor – Cable Braced.**  
*(FEMA E-74, 2012, Reducing the Risks of Nonstructural Earthquake Damage)*

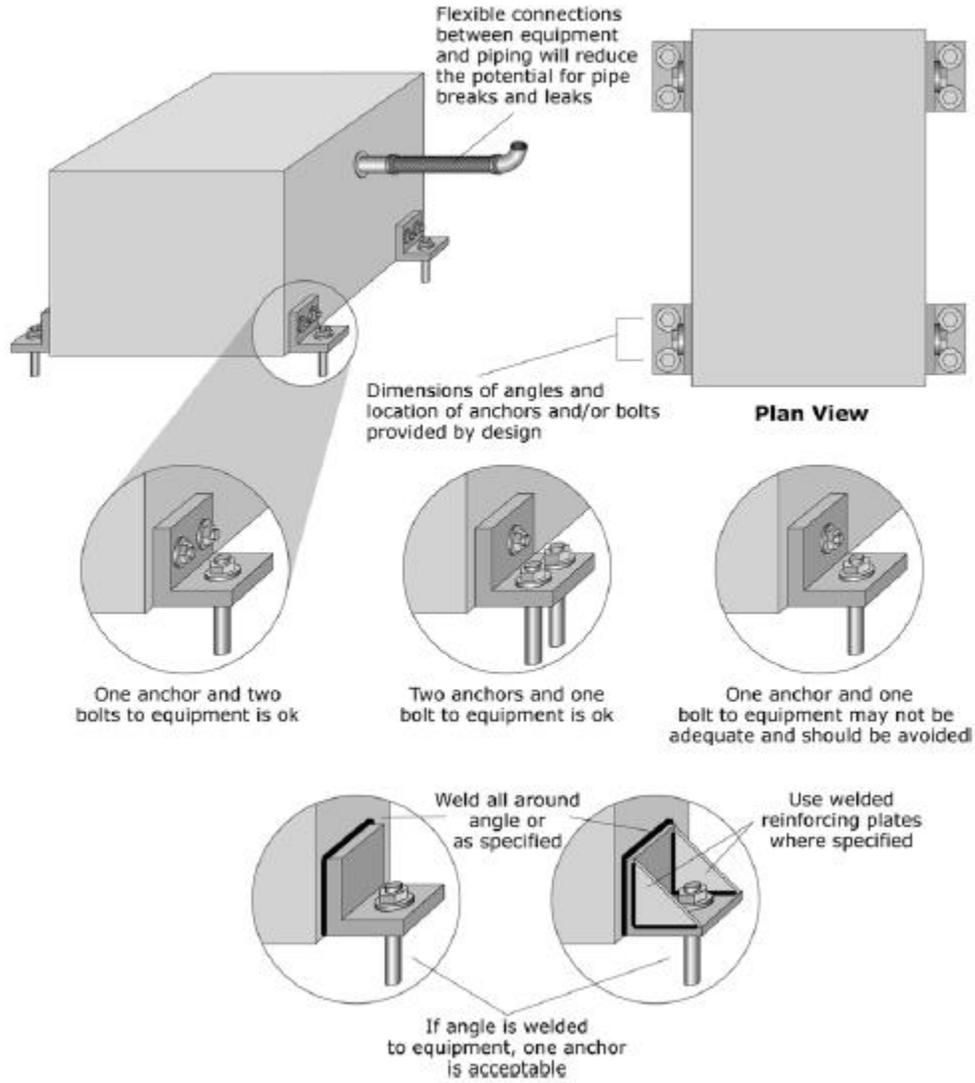
**Note: Rigidly mounted equipment shall have flexible connections for the fuel lines and piping.**

**Figure G-29. Rigidly Floor-mounted Equipment with Added Angles.**  
*(FEMA E-74, 2012, Reducing the Risks of Nonstructural Earthquake Damage)*

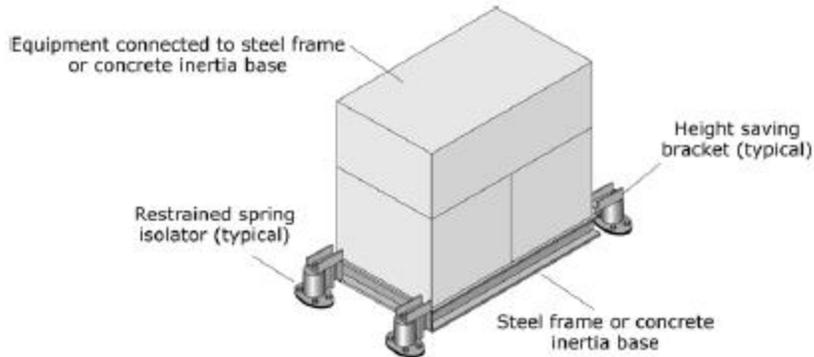
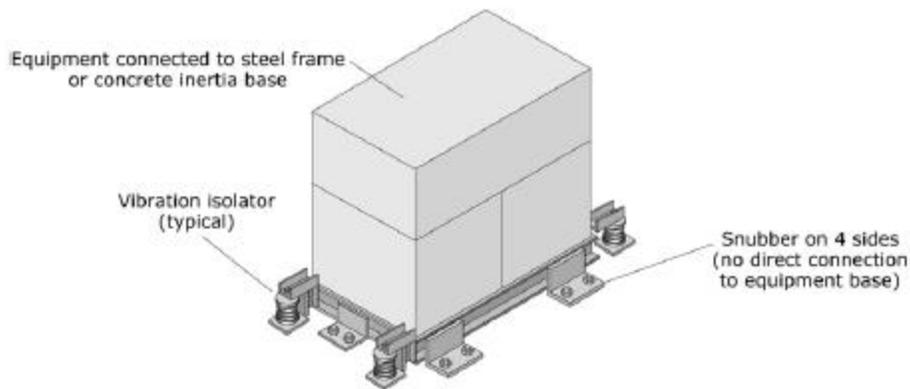
**Supplemental base with restrained spring isolators**

**Supplemental base with open springs and all-directional snubbers**

**Supplemental base with open springs and one-directional snubbers**

**Figure G-30. HVAC Equipment with Vibration Isolation.**  
*(FEMA E-74, 2012, Reducing the Risks of Nonstructural Earthquake Damage)*

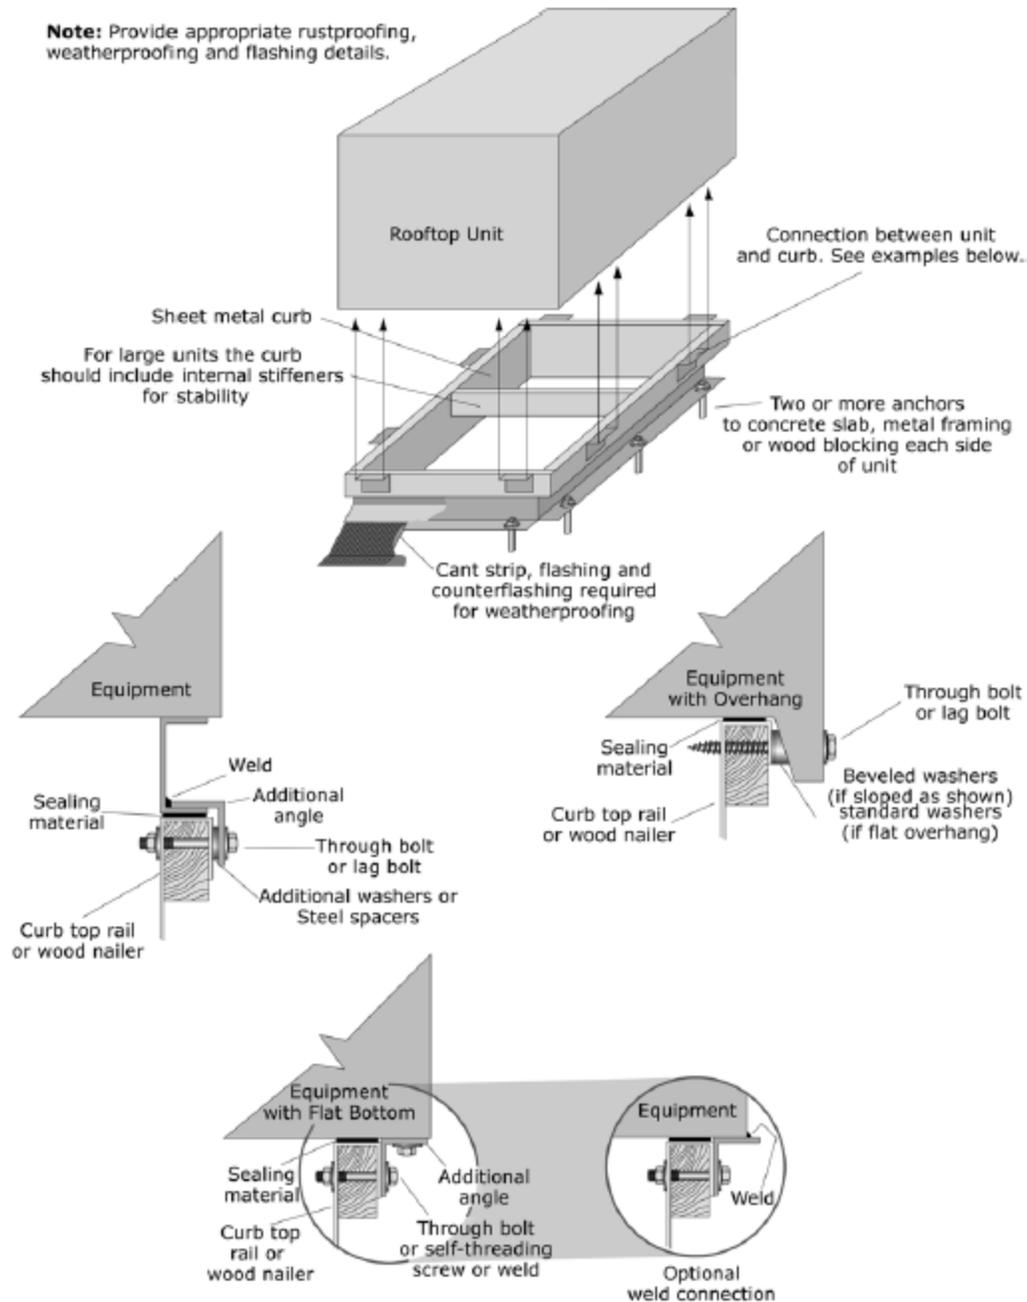
**Figure G-31. Rooftop HVAC Equipment.**

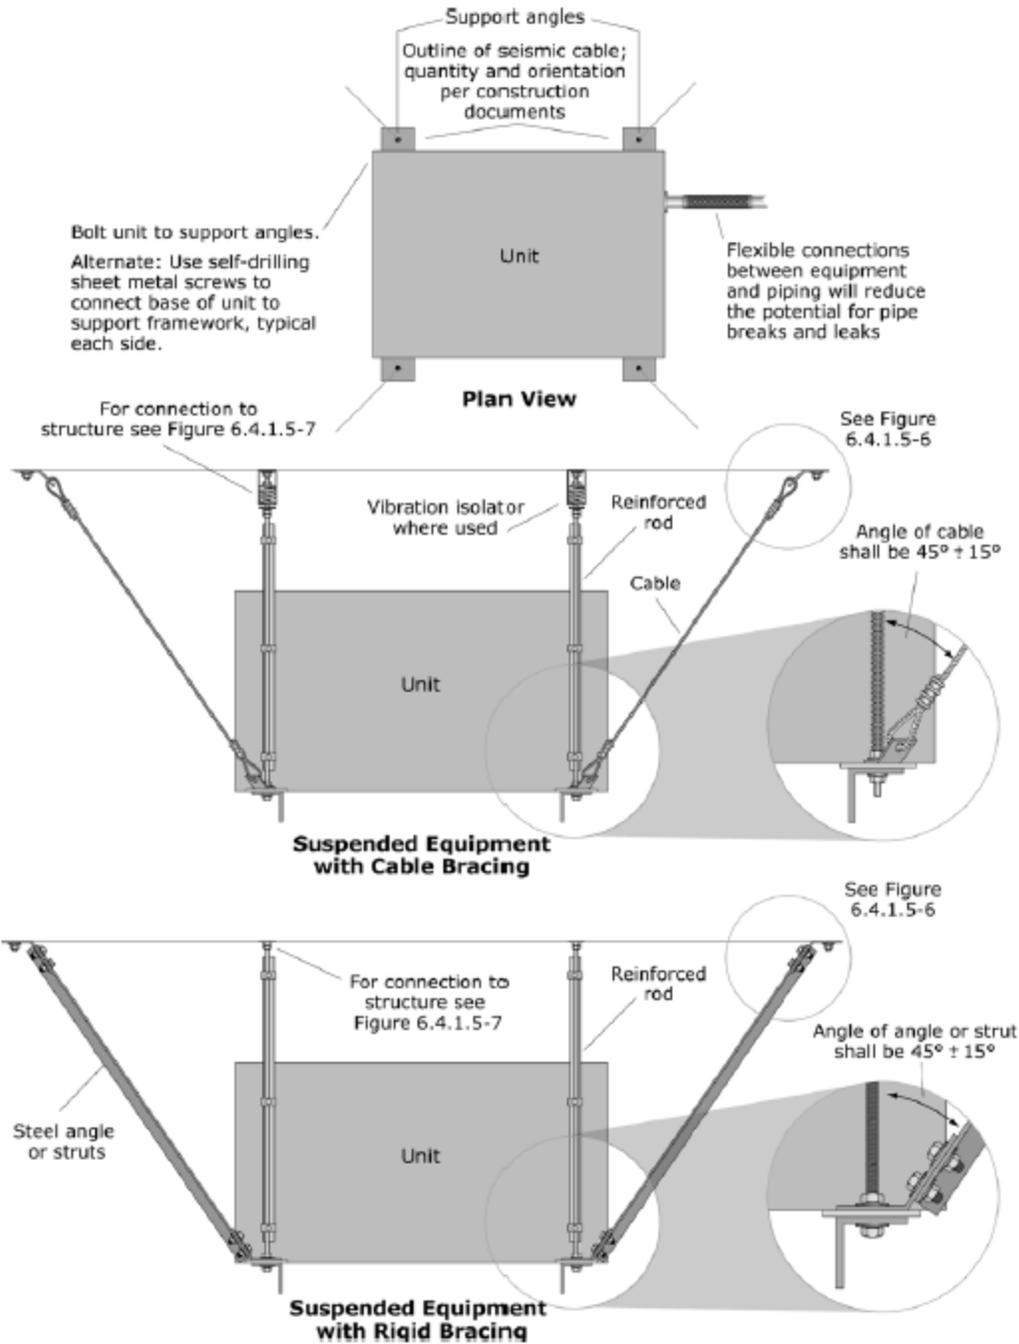
**Figure G-32. Suspended Equipment.**  
*(FEMA E-74, 2012, Reducing the Risks of Nonstructural Earthquake Damage)*

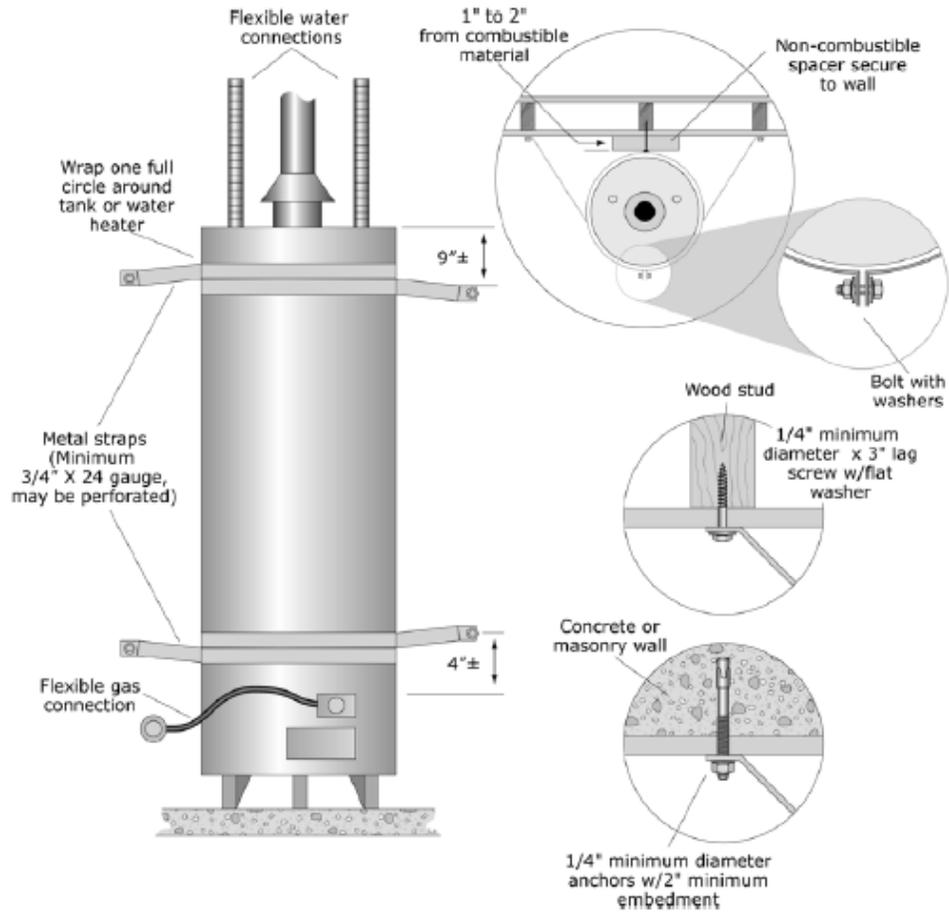
**Figure G-33. Water Heater Strapping to Backing Wall.**  
*(FEMA E-74, 2012, Reducing the Risks of Nonstructural Earthquake Damage)*

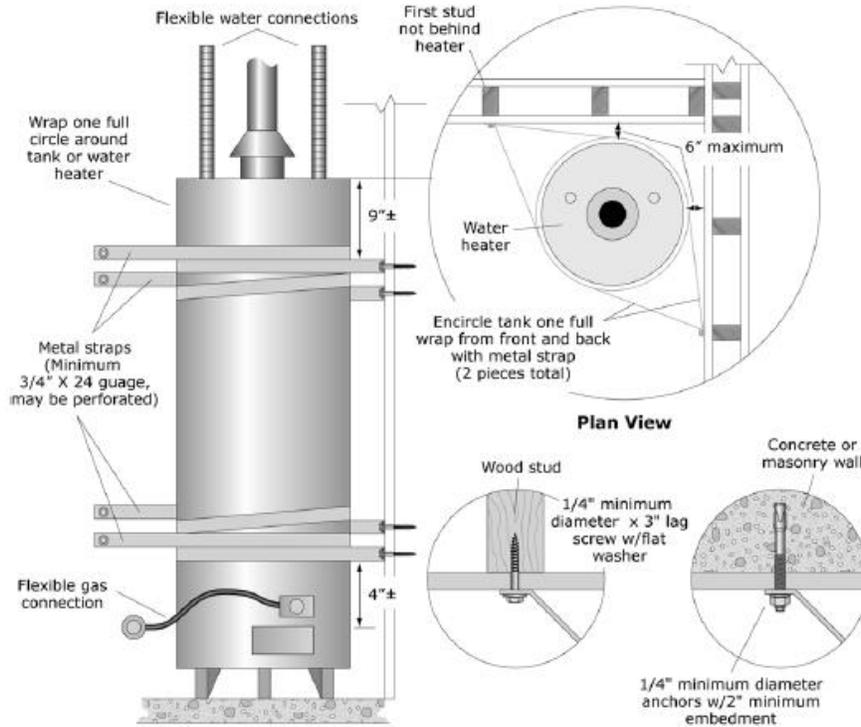
**Figure G-34. Water Heater – Strapping at Corner Installation.**  
*(FEMA E-74, 2012, Reducing the Risks of Nonstructural Earthquake Damage)*

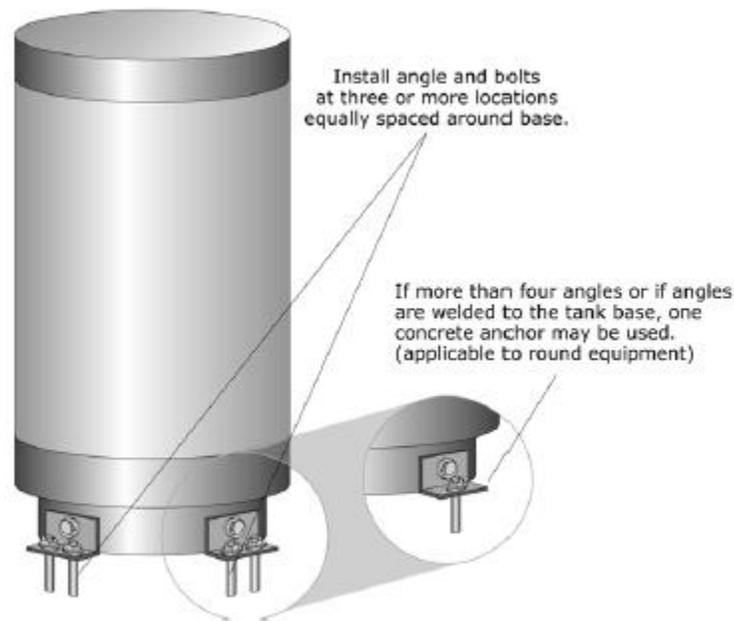
**Figure G-35. Water Heater – Base Mounted.**  
*(FEMA E-74, 2012, Reducing the Risks of Nonstructural Earthquake Damage)*

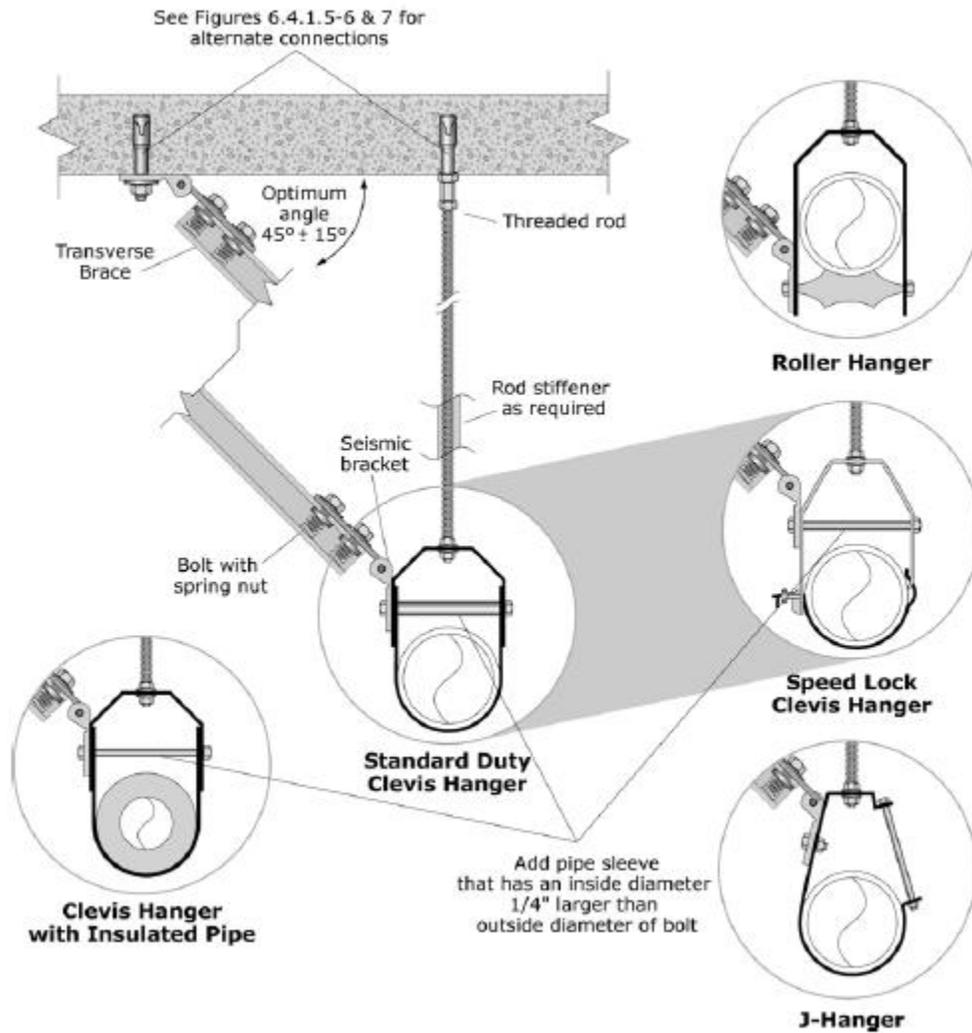
**Figure G-36. Rigid Bracing – Single Pipe Transverse.**  
*(FEMA E-74, 2012, Reducing the Risks of Nonstructural Earthquake Damage)*

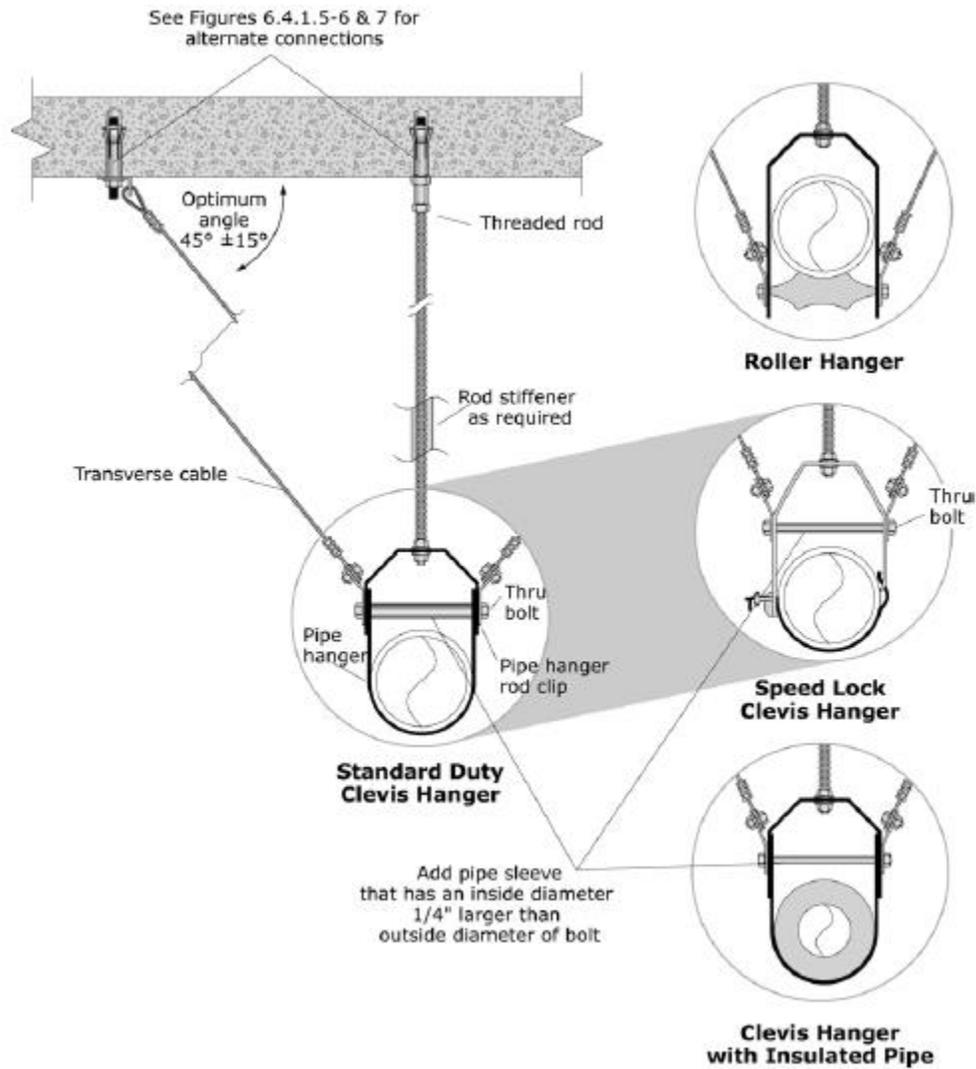
**Figure G-37. Cable Bracing – Single Pipe Transverse.**  
*(FEMA E-74, 2012, Reducing the Risks of Nonstructural Earthquake Damage)*

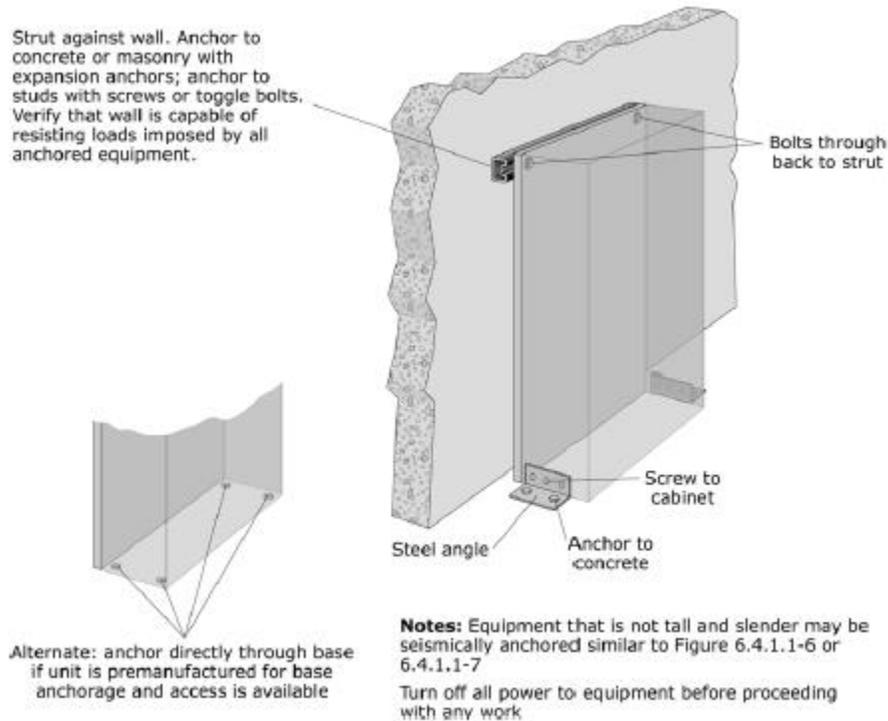
**Figure G-38. Electrical Control Panels, Motor Controls Centers, or Switchgear.**  
*(FEMA E-74, 2012, Reducing the Risks of Nonstructural Earthquake Damage)*

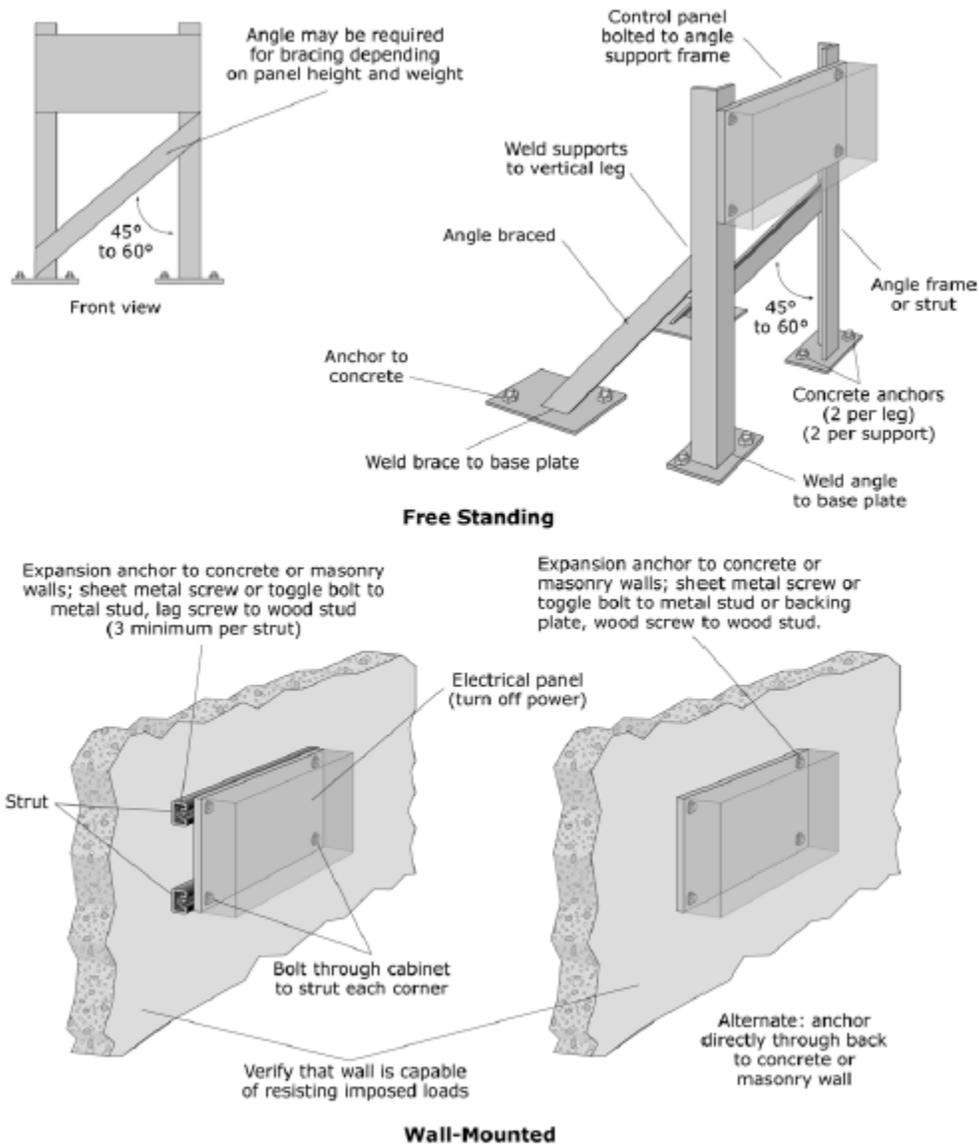
**Figure G-39. Freestanding and Wall-mounted Electrical Control Panels, Motor Controls Centers, or Switchgear.**  
*(FEMA E-74, 2012, Reducing the Risks of Nonstructural Earthquake Damage)*

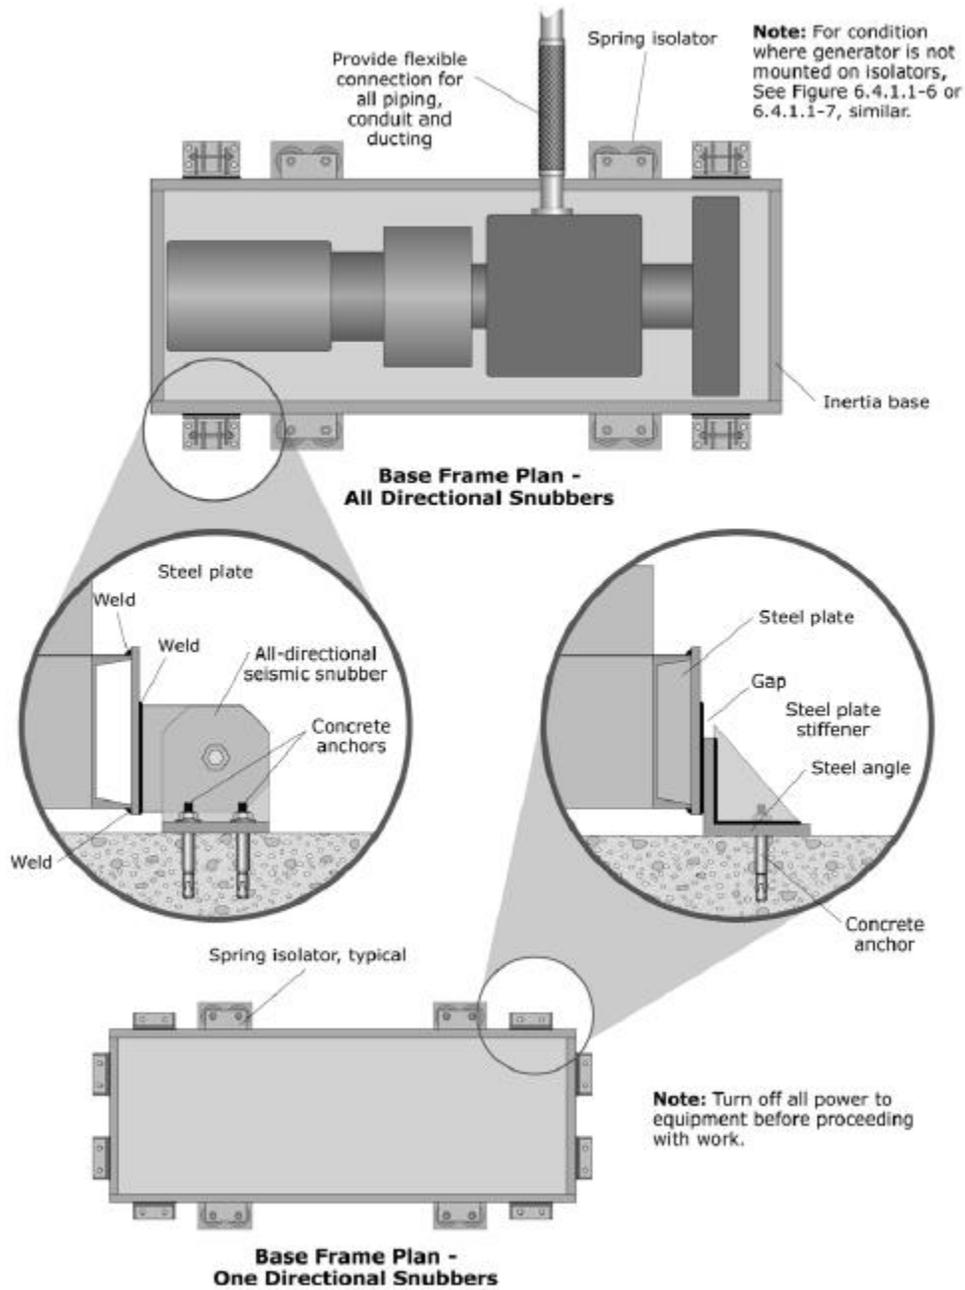
**Figure G-40. Emergency Generator.**  
*(FEMA E-74, 2012, Reducing the Risks of Nonstructural Earthquake Damage)*
