KELLER FARM MITIGATION BANK MITIGATION BANKING INSTRUMENT

REDMOND, WASHINGTON

December 2019

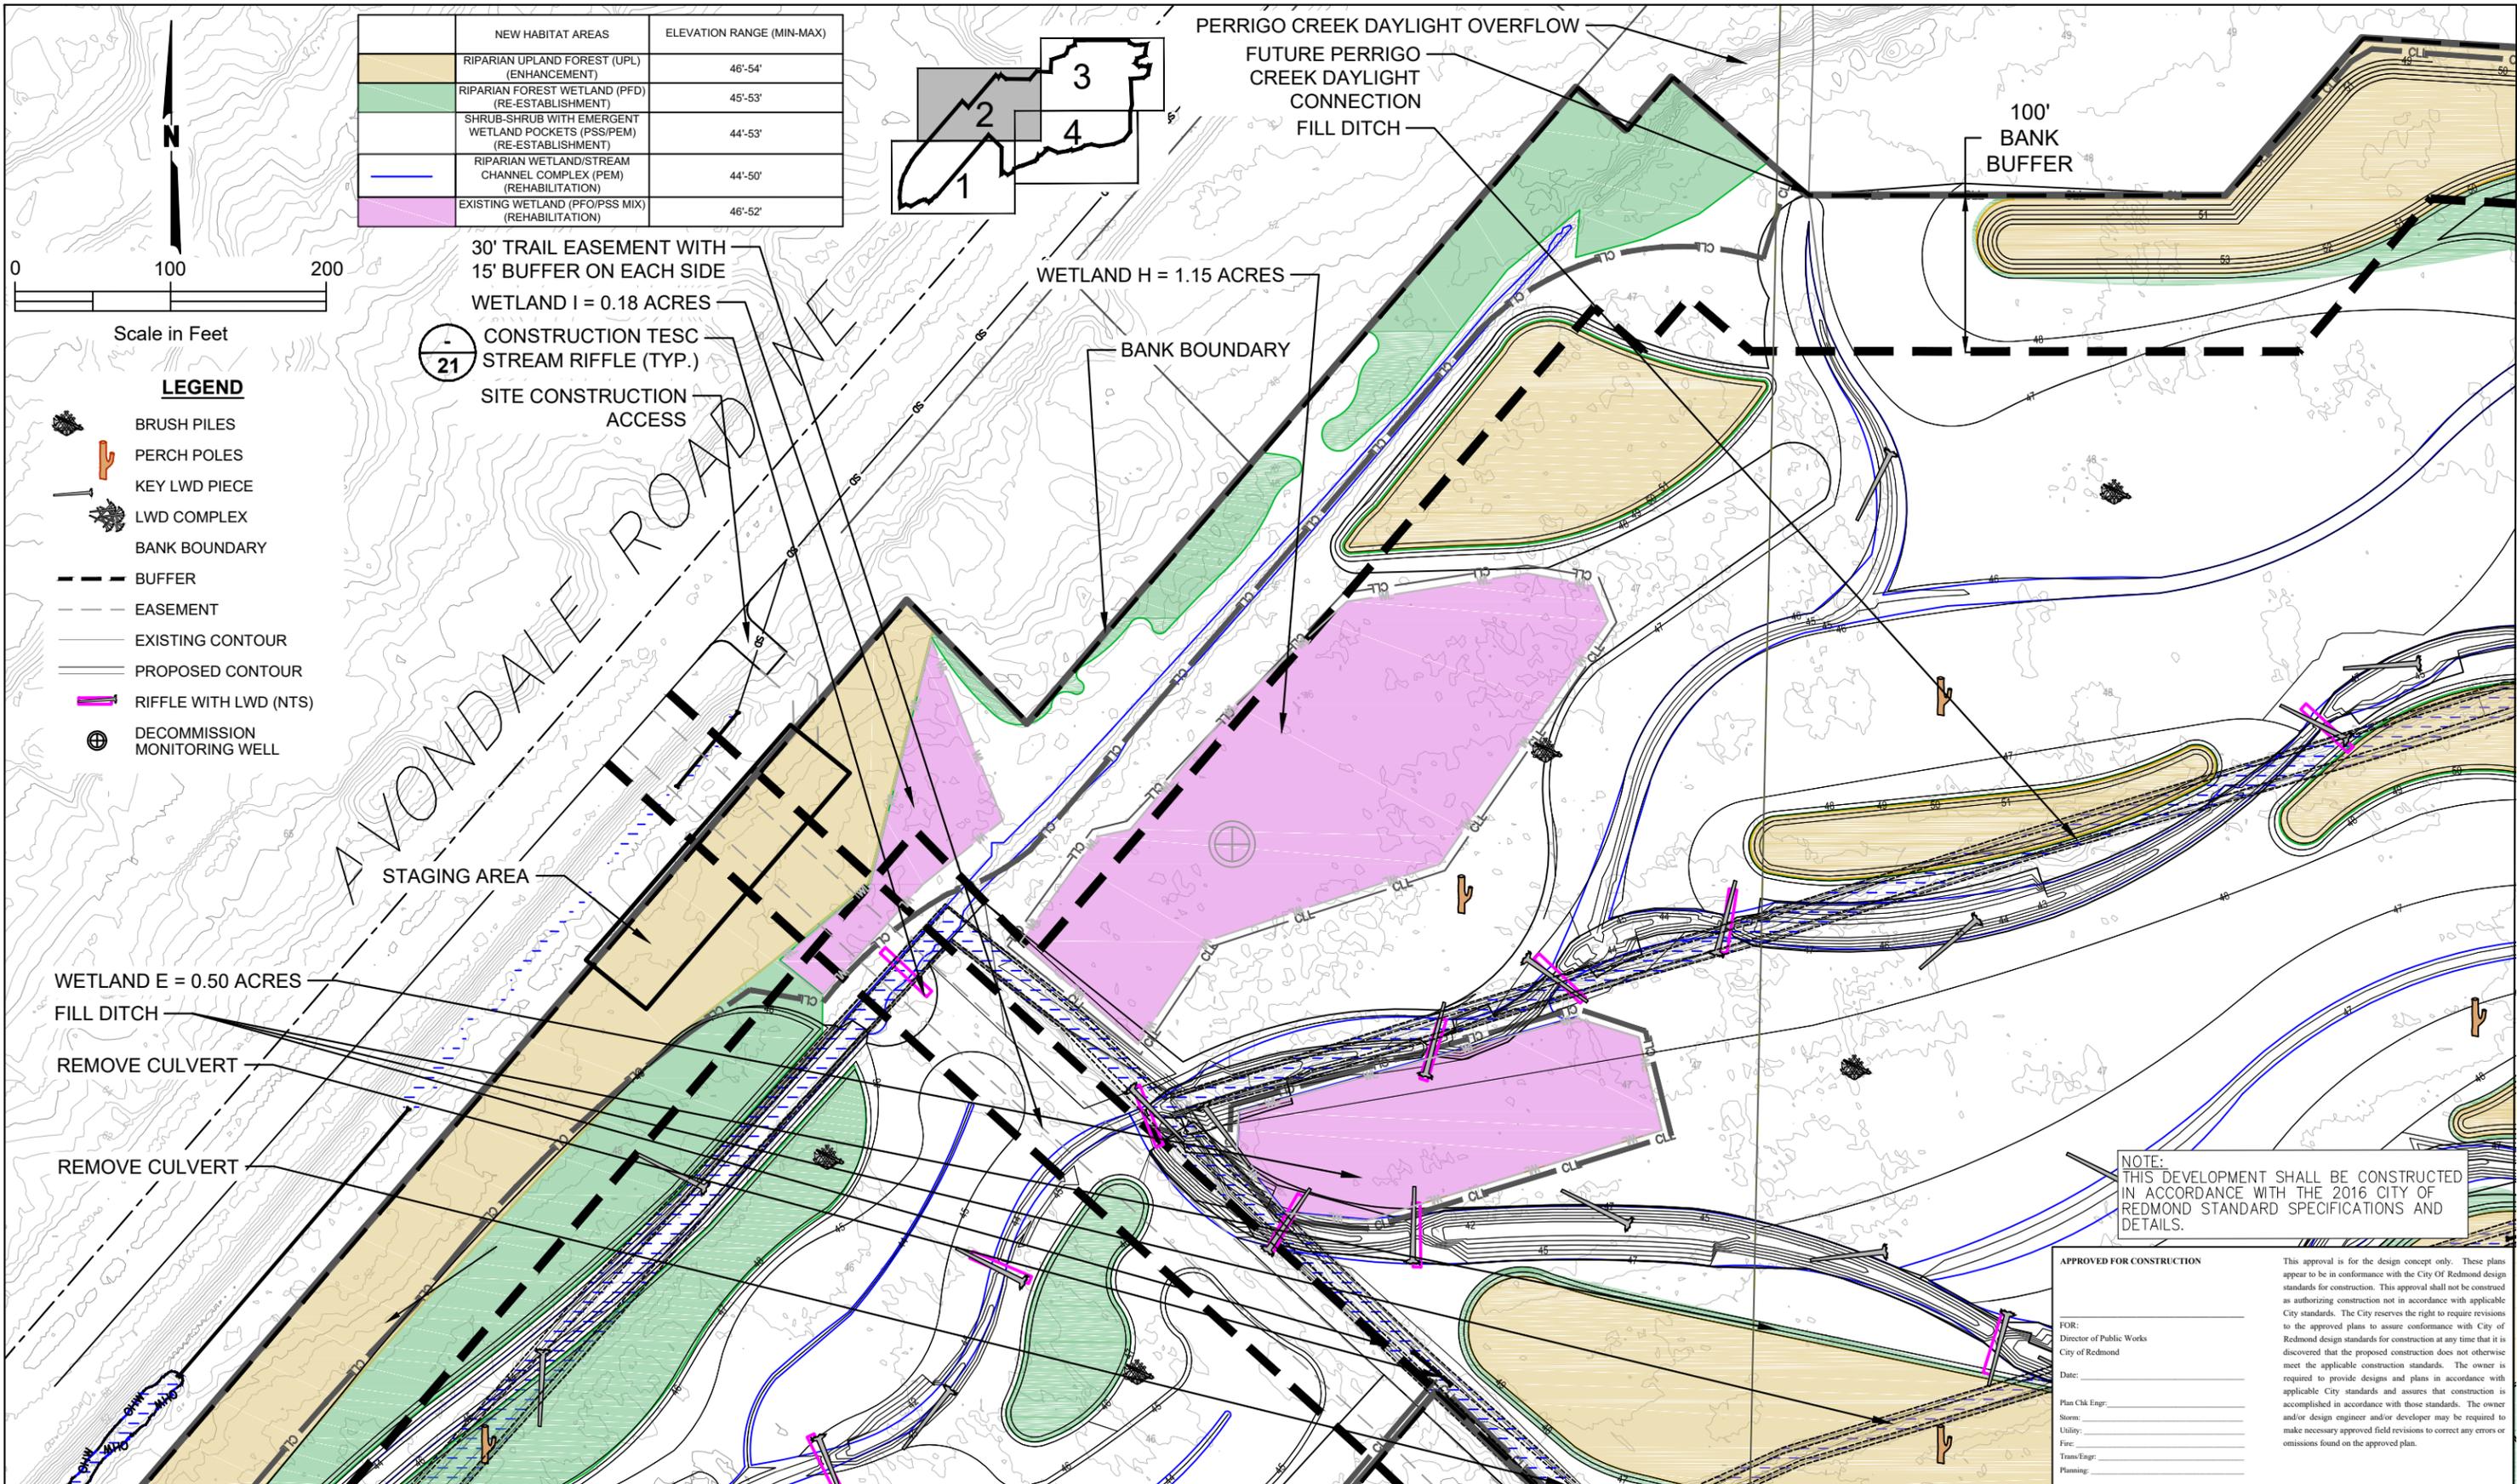
NEW HABITAT AREAS	ELEVATION RANGE (MIN-MAX)
[Yellow Box]	RIPARIAN UPLAND FOREST (UPL) (ENHANCEMENT)	46'-54'
[Green Box]	RIPARIAN FOREST WETLAND (PFD) (RE-ESTABLISHMENT)	45'-53'
[Light Green Box]	SHRUB-SHRUB WITH EMERGENT WETLAND POCKETS (PSS/PEM) (RE-ESTABLISHMENT)	44'-53'
[Blue Box]	RIPARIAN WETLAND/STREAM CHANNEL COMPLEX (PEM) (REHABILITATION)	44'-50'
[Purple Box]	EXISTING WETLAND (PFO/PSS MIX) (REHABILITATION)	46'-52'

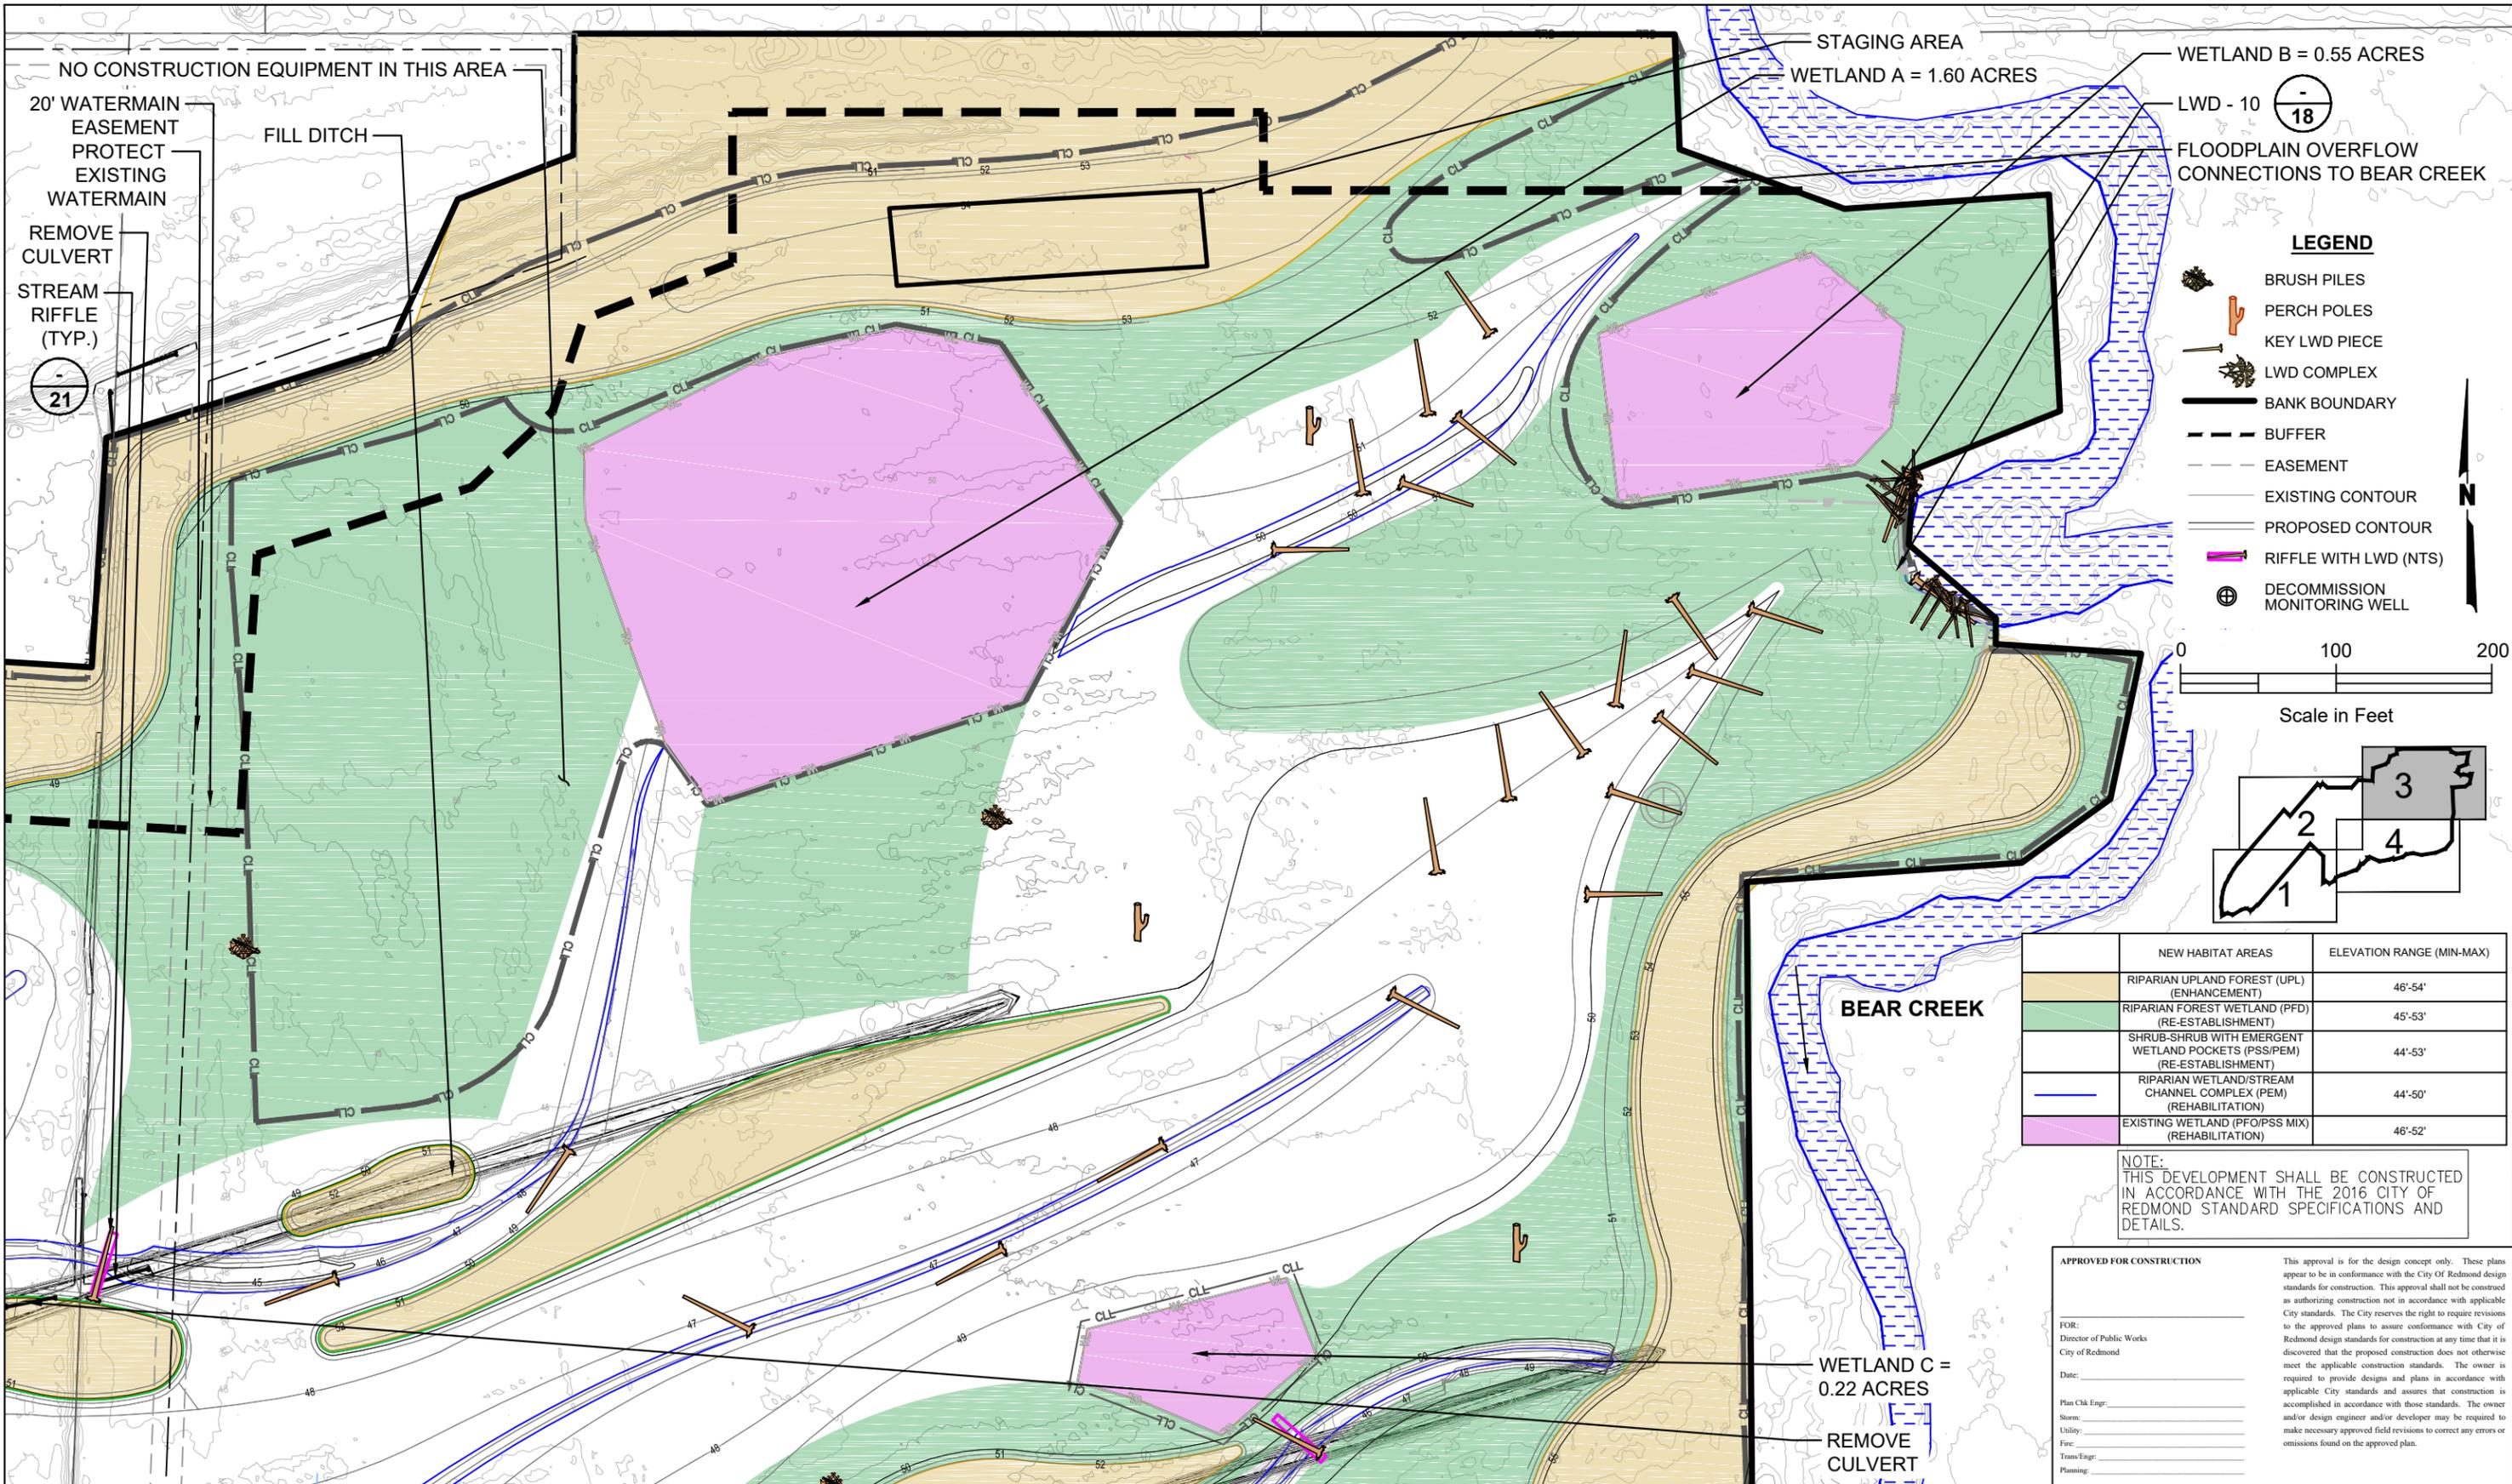
NEW HABITAT AREAS	ELEVATION RANGE (MIN-MAX)
RIPARIAN UPLAND FOREST (UPL) (ENHANCEMENT)	46'-54'
RIPARIAN FOREST WETLAND (PFD) (RE-ESTABLISHMENT)	45'-53'
SHRUB-SHRUB WITH EMERGENT WETLAND POCKETS (PSS/PEM) (RE-ESTABLISHMENT)	44'-53'
RIPARIAN WETLAND/STREAM CHANNEL COMPLEX (PEM) (REHABILITATION)	44'-50'
EXISTING WETLAND (PFO/PSS MIX) (REHABILITATION)	46'-52'

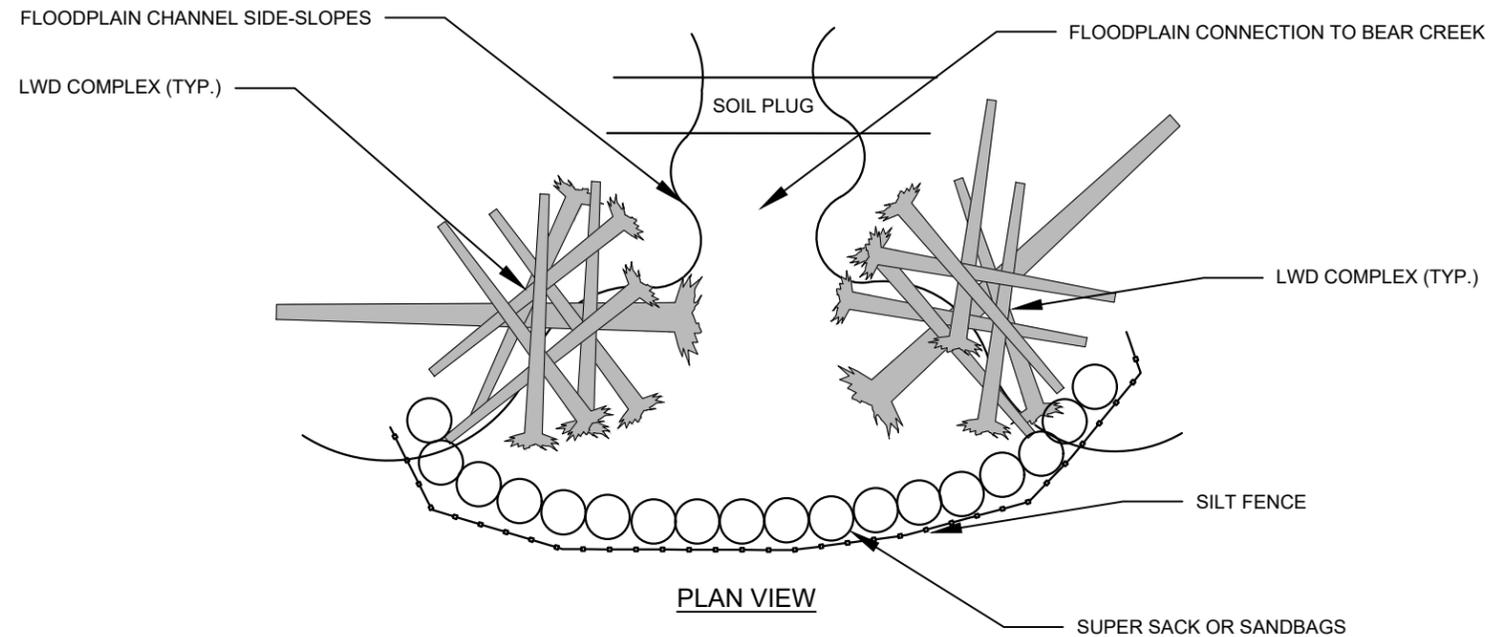
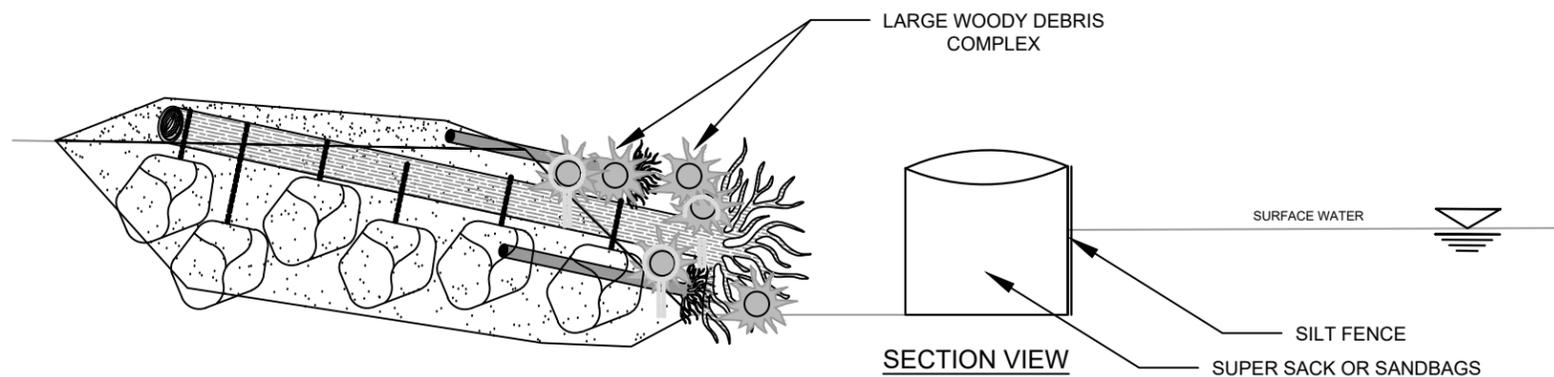
LARGE WOODY DEBRIS COMPLEX WATER ISOLATION BERM

- 1) FILL SUPER SACKS ON-SHORE WITH ROCKY MATERIAL. AVOID USING SILTY MATERIAL.
- 2) WIPE THE OUTSIDE AND BOTTOMS OF BAGS CLEAN BEFORE INSTALLATION INTO THE WATER BODY.
- 3) SLOWLY LOWER SUPER SACKS INTO CREEK.
- 4) START INSTALLING THE FIRST SUPER SACK AT THE UPSTREAM TOE OF SLOPE.
- 5) PLACE A SECOND SUPER SACK UPHILL ON THE BANK ADJACENT FIRST BAG.
- 6) CONTINUE TO PLACE SUPER SACKS IN AN ARC TO CREATE A CLEAN POOL TO CONTAIN SEDIMENT WHEN INSTALLING LWD COMPLEXES.
- 7) LINE TOP, INSIDE EDGE AND BOTTOM OF CREEK WITH A GEO-TEXTILE EROSION CONTROL FILTER FABRIC.
- 8) DO NOT DISTURB BOTTOM OF CREEK OR SIDE-SLOPES.

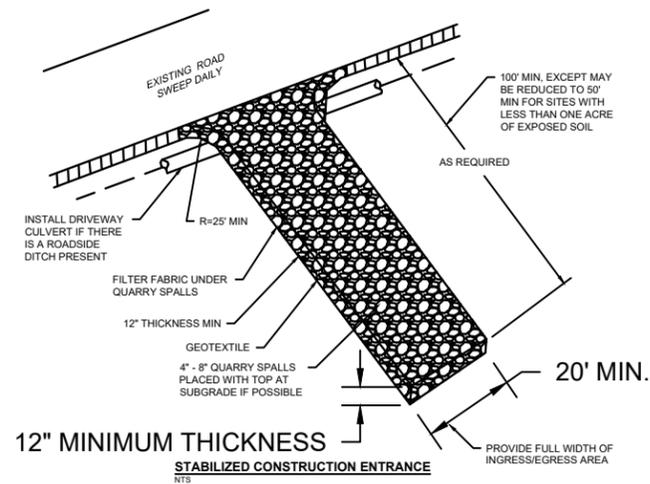
CONSTRUCTION ENTRANCE DETAIL

1. STONE SIZE - USE 4" STONE OR RECLAIMED OR RECYCLED CONCRETE EQUIVALENT.
2. LENGTH - AS REQUIRED BUT NOT LESS THAN 50' (EXCEPT ON SINGLE RESIDENCE LOT WHERE A 30' MINIMUM LENGTH WOULD APPLY).

8. PERIODIC INSPECTION AND NEEDED MAINTENANCE SHALL BE PROVIDED AFTER EACH RAIN.

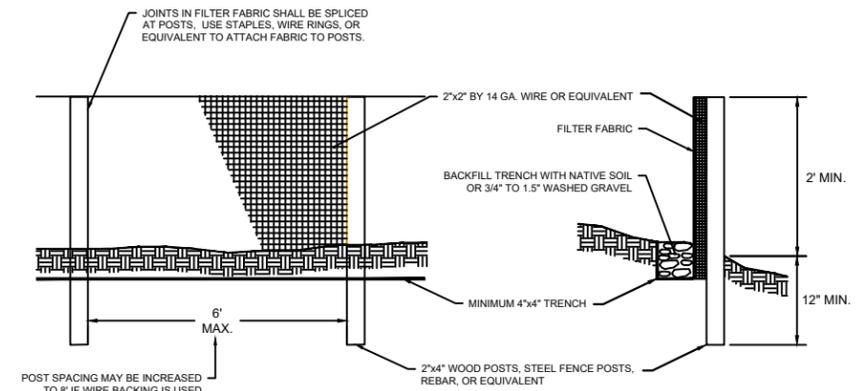
SILT FENCE DETAIL

NOTE: FILTER FABRIC FENCES SHALL BE INSTALLED ALONG CONTOUR WHENEVER POSSIBLE.

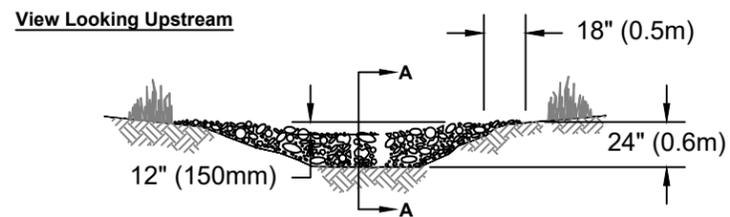
ROCK CHECK DAM DETAIL

1. KEY STONE INTO CHANNEL BANKS AND EXTEND IT BEYOND THE ABUTMENTS A MINIMUM OF 18" (0.5M) TO PREVENT FLOW AROUND DAM.
2. STREAM AND RIFFLE BED MATERIALS ACCEPTABLE FOR GRAVEL CHECK DAMS.

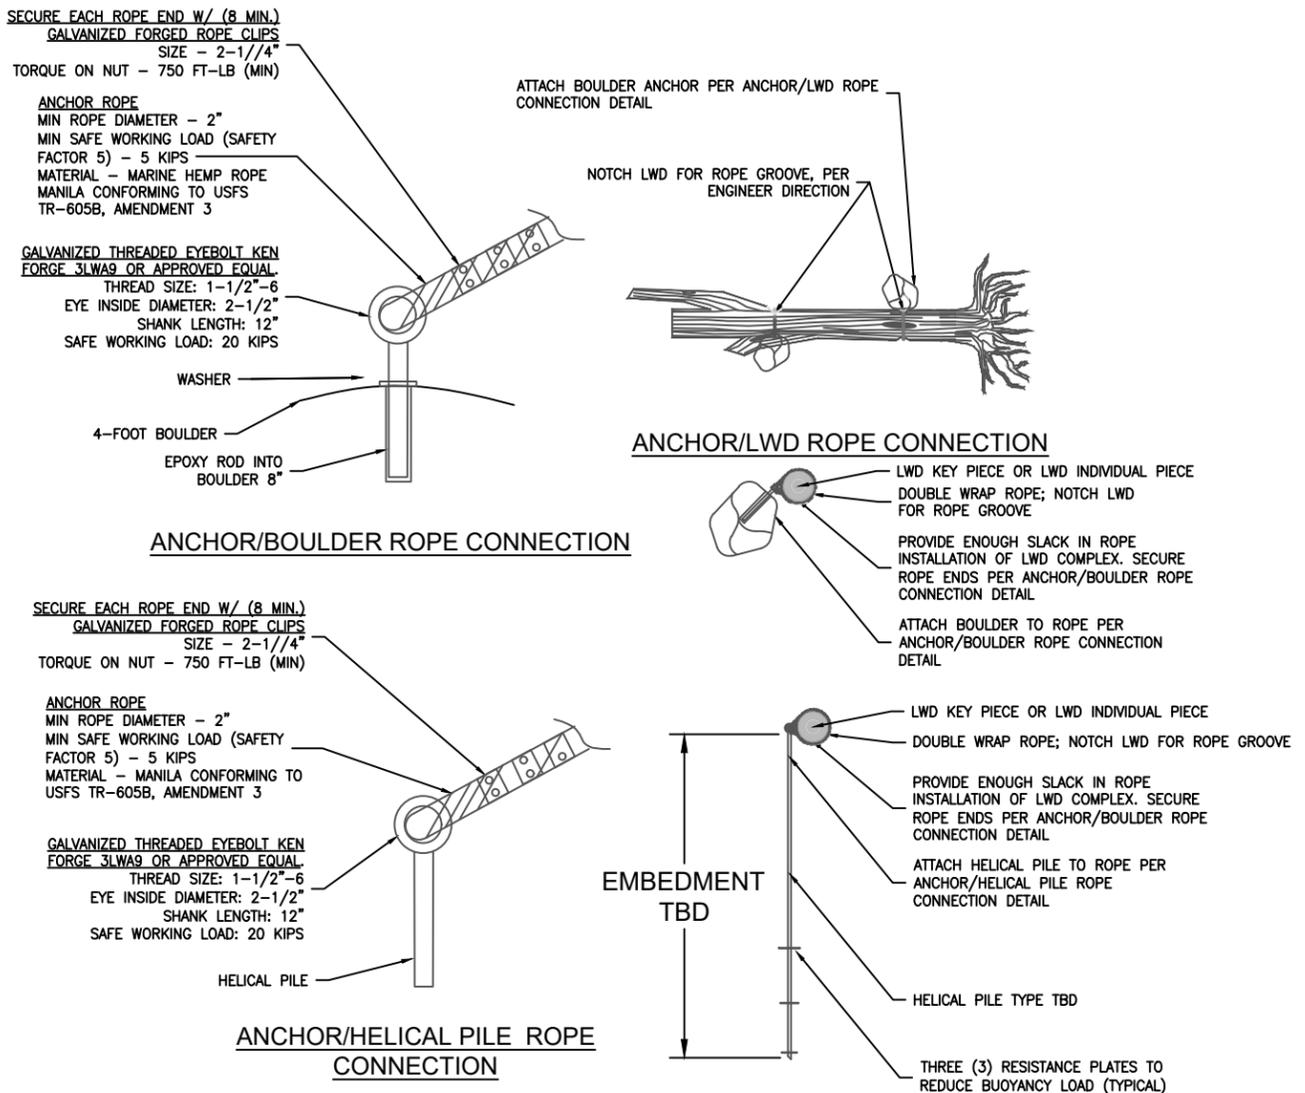
LWD ANCHOR DETAIL

- LWD ANCHORING NOTES**
1. ANCHOR LWD AT LOCATIONS SHOWN ON PLANS, LOCATIONS AT OR BELOW OHWM, AND AS DIRECTED BY ENGINEER
 2. DRILL 8" LONG 1-3/4" DIAMETER HOLE IN BOULDER.
 3. BLOW ALL DUST OUT OF DRILL HOLE USING OIL FREE COMPRESSED AIR AND WIRE BRUSH.
 4. FILL DRILL HOLE 1/2 TO 3/4 HOLE DEPTH WITH HILTE HIT-500-RE EPOXY.
 5. INSTALL THREADED ROD IN HOLE, TURNING COUNTER-CLOCKWISE UNTIL ANCHOR BOLT IS TOUCHING BOTTOM OF HOLE.
 6. NOTCH LWD WITH GROOVE FOR ANCHOR ROPE, OR DRILL HOLE THROUGH LWD.
 7. ATTACH ANCHOR ROPE TO THREADED ROD EYE. PROVIDE ENOUGH SLACK IN ROPE FOR BOULDER TO REST FIRMLY ON GROUND SURFACE W/O TENSION IN THE ROPE. BACKFILL AND COMPACT TO DENSE CONDITIONS FOR LWD'S IN TRENCH OR CUTS. USE SMALL VIBRATORY COMPACTOR TO ACHIEVE COMPACTION.

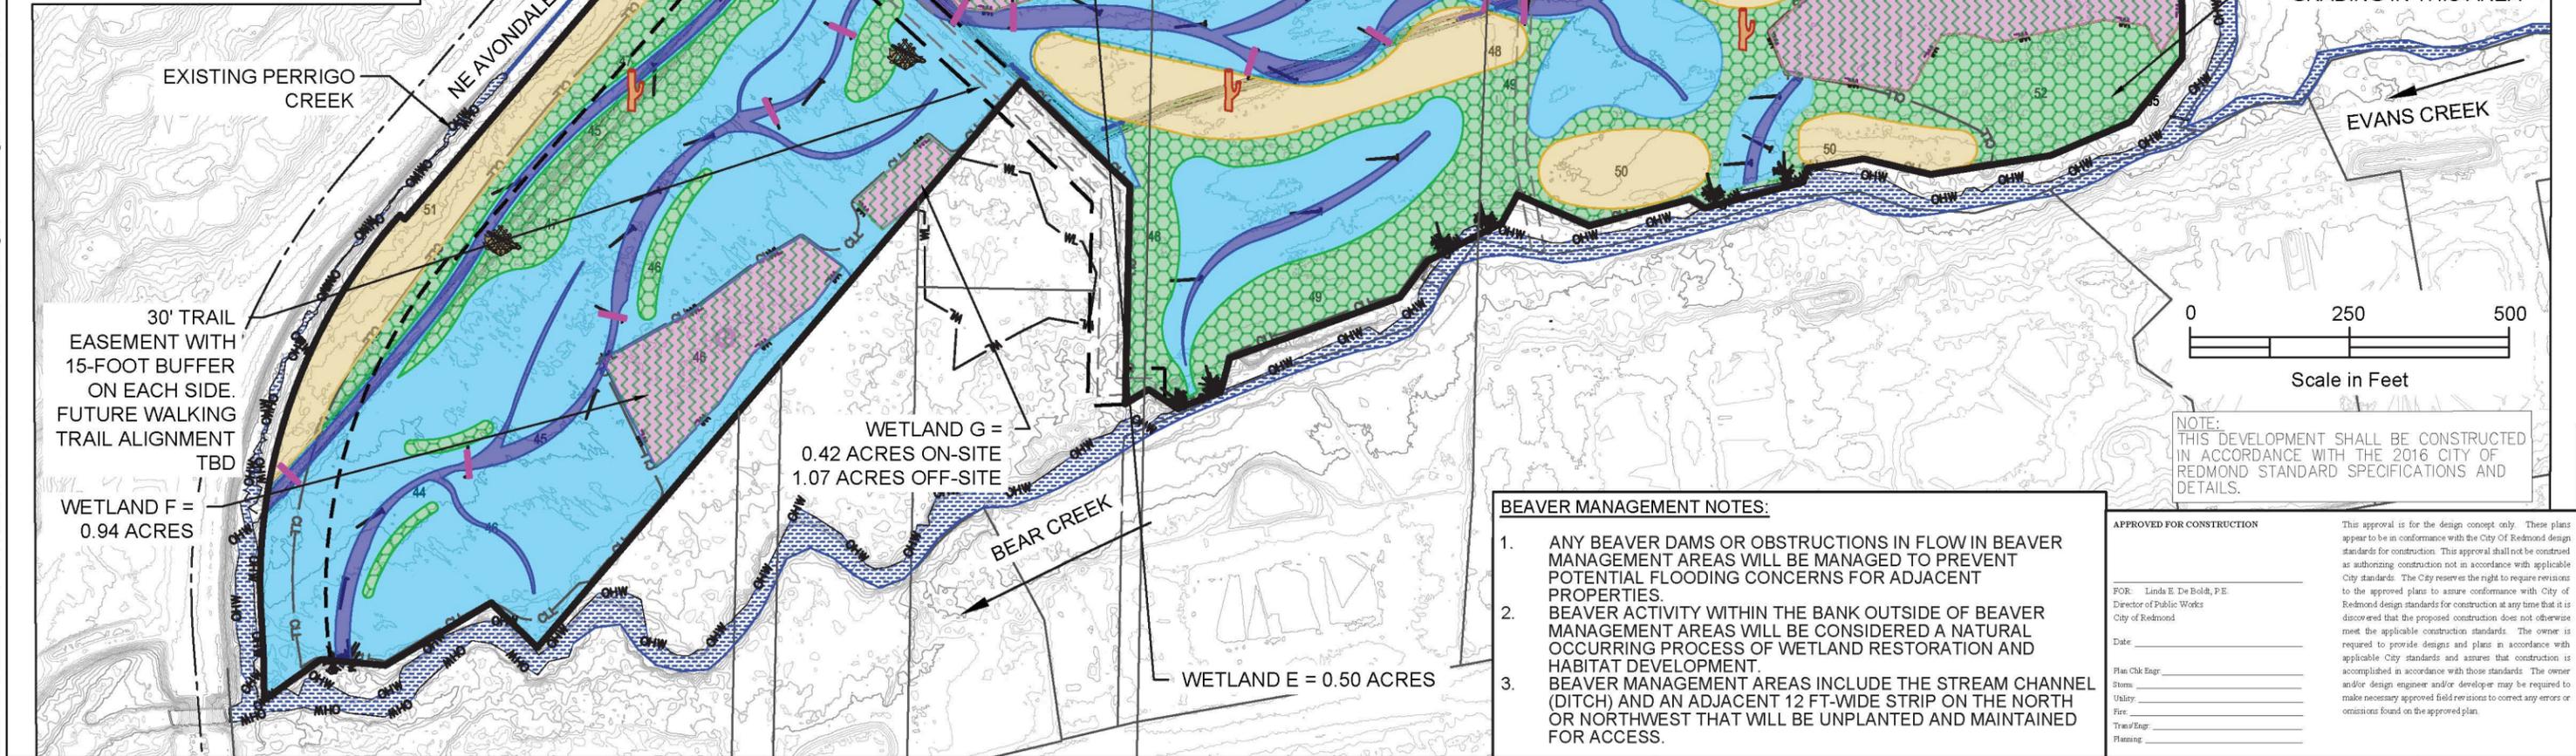
- STREAM CHANNEL COMPLEX (IN BANK)
7,114 FT EXISTING LENGTH
12,276 FT PROPOSED LENGTH
- EXISTING STREAMS (OFFSITE)
- BRUSH PILES (MIN 11)
- PERCH POLES (MIN 9)
- KEY LWD PIECE (MIN 52)
- LWD COMPLEX (MIN 10)
- BANK BOUNDARY (75.2 AC.)
- BUFFER
- EASEMENT
- EXISTING CONTOUR
- PROPOSED CONTOUR
- RIFFLE WITH LWD (21) (NTS)
- BEAVER MANAGEMENT AREAS

- BEAVER MANAGEMENT NOTES:**
- ANY BEAVER DAMS OR OBSTRUCTIONS IN FLOW IN BEAVER MANAGEMENT AREAS WILL BE MANAGED TO PREVENT POTENTIAL FLOODING CONCERNS FOR ADJACENT PROPERTIES.
 - BEAVER ACTIVITY WITHIN THE BANK OUTSIDE OF BEAVER MANAGEMENT AREAS WILL BE CONSIDERED A NATURAL OCCURRING PROCESS OF WETLAND RESTORATION AND HABITAT DEVELOPMENT.
 - BEAVER MANAGEMENT AREAS INCLUDE THE STREAM CHANNEL (DITCH) AND AN ADJACENT 12 FT-WIDE STRIP ON THE NORTH OR NORTHWEST THAT WILL BE UNPLANTED AND MAINTAINED FOR ACCESS.
