**INTERIM REMEDIAL ACTION PLAN
RAMCO ALUMINUM WASTE DISPOSAL SITE
PORT OF KLINKITAT INDUSTRIAL PARK
DALLESPOUR, WASHINGTON**

October 9, 2006

**Prepared by Washington State Department of Ecology
Toxics Cleanup Program
Robert D. Swackhamer PE (509) 454-7840**

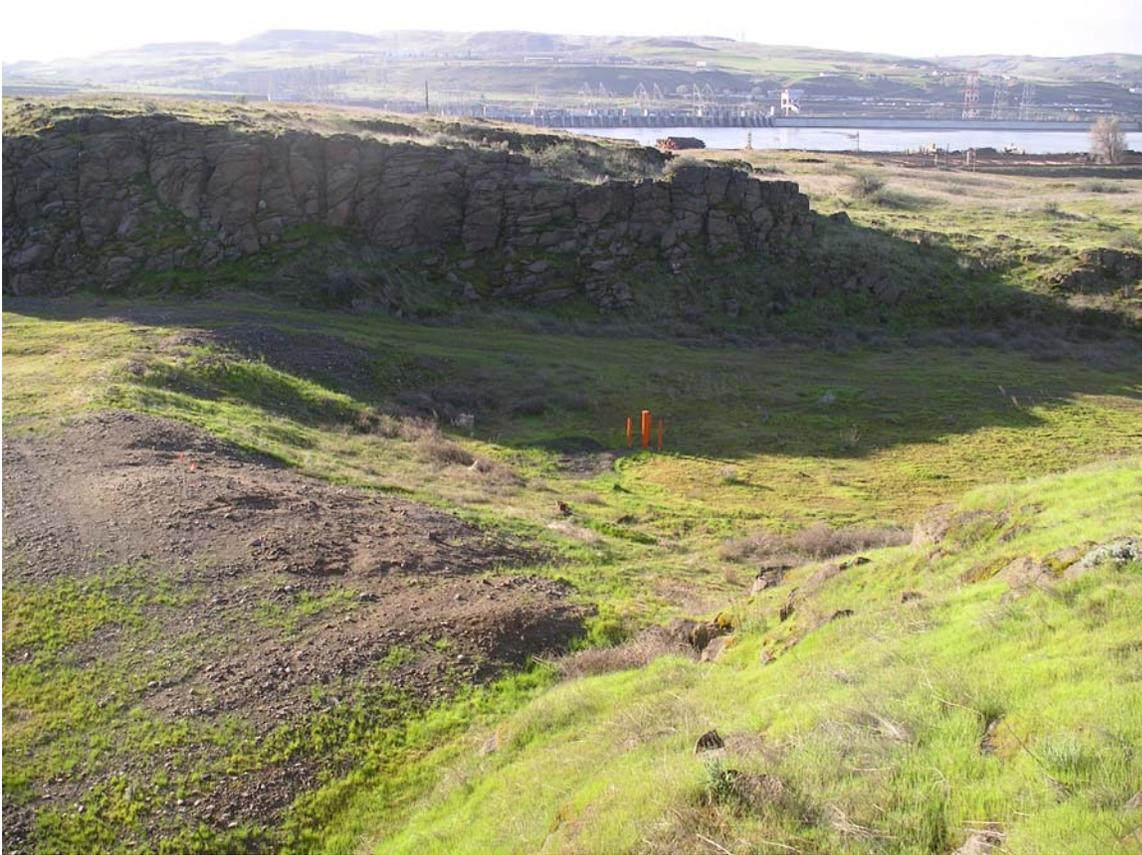
Photo # 1 – West edge of the landfill occupies the center left and lower left of photo. Basalt outcrop bluff in upper left and center forms the south wall of the bowl in which the unlined landfill sits. Columbia River, also known as Lake Celilo at this point, is in the background to the south. Orange pipes in center indicate position of monitoring well. (Photo by Jeff Newschwander)

underlain and surrounded on almost three sides by Columbia River Basalt outcrop of The Dalles Formation, Miocene Epoch. See Figure 1 and Figure 2 for the project location. See Appendix A for photographs of the landfill site.

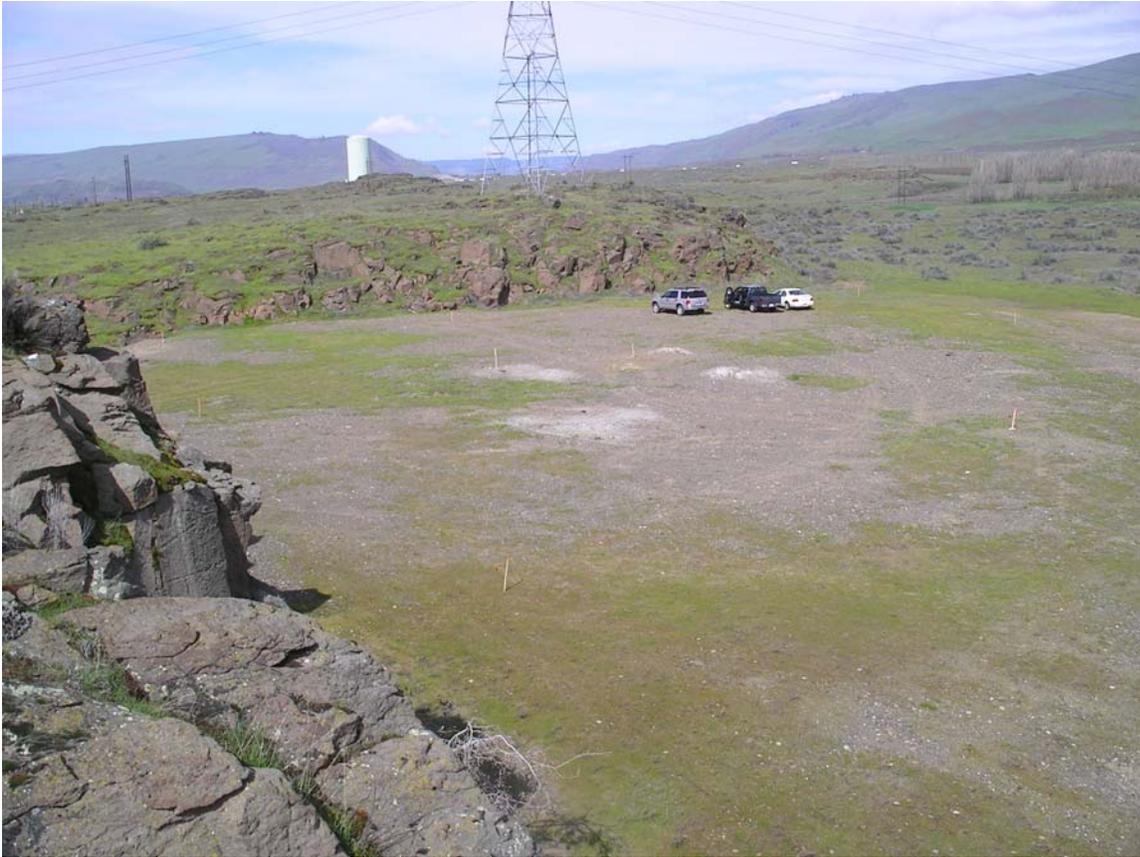
Photo # 2 – Looking northwest and down on landfill cover from atop basalt outcrop bluff that forms southern wall of bowl in which the landfill sits. The landfill cover is the relatively flat area that occupies most of the photograph. The vehicles are parked on the landfill cover. Note Bonneville Power Administration electrical power transmission lines and tower. (Photo by Jeff Newschwander)

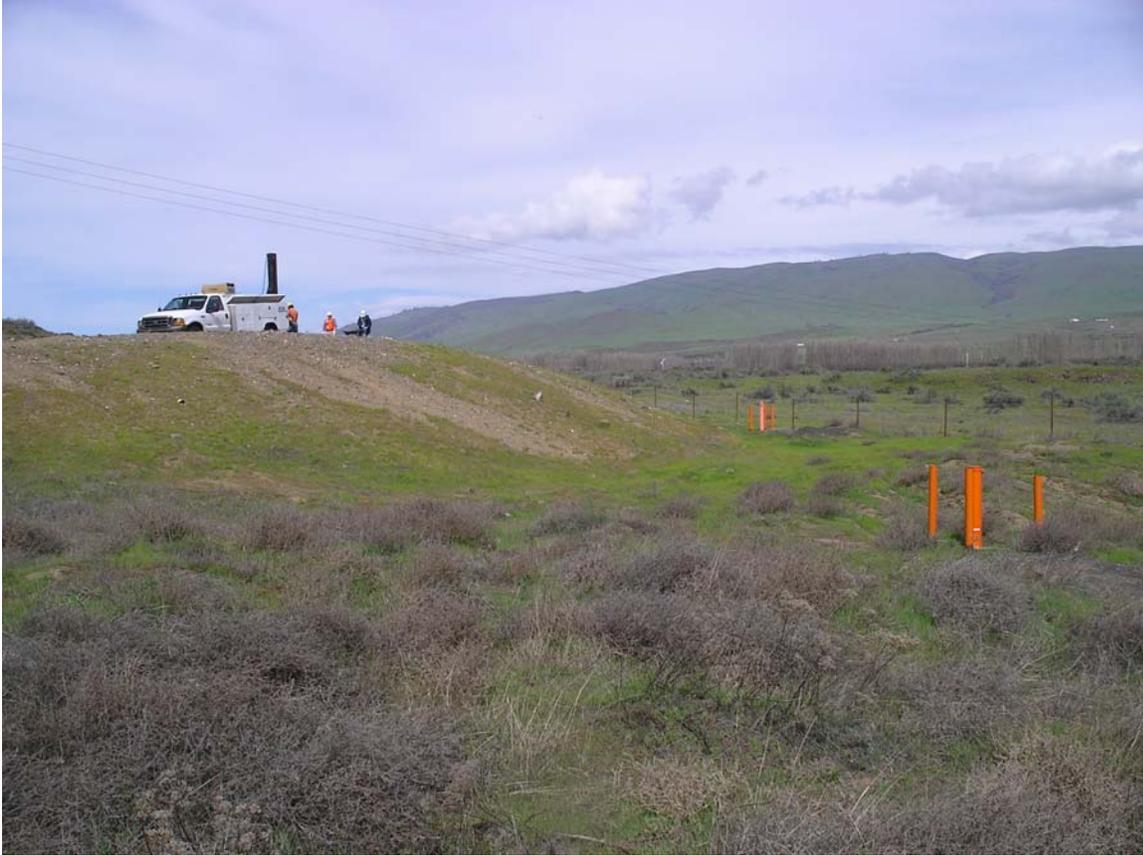
Photo # 3 – Looking north, with the east edge of the landfill on the left. Spearfish Lake is outside of the photo frame on the right. Orange pipes indicate locations of groundwater monitoring wells. (Photo by Jeff Newschwander)

In June and July of 2005, the Washington Department of Ecology oversaw the installation of five groundwater monitoring wells onsite, adjacent to the landfill, to determine the depth to groundwater and the impacts the landfill may be having on the groundwater in the area. Results are summarized in the next section of this report, Section 2.3 Contaminants of Concern.

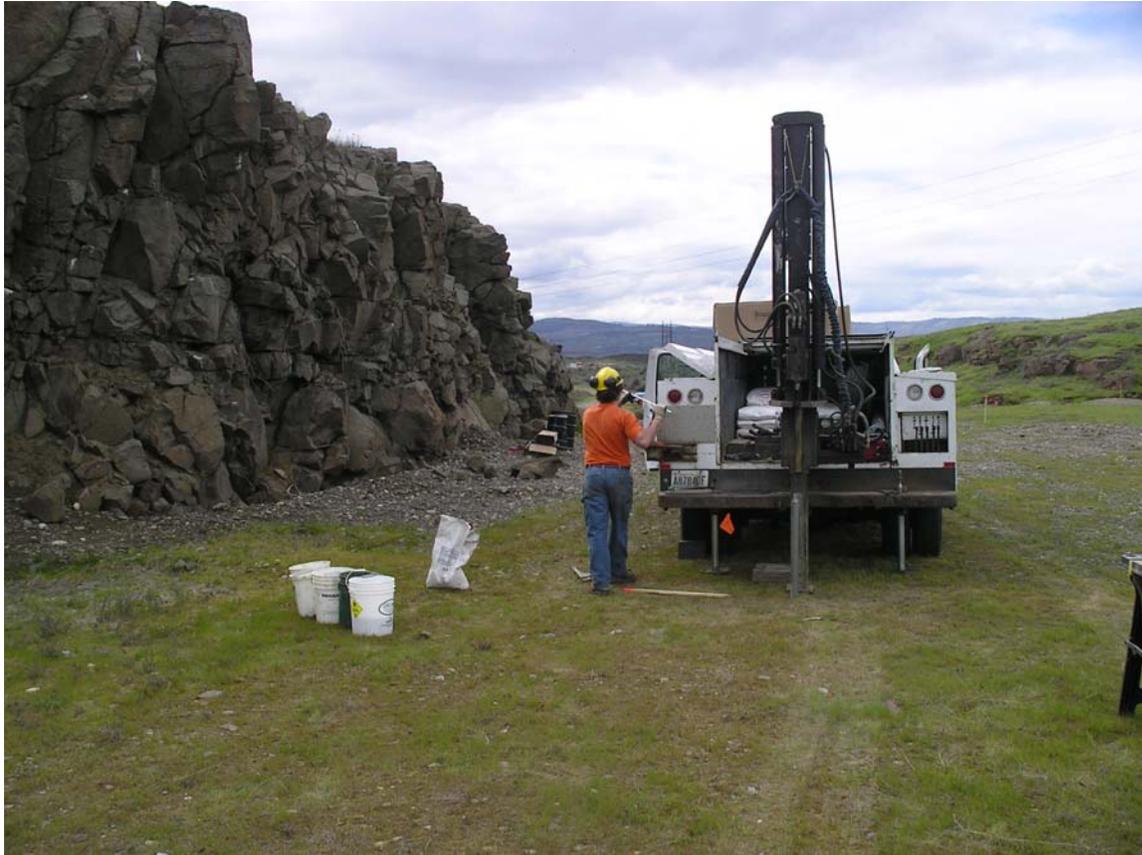
Photo # 4 – Geoprobe machine and operator indicate scale of basalt outcrop bluff which forms south wall of bowl in which the landfill sits. (Photo by Jeff Newschwander)

In April 2006, Ecology oversaw additional sampling of the aluminum waste in the landfill using a geoprobe. Geoprobe is a brand of hydraulically powered machines using the direct push technique to obtain soil samples. Direct push means pushing tools and samplers into the ground rather than having to drill to remove soil or make a path. Essentially the weight of the geoprobe machine is used as a hammer to drive the steel and sampler into the ground.
