# **Flow Summary for Gaging Stations on the Stillaguamish River and Selected Tributaries**

## **May through October 2001**

Publication No. 03-03-019

*by  
Chuck Springer*

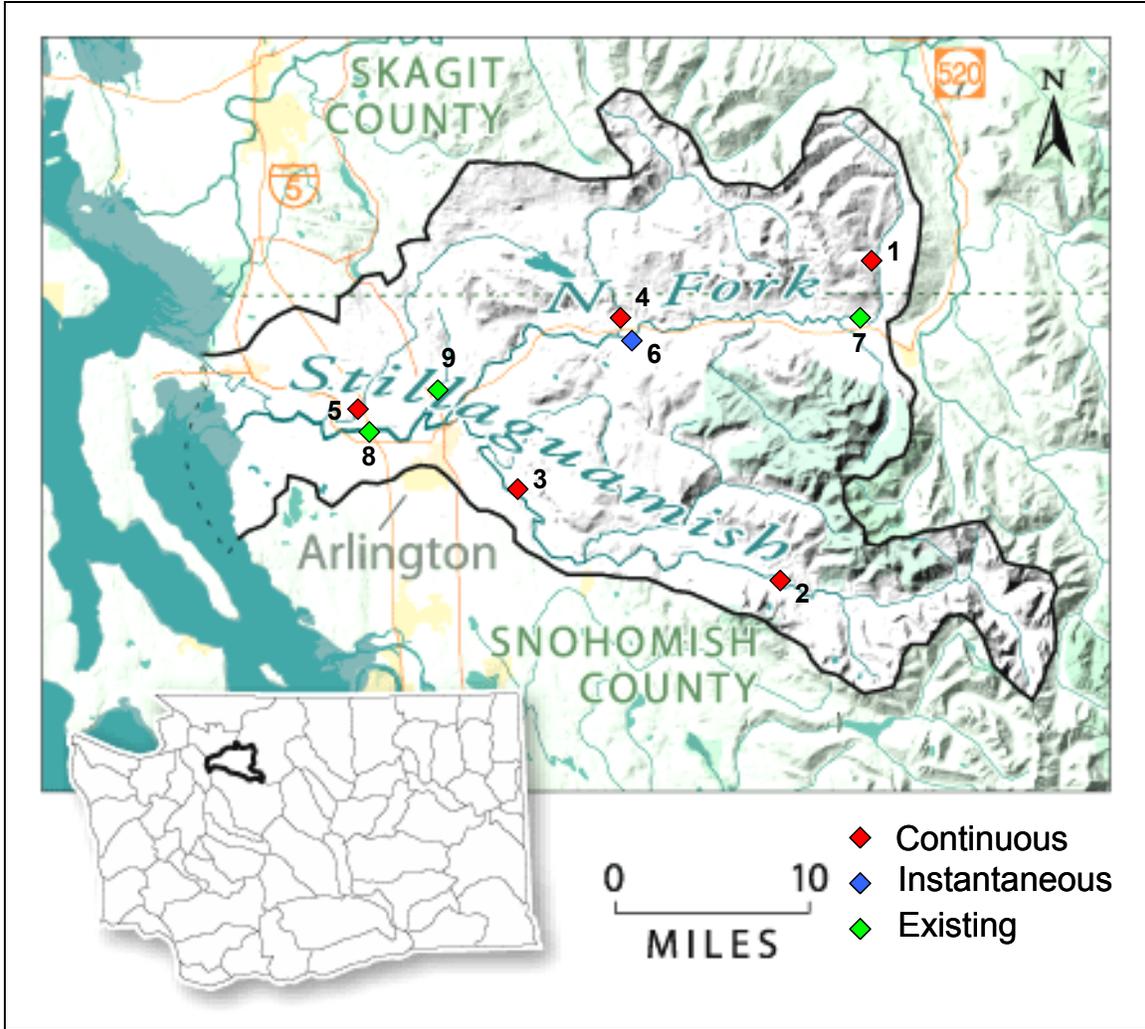
Figure 1: Map of Stillaguamish TMDL study sites.

On the North Fork Stillaguamish River, the continuous gaging station was located above Crevice Creek in the Mount Baker/Snoqualmie National Forest, at river mile 39.0 (Figure 1, Site 1).

On the South Fork, the uppermost continuous gaging station was located across from the Mount Baker/Snoqualmie National Forest Verlot Campground, at river mile 46.5 (Site 2). The lower station on the South Fork was located at Snohomish County's River Meadows Park, approximately 4 miles southwest of Arlington, at river mile 24.4 (Site 3). On Deer Creek, the gaging station was located at a private residence approximately 0.5 miles upstream of the mouth in Oso (Site 4). On Pilchuck Creek, the gaging station was located approximately 0.5 miles above the mouth (Site 5).

In addition to the five continuous gaging stations, one instantaneous gaging station was established on the North Fork Stillaguamish River above Deer Creek in Oso, at river mile 14.5 (Site 6).

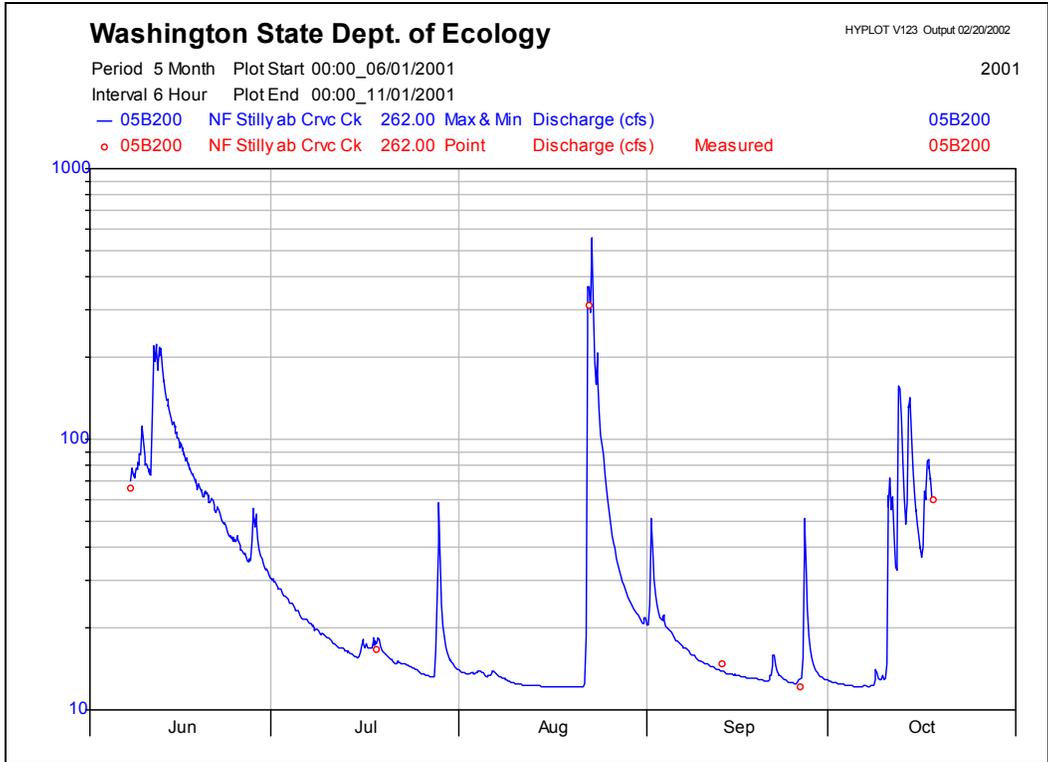
**Figure 2: Discharge hydrograph for Site 1.**

The average daily discharge for Site 1 ranged from just over 12 cubic feet per second (cfs) during dry periods in August, September and October, to over 300 cfs during an intense storm event in August. Peak flow during the study period was over 550 cfs on August 22 (Figure 2). Daily discharge averages are presented in Appendix B, Table 1. The rating curve encompassed nearly 60% of the range of discharge, with flow measurements ranging from 12 to 315 cfs (Figure 3). However, discharge exceeded the rating curve less than 1% of the time over the duration of the study period (Figure 4). The rating curve, a polynomial regression of discharge versus pressure transducer readings, had an  $r^2$  of 0.99. All six discharge measurements conducted at this station during the study period were within 10% of the flow predicted by the rating curve, and three were within 5% of the flow predicted by the rating curve. The linear regression of staff gage readings against pressure transducer readings was also quite strong, with an  $r^2$  of 1.00 (Figure 5). The overall trend in streamflow at Site 1 reflects a typical dry-period decline in discharge, with the exception of several small storm events occurring at various times throughout the study period, and the water year peak event occurring in late August.

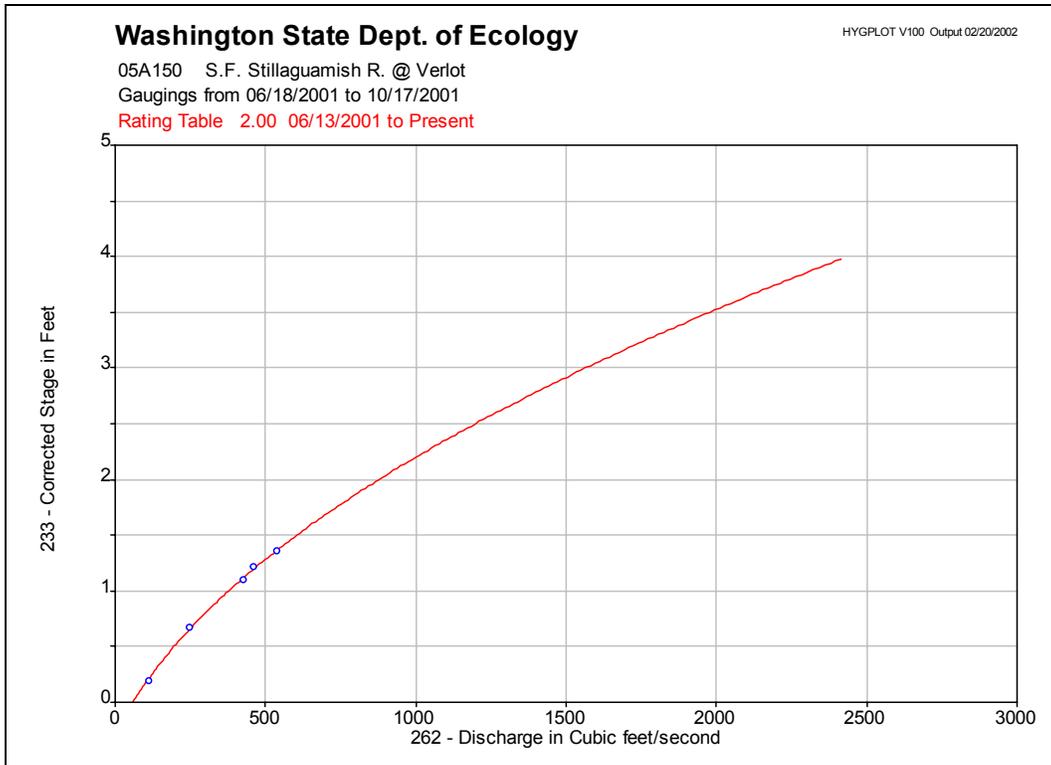
**Figure 3: Discharge rating curve for Site 1.**

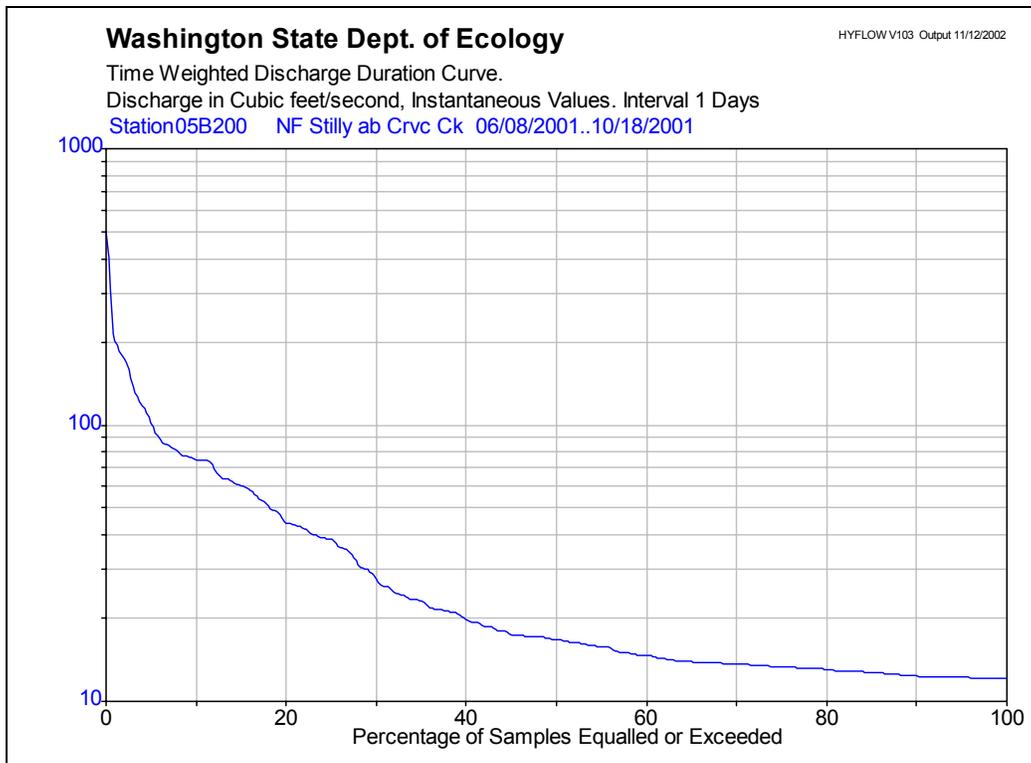
**Figure 4: Flow exceedence graph for Site 1.**

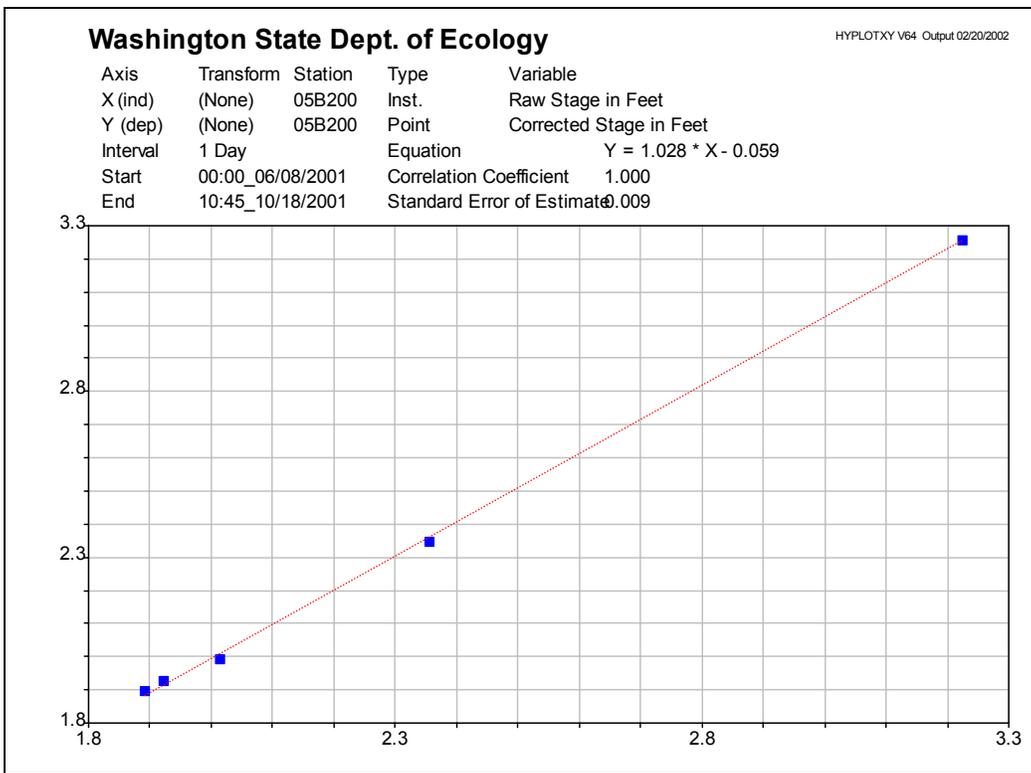
**Figure 5: Linear regression of staff gage versus pressure transducer readings for Site 1.**

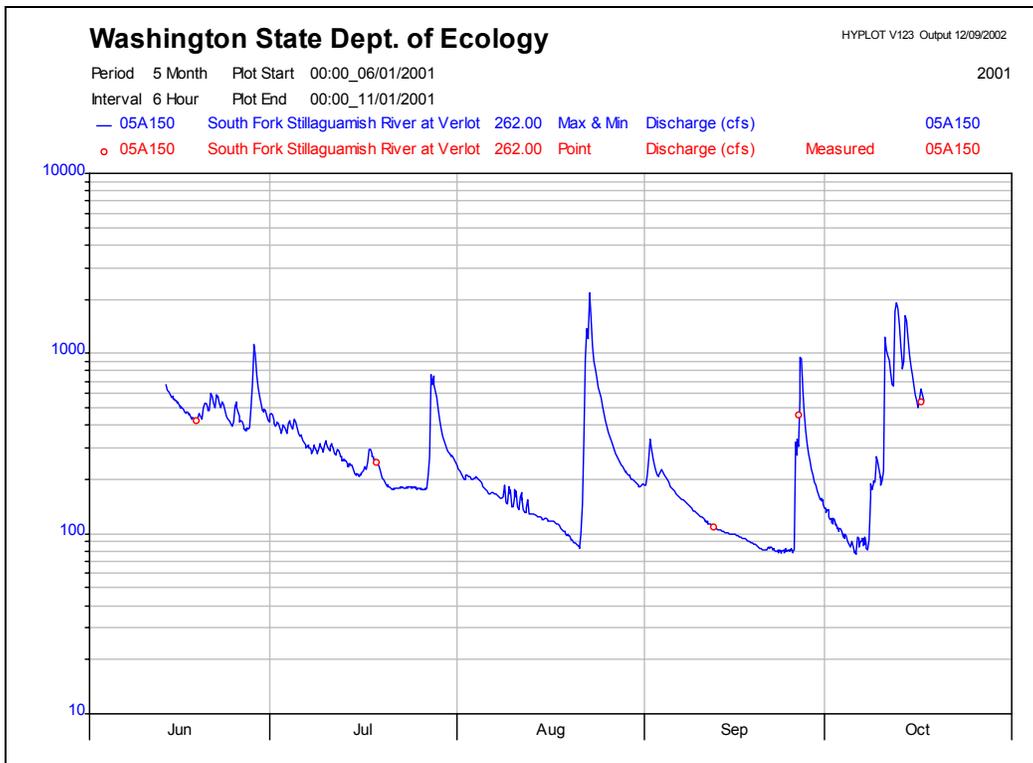
**Figure 6: Discharge hydrograph for Site 2.**

The average daily discharge for Site 2 ranged from 80 cfs during dry periods in August, September and early October, to over 1300 cfs during storm events in mid-October. Peak flow during the study period was nearly 2,200 cfs on August 23 (Figure 6). Daily discharge averages are presented in Appendix B, Table 2. The rating curve encompassed less than 25 percent of the range of flows encountered during the study period, with discharge measurements ranging from 100 cfs to 530 cfs (Figure 7). A substantial portion of the discharge data collected at this site exceeded the rating curve. A discharge of 530 cfs was exceeded more than 15% of the time over the duration of the study period (Figure 8). Channel conditions at this site, combined with the lack of an adequate bridge crossing, resulted in an inability to measure flows greater than 550 cfs. The rating curve, a polynomial regression of discharge versus pressure transducer readings, had an  $r^2$  of 0.99. All five discharge measurements conducted at this station during the study period were within 5% of the flow predicted by the rating curve. The linear regression of staff gage readings versus pressure transducer readings was strong during low-flow conditions, but not so strong during high flow conditions, with an overall  $r^2$  of 0.976 (Figure 9).

The overall trend in streamflow at Site 2 reflects a typical dry-period decline in discharge, with the exception of several small storm events occurring at various times throughout the study period, and the water year peak event occurring in late August. However, during one distinct five-day time period of the study period (August 8-12), a diurnal cycle in stage readings was encountered. This was later determined to be related to an equipment problem, and the original data was corrected. Additional discussion of this problem is included as Appendix C.

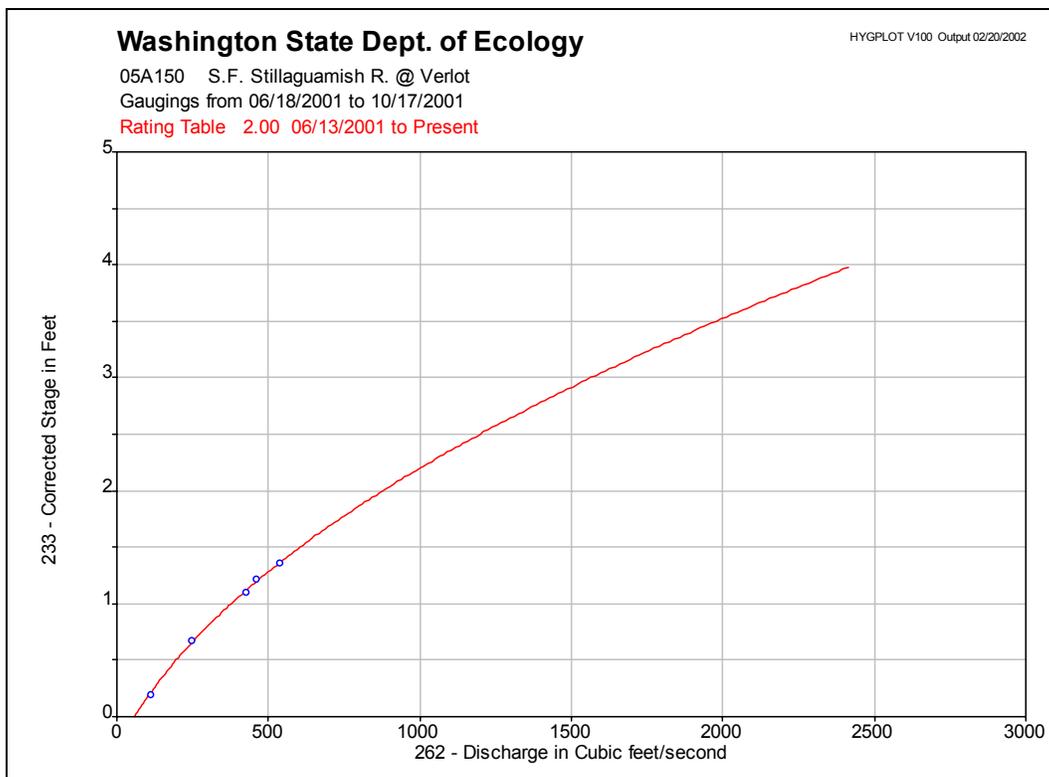
**Figure 7: Discharge rating curve for Site 2.**

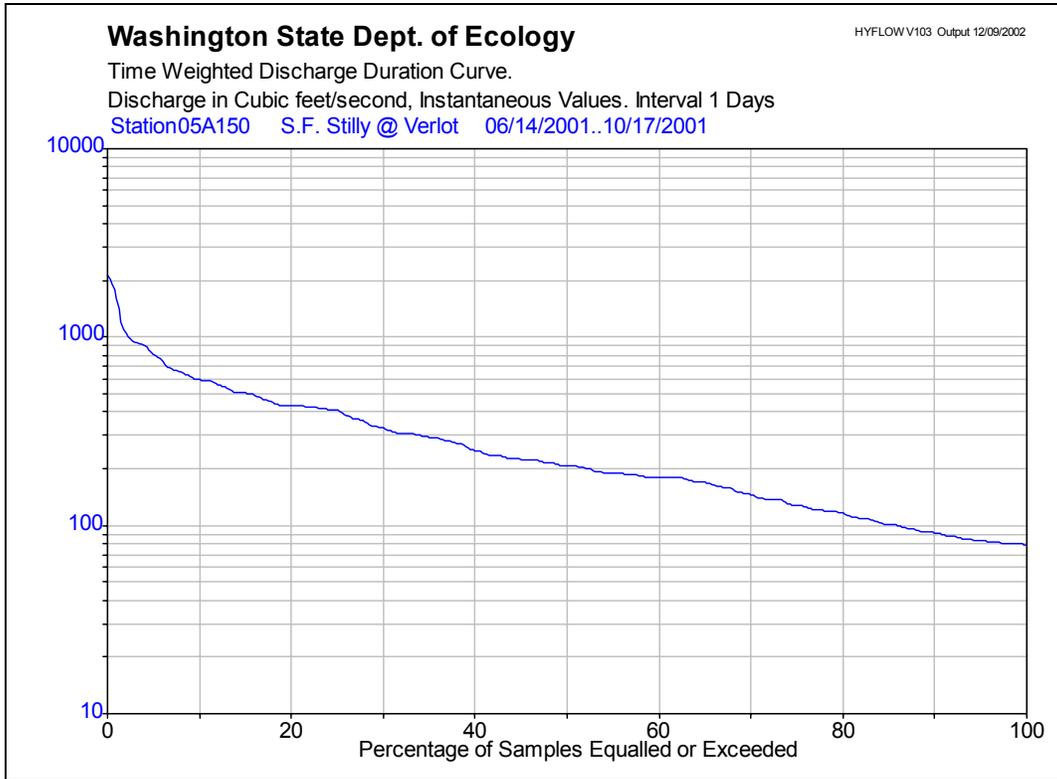
**Figure 8: Flow exceedence graph for Site 2.**

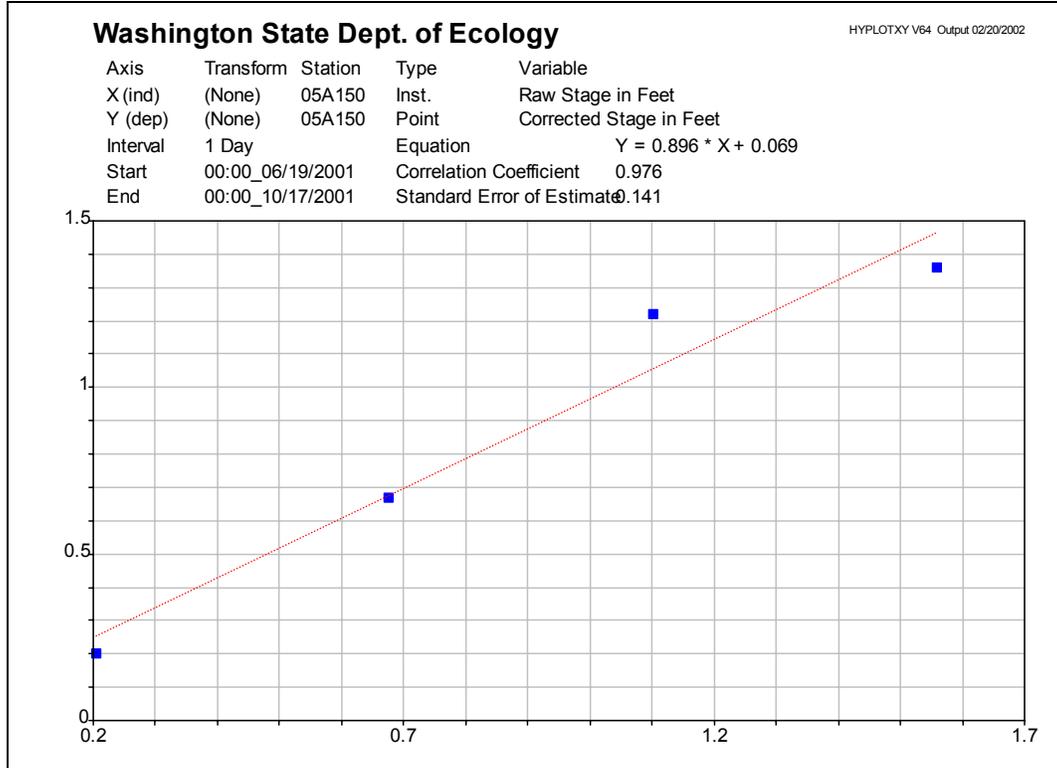
**Figure 9: Linear regression of staff gage versus pressure transducer readings for Site 2.**

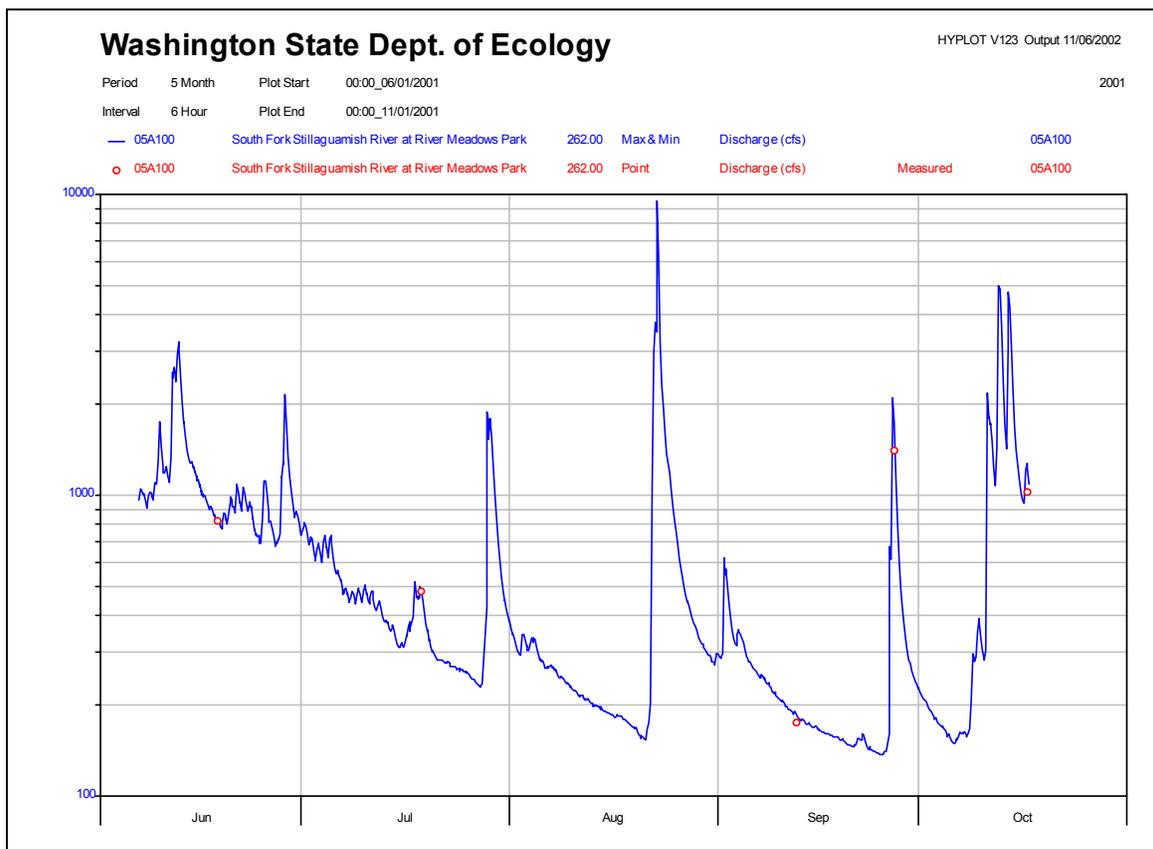
Figure 10: Discharge hydrograph for Site 3.

The average daily discharge for Site 3 ranged from around 140 cfs during dry periods in August, September and early October to 4400 cfs during a storm event in late August. Peak flow during the study period was nearly 9,500 cfs on August 23 (Figure 10). Daily discharge averages are presented in Appendix B, Table 3. The rating curve for Site 3 encompassed less than 15 percent of the range of flows encountered during the study period, with flow measurements ranging from 175 cfs to 1400 cfs (Figure 11). Channel conditions at the site, combined with the lack of an adequate bridge crossing, resulted in an inability to measure flows greater than 1,400 cfs. However, discharge exceeded the rating curve less than 10% of the time over the duration of the study period (Figure 12). Within the range of measured flows, the fit of the rating curve was very good. A log-log regression of river stage against discharge had an  $r^2$  value of 0.999 (Figure 13). All five discharge measurements conducted at this station during the study period were within 5% of the flow predicted by the rating curve. The linear regression of staff gage readings versus pressure transducer readings was stronger during low flow conditions than during high flow conditions, with an overall  $r^2$  of 0.991 (Figure 14). The overall trend in streamflow at Site 3 reflects a typical dry-period decline in discharge, with the exception of several small storm events occurring at various times throughout the study period, and the water year peak event occurring in late August.

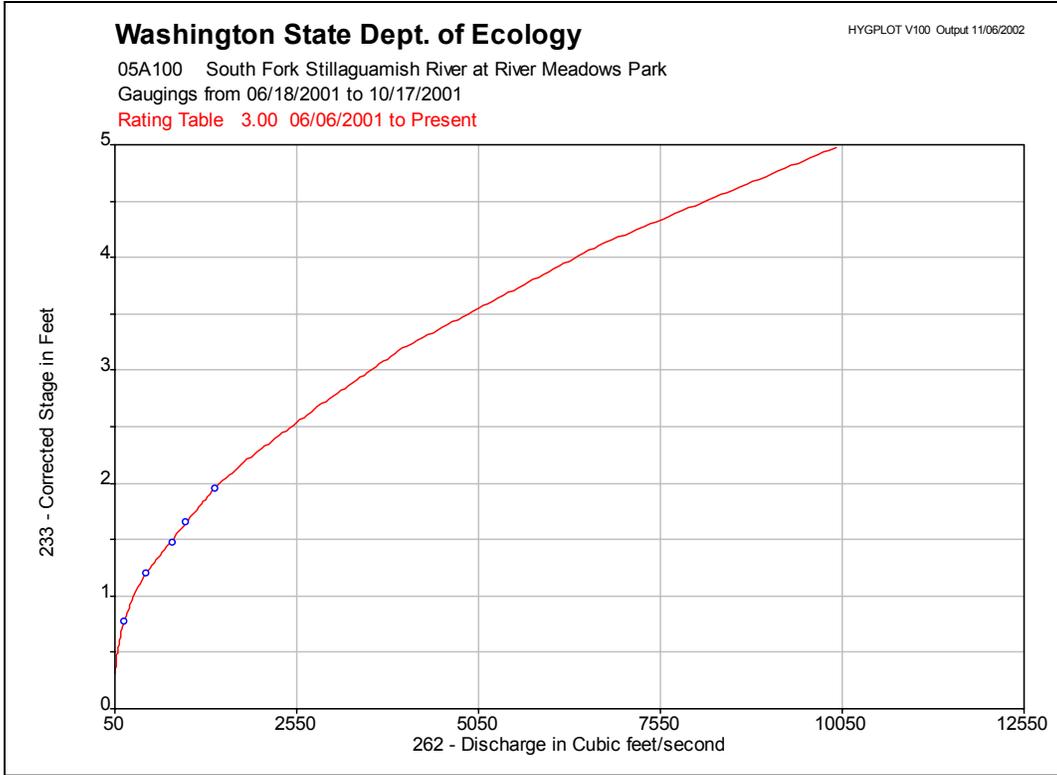
**Figure 11: Discharge rating curve for Site 3.**

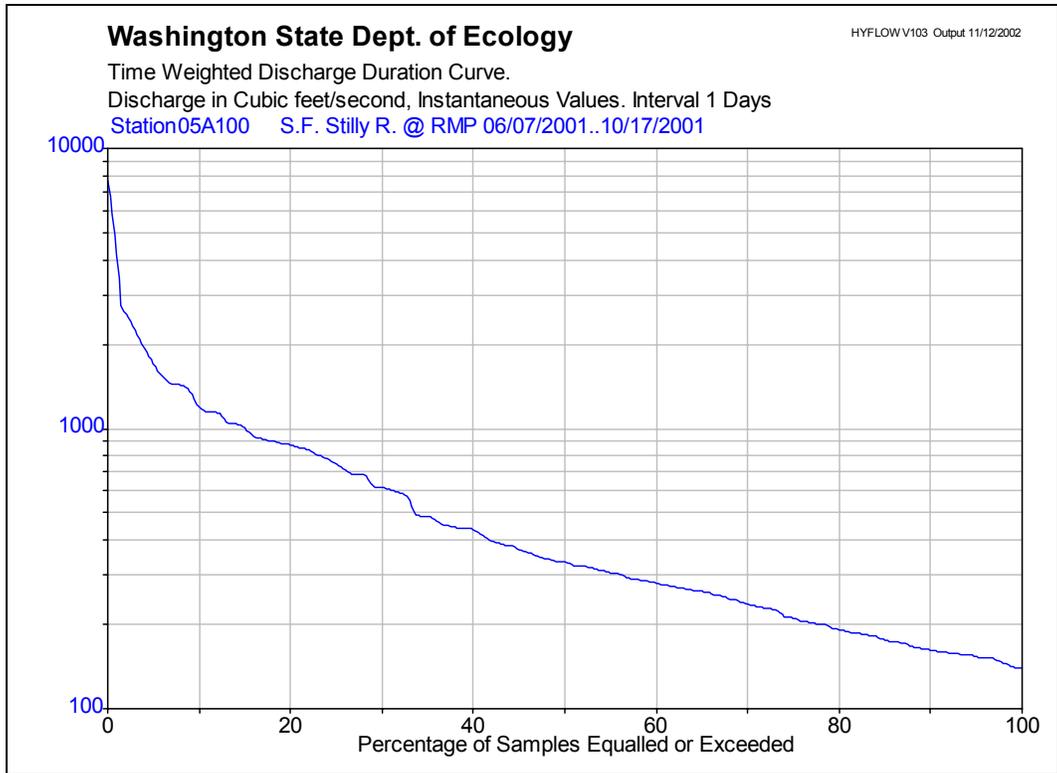
**Figure 12: Flow exceedence graph for Site 3.**

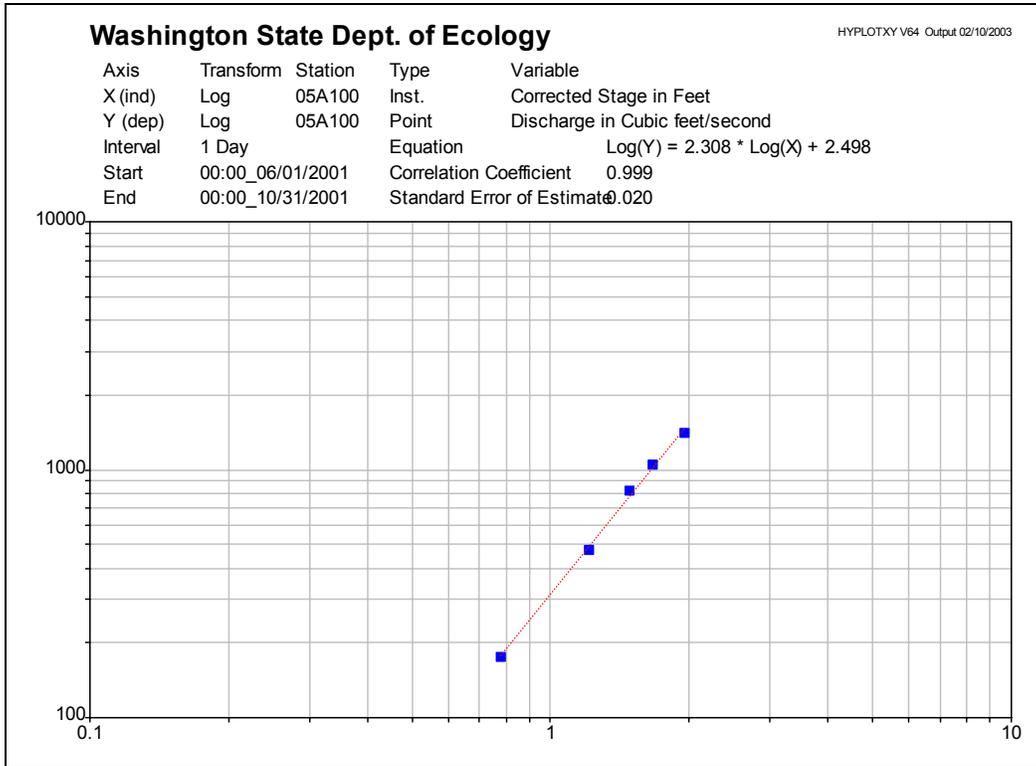
**Figure 13: Log-Log regression of stage versus discharge for Site 3.**

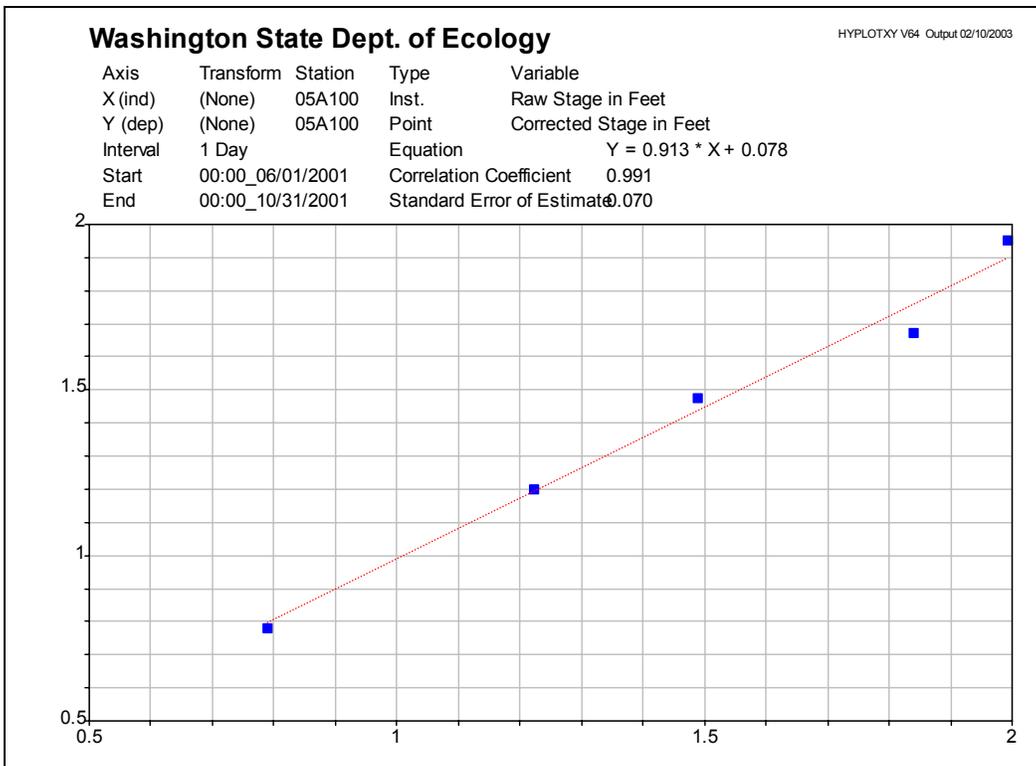
**Figure 14: Linear regression of staff gage versus pressure transducer readings for Site 3.**

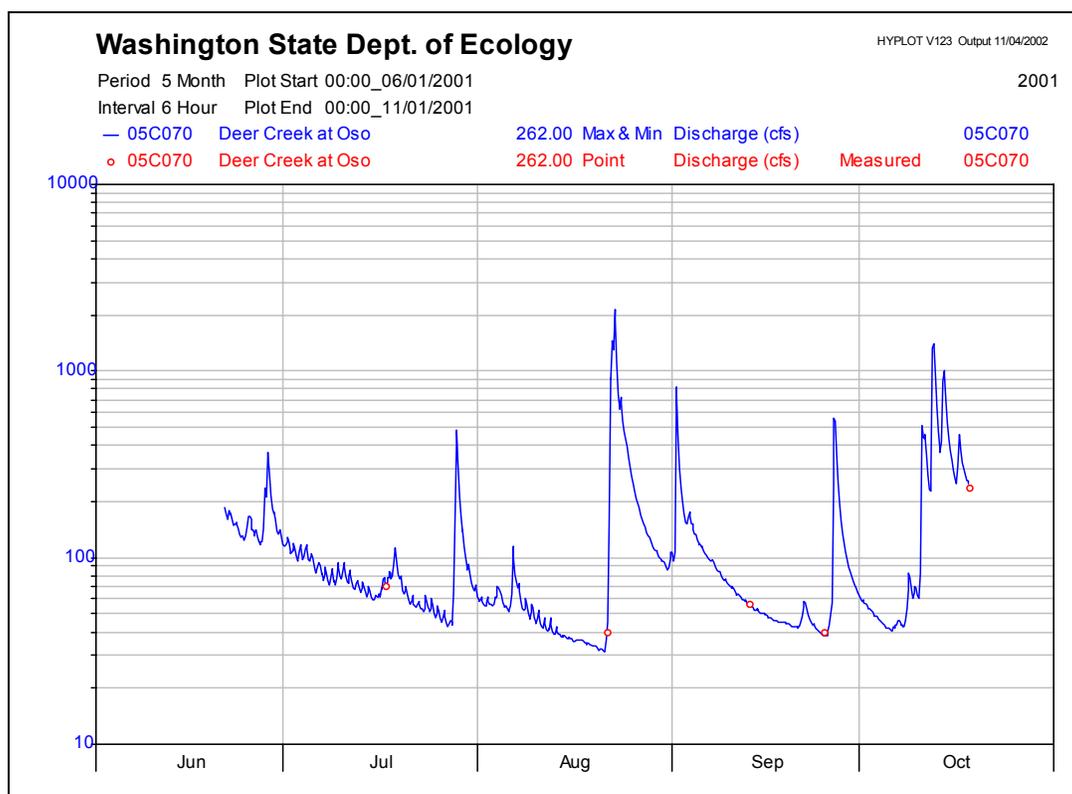
Figure 15: Discharge hydrograph for Site 4.

The average daily discharge for Site 4 ranged from over 30 cfs in mid-August to 1,240 cfs during a storm event in late-August. Peak flow during the study period was 2,150 cfs on August 22 (Figure 15). Daily discharge averages are presented in Appendix B, Table 4. The rating curve encompassed only 10 percent of the range of flows encountered during the study period, with flow measurements ranging from 40 cfs to 236 cfs (Figure 16). Channel conditions at the site, combined with the lack of an adequate bridge crossing, resulted in an inability to measure flows greater than 240 cfs. Discharge exceeded the rated range of flows during peak flows each month of the study period, with event peaks ranging from 364 cfs in June to 2,150 cfs during the peak event in August. This represents a fairly sizeable portion of the encountered flows, as discharge exceeded the rating curve 10% of the time over the duration of the study period (Figure 17). The rating curve, a polynomial regression of discharge versus pressure transducer readings, had an  $r^2$  of 0.999. All five discharge measurements conducted at this station during the study period were within 5% of the flow predicted by the rating curve. The linear regression of staff gage readings versus pressure transducer readings was strong throughout the range, with an  $r^2$  of 1.00 (Figure 18). The overall trend in streamflow at Site 4 reflects a typical dry-period decline in discharge, with the exception of several small storm events occurring at various times throughout the study period, and the water year peak event occurring in late August.

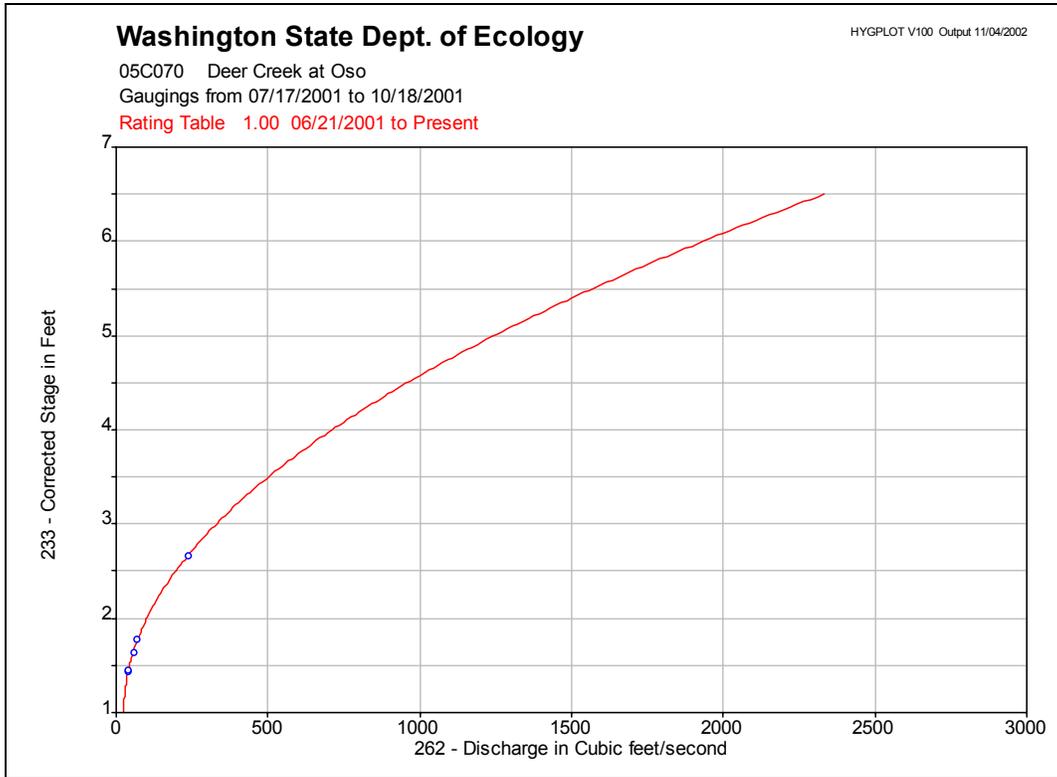
**Figure 16: Discharge rating curve for Site 4.**

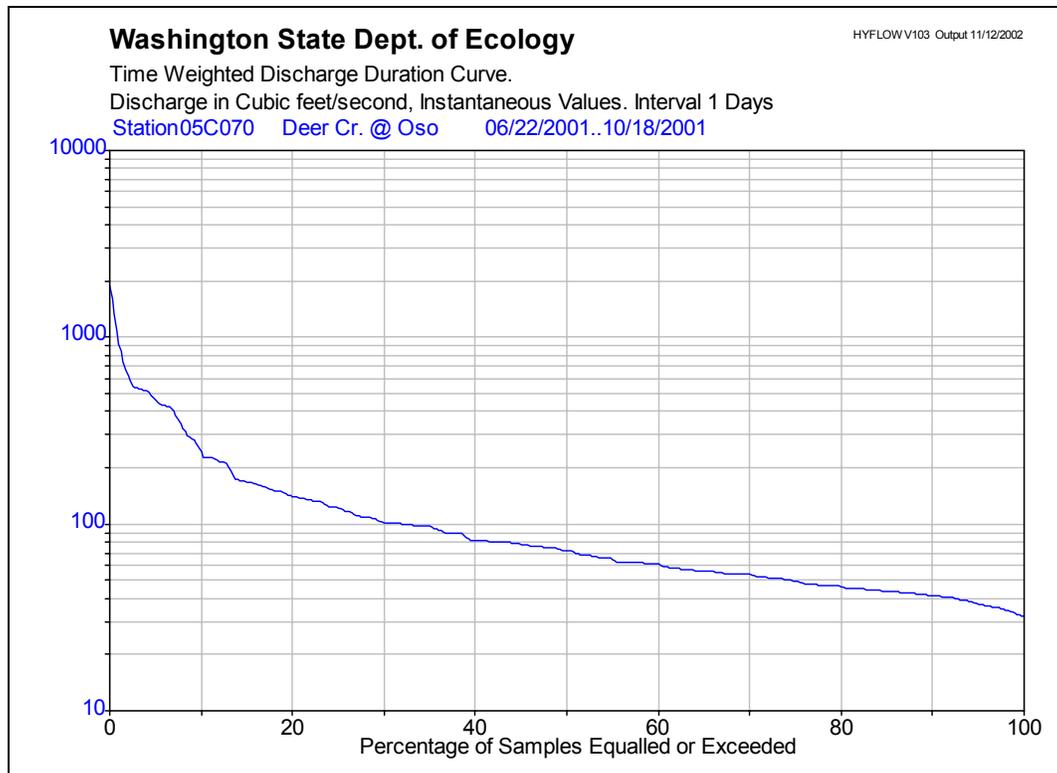
**Figure 17: Flow exceedence graph for Site 4.**

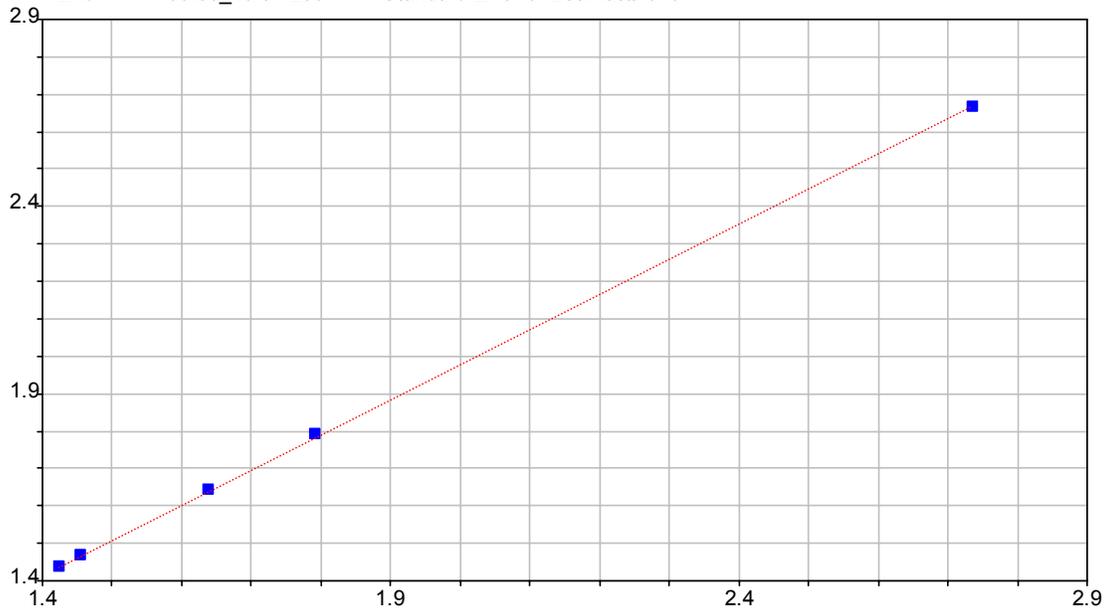
Axis	Transform	Station	Type	Variable
X (ind)	(None)	05C070	Inst.	Raw Stage in Feet
Y (dep)	(None)	05C070	Point	Corrected Stage in Feet
Interval	1 Day		Equation	$Y = 0.943 * X + 0.090$
Start	00:00_06/01/2001		Correlation Coefficient	1.000
End	00:00_10/31/2001		Standard Error of Estimate	0.010

**Figure 18: Linear regression of staff gage versus pressure transducer readings for Site 4.**

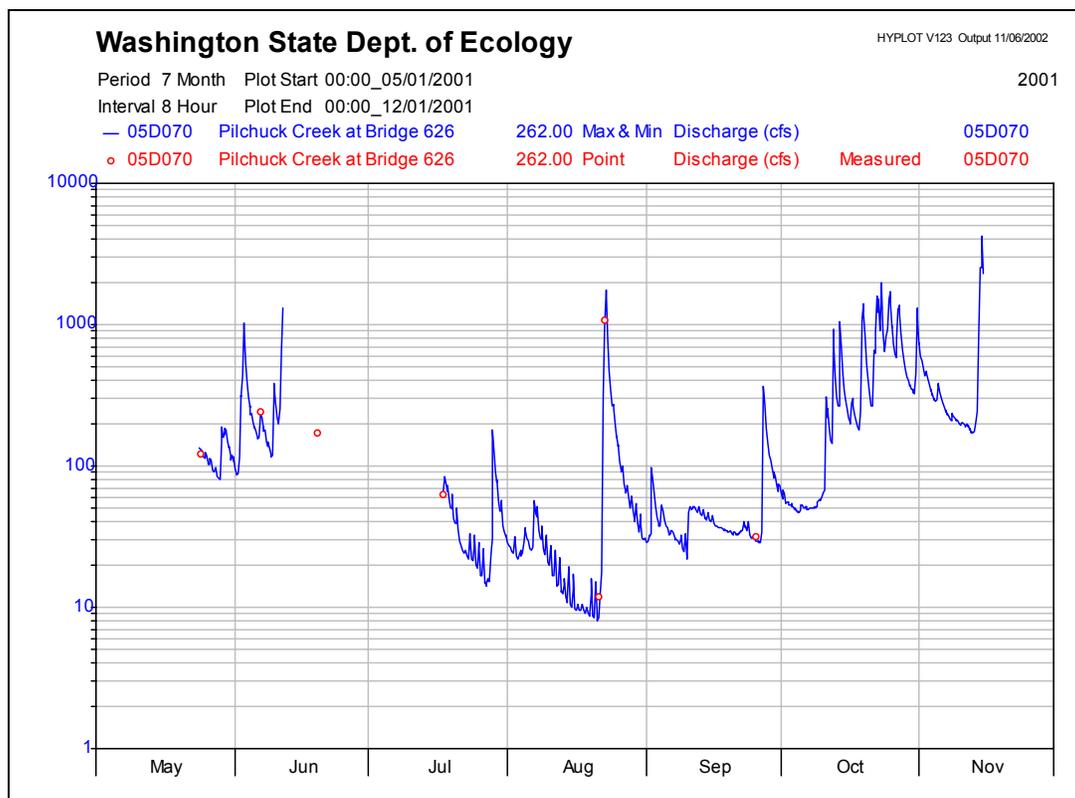
Figure 19: Discharge hydrograph for Site 5.

The average daily discharge for Site 5 ranged from 9.5 cfs in mid-August to 1,740 cfs during a storm event in mid-November. Peak flow during the study period was 3,970 cfs on November 14 (Figure 19). Daily discharge averages are presented in Appendix B, Table 5. The rating curve encompassed only 27 percent of the range of flows encountered during the study period, with flow measurements ranging from 12 cfs to 1,080 cfs (Figure 20). However, discharge exceeded the rating curve only 2% of the time during the study period (Figure 21). The rating curve, a polynomial regression of discharge versus pressure transducer readings, had an  $r^2$  of 0.999. Out of seven discharge measurements conducted at this station during the study period, six were within 10% of the flow predicted by the rating curve, and four were within 5% of the flow predicted by the rating curve. The linear regression of staff gage readings versus pressure transducer readings was strong throughout the range, with an  $r^2$  of 1.00 (Figure 22). The overall trend in streamflow at Site 5 reflects a typical dry-period decline in discharge, with the exception of several small storm events occurring at various times throughout the study period, and the water year peak event occurring in late August. The rise in flows with the onset of fall rains began in early- to mid-October.

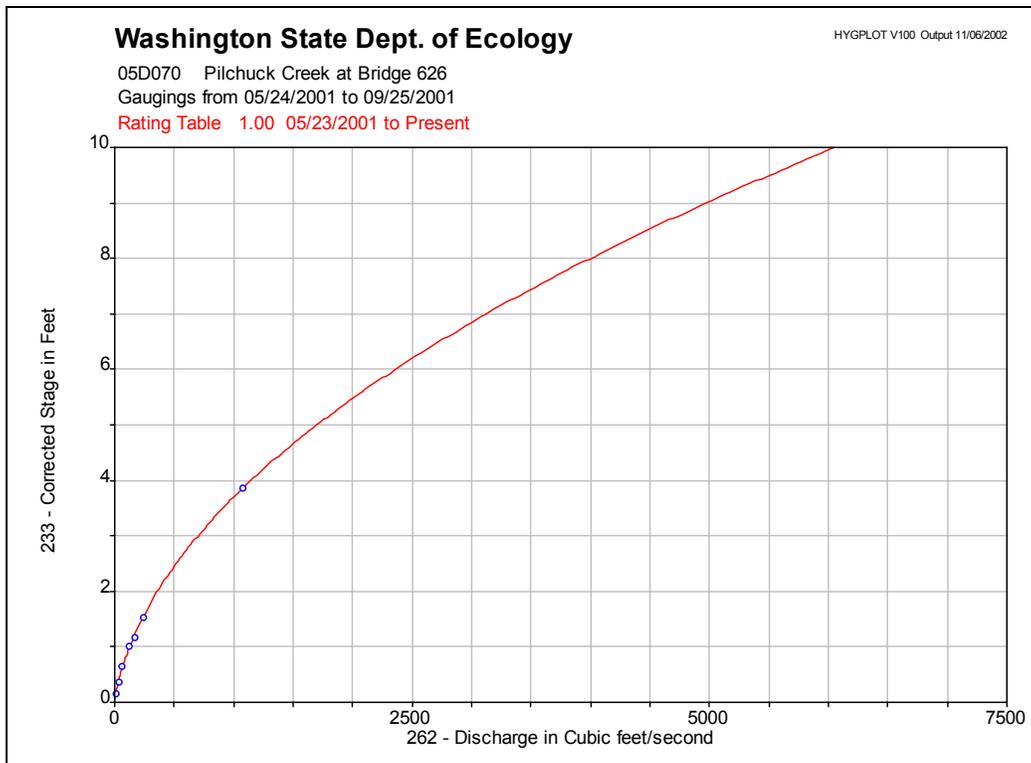
**Figure 20: Discharge rating curve for Site 5.**

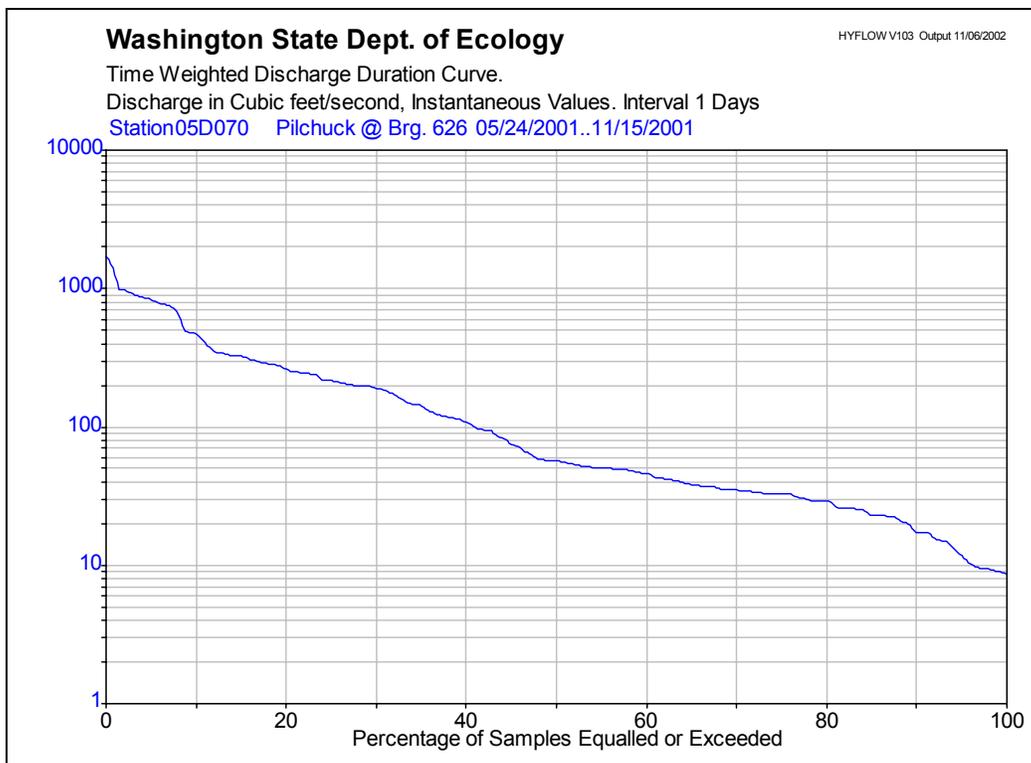
**Figure 21: Flow exceedence graph for Site 5.**

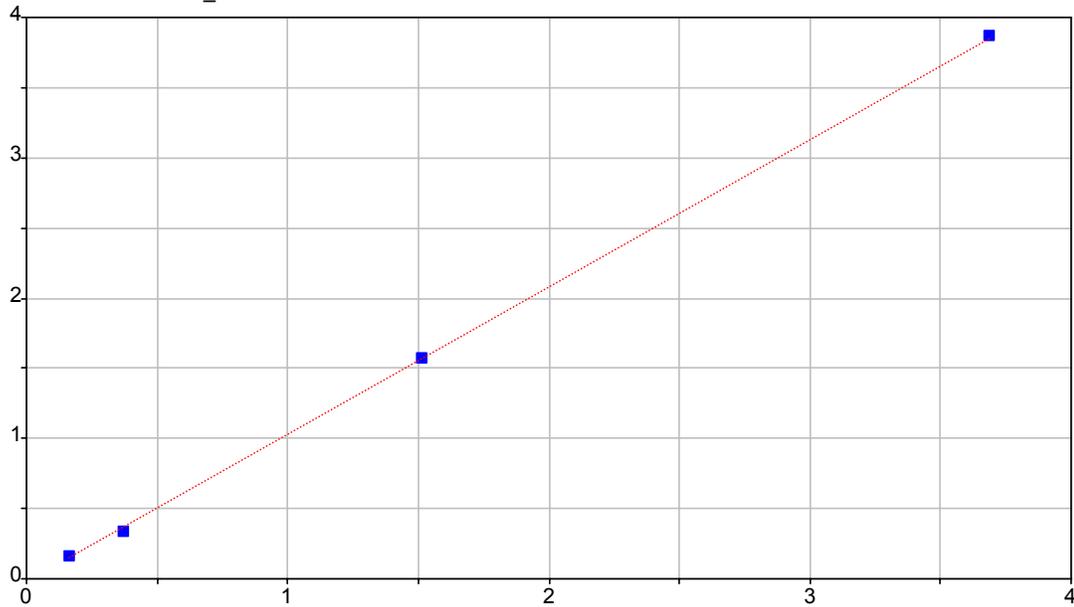
Axis	Transform	Station	Type	Variable
X (ind)	(None)	05D070	Inst.	Raw Stage in Feet
Y (dep)	(None)	05D070	Point	Corrected Stage in Feet
Interval	1 Day		Equation	$Y = 1.050 * X - 0.024$
Start	00:00_05/25/2001		Correlation Coefficient	1.000
End	10:15_09/25/2001		Standard Error of Estimate	0.043

**Figure 22: Linear regression of staff gage versus pressure transducer readings for Site 5.**

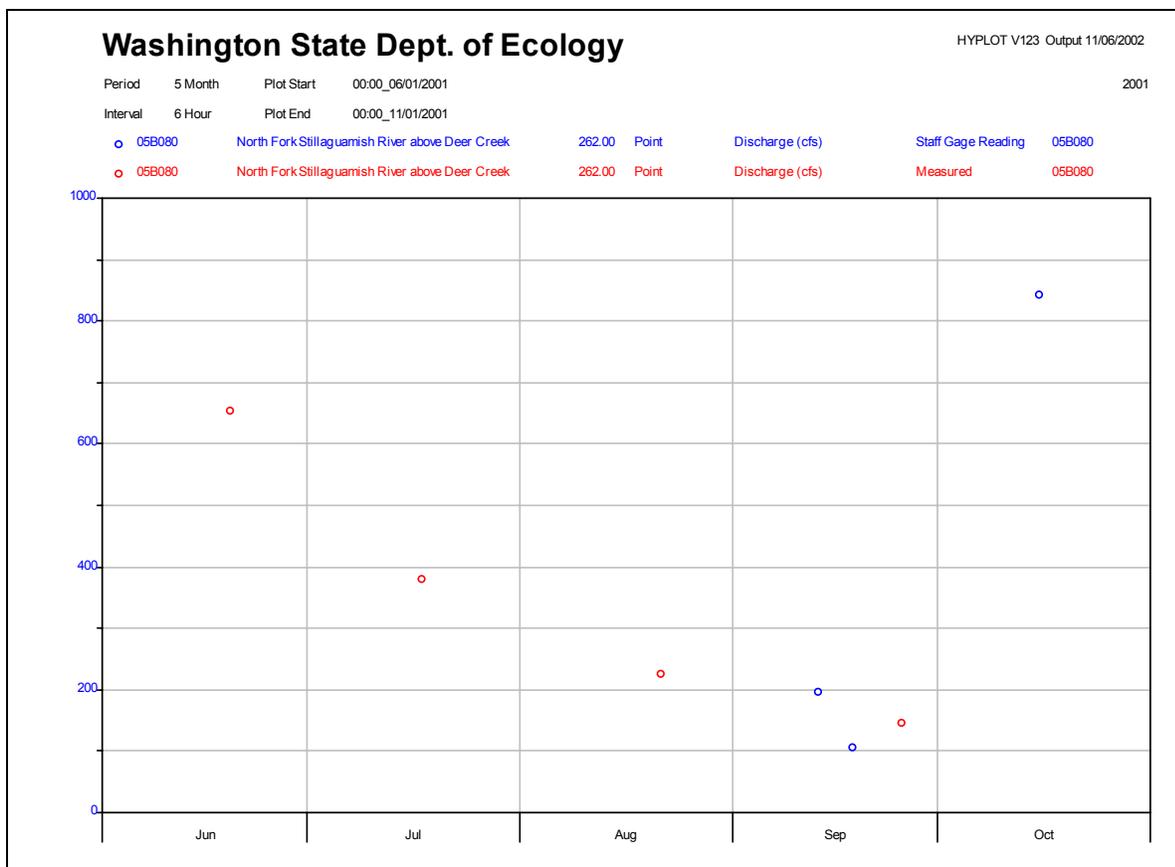
Figure 23: Discrete flow hydrograph for Site 6.

Continuous data collection was not conducted at Site 6. Instead, a rating curve was developed, and used to derive flows from stage readings taken during temperature sampling visits by Watershed Ecology Section staff. The stage index for this site was derived from a reference point established on a bridge over the river. River stage readings were taken by measuring from the reference point down to the water surface. Thus, as the river rose, the distance from the reference point to the water surface would decrease, and vice versa. Flows encountered during the study period ranged from just over 100 cfs in mid-September to over 840 cfs in mid-October (Figure 23). The rating curve encompassed nearly 70% of the range of flows encountered during the study period, with flow measurements ranging from 145 cfs to 655 cfs (Figure 24). The linear regression of discharge versus distance to water surface measurements had an  $r^2$  of 0.999. All four discharge measurements conducted at the site during the study period were within 5% of the flow predicted by the rating curve. The overall trend in streamflow at Site 6 seems to be a typical dry-period decline in discharge. The storm events that occurred in each of the months of June through September were not measured, nor was temperature sampling conducted during those periods.
