# **Flow Summary for Gaging Stations on the Stillaguamish River and Selected Tributaries**

## **May through October 2001**

Publication No. 03-03-019

*by  
Chuck Springer*

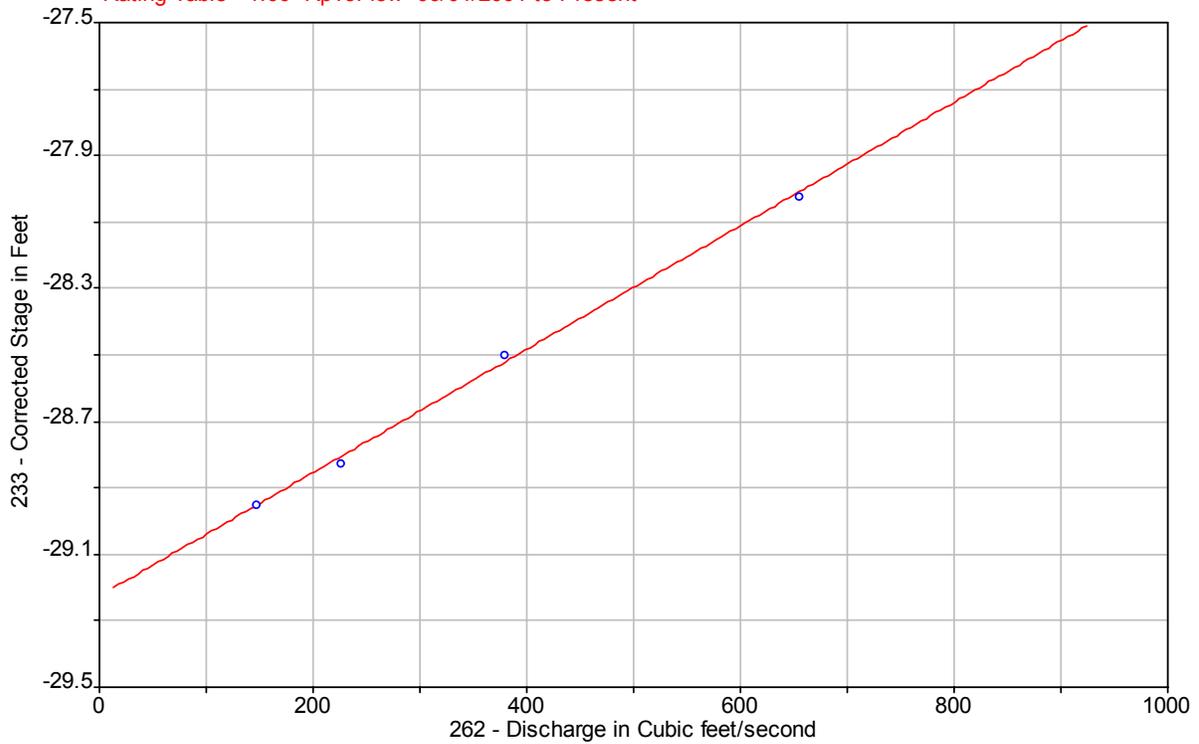
05B080 North Fork Stillaguamish River above Deer Creek

Gaugings from 06/19/2001 to 09/25/2001

**Figure 24: Discharge rating curve for Site 6.**

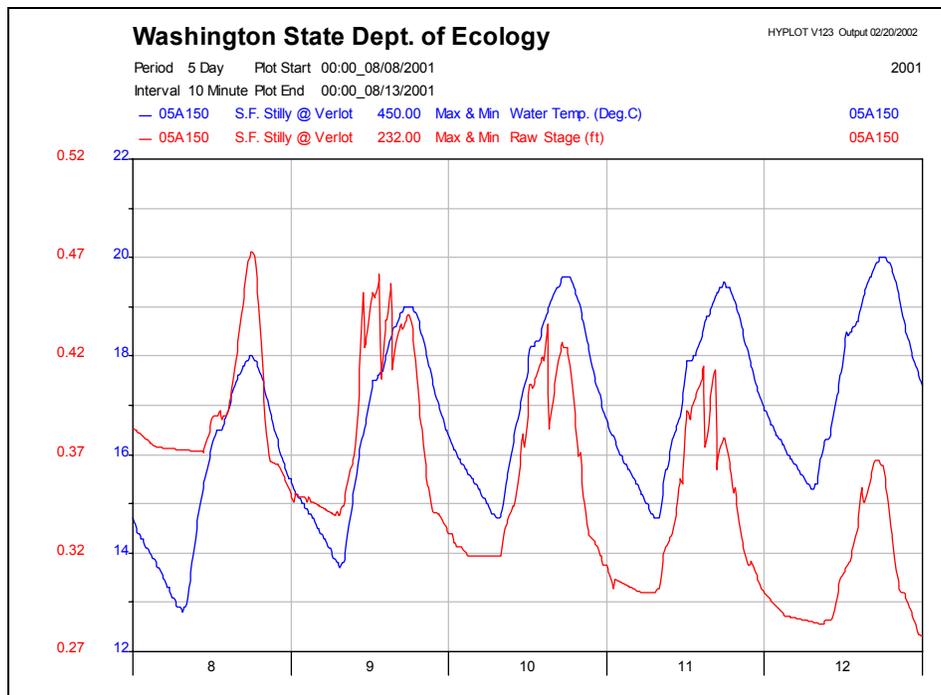
**Figure C-1: Diurnal water stage and temperature cycles during August 8-12, 2001.**

During one distinct five-day time period of the study period (August 8-12), a diurnal cycle in stage readings was encountered at Site 2: S.F. Stillaguamish R. at Verlot. During these days, river stage reached a minimum around 6:00 a.m. and peaked around 6:00 p.m. This cycle was closely correlated with the diurnal water temperature cycle (Figure C-1), with  $r^2$  values for individual days ranging from 0.68 to 0.84 (Figure C-2). The diurnal fluctuations in discharge ranged from 35 to 40 cfs.

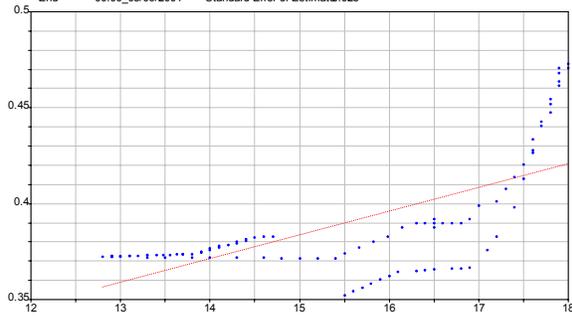
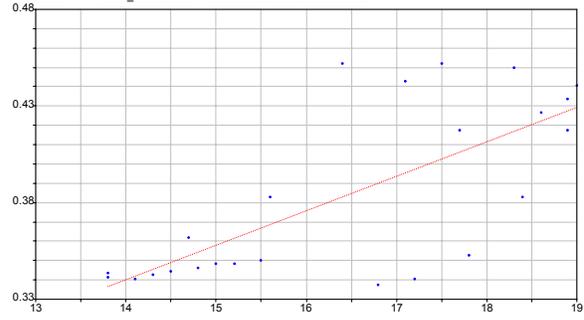
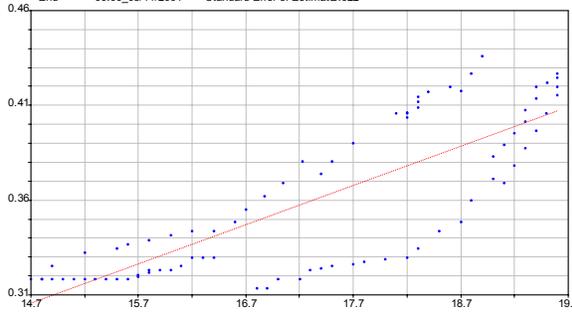
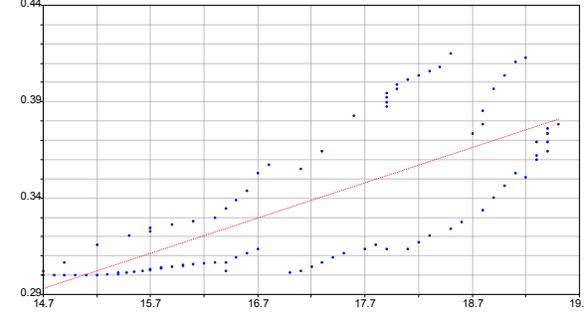
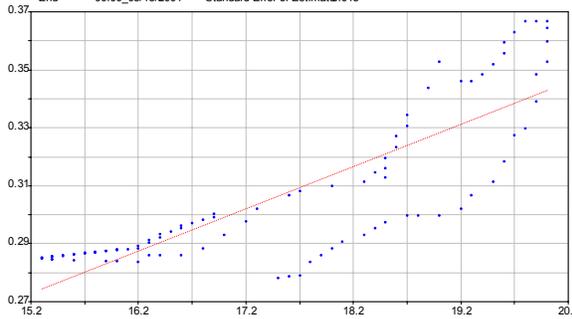
**Figure C-2: Water stage versus temperature regressions for Site 2 - August 8-12, 2001.**

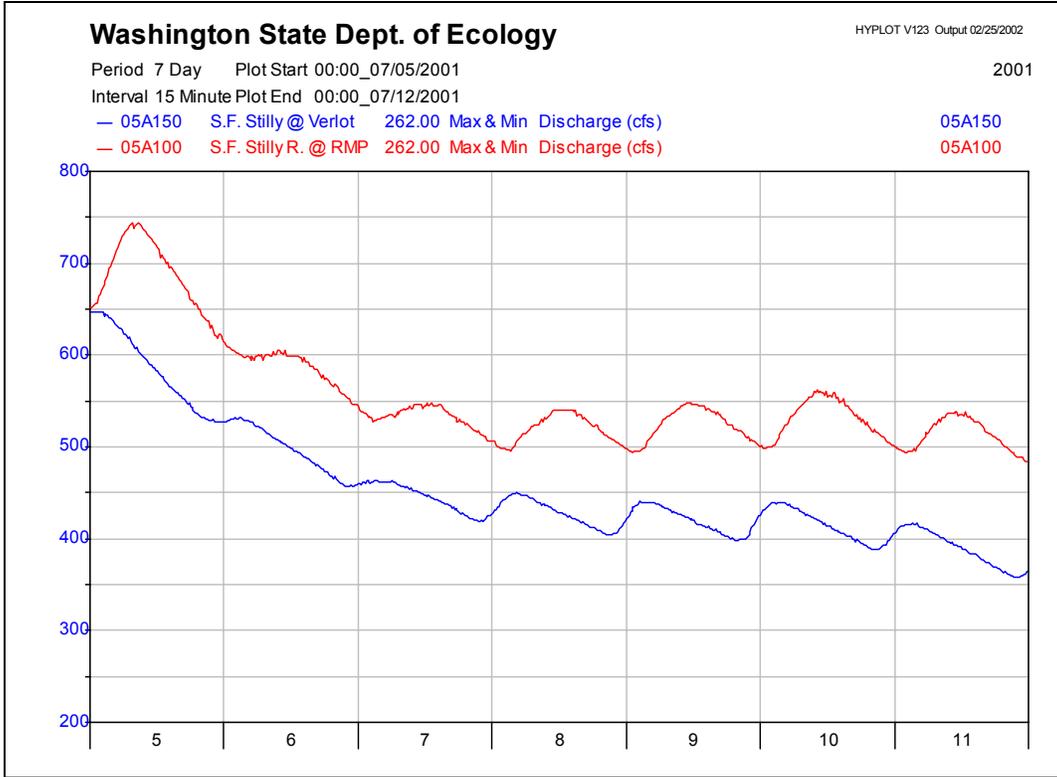
**Figure C-3: Comparison of Sites 2 and 3 during seven days in July, 2001.**

To further analyze this pattern, data for this station were compared with a downstream station; S.F. Stillaguamish R. at River Meadows Park (Site 3). During most of the study period, streamflow data collected from Site 3 closely follows that collected from Site 2, with a time-of-travel delay of approximately 8 hours during low-flow conditions. Data for the two sites were compared during two periods of apparent diurnal cycles: July 5-11, 2001 and August 8-12, 2001. During the first period (July 5-11), the rise and fall cycles in stage at Site 2 are followed by a corresponding rise and fall in stage at Site 3 (Figure C-3). However, during the second period (August 8-12), there is no corresponding cyclical rise and fall in stage at Site 3 following the diurnal rise and fall cycles in stage at Site 2 (Figure C-4). This leads the author to believe that the apparent diurnal cycle at Site 2 during August 8-12 was actually sensor error, most likely caused by the formation of an air pocket near the diaphragm of the pressure transducer. Such a scenario would result in a temperature-related diurnal cycle in pressure readings caused by thermal expansion and contraction of the air pocket. The heavy bedload present in the water column may have facilitated the dissipation of the air pocket after a short period of time, thus resuming a normal pattern in river stage.

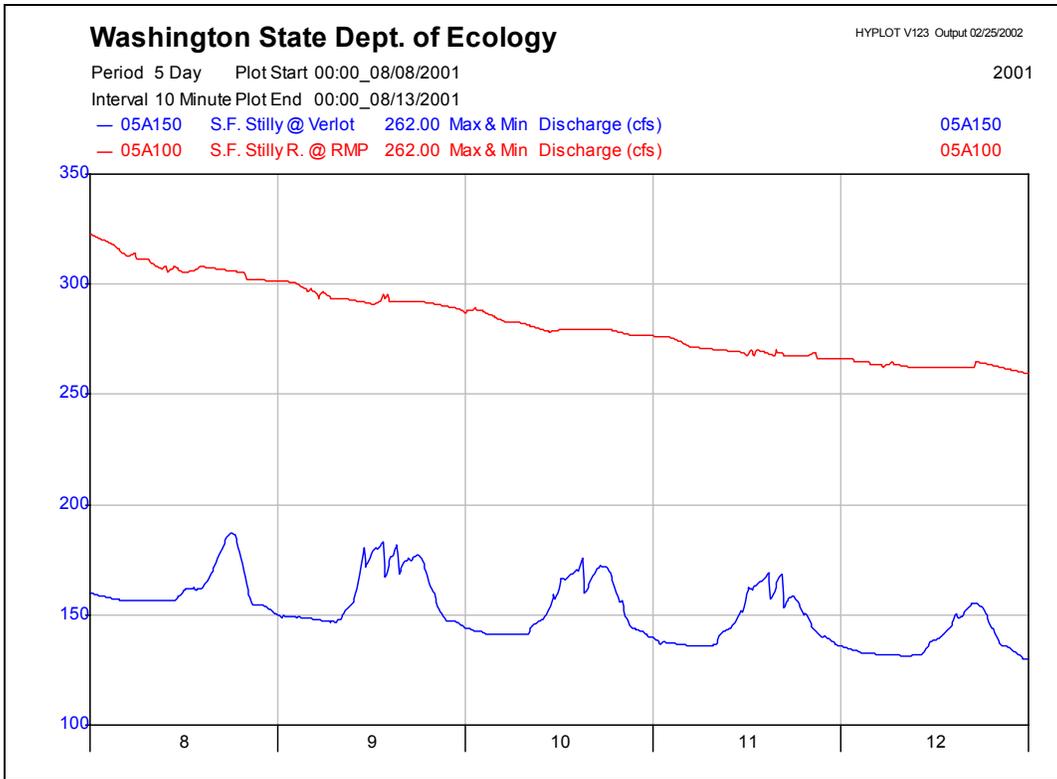
**Figure C-4: Comparison of Sites 2 and 3 during five days in August, 2001.**
