# Eyes Over Puget Sound

## Surface Conditions Report, July 15, 2013

*Up-to-date observations of visible water quality conditions in Puget Sound and the Strait of Juan de Fuca*

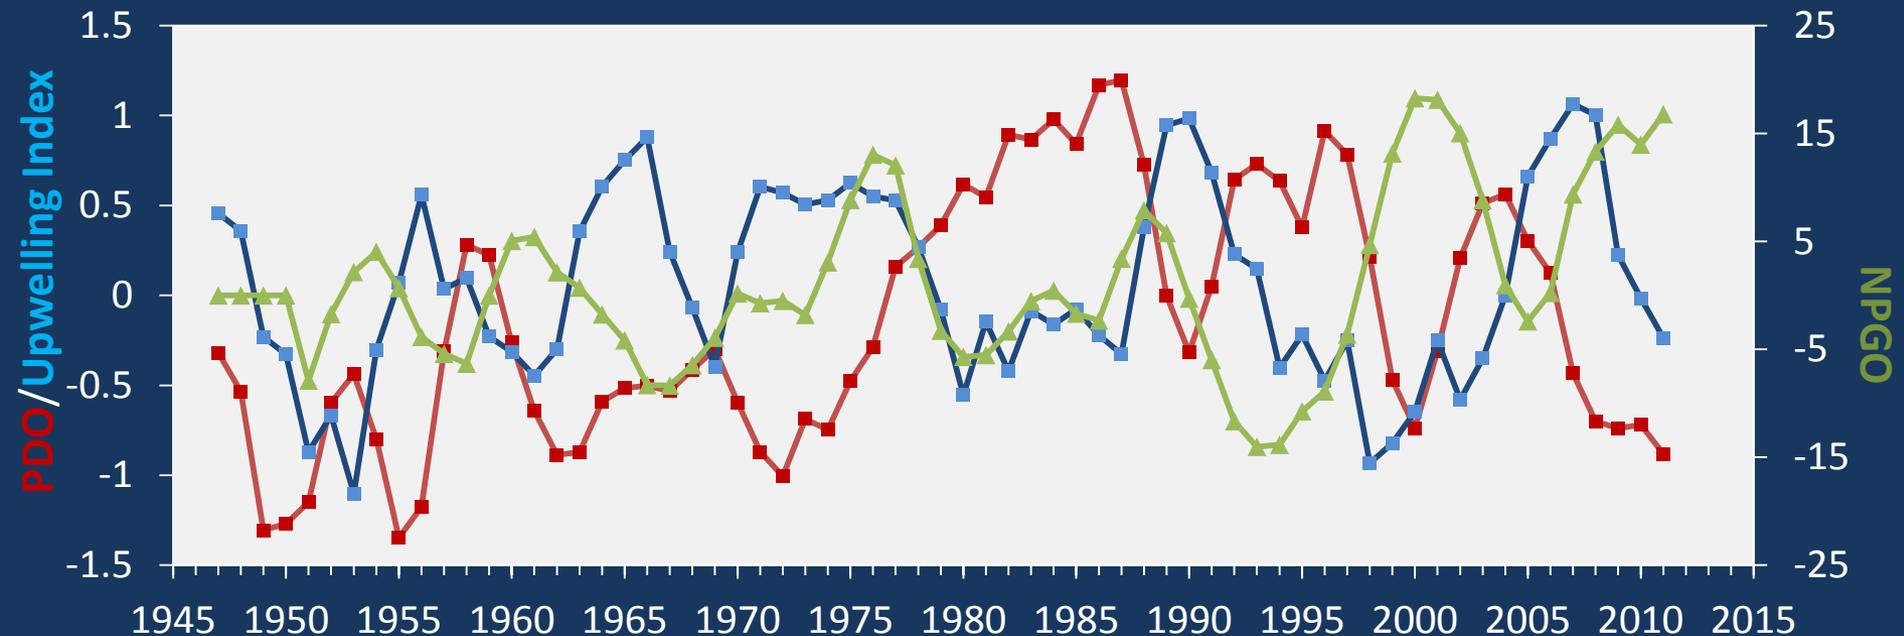
## Three-year running average of PDO, Upwelling, and NPGO indices scores

Ocean boundary conditions have been favorable for water quality in Puget Sound: (a) colder water (PDO), (b) less upwelled low oxygen and high nutrient ocean water reaching Puget Sound (Upwelling Index), and (c) higher surface productivity along the coast (NPGO). Where are we heading next?

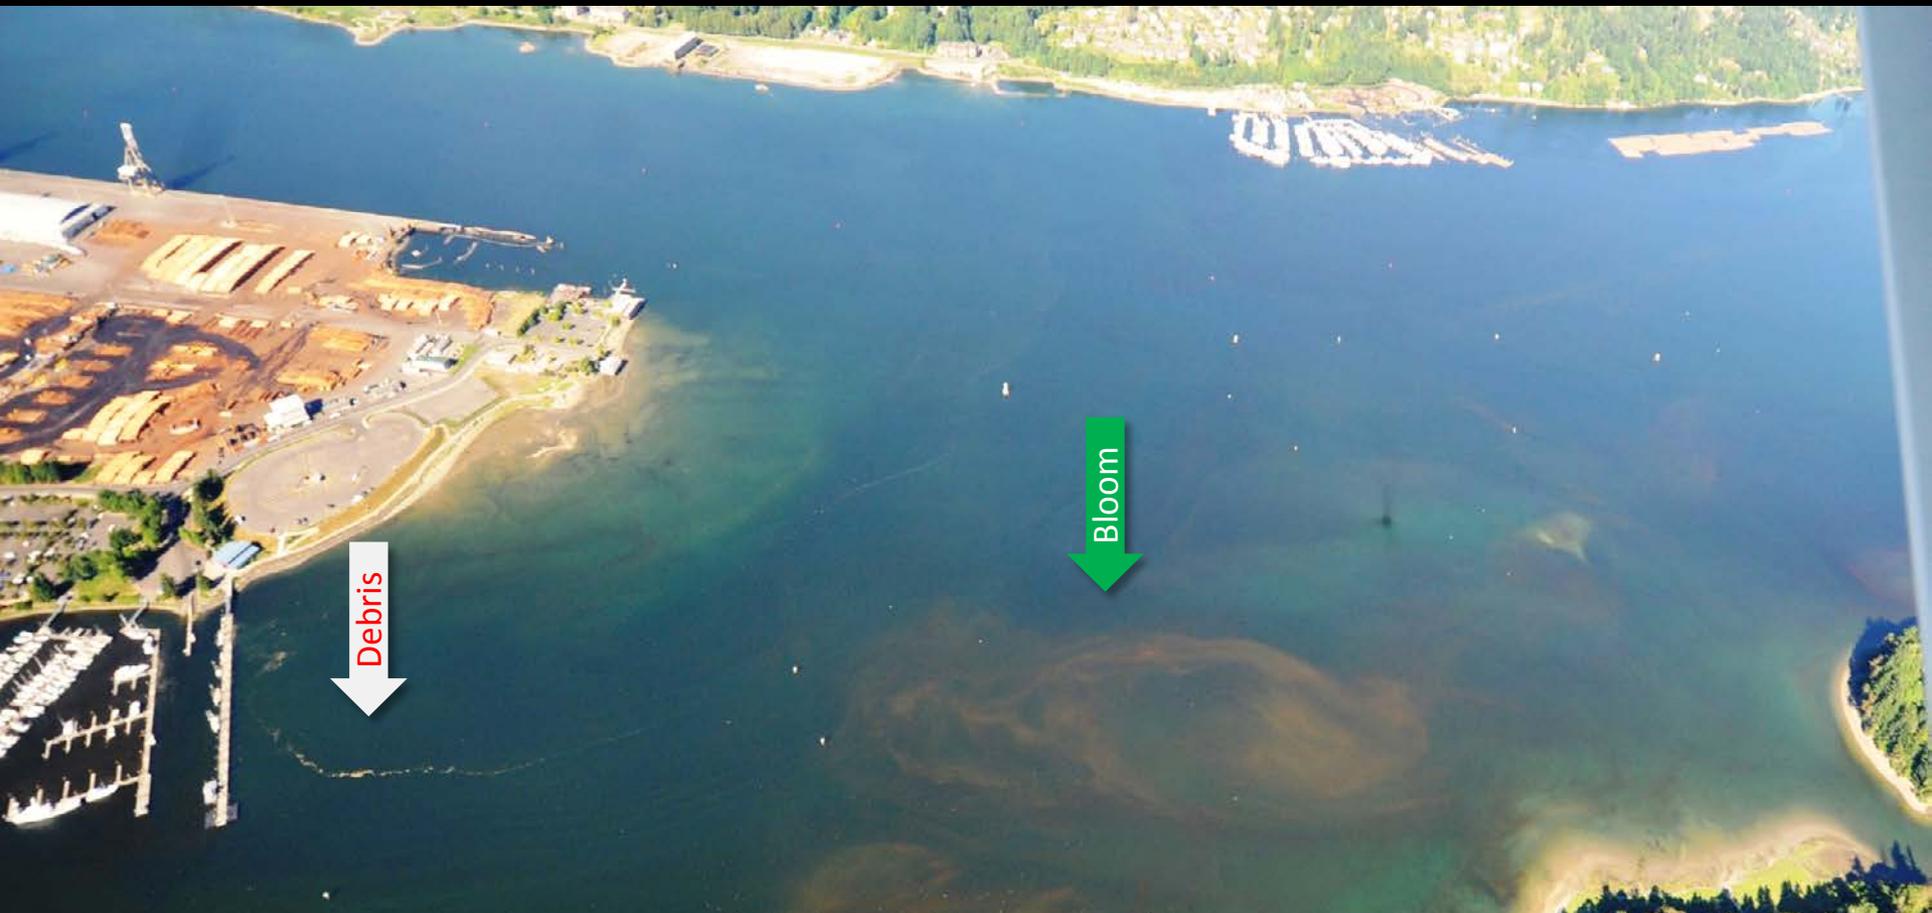
Location: Swantown Marina (Budd Inlet, South Sound), 9:39 AM.

*Red-brown bloom and organic debris (macroalgae).*

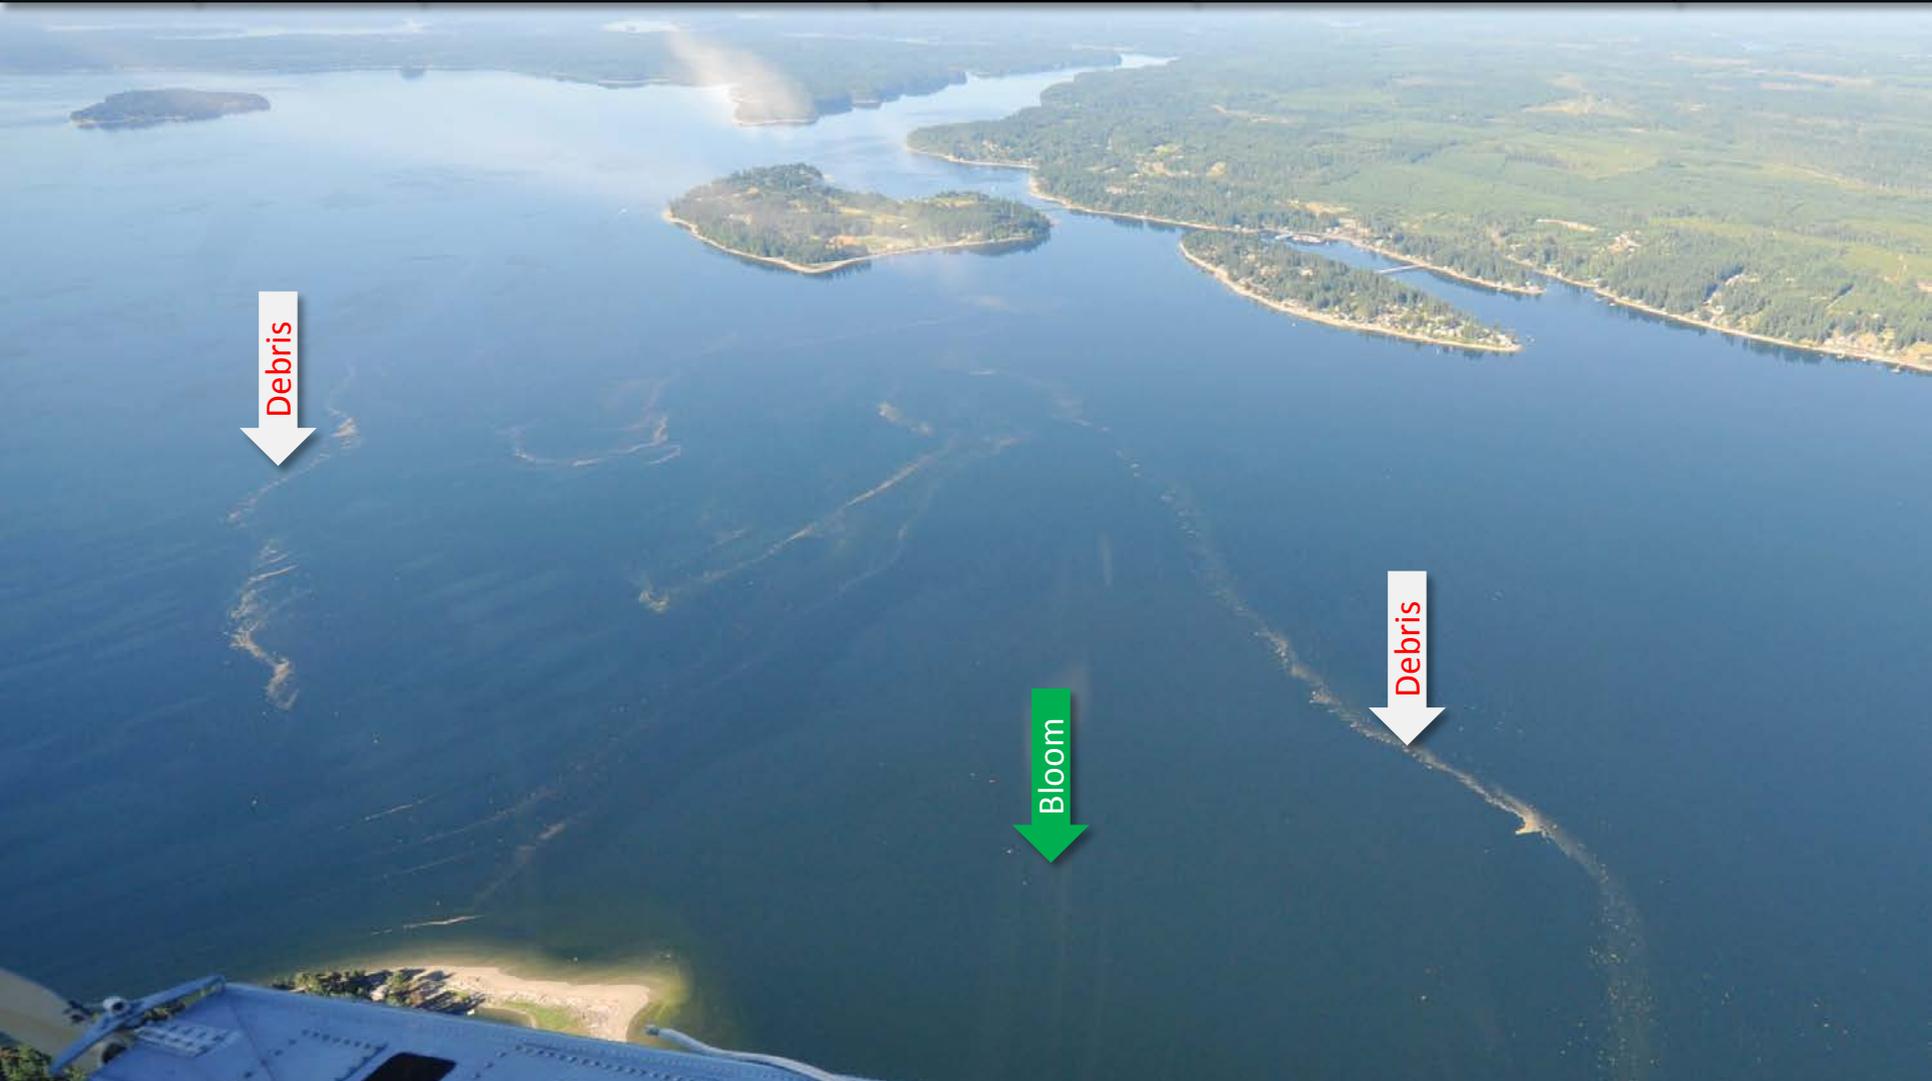
*Large lines of organic surface debris and a weak olive-brown bloom.*  
Location: Case Inlet near Pickering Passage (South Sound), 9:55 AM.

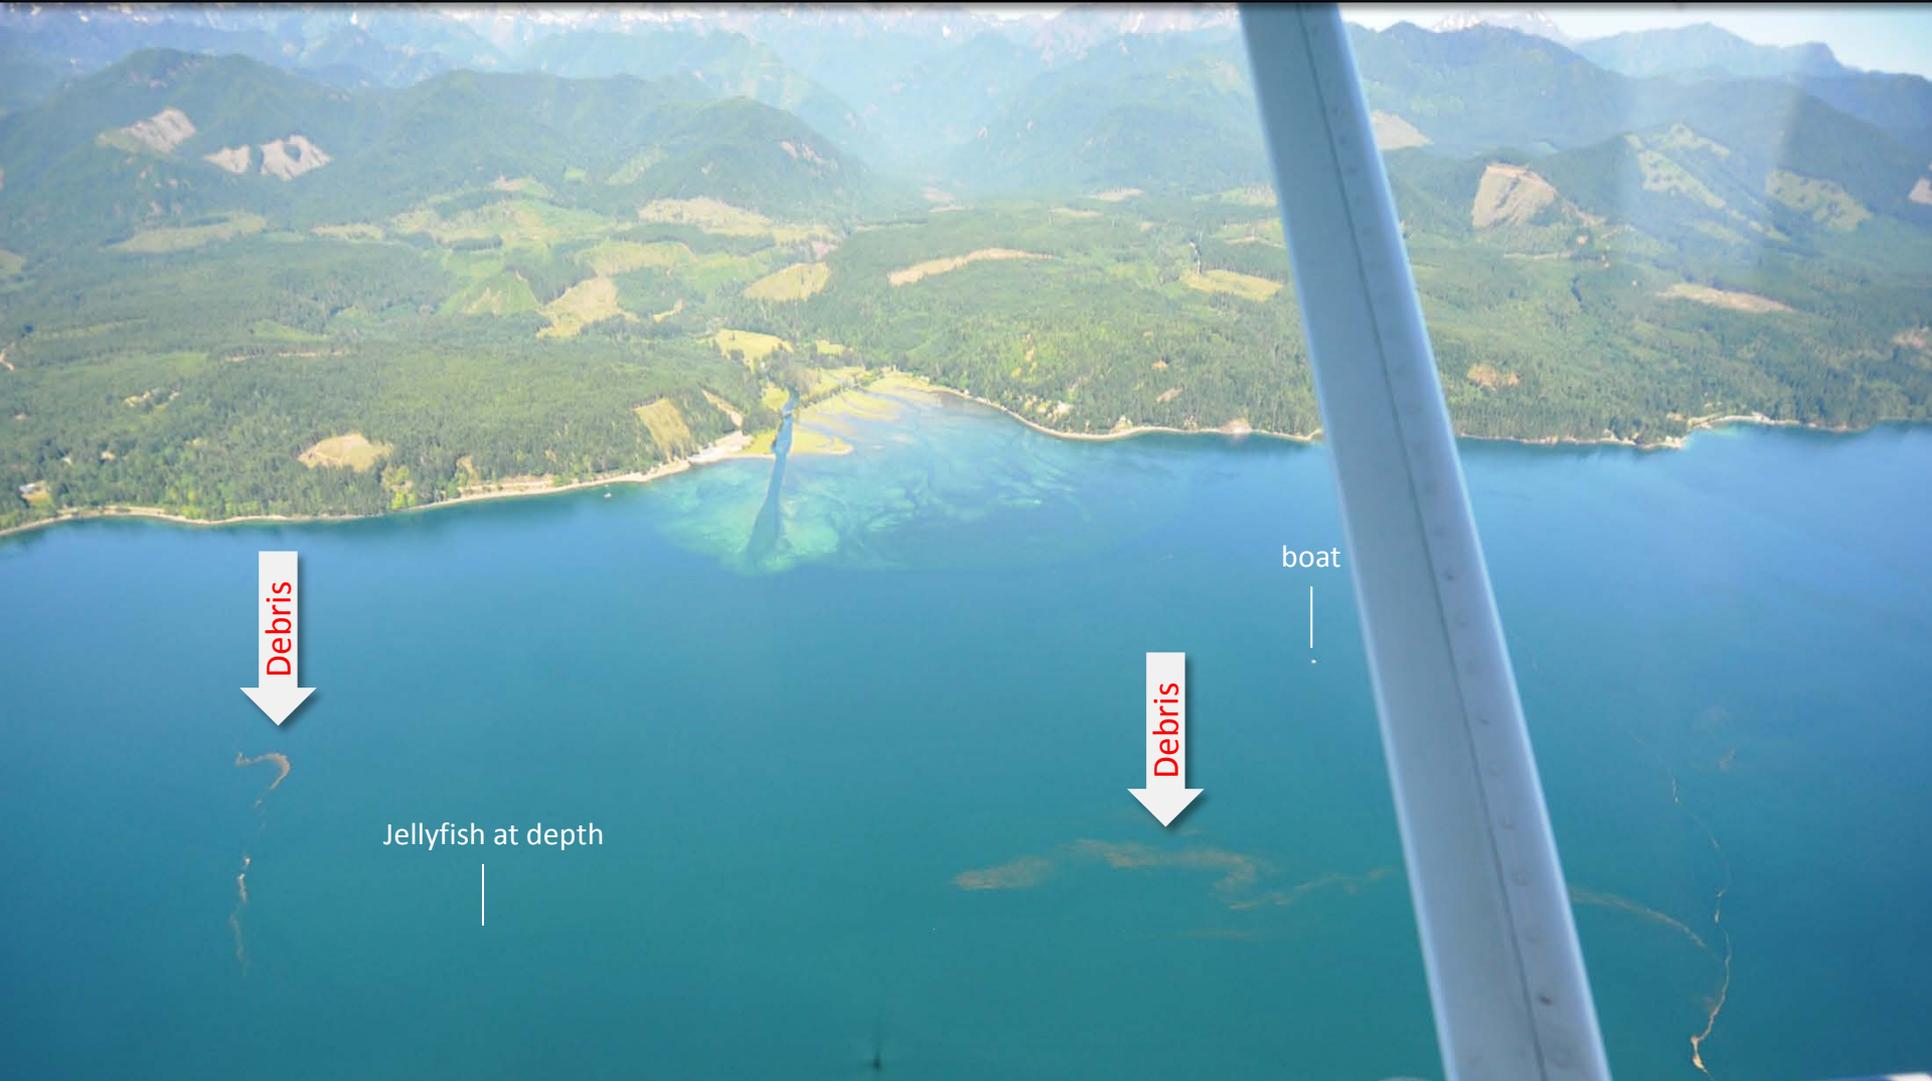
*Large drifting mats of organic material at surface.*  
Location: Hamma Hamma River (Hood Canal), 11:13 AM.

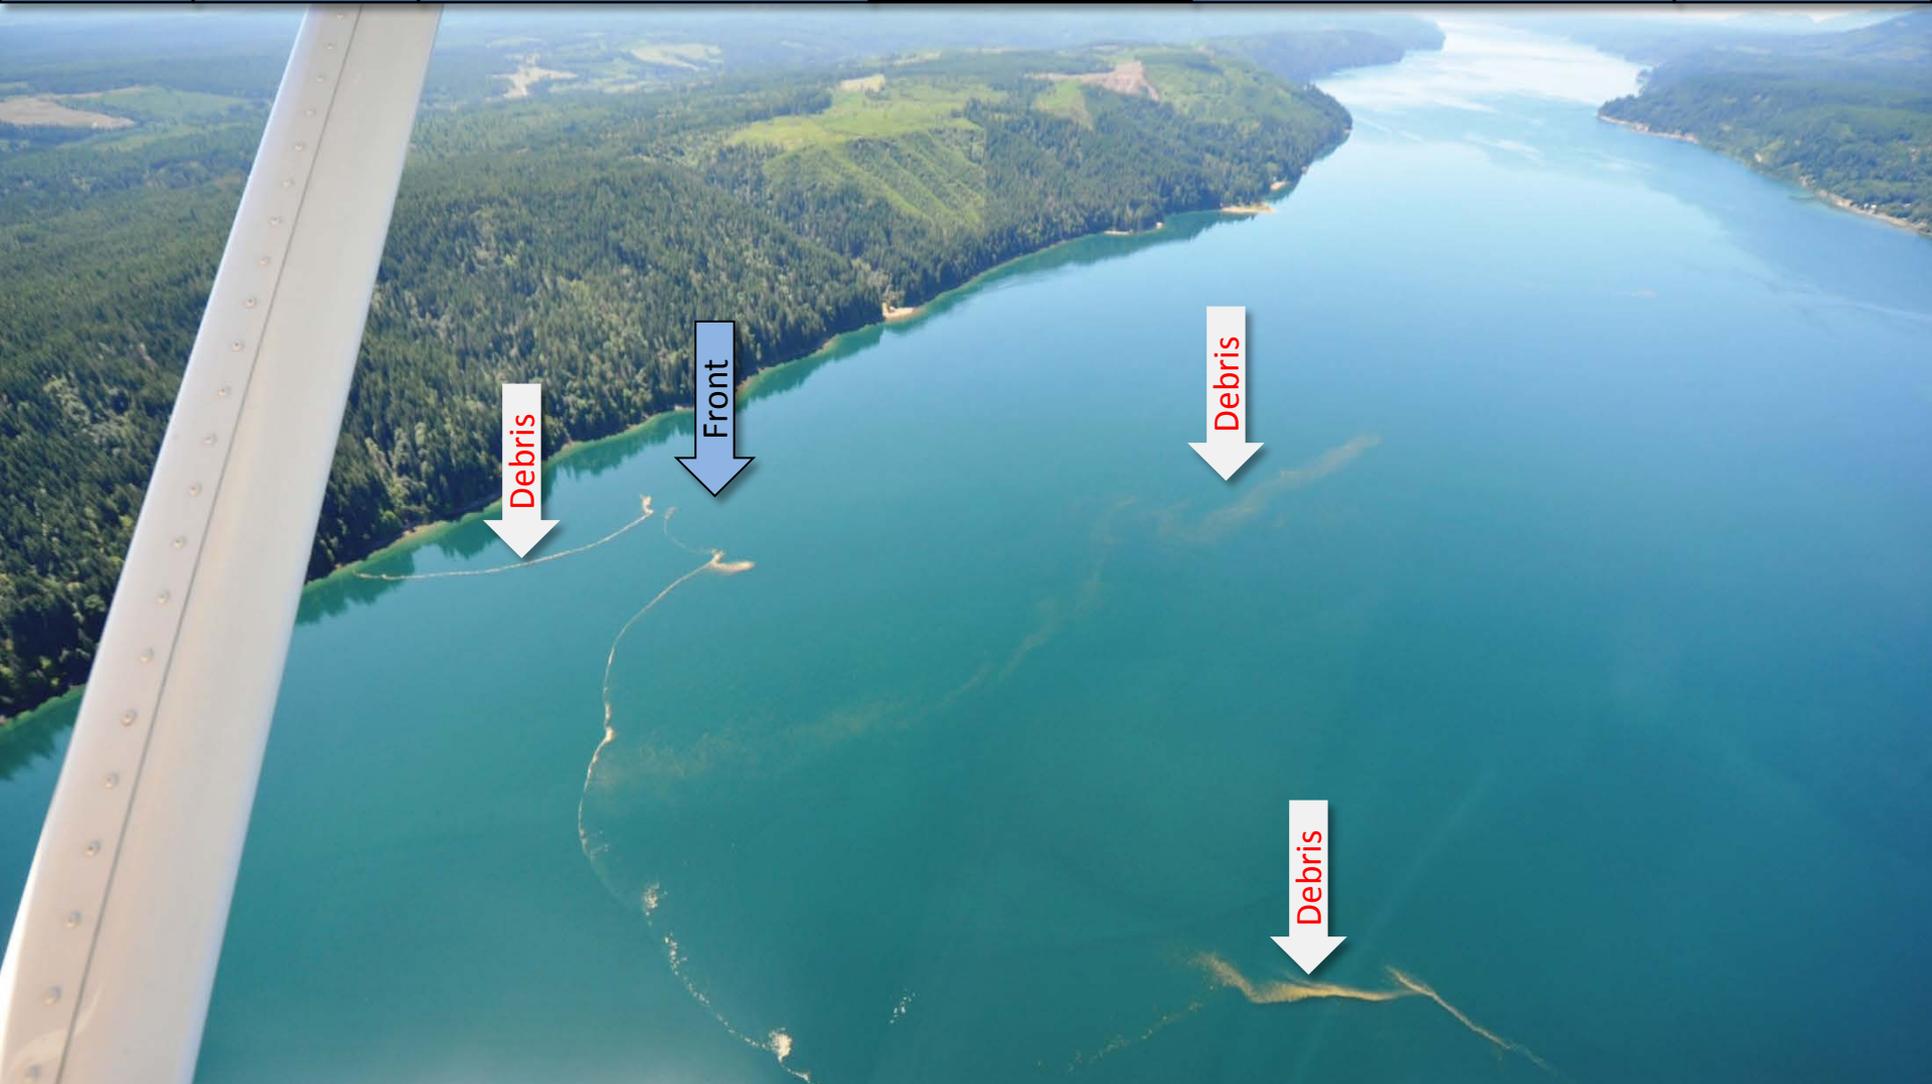
*Large drifting mats of organic material at surface partially delineating a front.*  
Location: Hamma Hamma River (Hood Canal), 11:59 AM.

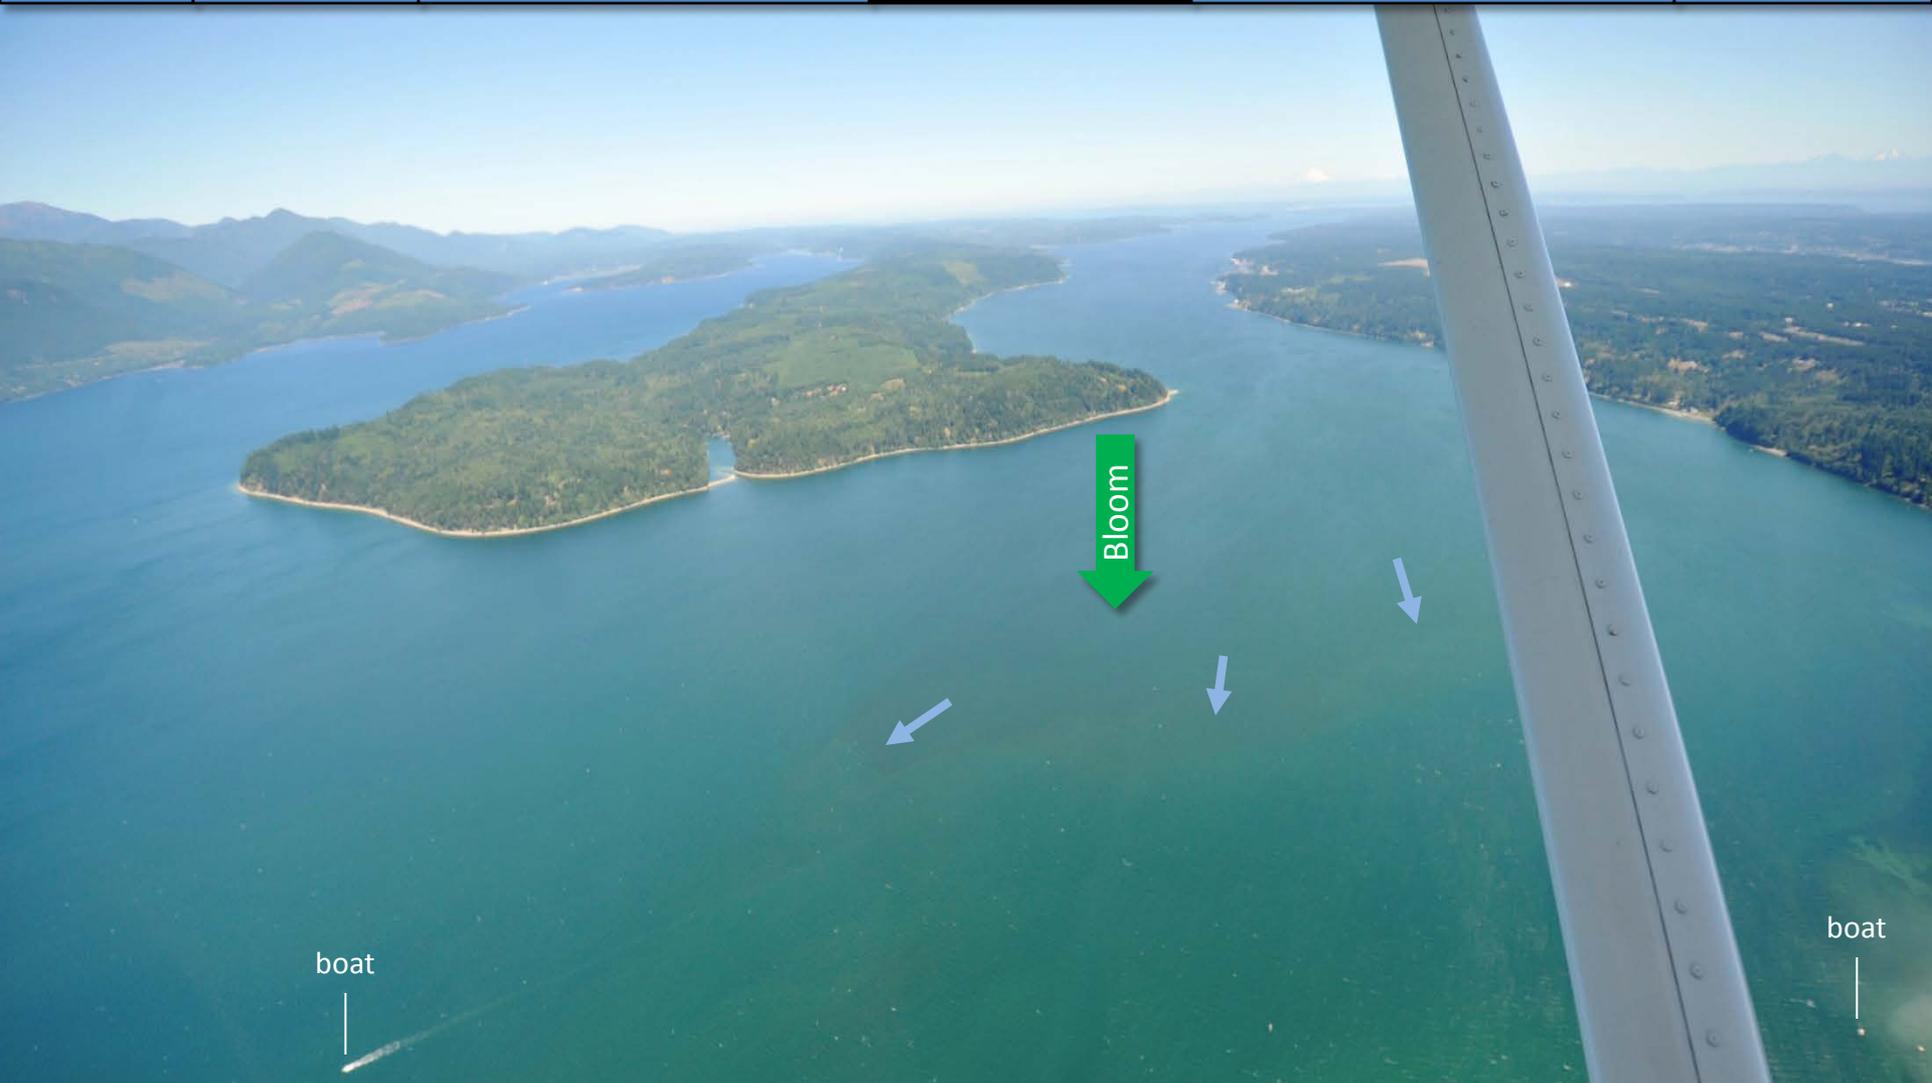
Location: Little Beef Harbor, Dabob Bay (Hood Canal), 12:08 PM.

*Olive-brown water moving in from the north with tides, waves, and strong northerly winds.*

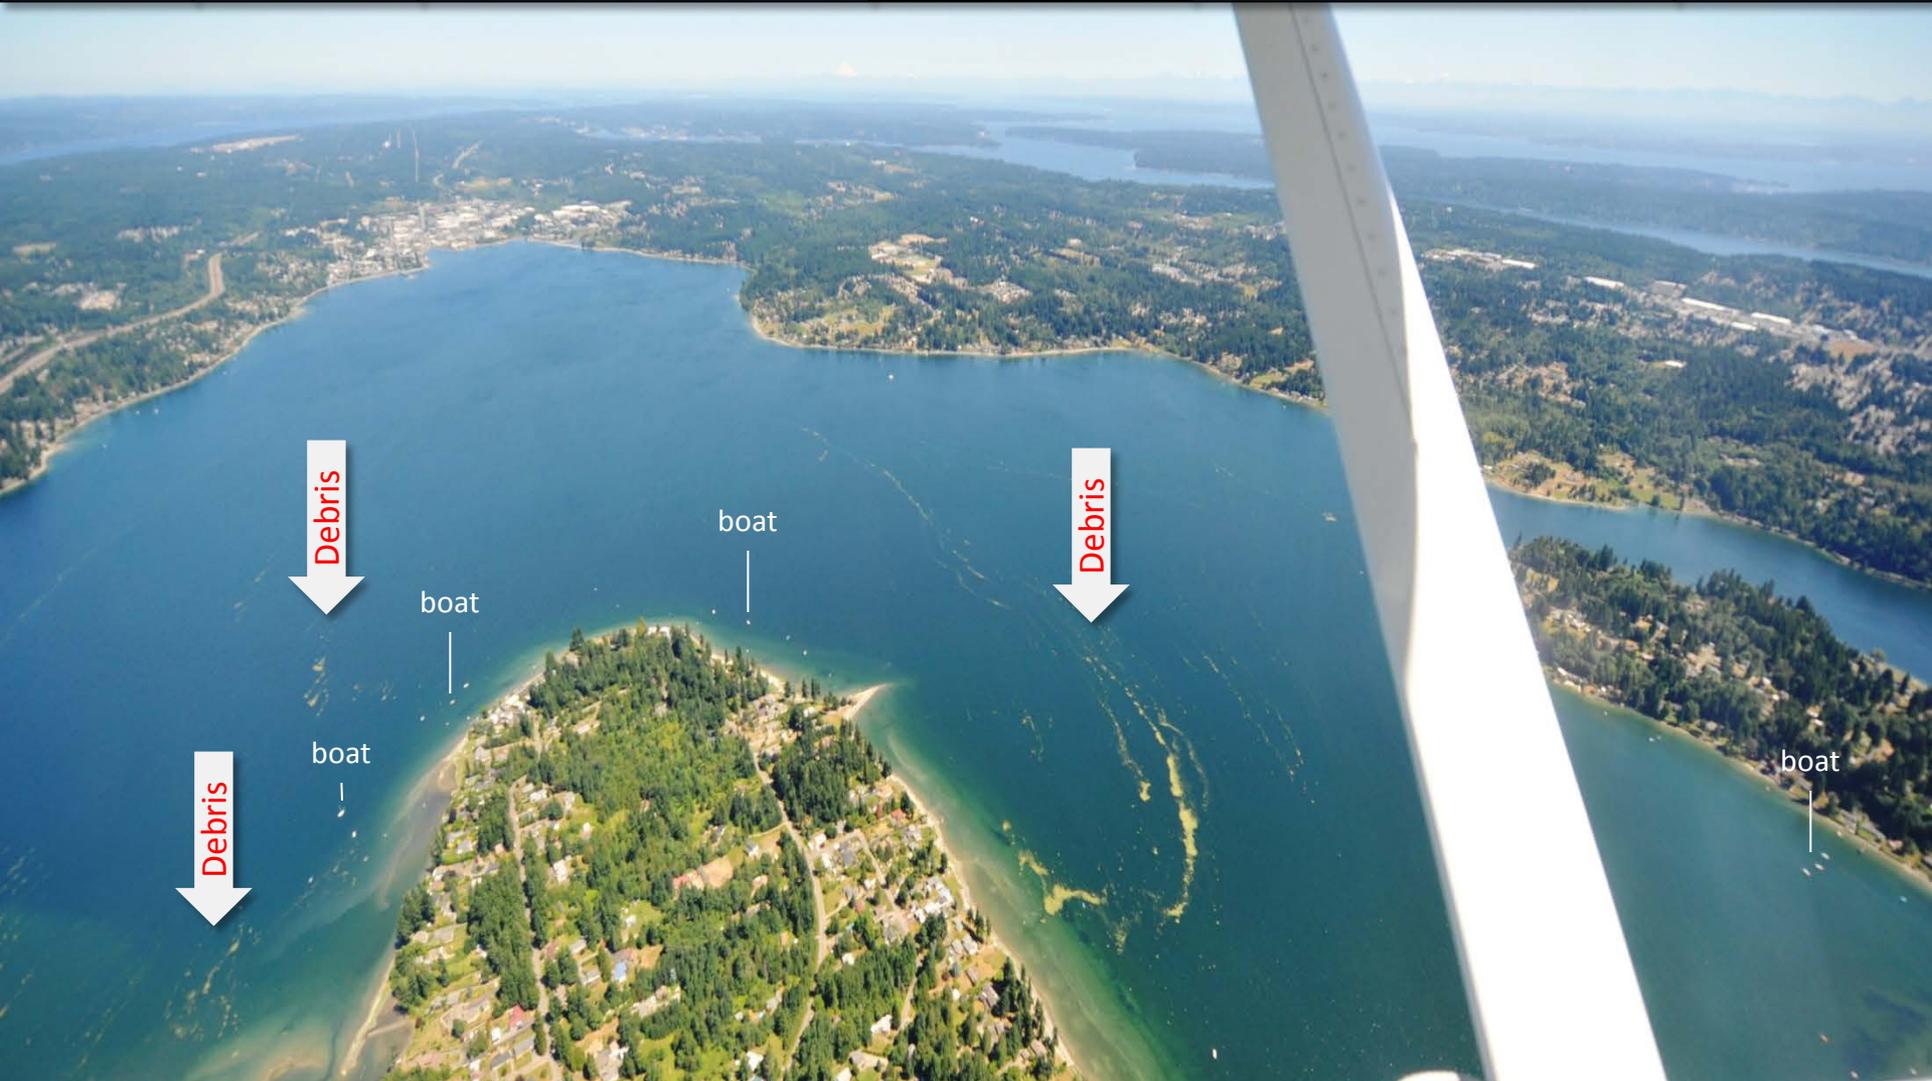
Location: Dyes Inlet (Kitsap Peninsula), 12:11 PM.

*Large debris rafts (algal mats) lining up parallel to wind direction.*

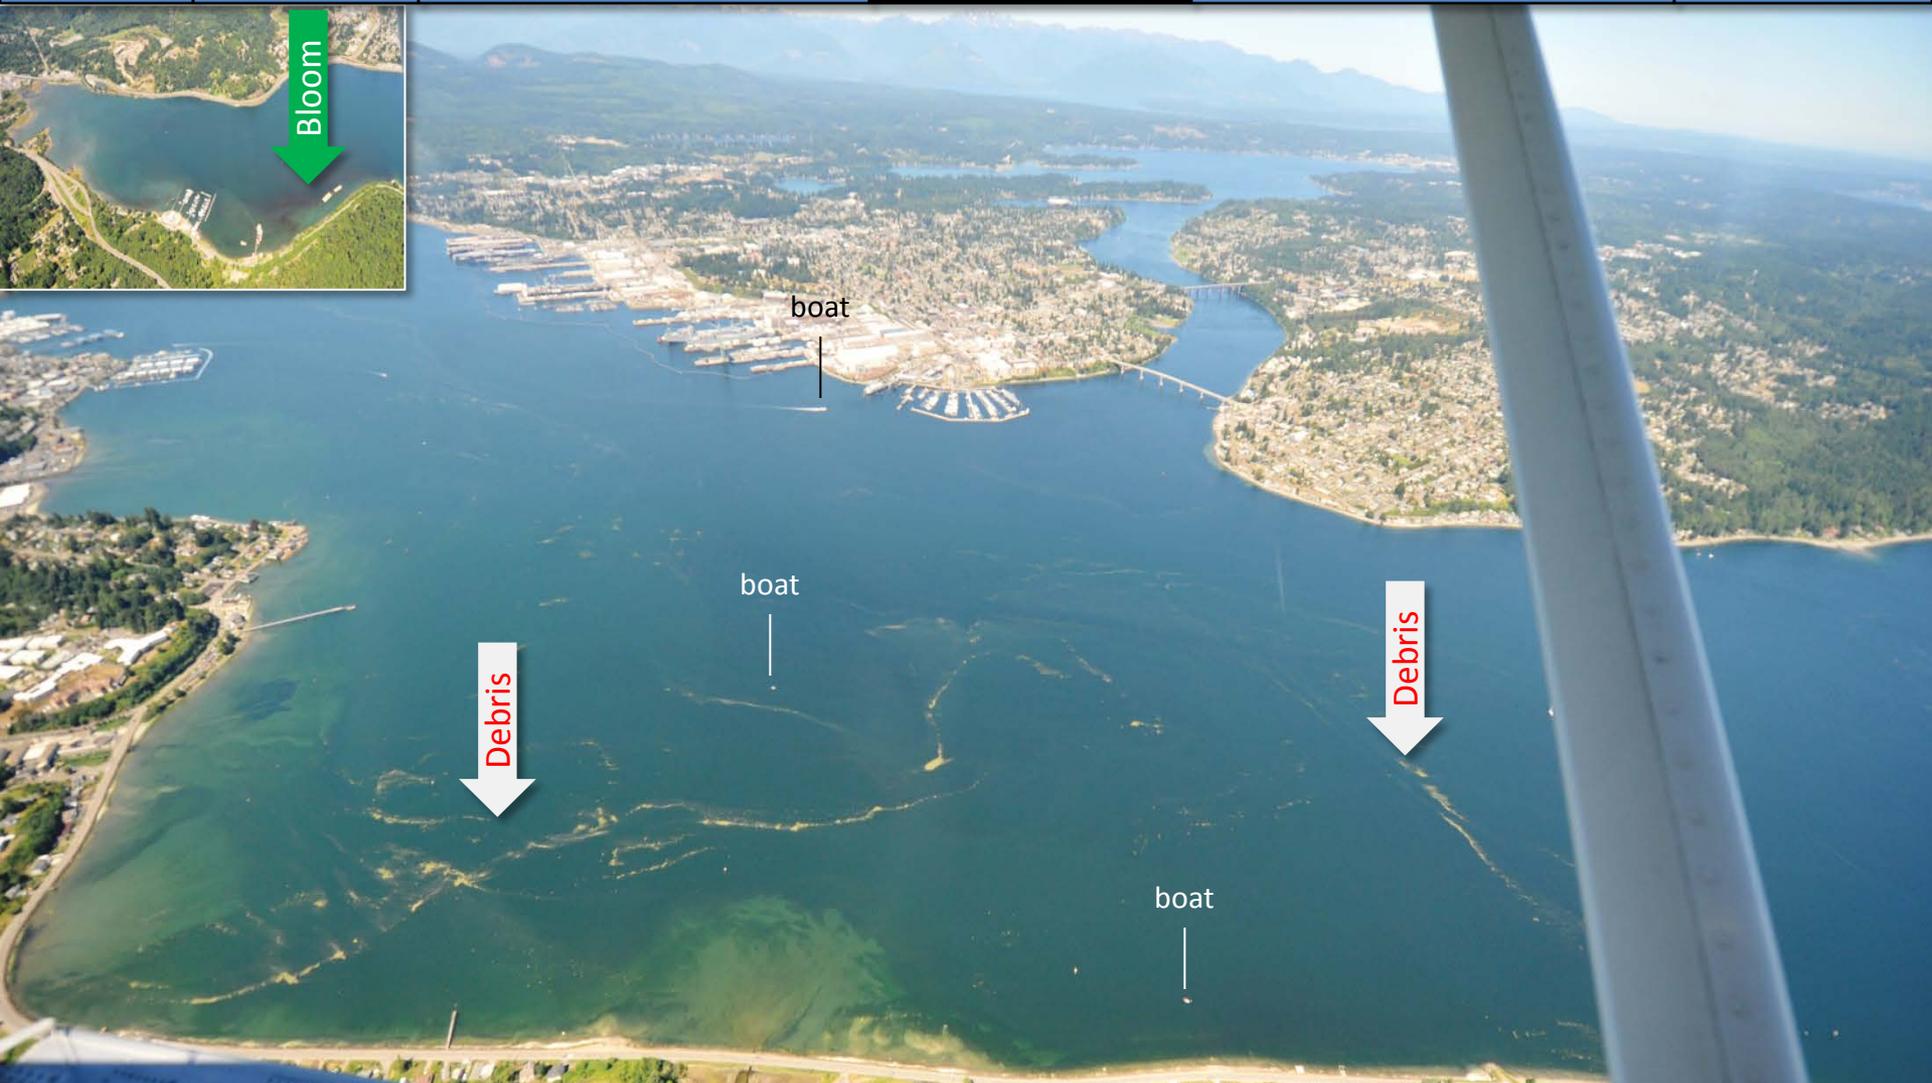
*Large debris rafts (algal mats) following water movement.  
Location: Sinclair Inlet (Kitsap Peninsula), 12:15 PM.*

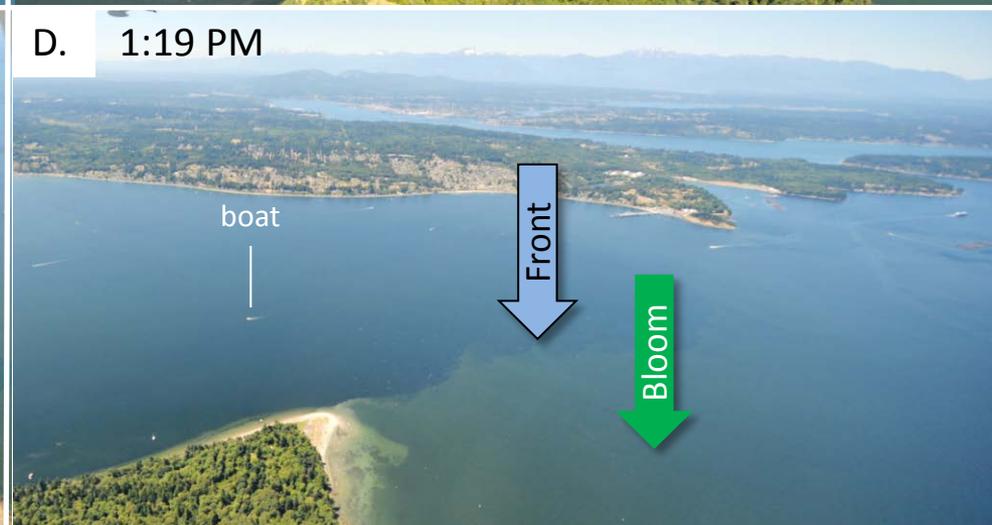
*Location: Near Bainbridge Island (Kitsap Peninsula).*

*Debris rafts and discolored water from blooms show water movement and fronts.*

*A. Sinclair Inlet, B. Agate Passage C. Rich Passage D. Off Blake Island.*

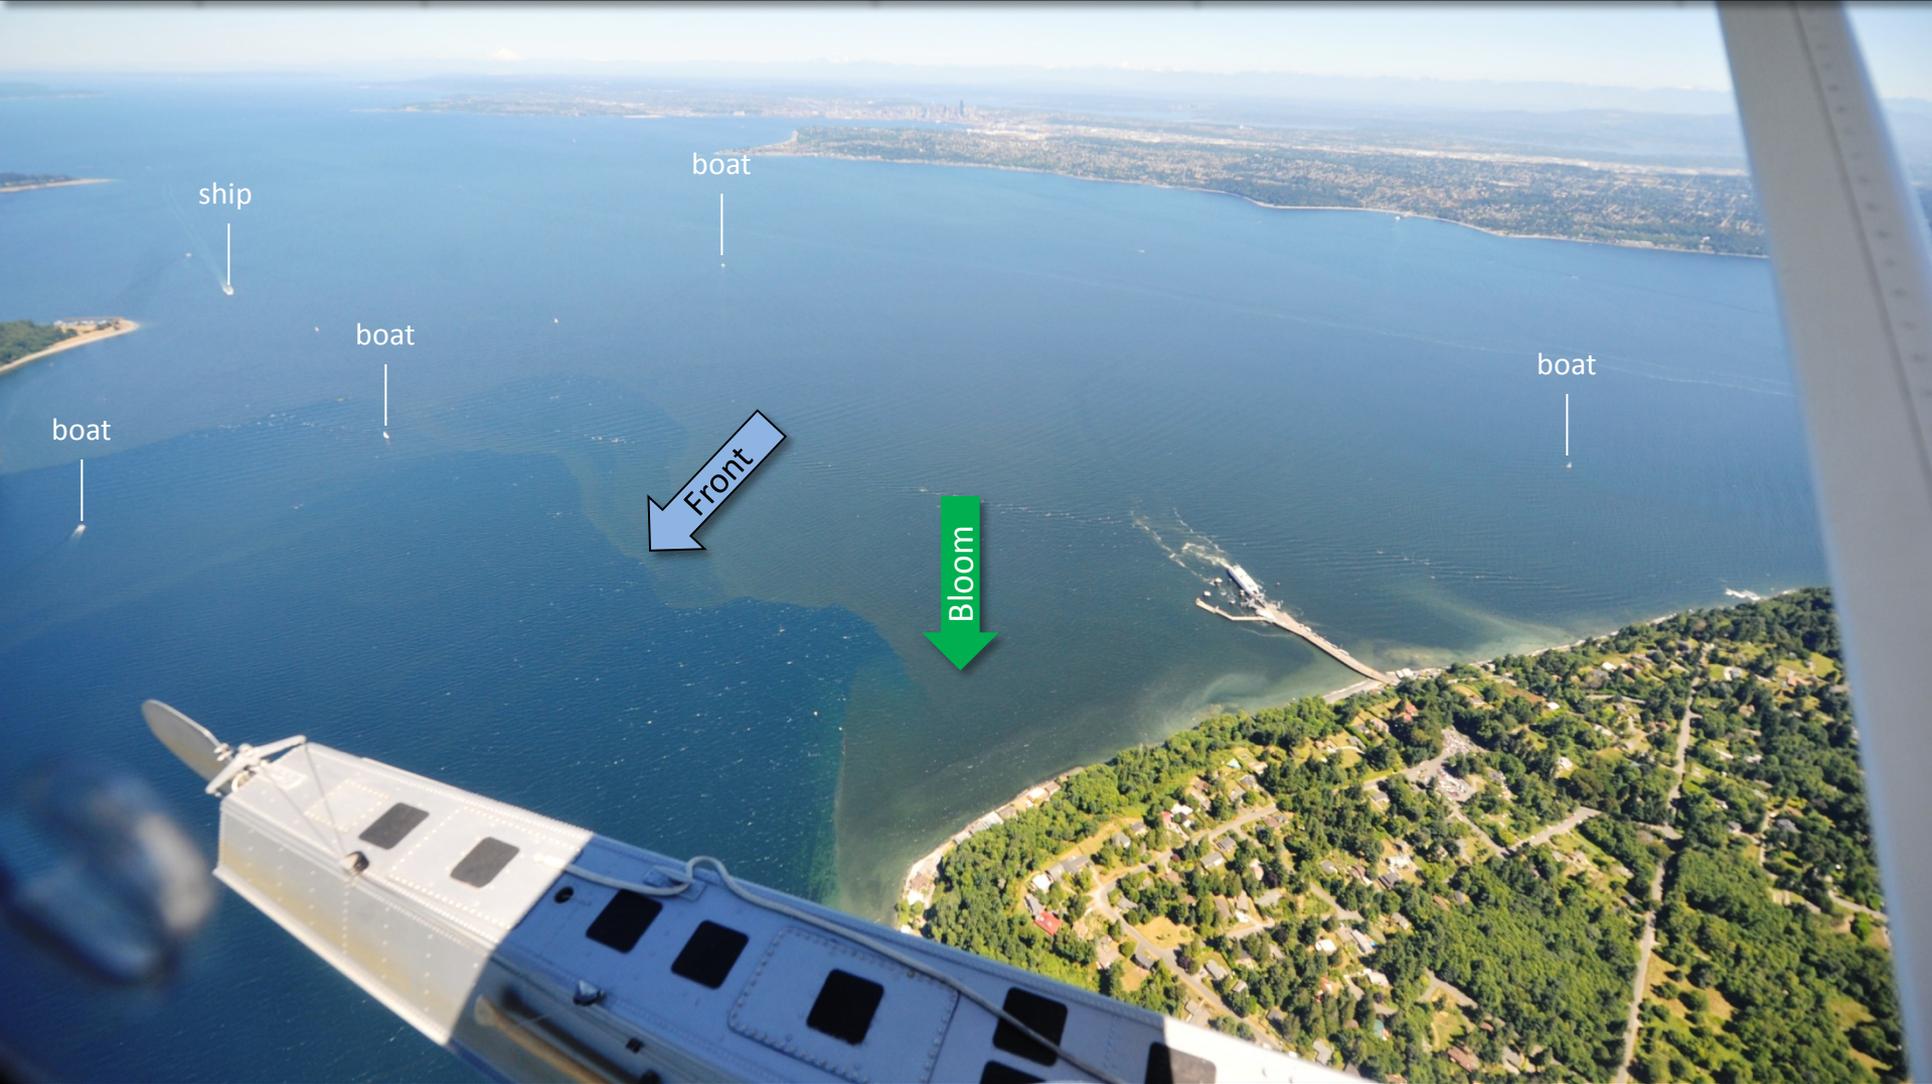
*Olive-brown water blown in by northerly winds meets clearer water from Colvos Passage.  
Location: North Vashon Island (Central Basin), 1:20 PM.*

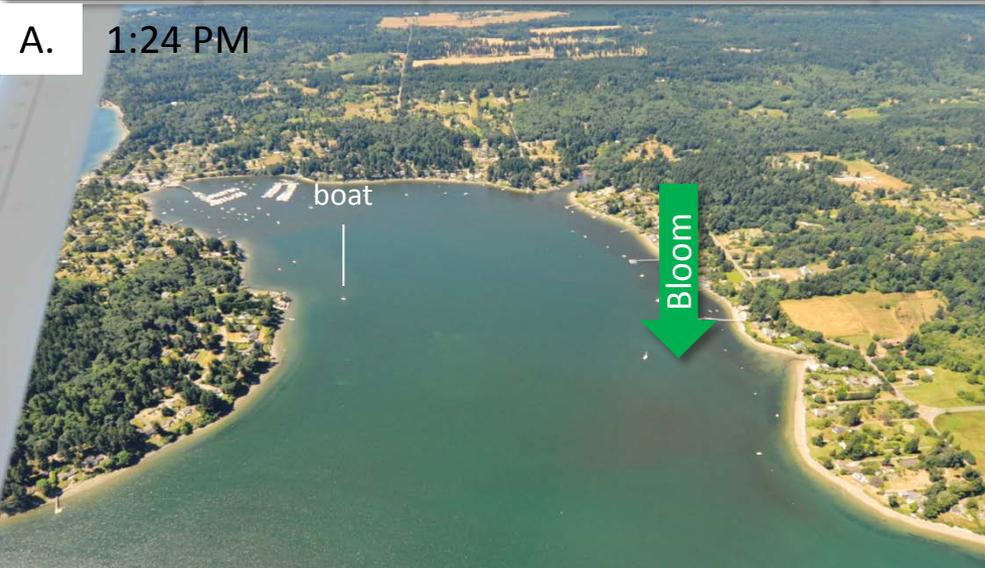
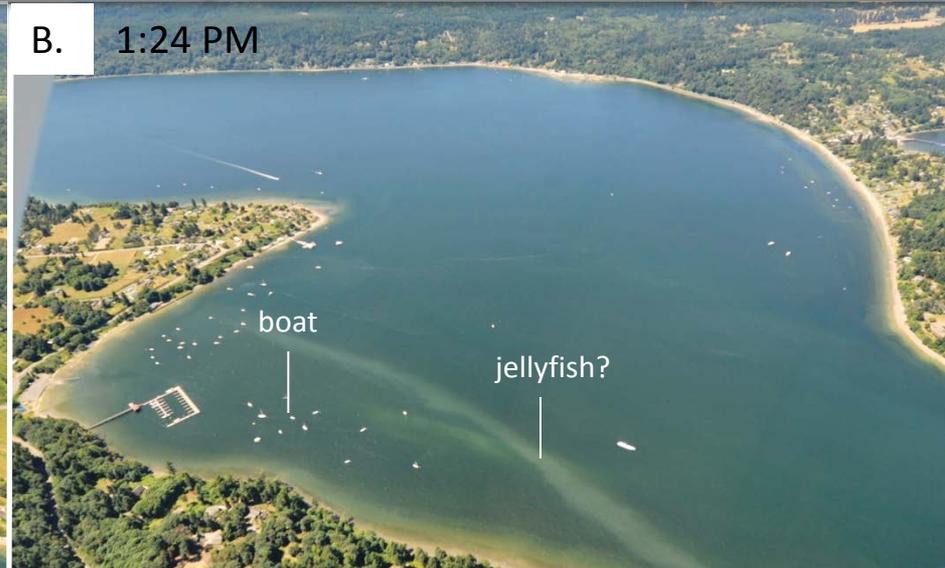
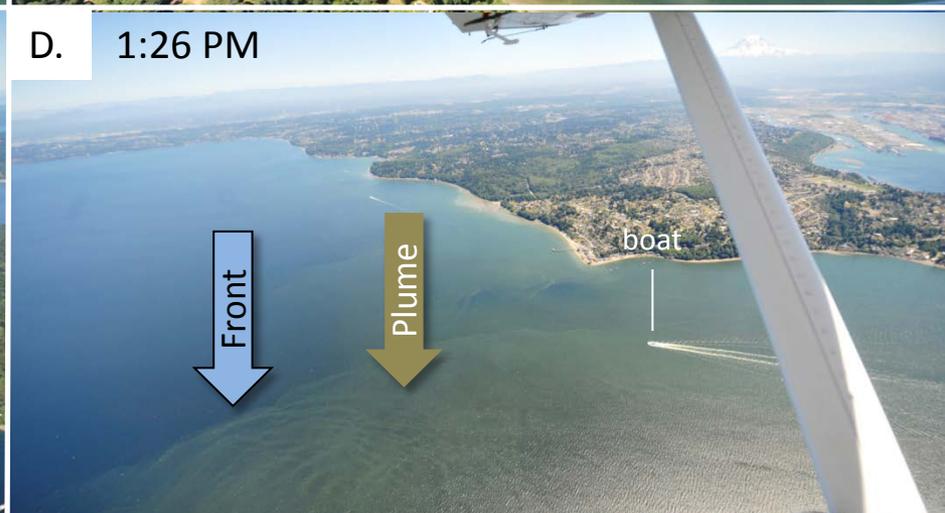
*Algal bloom and jellyfish? A & B. Quartermaster Harbor. Puyallup River plume near C. Entrance to Quartermaster Harbor and D. Dash Point. Location: South Central Basin.*

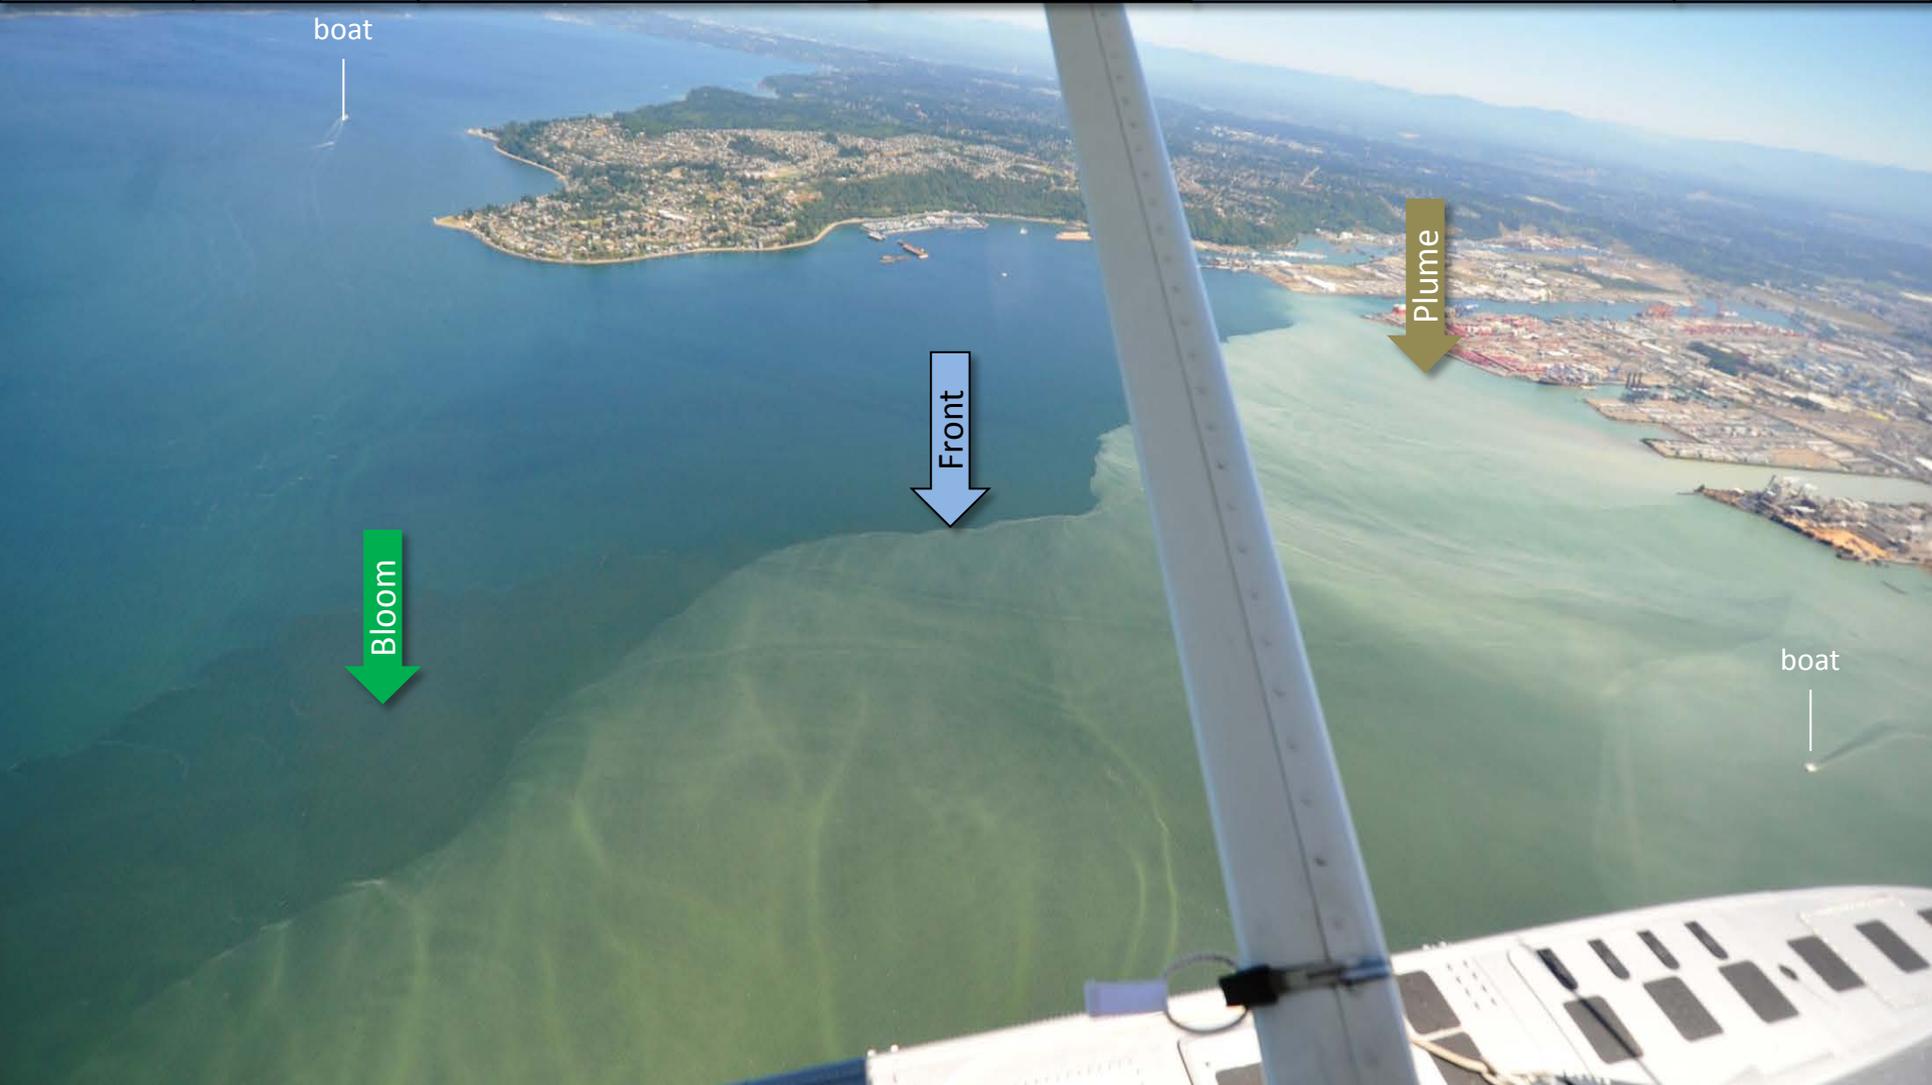
*Puyallup River Plume and olive-brown water (algal bloom?)*  
Location: Commencement Bay (South Central Basin), 1:28 PM.
