# Eyes Over Puget Sound

## Surface Conditions Report, July 15, 2013

*Up-to-date observations of visible water quality conditions in Puget Sound and the Strait of Juan de Fuca*

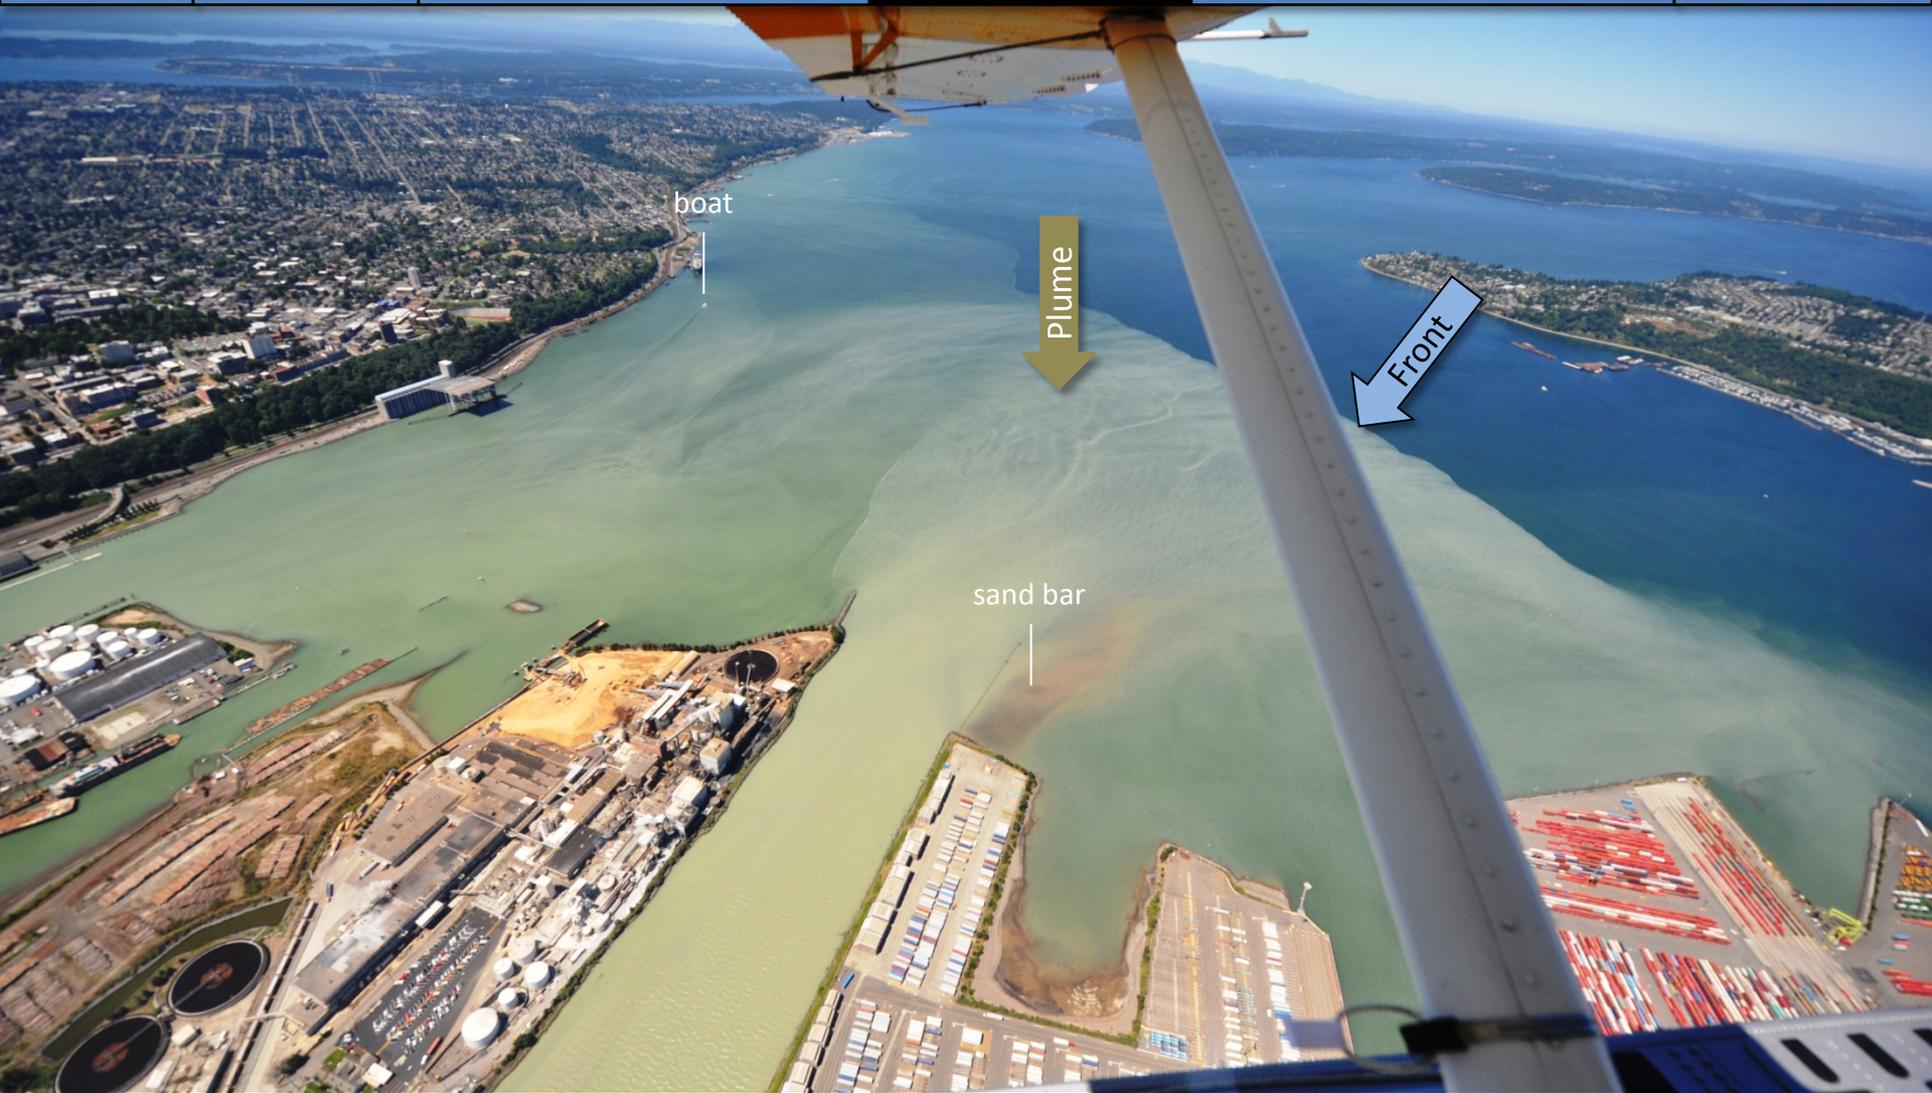
Location: Commencement Bay (South Central Basin), 1:29 PM.

*Puyallup River Plume and a sand bar*

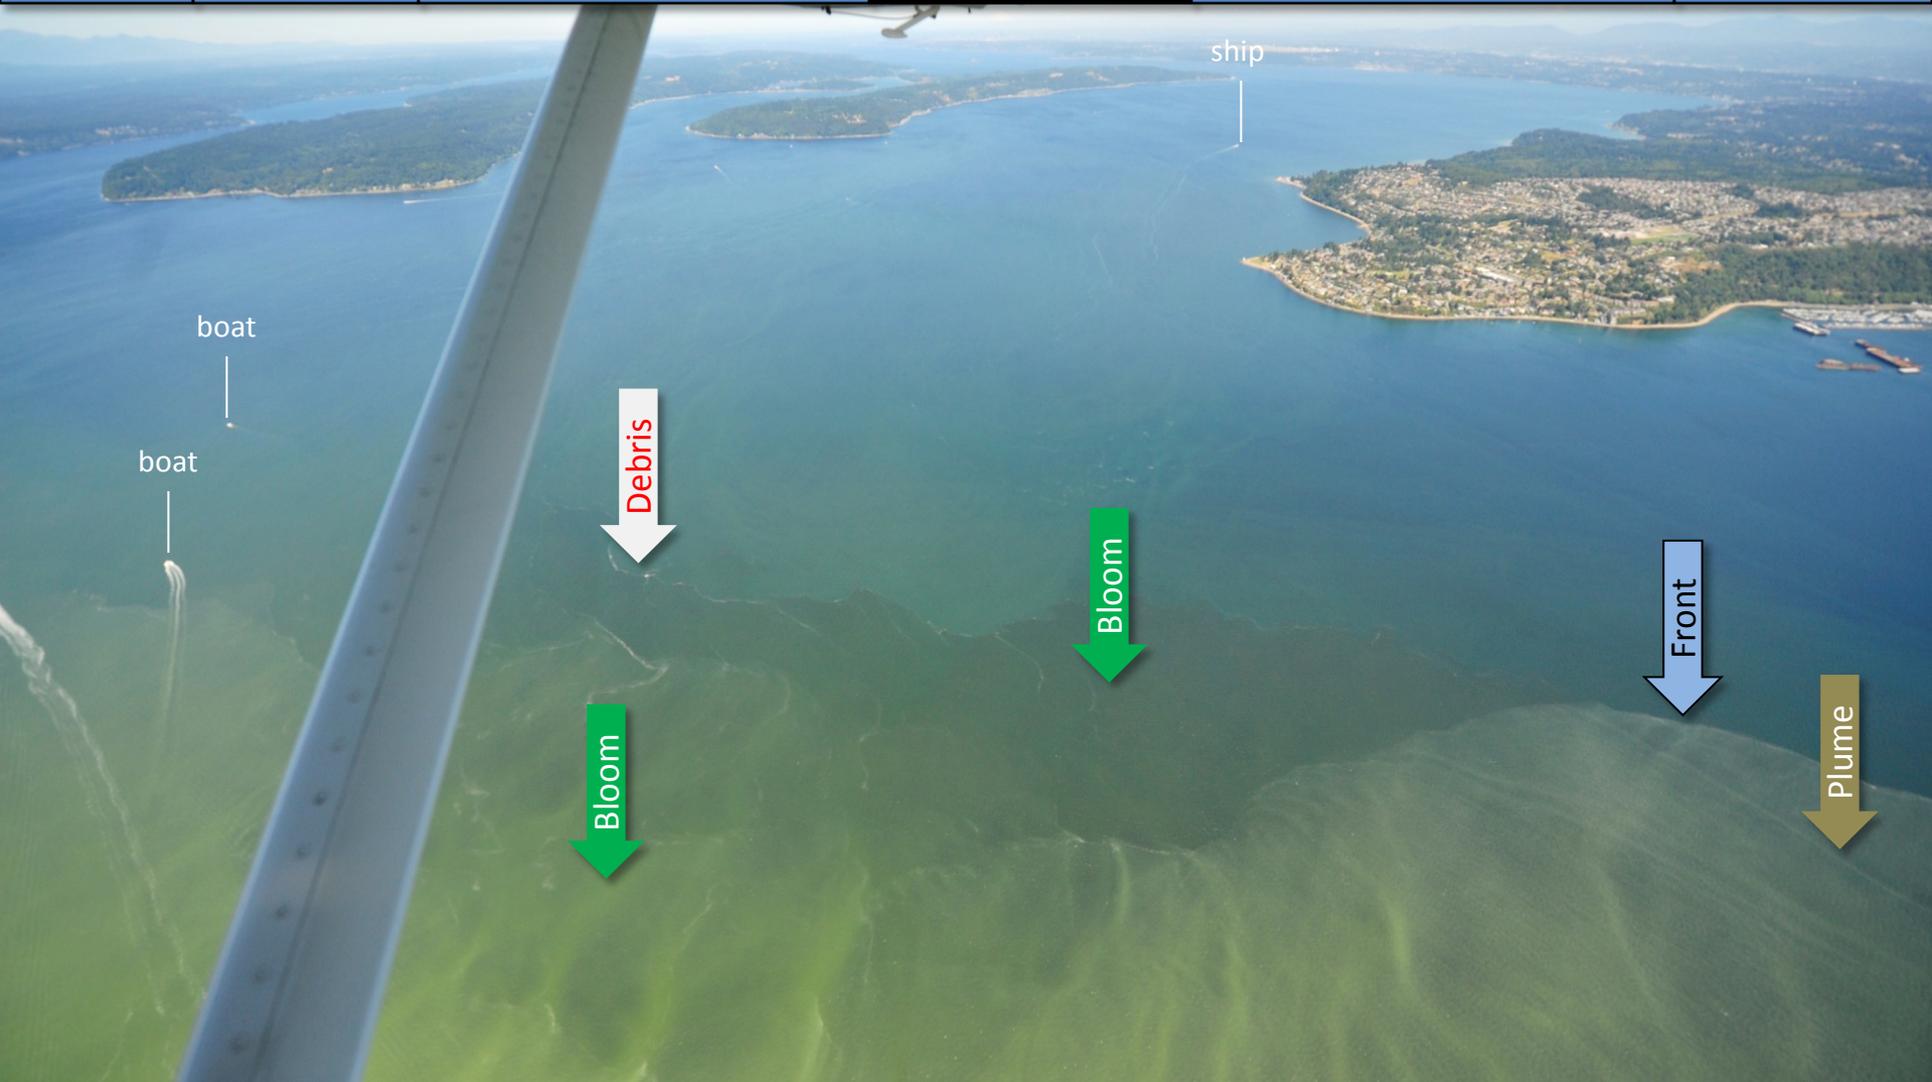
*Puyallup River Plume, olive-brown and yellow-green water (algal bloom?), and organic debris.*  
Location: Commencement Bay (South Central Basin), 1:31 PM.

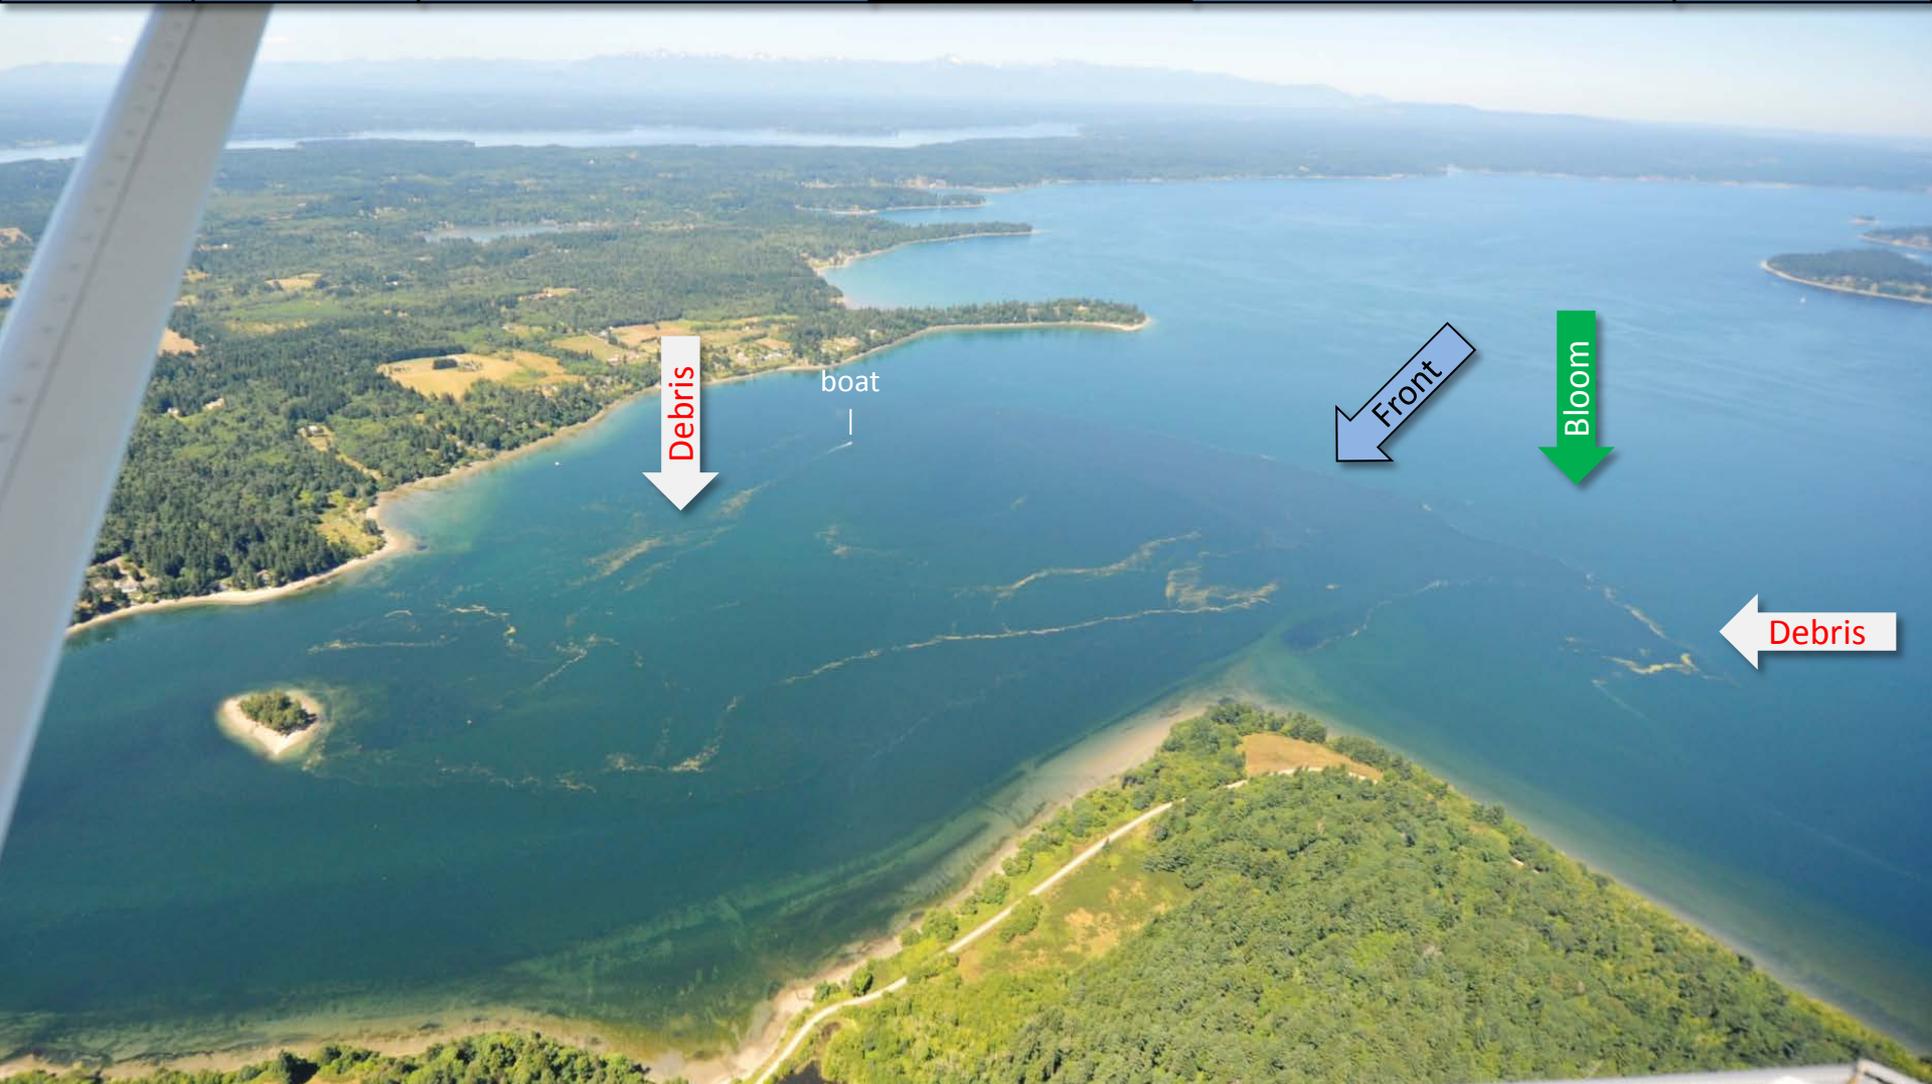
*Large debris rafts (algal mats) following water movement into Carr Inlet.  
Location: Pitt Passage Island (South Sound), 1:37 PM.*

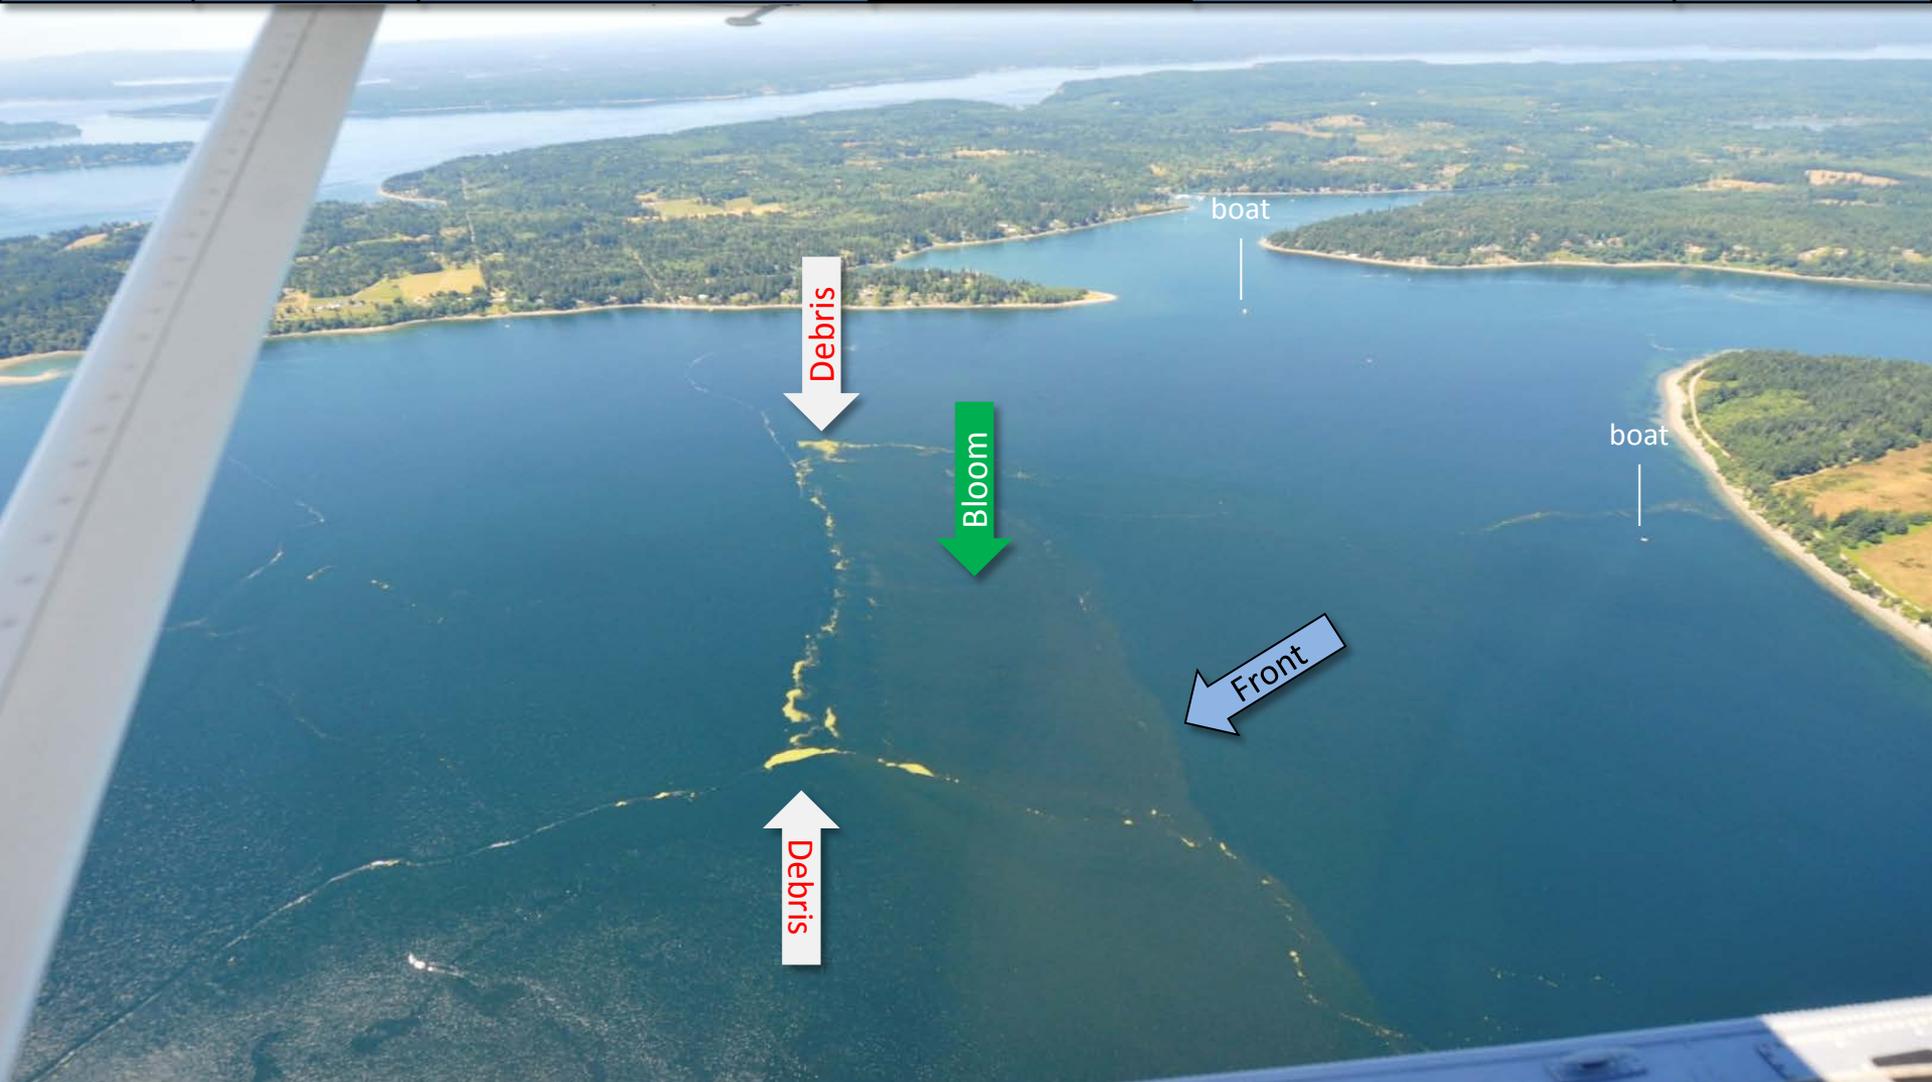
*Large debris rafts (algal mats) and olive-brown algal bloom following water movement.  
Location: West of Anderson Island (South Sound), 1:38 PM.*

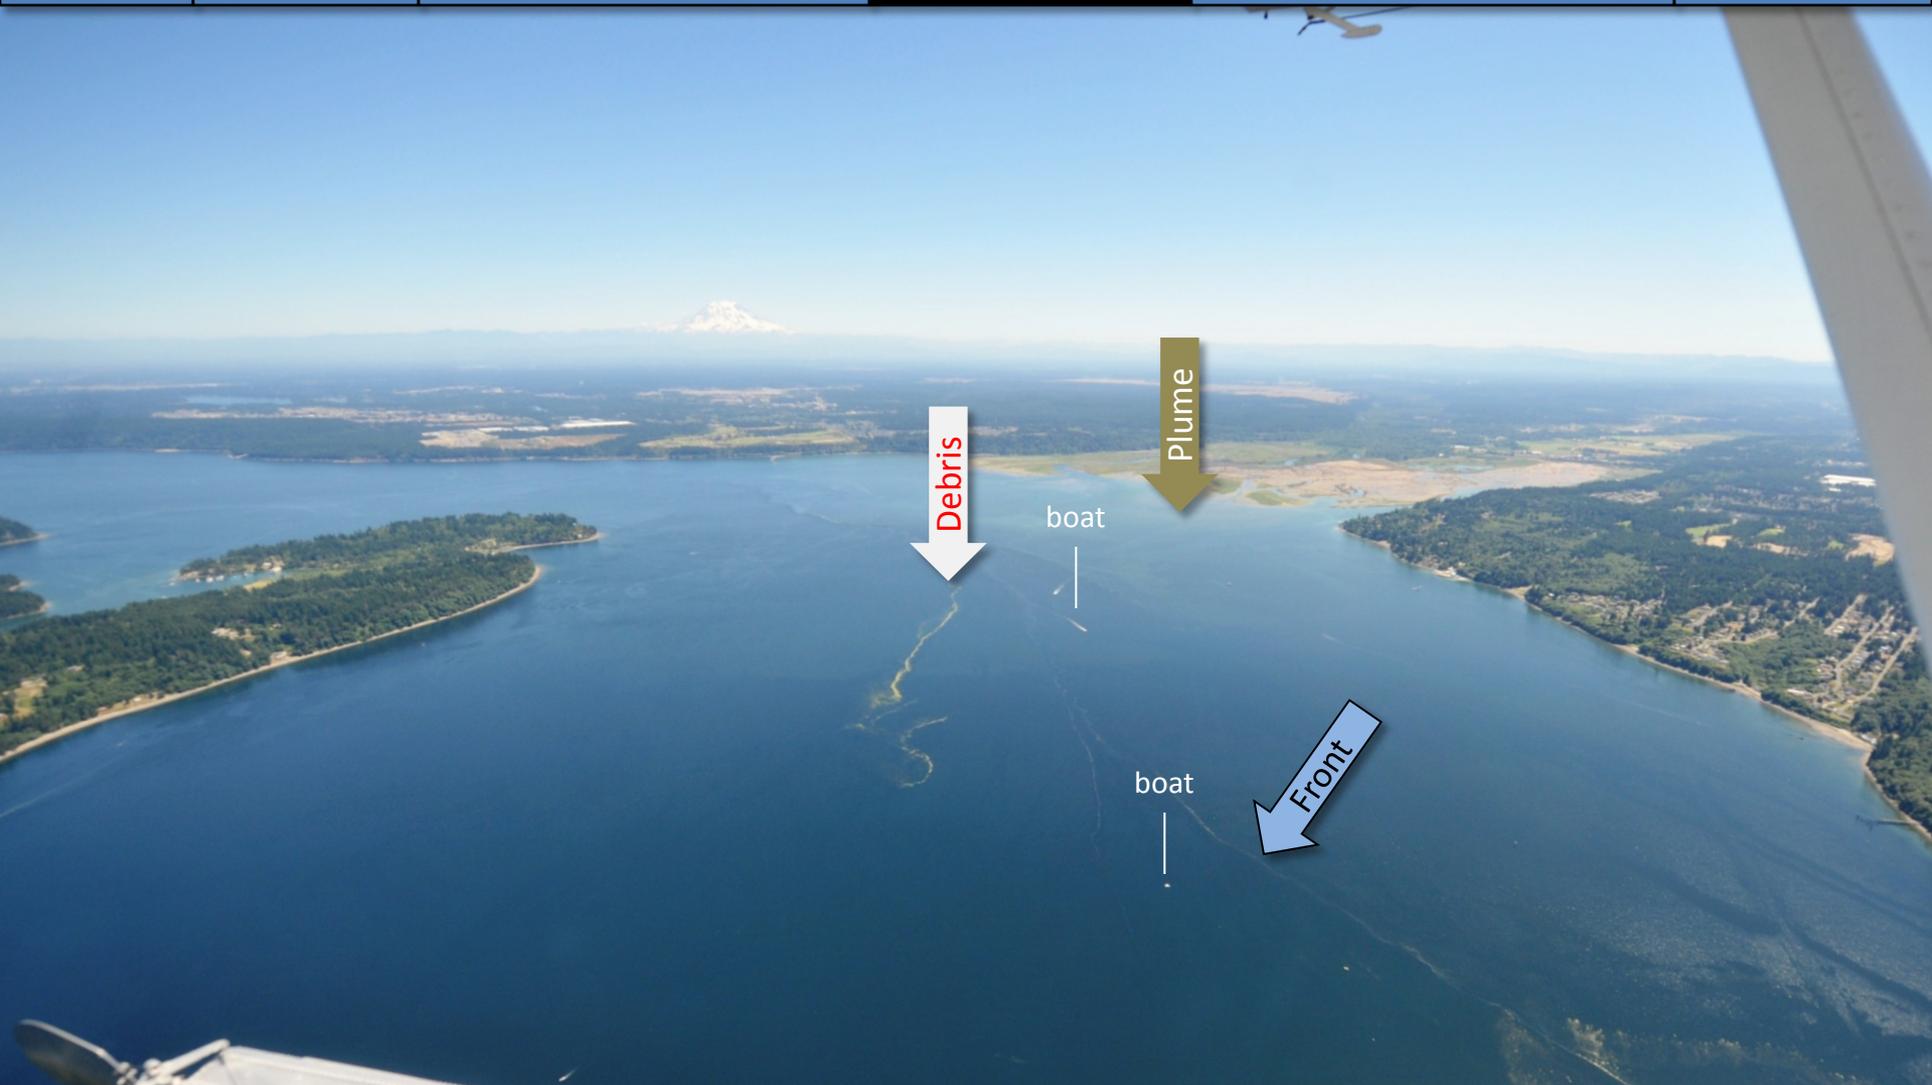
*Large debris rafts (algal mats) following water movement.  
Location: Nisqually Reach (South Sound), 1:41 PM.*

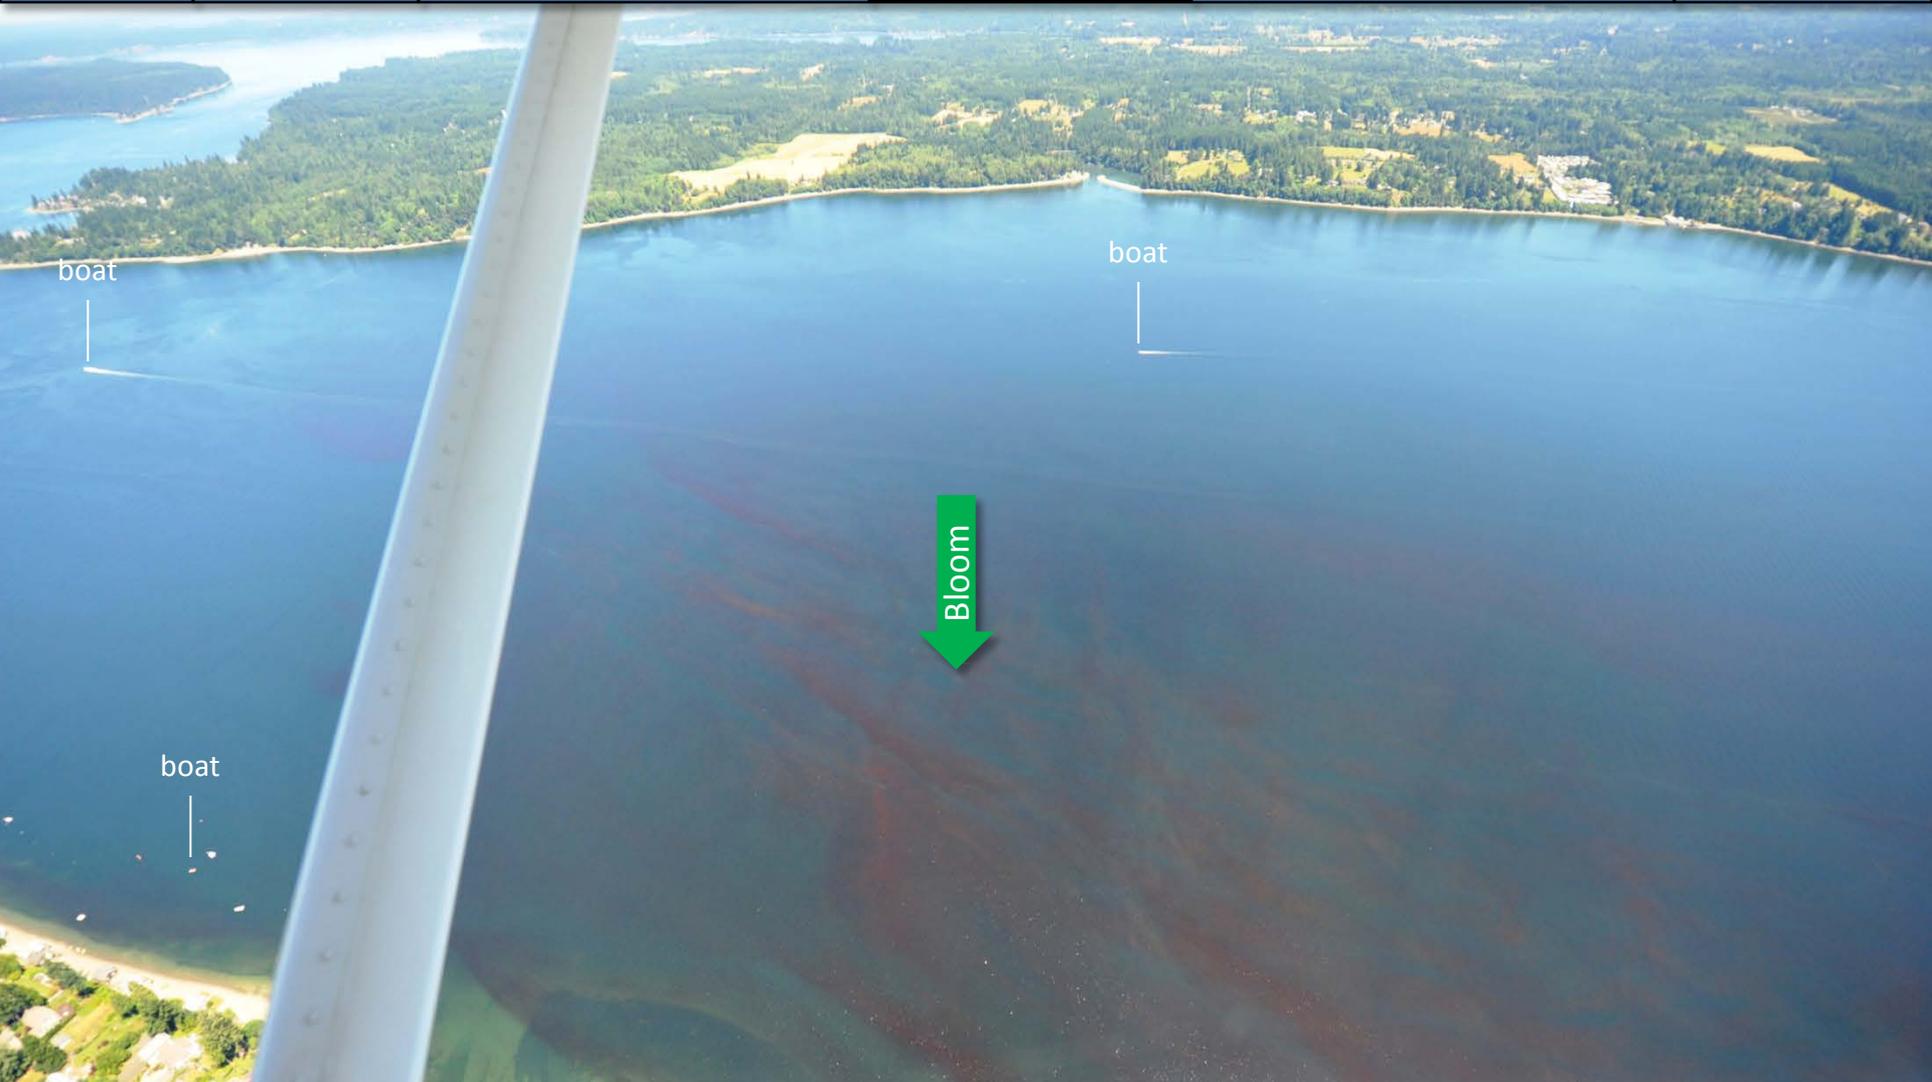
*Red-brown algae bloom near the surface.*  
Location: Budd Inlet (South Sound), 1:45 PM.

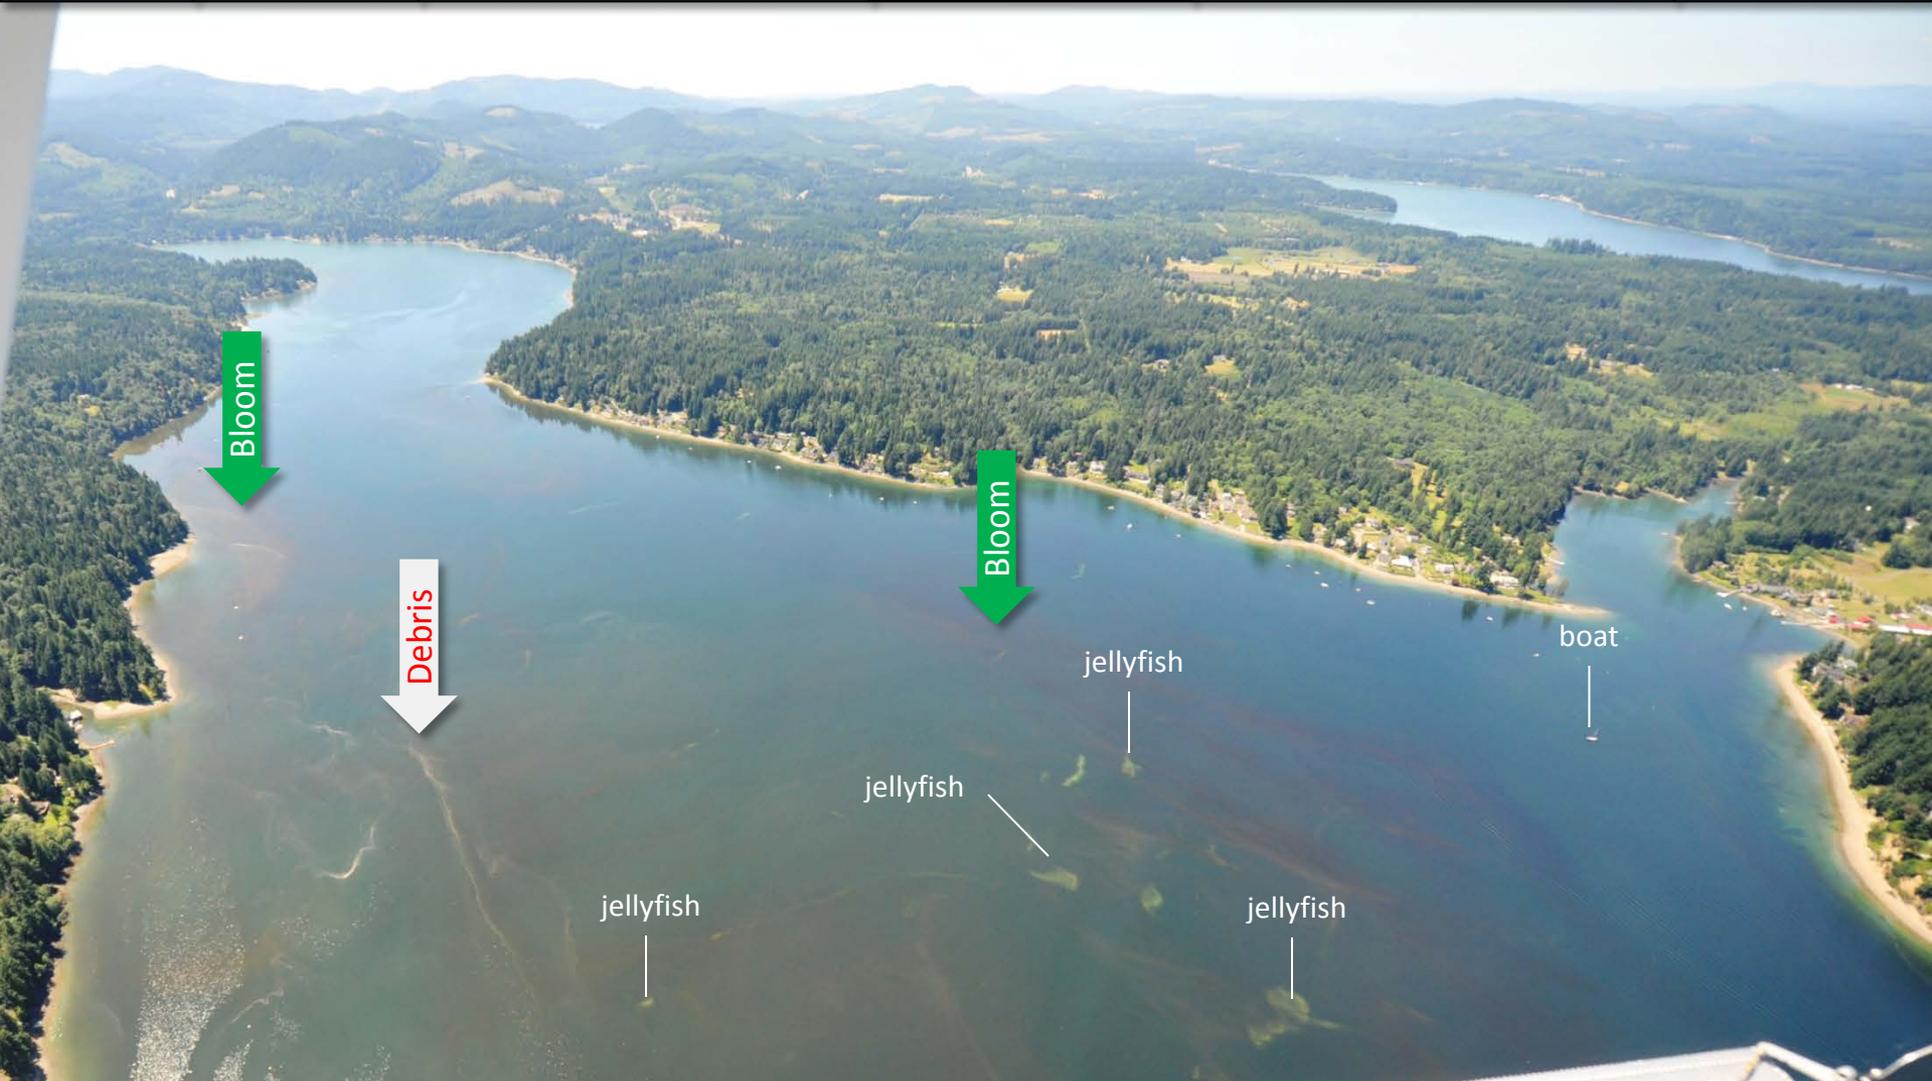
Location: Eld Inlet (South Sound), 1:47 PM.

*Orange and red-brown bloom and patches of jellyfish near the surface.*
