**EFFECTIVENESS OF FOREST ROAD  
AND TIMBER HARVEST BEST MANAGEMENT PRACTICES  
WITH RESPECT TO SEDIMENT-RELATED  
WATER QUALITY IMPACTS**

Interim Report No. 2

by  
Ed Rashin  
Casey Clishe  
Andy Loch

May 1994

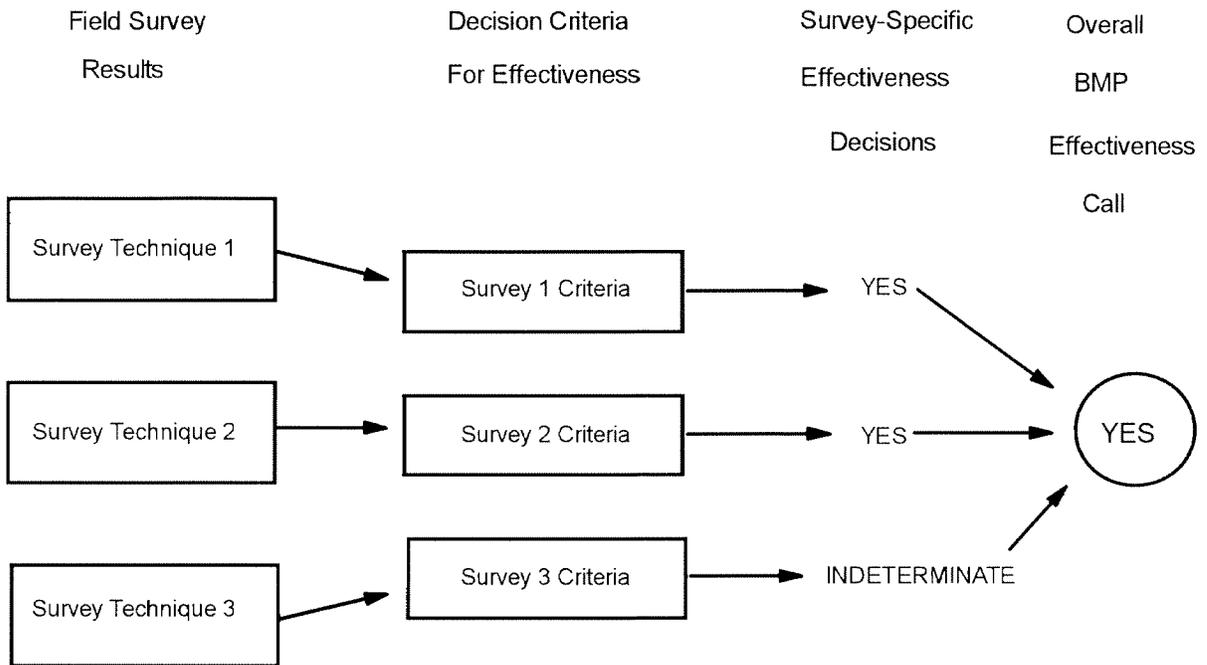
Figure 1: Weight-of-Evidence Approach for Determining BMP Effectiveness  
 (Applied to Each BMP Example)

The weight-of-evidence approach is illustrated in Figure 1. The results of each survey will be evaluated using decision criteria which relate survey results to the water quality standards and erosion processes the BMP is intended to control. Survey results will fall into one of three categories: "Yes," the BMP example was effective; "No," the BMP example was not effective; or, in some cases, "Indeterminate," meaning effectiveness could not be determined for this BMP example with the survey technique used. Indeterminate calls may be used where it is found that the survey technique was not appropriate to document the type of change that occurred at a particular site, or where interferences did not allow adequate evaluation of a particular practice. The evidence from the different survey techniques employed will be used collectively to determine effectiveness of that particular BMP example. However, since the survey techniques vary in their sensitivity, all survey results may not be weighted equally. The overall BMP effectiveness call for each example will be either "Yes," "No," or "Partially Effective" (in the case of mixed results).

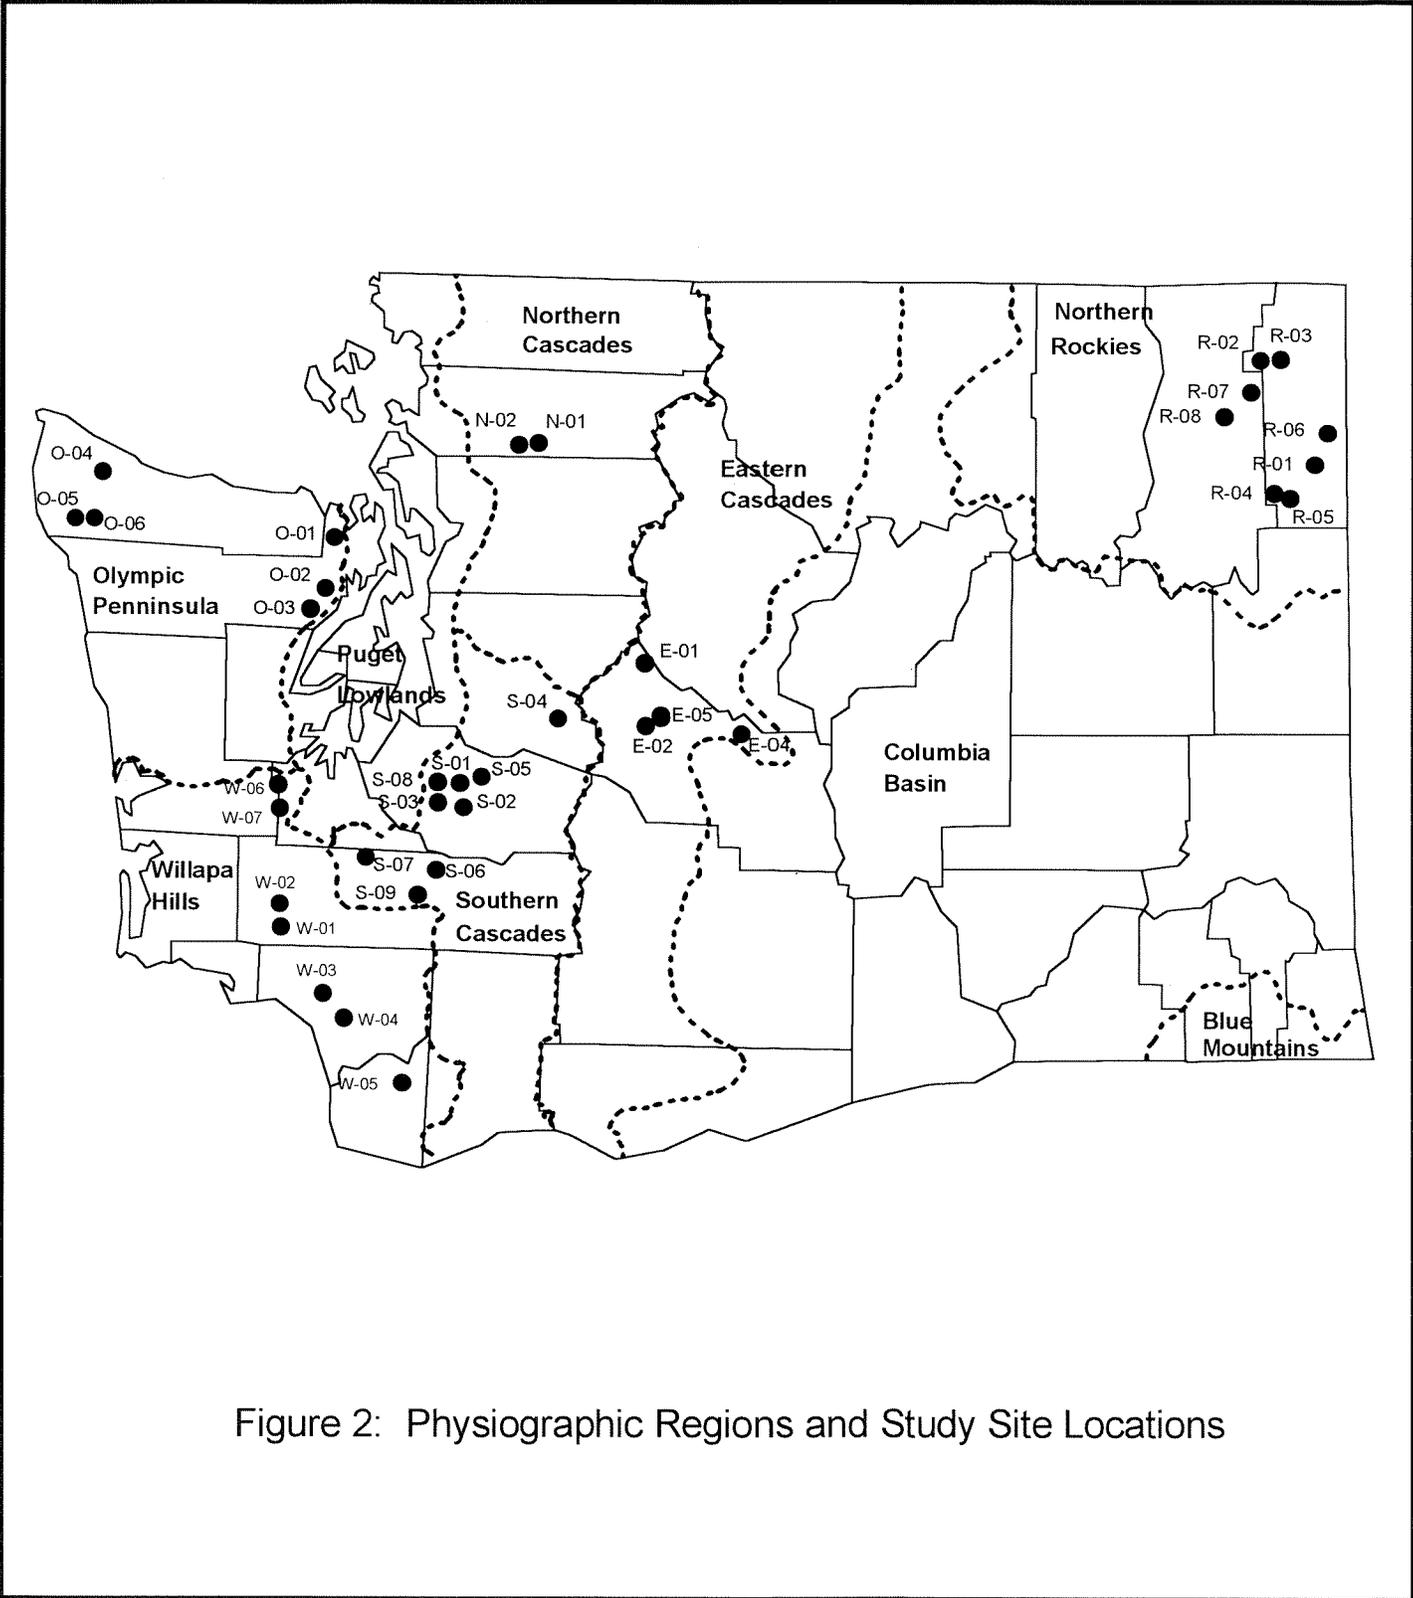
Figure 2: Physiographic Regions and Study Site Locations

To date we have selected 36 study sites at which we are evaluating 90 examples of specific BMP implementation. Study site locations are shown on a map of physiographic regions in Figure 2. Table 2 summarizes study sites according to physiographic regions, BMPs evaluated, and the slope hazard categories described earlier. We have grouped BMP
