Washington State Wetland Mitigation Evaluation Study

Phase 1: Compliance

June 2000
Publication No. 00-06-016

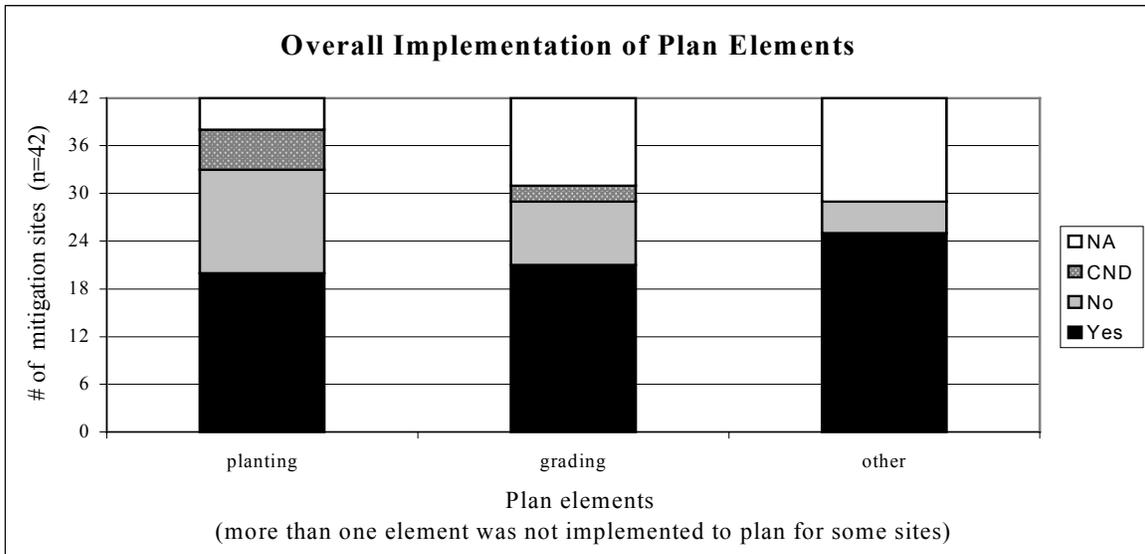
- 16 projects were not implemented to plan (refer to Graph 1). Of these:
 - 13 projects (81%) did not implement planting according to plan.
 - 8 projects (50%) did not implement grading according to plan.
 - 4 projects (25%) did not implement the “other” element according to what was indicated in the mitigation plan.

Graph 1. Yes=implemented to plan; No=not implemented to plan; CND=could not determine if implemented to plan; NA=not applicable plan element.

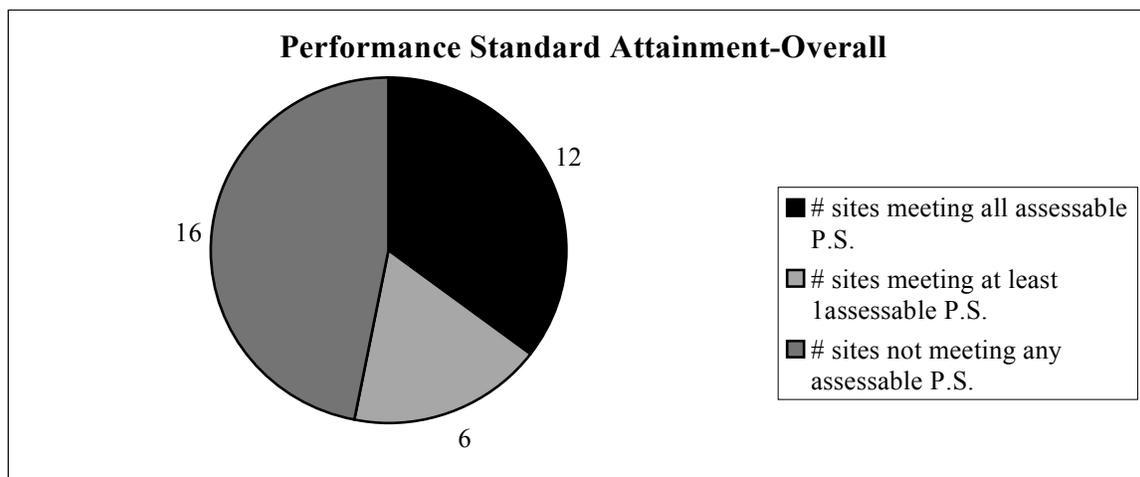
- 2 projects had performance standards which could not be assessed within the parameters of this study.
- 12 projects (35%) met all assessable performance standards.
- 22 projects (65%) failed to meet one or more of the assessable performance standards.

Graph 2. 34 projects with assessable performance standards were considered for this evaluation

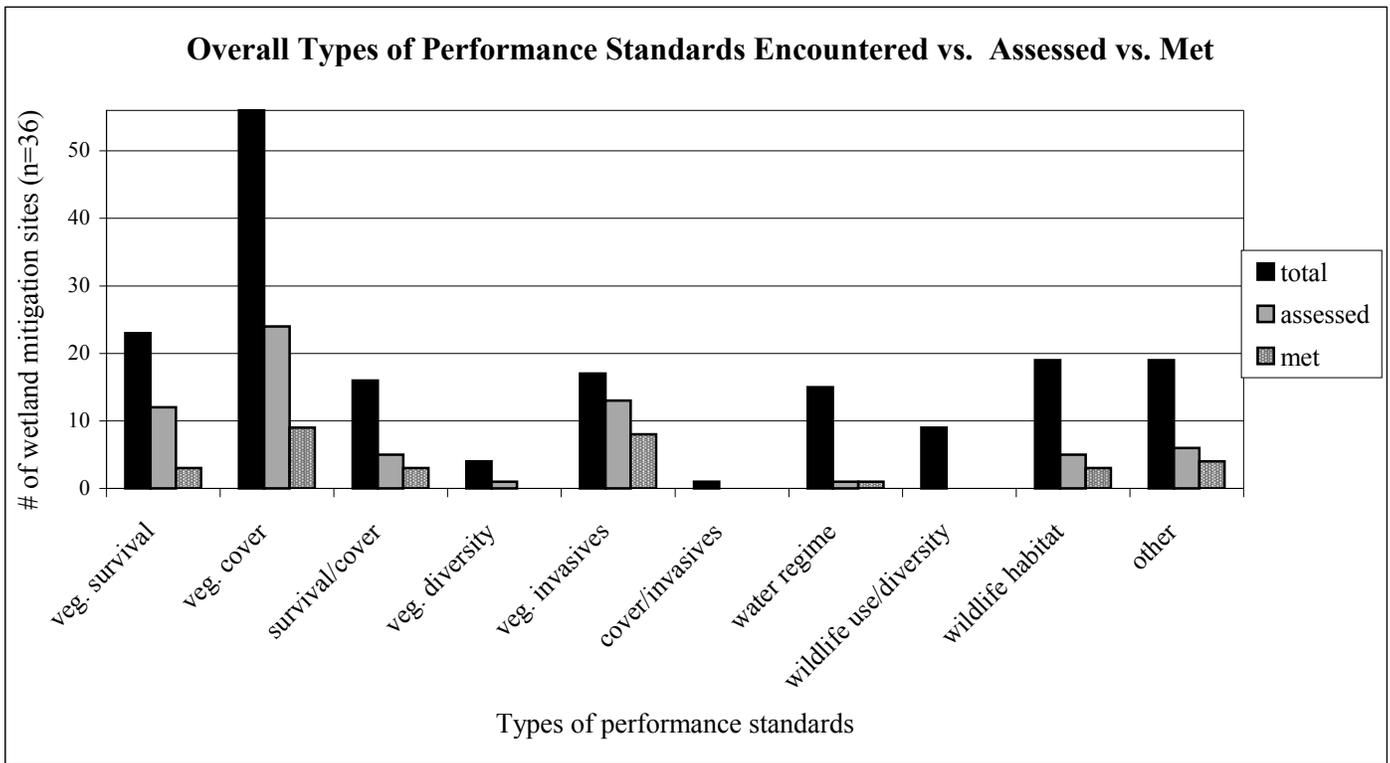
Graph 3. Depicts the variation between the total number of performance standards encountered, the number that this study was able to assess, and the number that were met. 36 projects were considered for this evaluation (this excludes: 3 projects not implemented; 4 preservation-only projects; and 2 projects with no performance standards, only goals).

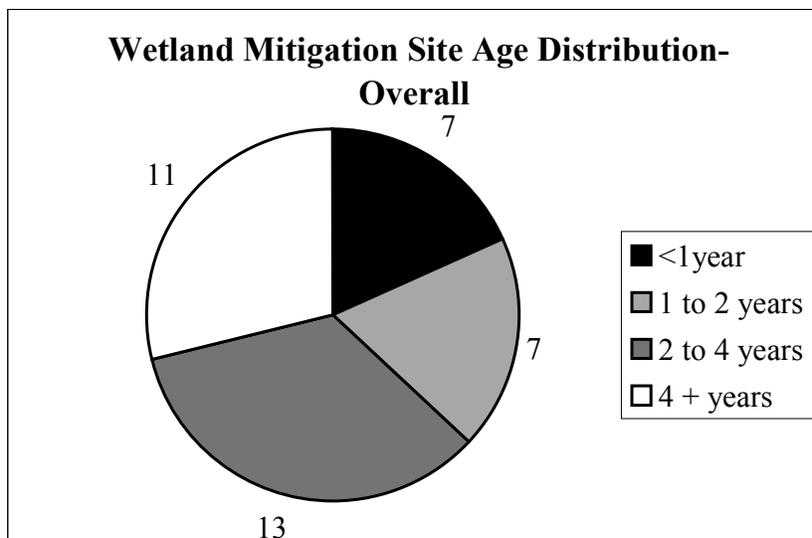
- 7 projects (18%) were less than one-year post implementation.
- 7 projects (18%) were at least one year but less than 2 years post implementation.
- 13 projects (34%) were at least 2 years but less than 4 years post implementation.
- 11 projects (29%) were at least 4 years post implementation or older.

Graph 4. 38 projects considered for this evaluation.

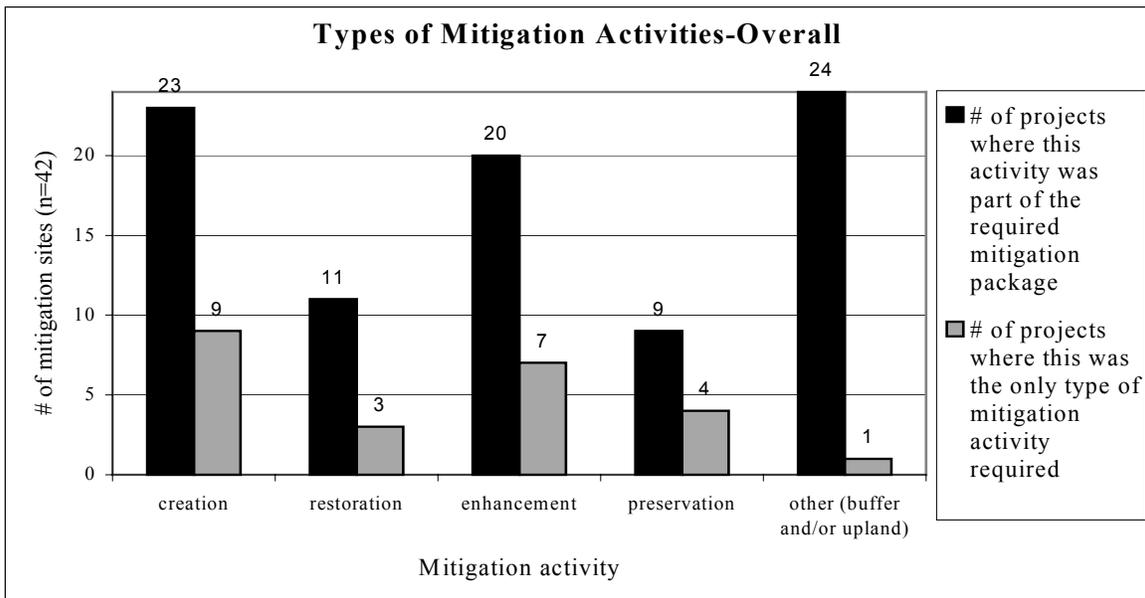
- 42 projects considered (refer to Graphs 5 and 6).
 - 23 projects (55%) involved creation.
 - 11 projects (31%) involved restoration.
 - 20 projects (48%) involved enhancement.
 - 9 projects (21%) involved preservation.
- 24 projects (60%) involved a single type of mitigation activity, such as creation.
- 18 projects (43%) proposed to perform a mixture of mitigation activities. For example, creation and enhancement.
- Over half (24) of the projects involved a buffer/upland and/or riparian component. All but one of these (#99) involved at least one other mitigation activity.

Graph 5. Number of sites implementing each type of mitigation activity. Black bars indicate the total number of sites that implemented a given mitigation activity, while the gray bars indicate the number of sites that implemented just the particular single mitigation activity.

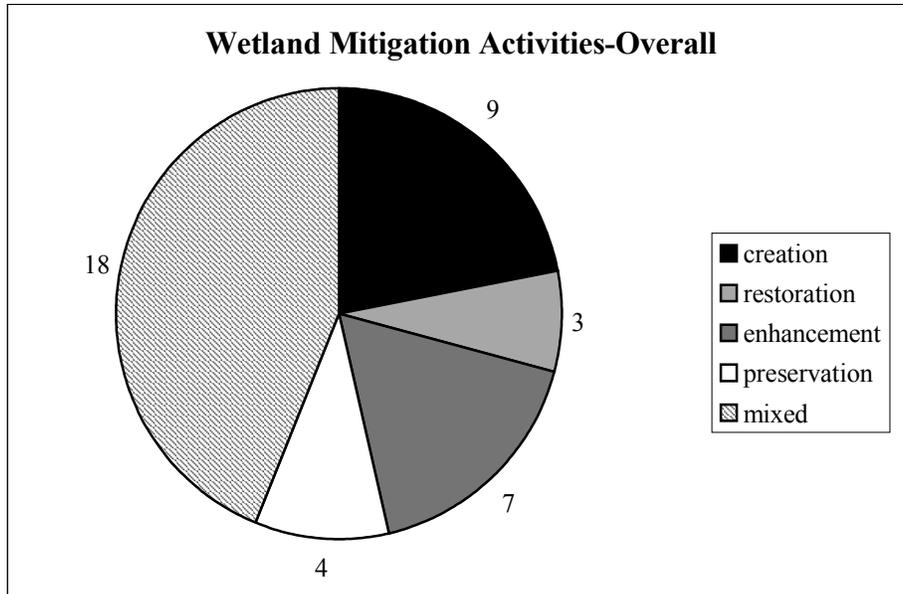
Graph 6. This pie chart shows the percentage of projects that implemented each individual type of wetland mitigation activity and the percentage of projects that implemented a combination of wetland mitigation activities. 41 projects considered (this excludes the buffer-only enhancement).

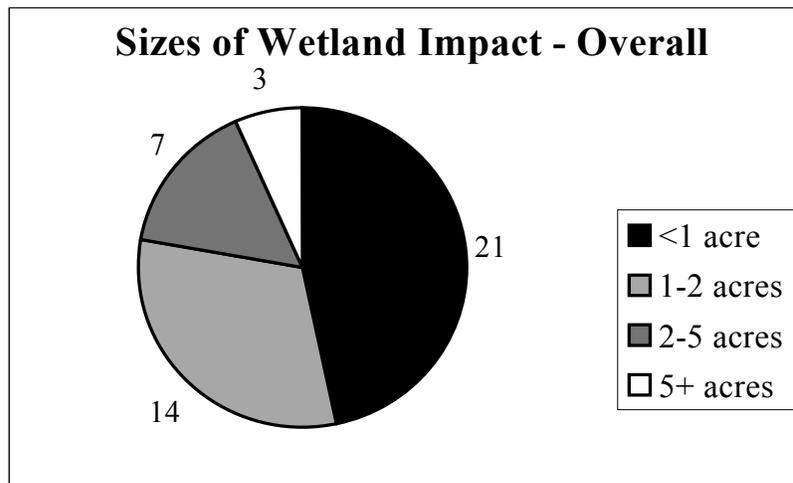
All 45 projects were considered for this analysis as all projects had completed the permitted wetland impact. The wetland impacts, which triggered the compensatory mitigation actions evaluated for this study, ranged in size from less than a tenth of an acre to 21 acres. Refer to Graph 7.

Graph 7. All 45 projects considered for this evaluation.

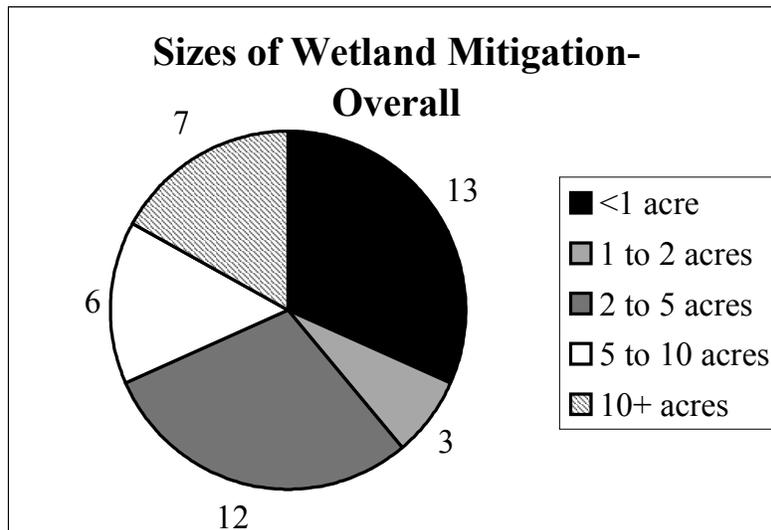
The wetland mitigation projects evaluated for this study varied considerably in size of wetland impact, types of mitigation activities, and size of compensatory mitigation. It should be noted that in regard to size of mitigation acreage, several (11) projects mentioned buffer and or riparian mitigation, but acreage was either not mentioned or was provided in a form that could not be converted to acreage. In particular, one westside project (#99) involved solely buffer enhancement, but no mitigation acreage was identified in the permit or in the mitigation plan. This project was therefore not included in the analysis of mitigation size. Additionally, the three compensatory wetland mitigation projects that were not implemented were excluded from this evaluation. The 41 remaining wetland mitigation sites visited ranged in estimated or proposed size from less than a fifth of an acre to 205 acres.

Graph 8. 41 projects considered for this evaluation. This excludes the projects that were not implemented and a buffer-only enhancement which specified no acreage.

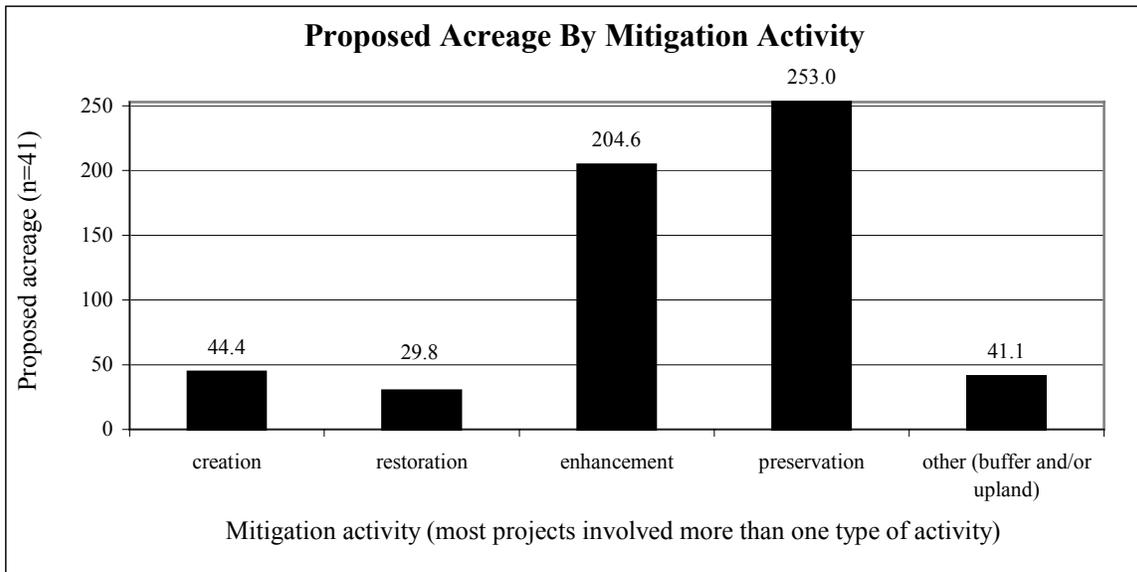
Graph 9. Numbers at top of bars indicate the proposed mitigation acreage for each activity. 41 projects were considered for this evaluation. This excludes the 3 projects not implemented and the buffer-only enhancement which specified no acreage.

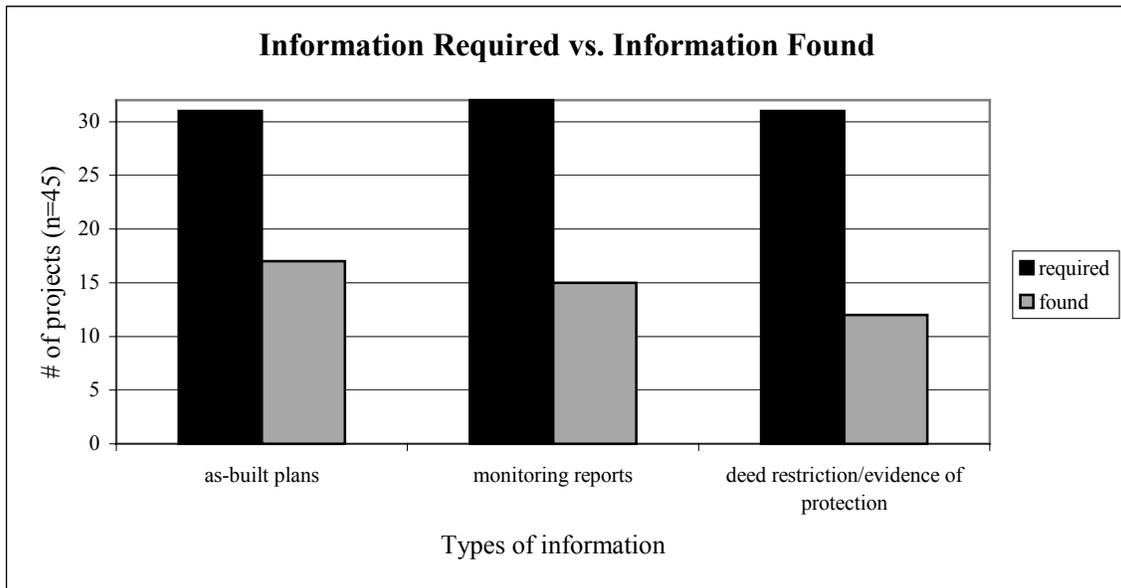
Agencies should require all applicants to submit an as-built document and periodic monitoring reports. Phase 1 found eight projects for which as-builts were not required and 7 projects for which monitoring reports were not required. When permits required the submission of these documents, about half of the projects were in compliance with these requirements. See Graph 10.

Graph 10. Number of projects requiring that as-builts, monitoring reports, and deed restrictions be submitted compared to the number of projects for which this information was found.

When an as-built is not submitted within the required timeframe specified in the permit, agency staff should contact the applicant to check the status of the project. A letter or phone call might provide the impetus for an applicant to perform the actions necessary to get a project into permit compliance. Periodic site visits should be conducted by permitting staff to verify as-builts or monitoring reports, and also to provide feedback or technical expertise on projects that are struggling to meet performance standards.
