**Norfolk Combined Sewer Overflow
(Duwamish River)
Sediment Cap Recontamination**

Phase I Investigation

February 2003

by
Nigel Blakley and Richard Jack

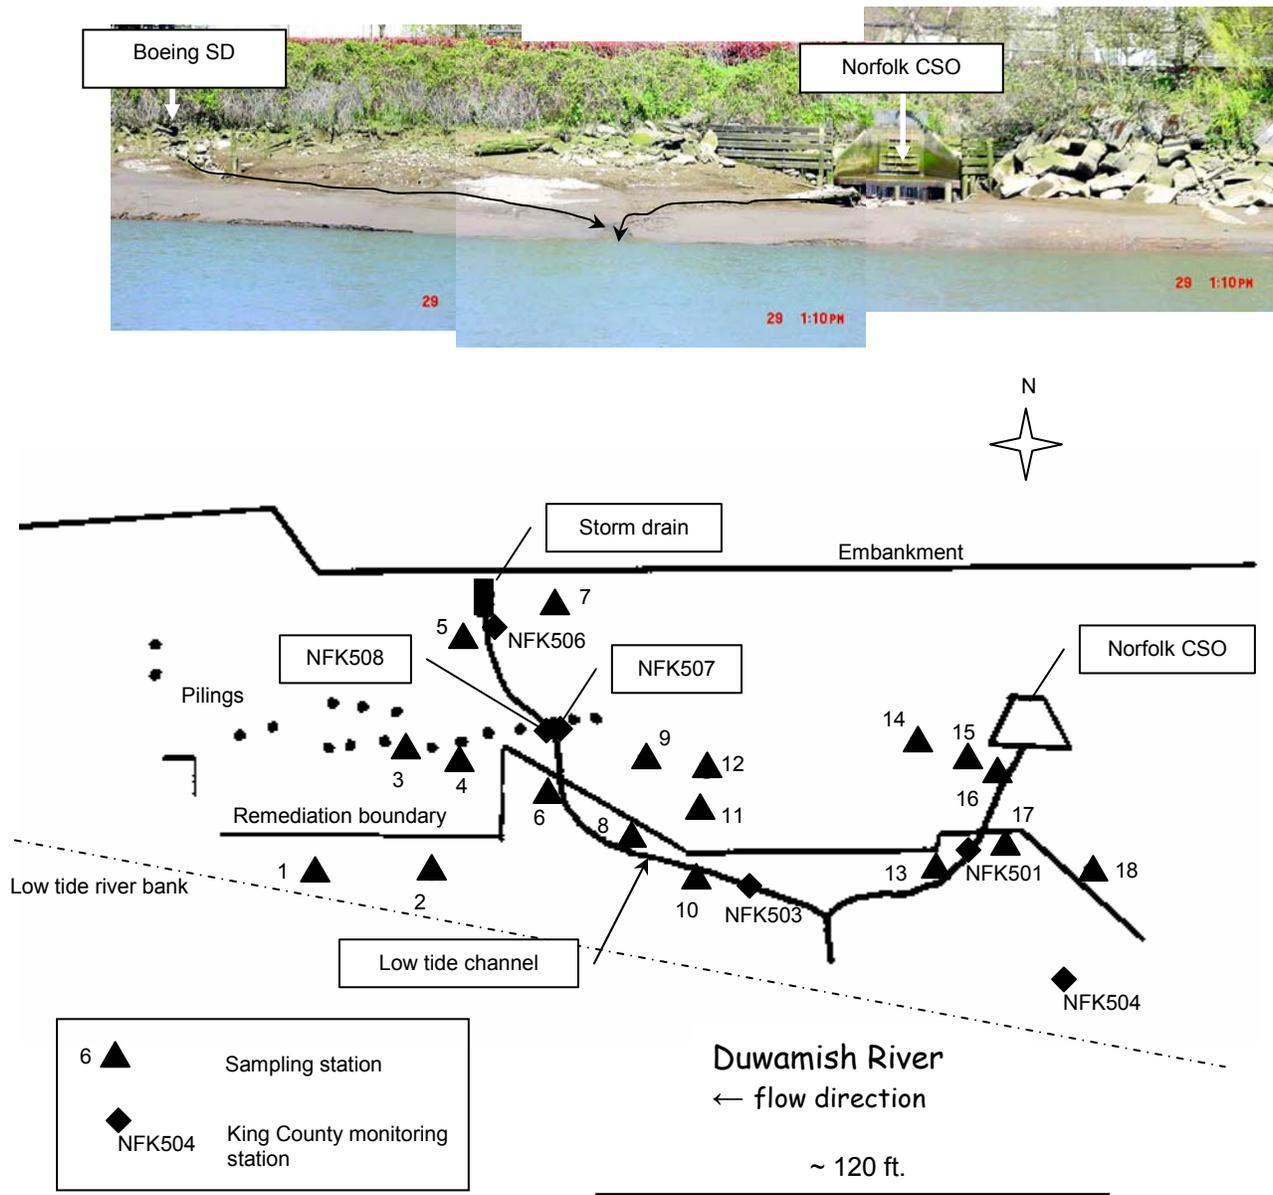
Figure 2. Sampling locations.

Photo: sampling area in the vicinity of the Norfolk CSO and Boeing Storm Drain outfalls. Lines with arrows indicate low tide channels from the outfalls. Distance between outfalls is approximately 120 ft.

Schematic map: sampling locations. Not to scale, locations are approximate. Stations below the remediation boundary (e.g., Station 1) are within the area remediated in 1999. Station 19 location is the same as Station 7 (field duplicate). Not shown: upstream reference Stations 20 and 21. Cleanup boundary location from EBD RP (1999; Appendix E).

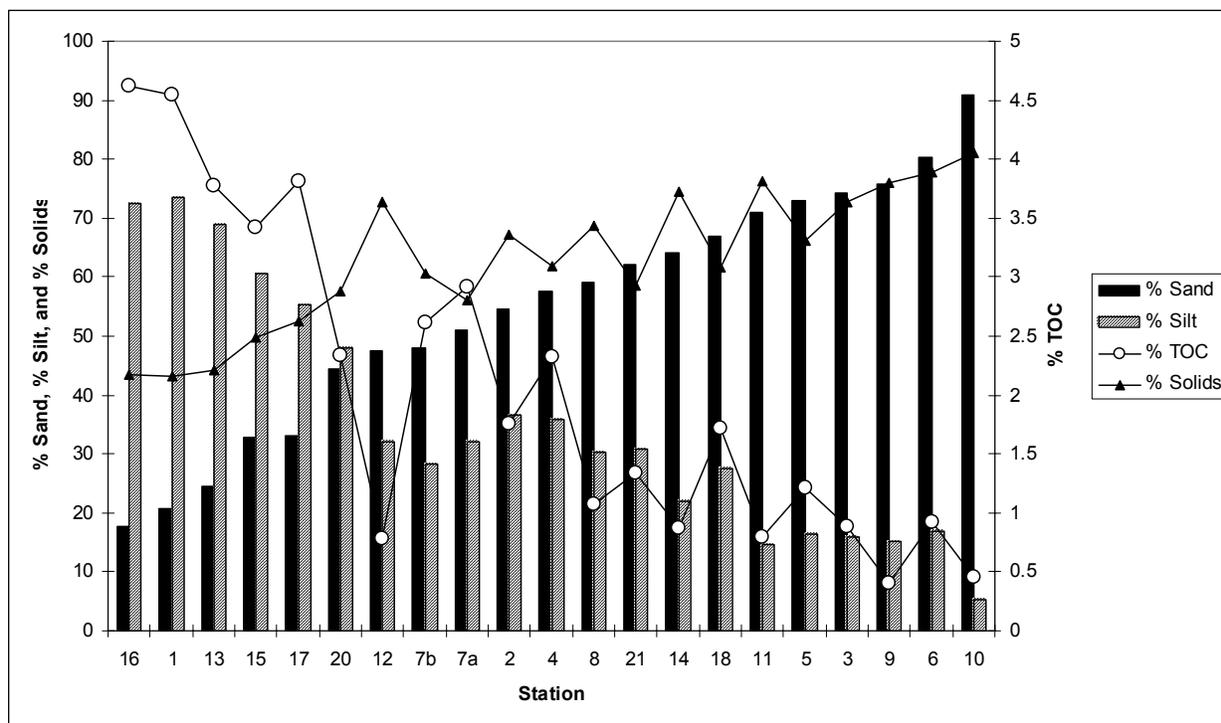
General patterns for conventional parameters are shown in Figure 3. Twelve stations had more than 50% sand, while five of the remaining stations had more than 50% silt. Percent solids tended to be higher at stations with high sand content, while total organic carbon (TOC) tended to be higher in silty samples. Stations with higher TOC and silt content (i.e., the five on the left side in Figure 3) were all in the vicinity of the Norfolk CSO outfall, with the exception of Station 1.

Figure 3. Characteristics of samples from each station. Stations 7a and 7b represent field duplicates from Station 7. Stations are arrayed in increasing order of sand content.

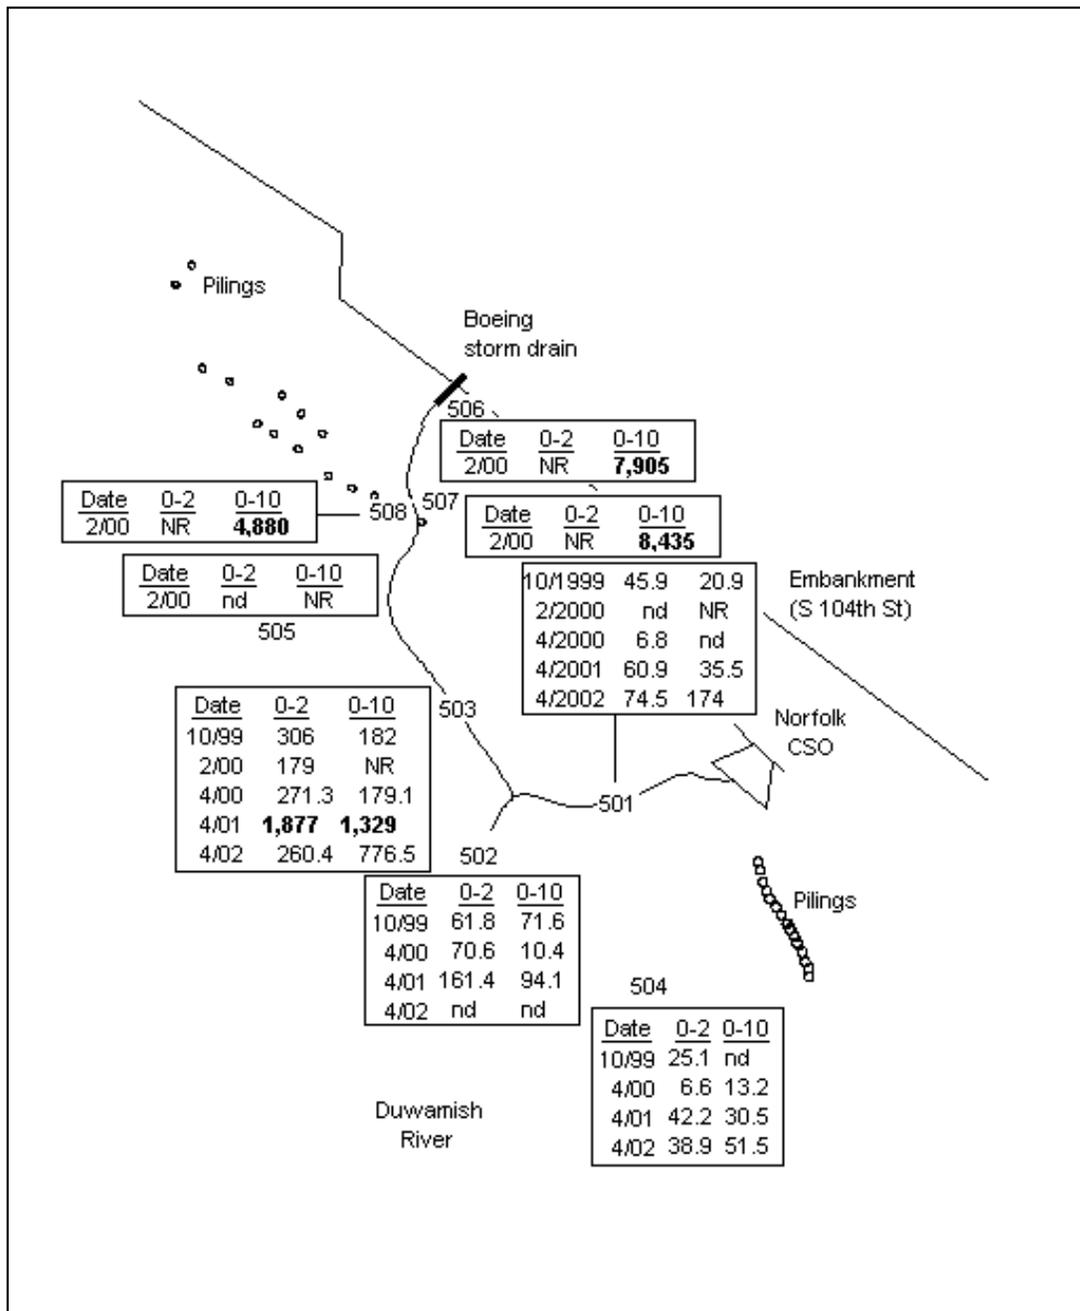
Results of this study are consistent with previous data from King County follow-up monitoring of the Norfolk CSO sediment cleanup (summarized in Figure 4). PCB concentrations over 1 mg/kg dw have previously been found outside the 1999 cleanup boundary, in the vicinity of the Boeing storm drain outfall (King County stations NFK506, 507, and 508). Despite the more extensive sampling coverage in the present study, concentrations over 1 mg/kg dw were only found near NFK508, at Station 4, and about 20 feet from NFK506, at Station 7 (Table 3).

A PCB concentration of over 1 mg/kg dw also was reported at NFK503 in 2001, but this result was not confirmed by 2002 monitoring data or supported by data from the present study. NFK503 is located in the channel formed by discharges from the Boeing storm drain outfall, and samples from Stations 6, 8 and 10, all located on the channel banks, did not exceed 1 mg/kg dw (Table 3).

Figure 4. Summary of PCB concentrations ($\mu\text{g}/\text{Kg dw}$) from King County post-remedial monitoring at stations NFK501-NFK508.

Rows in the tables at each sampling location show date (month/year), 0-2 cm depth PCB concentration and 0-10 cm concentration (nd = not detected, NR = not reported). Sources: King County, 2000; King County, 2001; King County, 2002.

Approximate remediation boundary is shown in Figure 2. The TOC-normalized concentrations, for comparison with Sediment Management Standards, are shown in Figure 6.

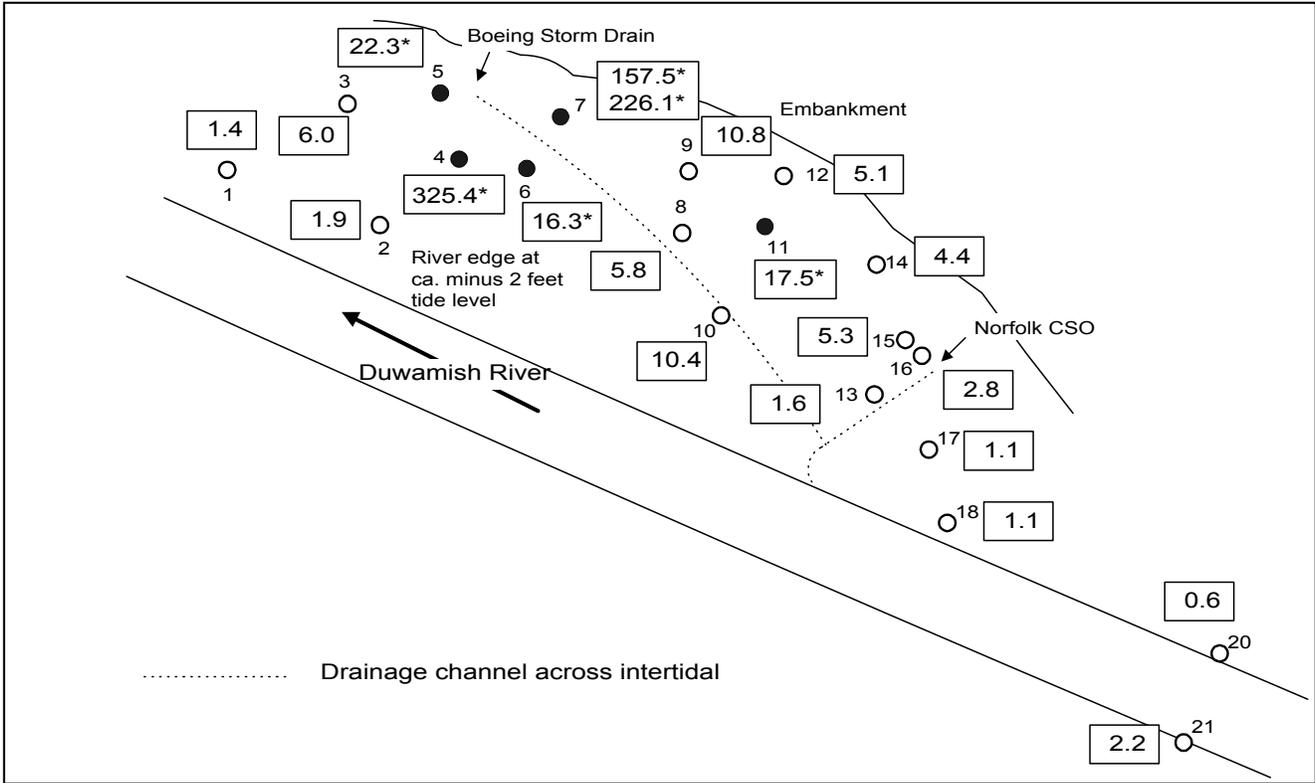
TOC-normalized PCB concentrations exceeded the SQS at five stations (Figure 5). At two of these stations the concentrations were also well above the CSL.

Figure 5. TOC-normalized PCB concentrations from this study (mg/Kg OC).

Values flagged with asterisk exceed the Sediment Quality Standard (12 mg/Kg OC) and in some cases, the Cleanup Screening Level (65 mg/Kg OC). Data from Table 2.

Approximate boundary of 1999 remediation area is shown in Figure 2.

Stations 4, 5, 6, 7 and 11 should be included in remediation of the PCB-contaminated sediment since these stations exceed the Sediment Management Standards Cleanup Screening Level.

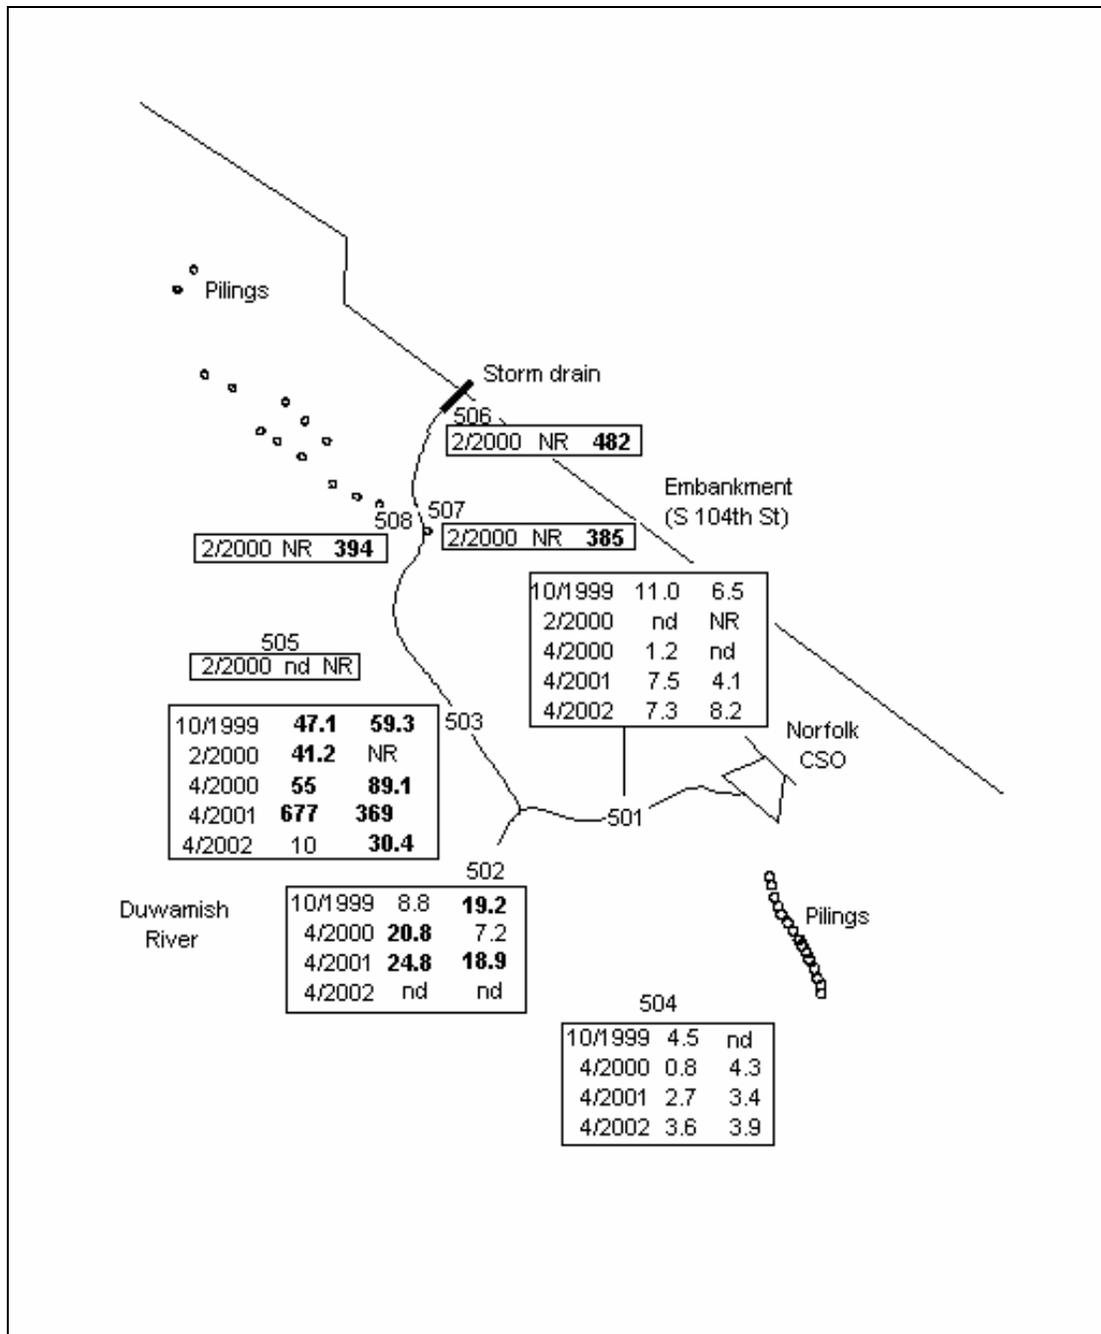
In previous sampling conducted by King County, exceedances of the CSL and/or SQS were observed at sampling stations in the vicinity of the Boeing storm drain outfall and in the channel below the outfall (Figure 6). Similarly, in this study all of the exceedances were in the vicinity of the storm drain outfall, with the exception of an exceedance of the SQS at Station 11 (Figure 5).

Figure 6. TOC-normalized PCB concentrations (mg/Kg OC) from King County post-remedial monitoring for comparison with Sediment Management Standards.

Values in bold font exceed the Sediment Quality Standard (12 mg/Kg OC) and in some cases, the Cleanup Screening Level (65 mg/Kg OC). Sources: King County, 2000; King County, 2001; King County, 2002.

Results of this study are consistent with the previous finding from King County monitoring data that there is an area of PCB-contaminated sediment in the vicinity of the Boeing storm drain outfall. At least part of this area was not included in the 1999 cleanup, based on a comparison of sampling locations with a map of the cleanup boundaries. PCB contamination has been observed at stations NFK506, NFK507 and NFK508 (Figure 6) and Stations 5 and 7 (Figure 5), for example, which are all outside the cleanup boundary. The Sediment Quality Standard (12 mg/kg organic carbon) was exceeded at five locations: Stations 4, 5, 6, 7 and 11. All of these stations are in the vicinity of the Boeing storm drain outfall, with the exception of Station 11, which is located between the Boeing storm drain and Norfolk CSO outfalls. At Stations 4 and 7, the PCB concentrations also exceeded the Cleanup Screening Level (65 mg/kg organic carbon). Station 6 appears to lie within the cleanup boundary and may therefore represent an instance of recontamination. King County also has reported exceedances of PCB sediment criteria at two locations (NFK503 and NFK502) within the cleanup boundary (Figure 6).

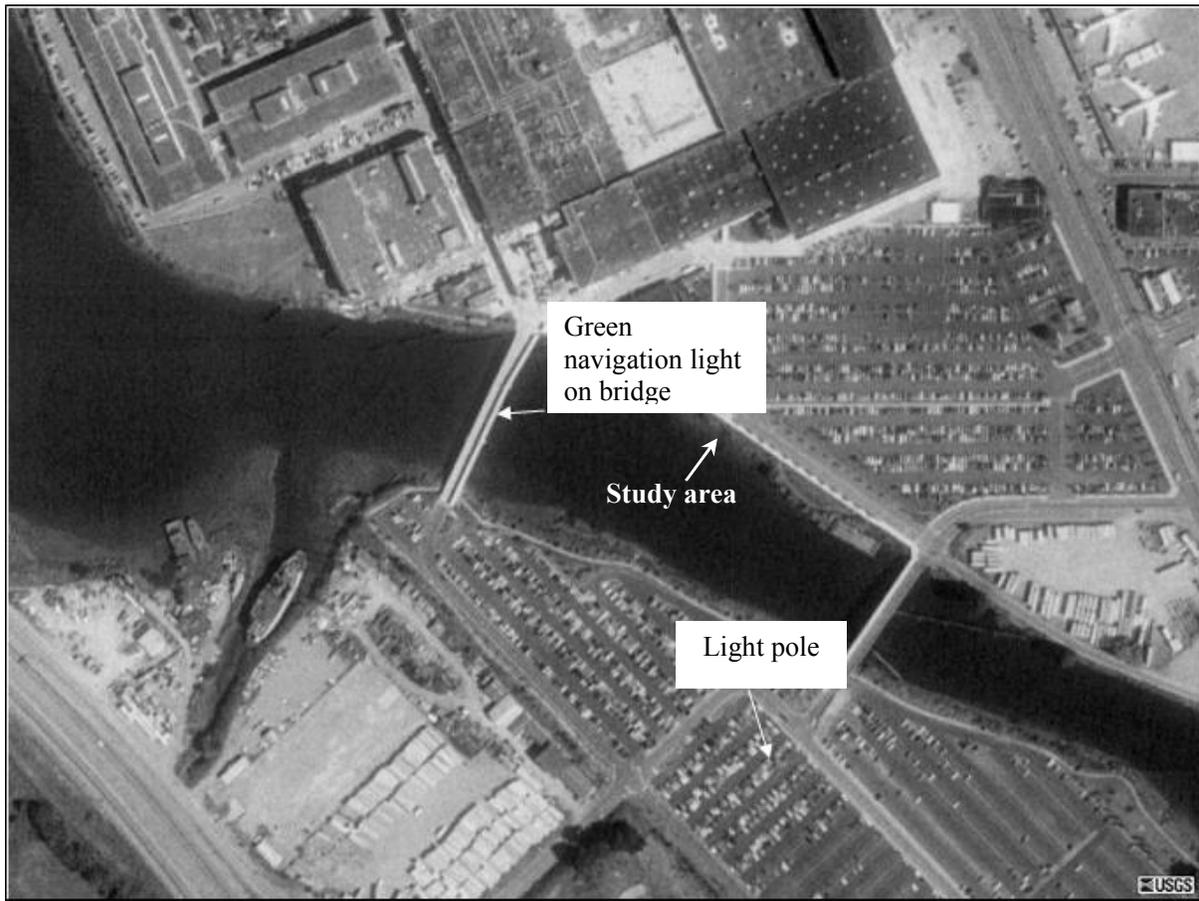
Figure A1. Locations of reference points used for bearings in Table A1.
