State of Washington Department of Ecology  
**Cruise Ship Memorandum of Understanding, Cruise Operations in Washington State Inspection Report**

Inspection Date 06/18/2010	Permit Number NA	County King	Receiving Waters Marine Waters	Ecology Inspector Amy Jankowiak, Compliance Specialist
Entry Time 9:02 am Exit Time 11:20 am	Photos Taken <input checked="" type="checkbox"/> Yes <input type="checkbox"/> No	Samples Taken <input type="checkbox"/> Yes <input checked="" type="checkbox"/> No	Inspection Announced <input checked="" type="checkbox"/> Yes <input type="checkbox"/> No	Discharges to: <input checked="" type="checkbox"/> Surface Water <input type="checkbox"/> Ground Water <input type="checkbox"/> Dewater <input type="checkbox"/> POTW

Name and Location of Site Inspected: RHAPSODY OF THE SEAS, Royal Caribbean International Passenger Vessel Pier 91, Seattle	Additional Participants/Inspectors:
On-Site Representative(s): <i>Name/Title/Phone/e-mail</i> Lizel De Bruin, Environmental Officer RH_EnvironmentalOfficer@rccl.com

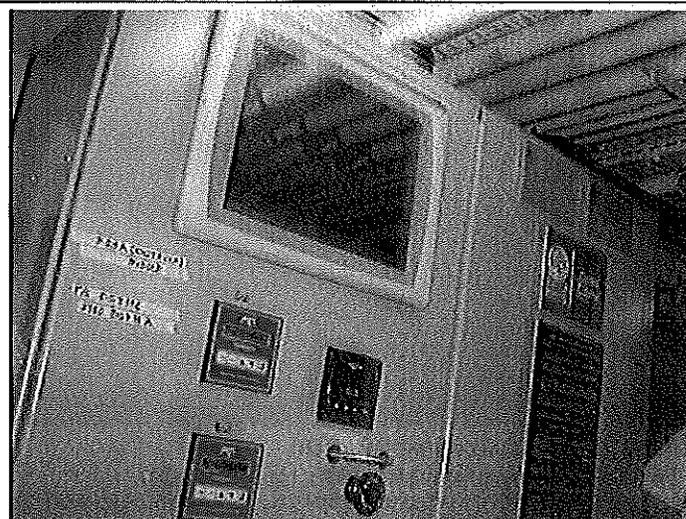
PHOTO #:02 DATE: JUNE 18, 2010  
TAKEN BY: AMY JANKOWIAK FILE No.: P6180024  
DESCRIPTION: NAVALISIS® SYSTEM CONTROLS

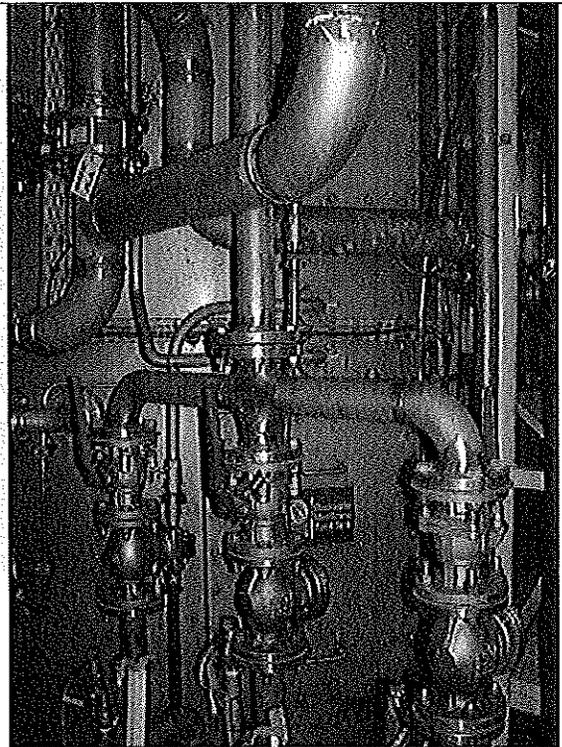
PHOTO #:07 DATE: JUNE 18, 2010  
TAKEN BY: AMY JANKOWIAK FILE No.: P6180029  
DESCRIPTION: NAVALIS® SYSTEM GRAY WATER COMBINES  
WITH BLACKWATER

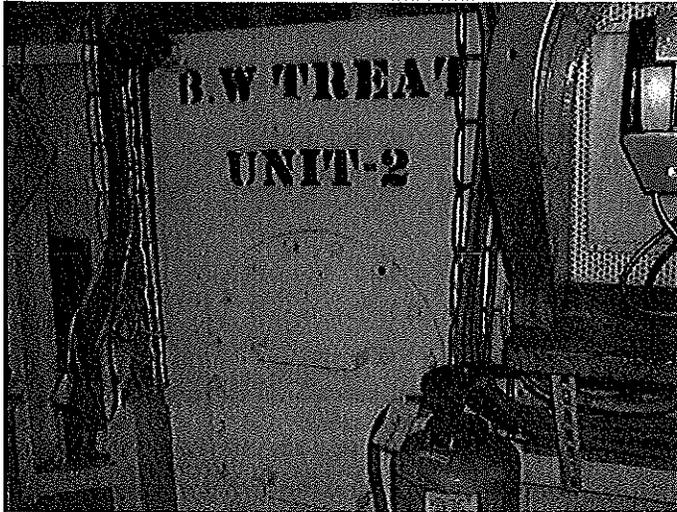
PHOTO #:13 DATE: JUNE 18, 2010  
TAKEN BY: AMY JANKOWIAK FILE No.:P6180037  
DESCRIPTION: HAAMAN TRADITIONAL MSD BLACKWATER  
TREATMENT TANK

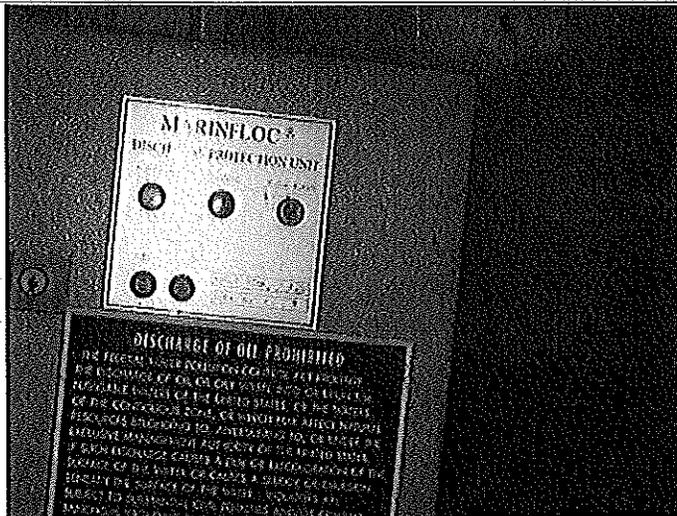
PHOTO #:15 DATE: JUNE 18, 2010  
TAKEN BY: AMY JANKOWIAK FILE No.: P6180040  
DESCRIPTION: OILY WATER SEPARATOR SYSTEM (OWS)

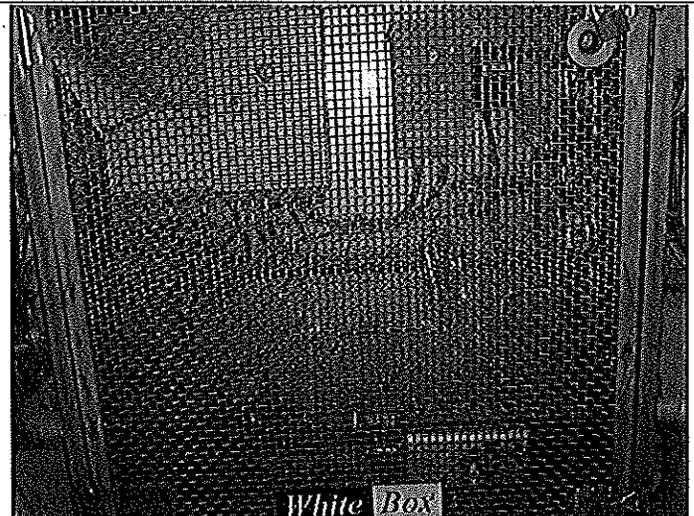
PHOTO #:16 DATE: JUNE 18, 2010  
TAKEN BY: AMY JANKOWIAK FILE No.: P6180041  
DESCRIPTION: OWS WHITE BOX

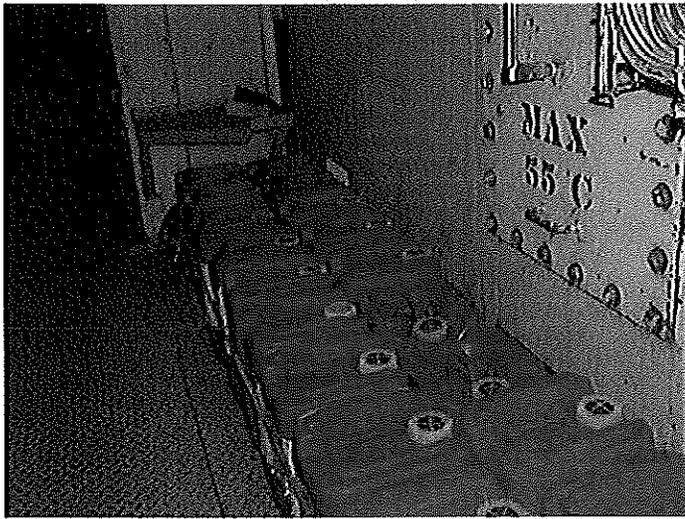
PHOTO #:17 DATE: JUNE 18, 2010  
TAKEN BY: AMY JANKOWIAK FILE No.: P6180043  
DESCRIPTION: EMPTY CONTAINERS TO BE RETURNED

Plastics, some paper, some cardboard, glass (photo #17), pallets, aluminum (photo #22), tin, scrap metals, laundry bins, and batteries are all recycled. Fluorescent lamps are also recycled. They are not crushed on board. Some materials are also donated when feasible. Garbage records looked to be in good order. Food waste is the only solid material being discharged out at sea.

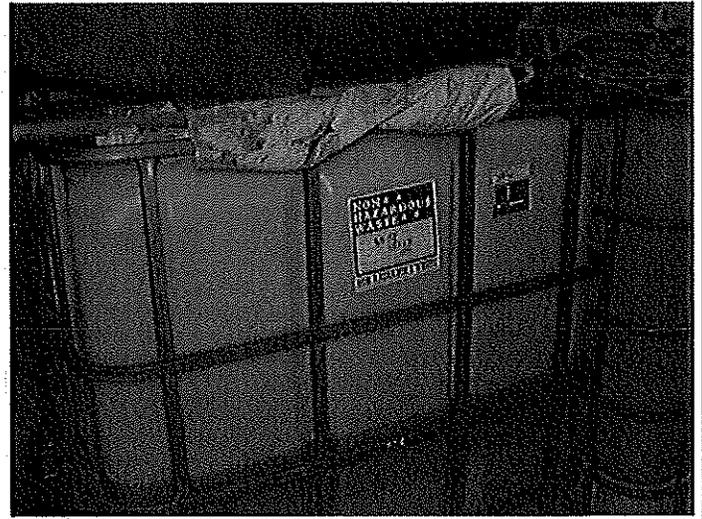
PHOTO #:18 DATE: JUNE 18, 2010  
TAKEN BY: AMY JANKOWIAK FILE No.: P6180045  
DESCRIPTION: USED COOKING OIL

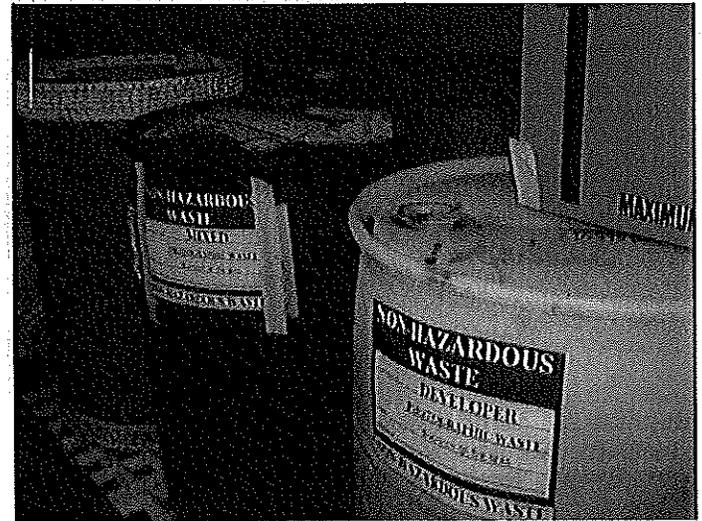
PHOTO #:19 DATE: JUNE 18, 2010  
TAKEN BY: AMY JANKOWIAK FILE No.: P6180047  
DESCRIPTION: HAZARDOUS WASTE (INCLUDING OLD X-RAY  
EQUIPMENT)

The liquid waste is drummed and off-loaded as non-hazardous waste. Other hazardous waste materials (photo #19) include photo waste filters (photo liquid waste from the silver recovery system is sent off as non-hazardous waste), spent chemicals, paints and paint thinners, aerosol condensate and filters from the fluorescent bulb mercury removal system. Hazardous waste is typically off-loaded in Seattle or in Victoria about once every six months. Hazardous waste records were reviewed and appear to be consistent with MOU requirements. In Seattle, Clean Harbors is currently used for off-loads. The last off-load was May 21, 2010.

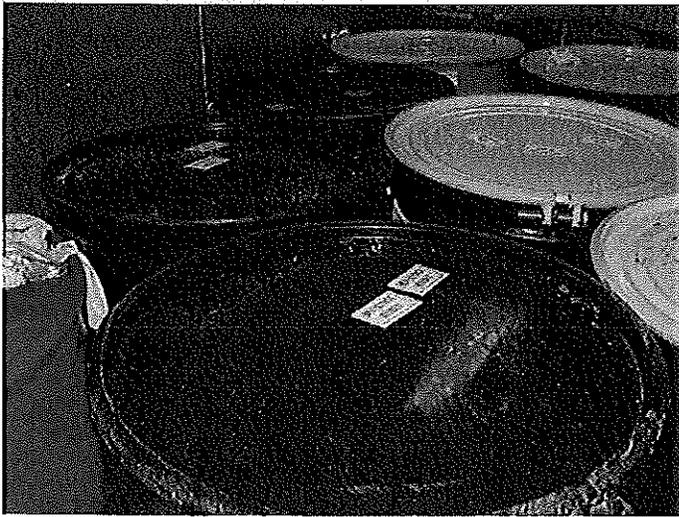
PHOTO #:21 DATE: JUNE 18, 2010  
TAKEN BY: AMY JANKOWIAK FILE No.: P6180049  
DESCRIPTION: OILY SLUDGE FOR OFF-LOADING

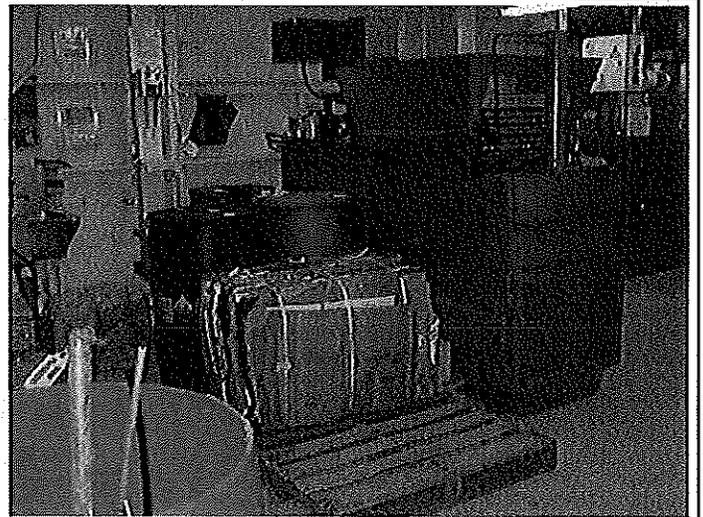
PHOTO #:22 DATE: JUNE 18, 2010  
TAKEN BY: AMY JANKOWIAK FILE No.: P6180050  
DESCRIPTION: GARBAGE/RECYCLE AREA

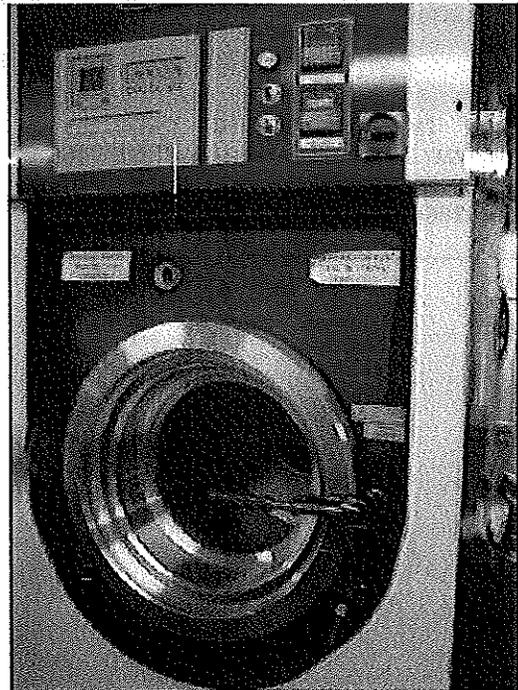
PHOTO #:28 DATE: JUNE 18, 2010  
TAKEN BY: AMY JANKOWIAK FILE No.: P6180060  
DESCRIPTION: DRY CLEANING SYSTEM

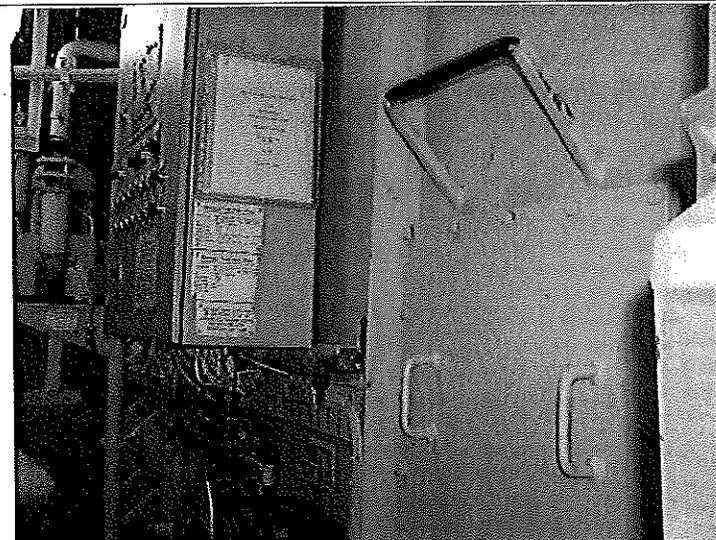
PHOTO #:04 DATE: JULY 6, 2010  
TAKEN BY: AMY JANKOWIAK FILE No.: P7060063  
DESCRIPTION: BLACK WATER TREATMENT SYSTEM (TRITON) (1 OF 4)

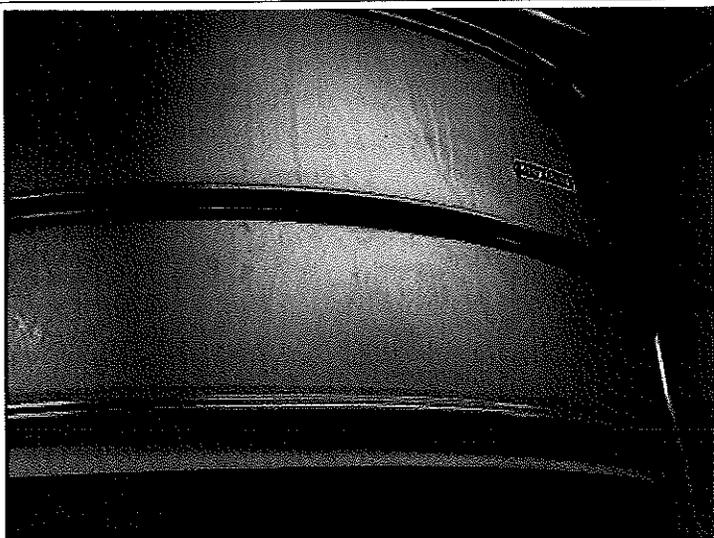
PHOTO #:09 DATE: JULY 6, 2010  
TAKEN BY: AMY JANKOWIAK FILE No.: P7060068  
DESCRIPTION: GRAY WATER TREATMENT SYSTEM SWECO  
(PRE-FILTER) FOR NON-WORKING AWTS

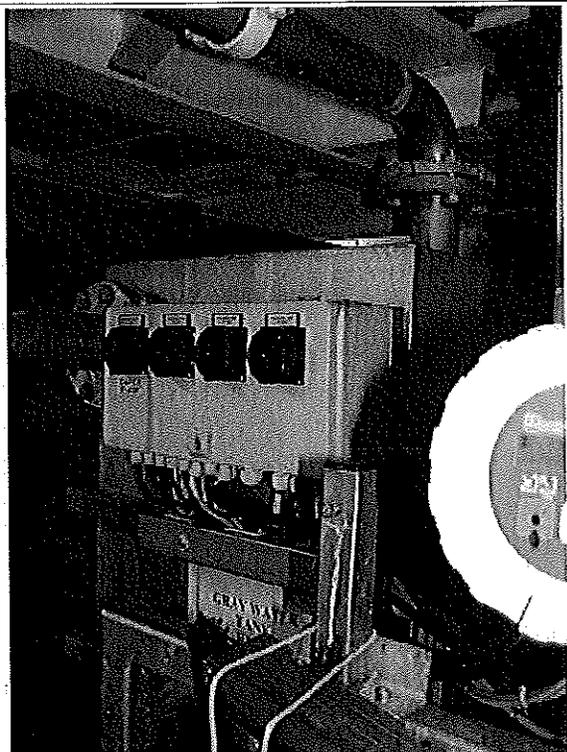
PHOTO #:10 DATE: JULY 6, 2010  
TAKEN BY: AMY JANKOWIAK FILE No.: P7060069  
DESCRIPTION: GRAY WATER TREATMENT SYSTEM SWECO  
(PRE-FILTER) FOR NON-WORKING AWTS

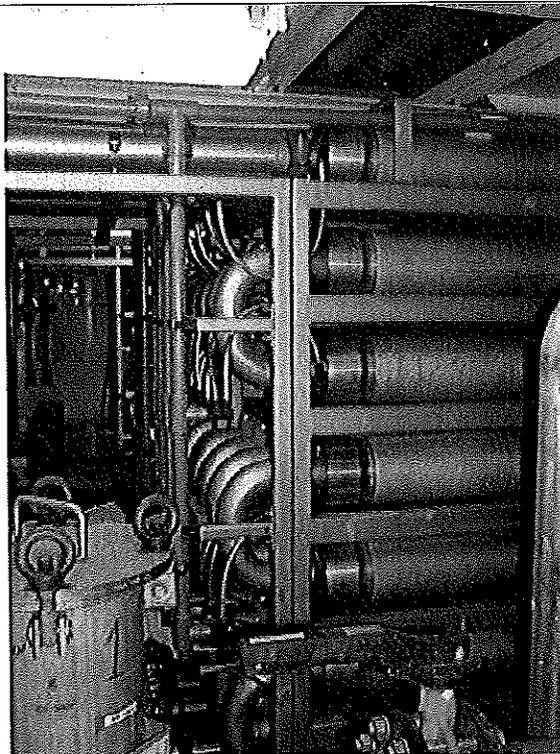
PHOTO #:11 DATE: JULY 6, 2010  
TAKEN BY: AMY JANKOWIAK FILE No.: P7060070  
DESCRIPTION: GRAY WATER TREATMENT SYSTEM PRE-RO  
TANK (FOR NON-WORKING AWTS)

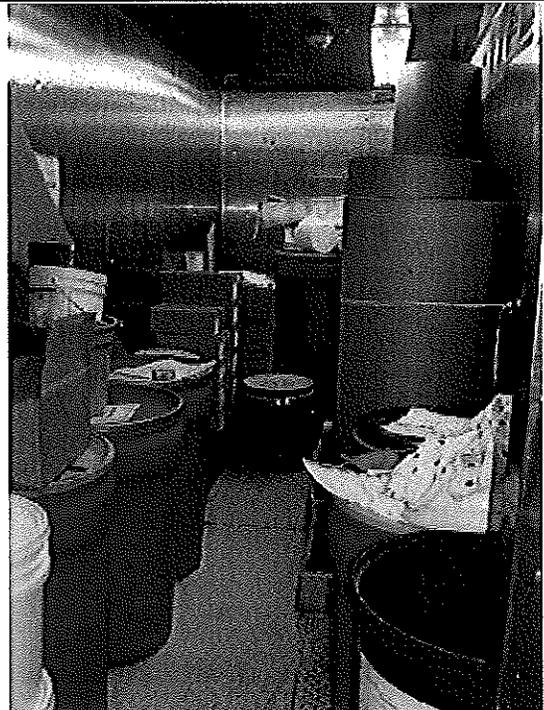
PHOTO #:18 DATE: JULY 6, 2010  
TAKEN BY: AMY JANKOWIAK FILE No.: P7060078  
DESCRIPTION: HAZARDOUS WASTE STORAGE

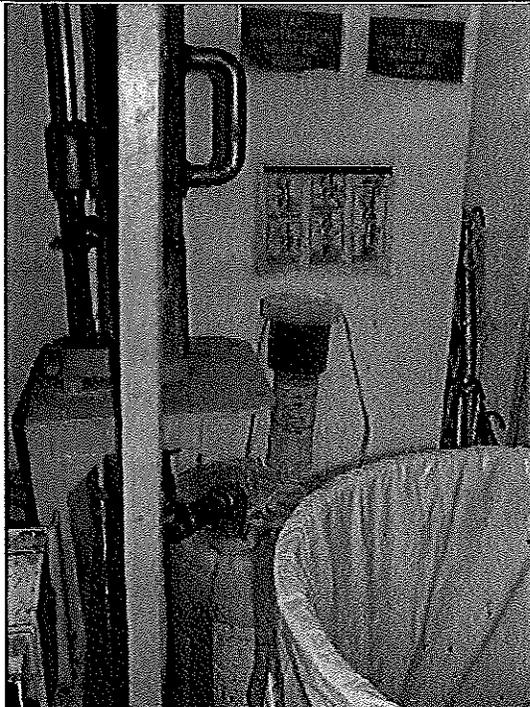
PHOTO #:21 DATE: JULY 6, 2010  
TAKEN BY: AMY JANKOWIAK FILE No.:P7060081  
DESCRIPTION: AEROSOL WASTE COLLECTION SYSTEM

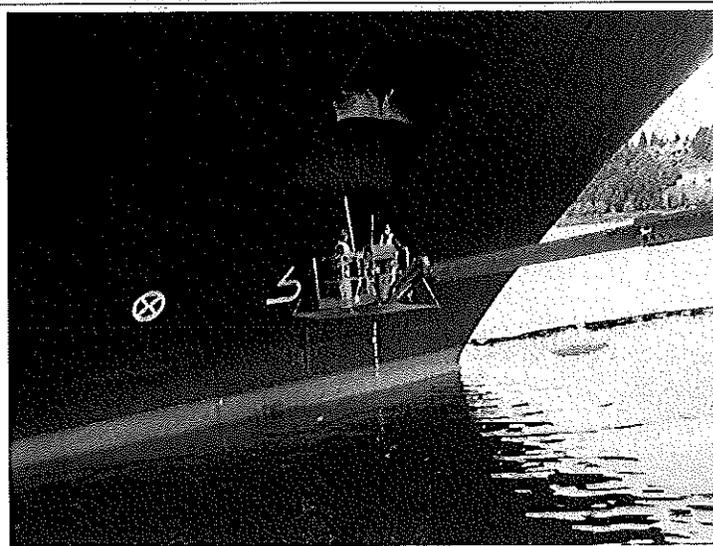
PHOTO #:02 DATE: JULY 31, 2010  
TAKEN BY: KEVIN C. FITZPATRICK FILE No.: P7310001  
DESCRIPTION: PAINTING ON ROTTERDAM WITH CHERRY PICKER  
AND TARP

It is recommended that the crew continue to take care with implementing best management practices when conducting any ship painting or maintenance while in port.

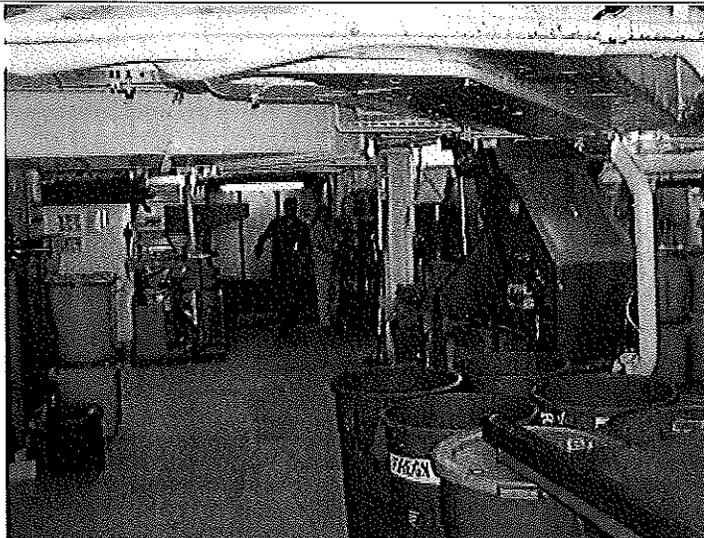
PHOTO #:07 DATE: JULY 31, 2010  
TAKEN BY: KEVIN C. FITZPATRICK FILE No.: P7310011  
DESCRIPTION: GARBAGE/RECYCLING ROOM

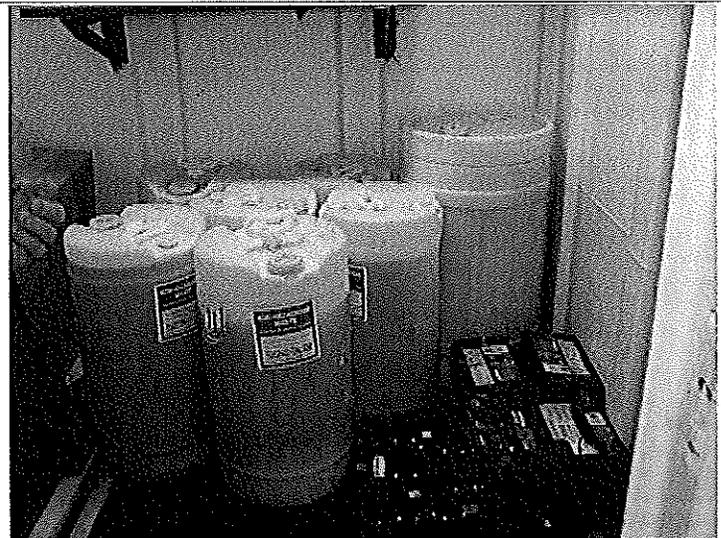
PHOTO #:08 DATE: JULY 31, 2010  
TAKEN BY: KEVIN C. FITZPATRICK FILE No.: P7310012  
DESCRIPTION: HAZARDOUS WASTE STORAGE

Dry cleaning no longer uses PERC, instead, a Miele system is used. Miele is a no-solvent based cleaner. Photo waste goes through a silver recovery system and is then off-loaded at less than 5ppm. X-ray's are done digitally, and do not have a waste product. Other hazardous waste materials (photo #08) including paints and thinners, and batteries, and

aerosol condensate, are off-loaded in Victoria, Canada. Hazardous waste records were reviewed and appear to be consistent with MOU requirements.

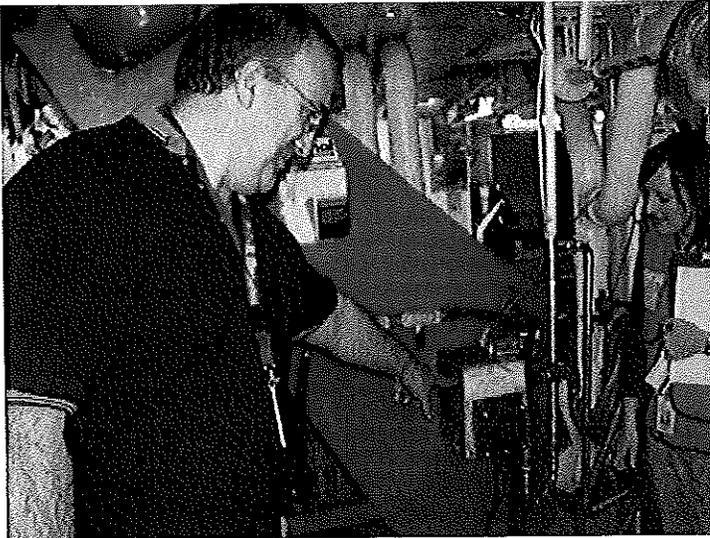
PHOTO #:09 DATE: JULY 31, 2010  
TAKEN BY: KEVIN C. FITZPATRICK FILE No.:P7310013  
DESCRIPTION: FOOD WASTE PRESS

Food waste is collected in various locations and is sent to the pulping system (photo #09). The food is separated in the main kitchens into three bins, garbage (gray), recycle (blue) and food (yellow) (photos #21 and #22). The Environmental Officer oversees the source separation and training. Some food wastes such as pineapple rinds, banana peels, and coffee, which clogs up the pulpers, is sent to the incinerators. The pulped food waste is discharged out at Sea. Used cooking oil (photo #06) is reused as biofuel by being burned with heavy fuel.

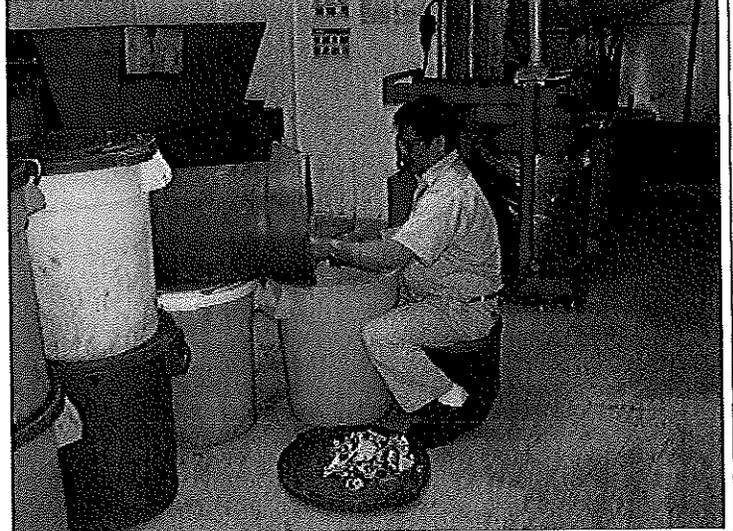
PHOTO #:10 DATE: JULY 31, 2010  
TAKEN BY: KEVIN C. FITZPATRICK FILE No.: P7310014  
DESCRIPTION: GARBAGE/RECYCLING SORTING

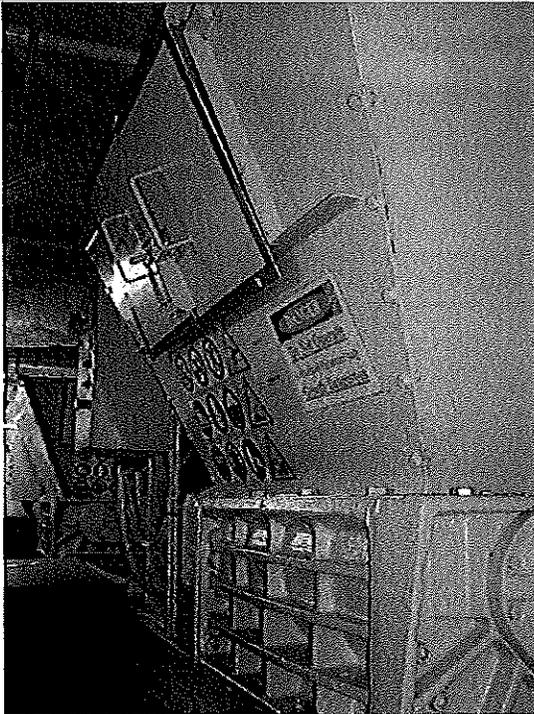
PHOTO #:03 DATE: AUGUST 16, 2010  
TAKEN BY: AMY JANKOWIAK FILE No.: P8160003  
DESCRIPTION: INCINERATOR RECEPTION

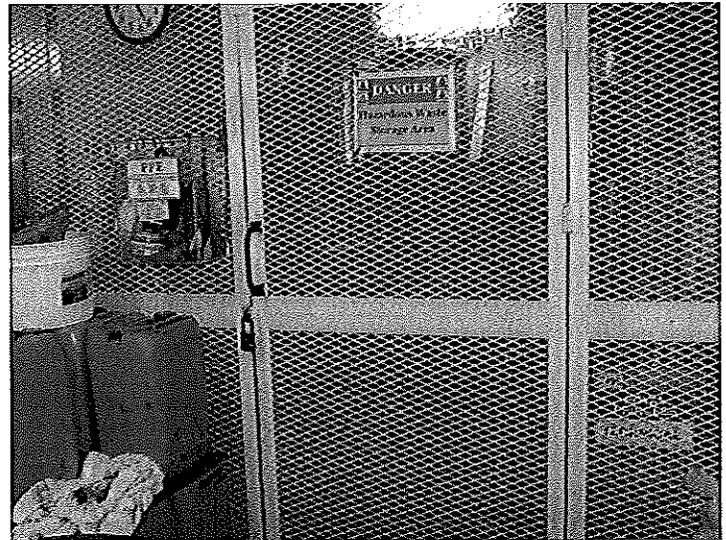
PHOTO #:04 DATE: AUGUST 16, 2010  
TAKEN BY: AMY JANKOWIAK FILE No.: P8160004  
DESCRIPTION: HAZARDOUS WASTE STORAGE LOCKER

The vessel does not offer dry cleaning services. Phosphate-free detergents are used in the laundry. Silver is captured from the photo and x-ray waste, and is treated to less than 5 ppm and is then incinerated. Hazardous wastes include chemicals, oily rags, printer cartridges, paints, batteries, bulbs (no crusher on board), sludge oil, aerosols (punctured), and sharps. All hazardous waste (photos #04 and #05) is off-loaded in Victoria.

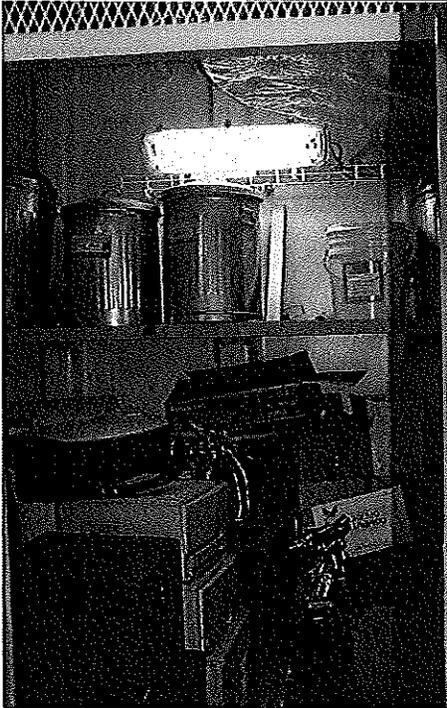
PHOTO #:05 DATE: AUGUST 16, 2010  
TAKEN BY: AMY JANKOWIAK FILE No.: P8160005  
DESCRIPTION: HAZARDOUS WASTE MATERIALS

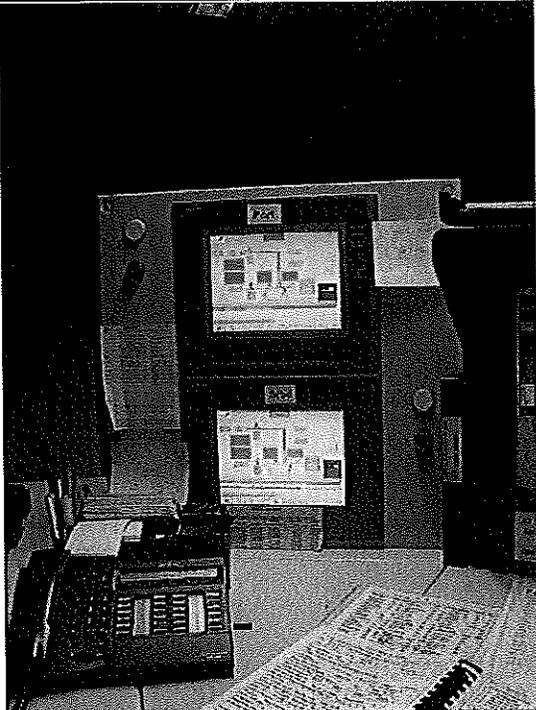
PHOTO #:09 DATE: AUGUST 16, 2010  
TAKEN BY: AMY JANKOWIAK FILE No.: P8160009  
DESCRIPTION: MBR TREATMENT SYSTEM DIAGRAMS IN ENGINE CONTROL ROOM

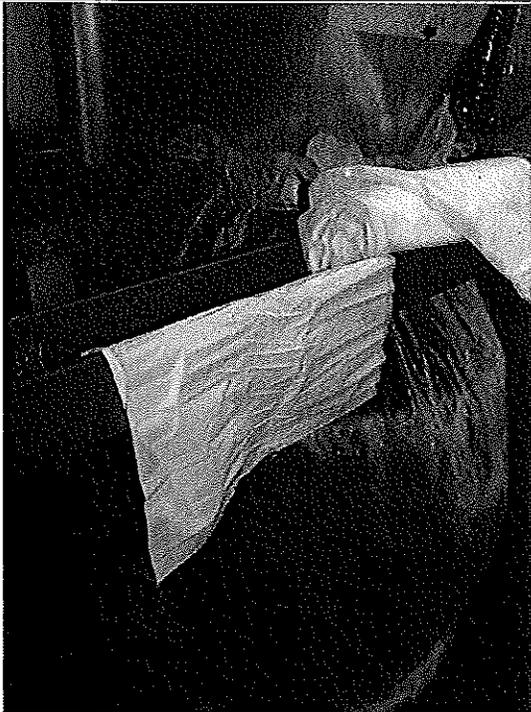
PHOTO #:15 DATE: AUGUST 16, 2010  
TAKEN BY: AMY JANKOWIAK FILE No.: P8160016  
DESCRIPTION: HAMWORTHY FILTER PRESS SCREENINGS

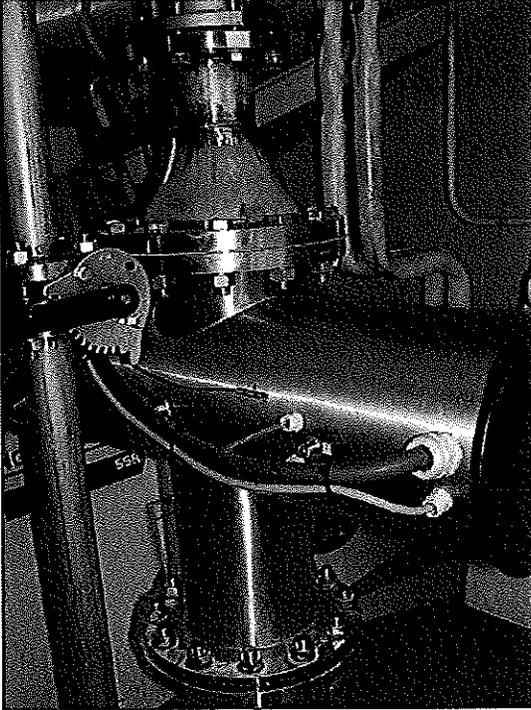
PHOTO #:17 DATE: AUGUST 16, 2010  
TAKEN BY: AMY JANKOWIAK FILE No.: P8160020  
DESCRIPTION: HAMWORTHY ULTRAVIOLET DISINFECTION UNIT

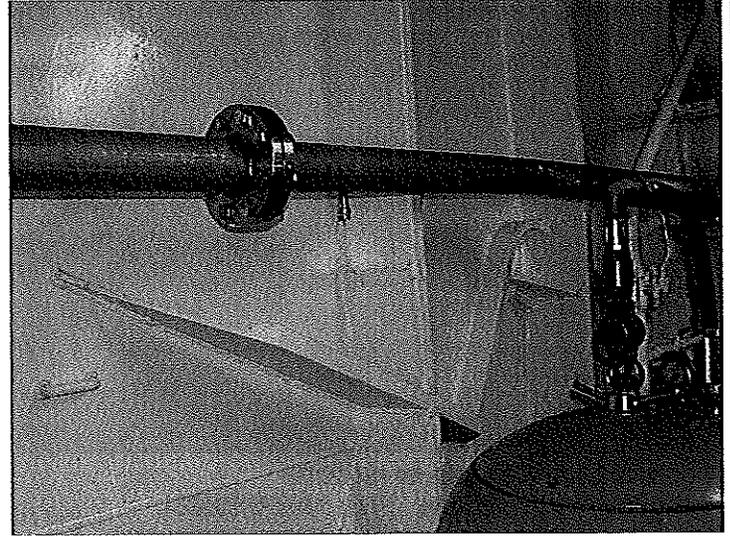
PHOTO #:18 DATE: AUGUST 16, 2010  
TAKEN BY: AMY JANKOWIAK FILE No.: P8160021  
DESCRIPTION: HAMWORTHY DISCHARGE SAMPLE POINT

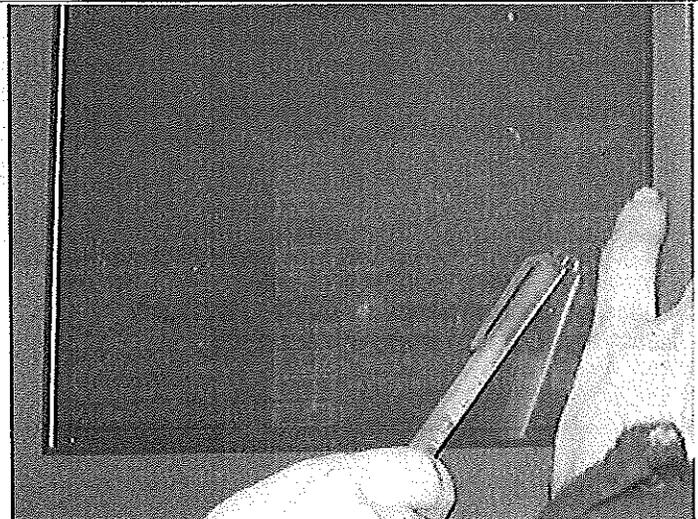
PHOTO #:04 DATE: AUGUST 29, 2010  
TAKEN BY: LORI LEVANDER FILE No.: P8290056  
DESCRIPTION: ALARM SETTINGS FOR SCANSHIP SYSTEM

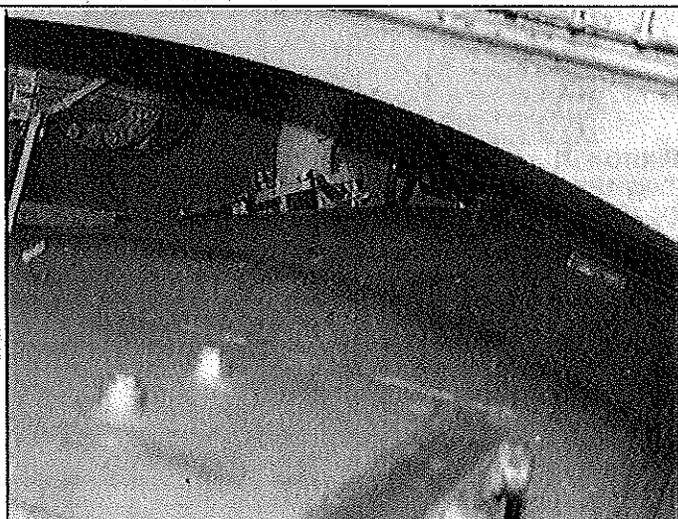
PHOTO #:08 DATE: AUGUST 29, 2010  
TAKEN BY: LORI LEVANDER FILE No.: P8290064  
DESCRIPTION: FOOD WASTE PULPER TANK

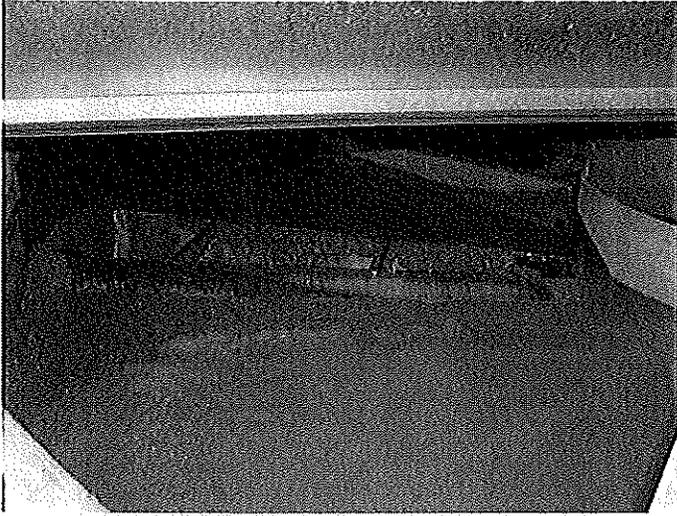
PHOTO #:37 DATE: AUGUST 29, 2010  
TAKEN BY: AMY JANKOWIAK FILE No.:P8290141  
DESCRIPTION: FLOTATION TANK – LID OPEN

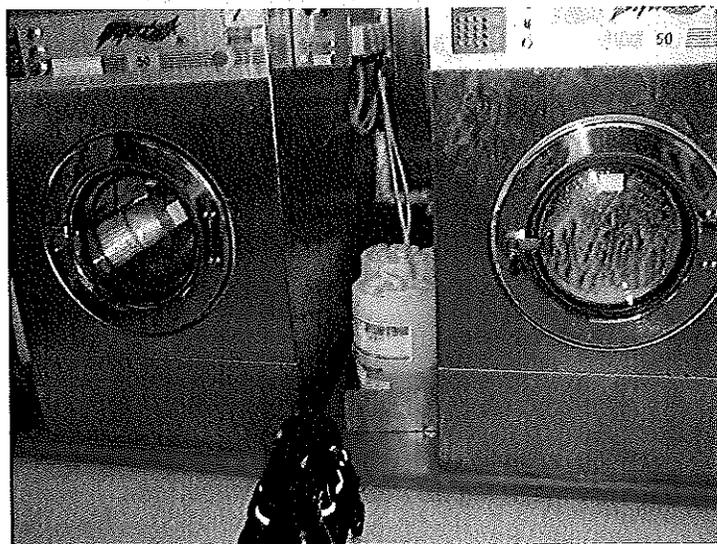
PHOTO #:03 DATE: SEPTEMBER 12, 2010  
TAKEN BY: AMY JANKOWIAK FILE No.:P9120007  
DESCRIPTION: DRY - WET CLEANING MACHINES

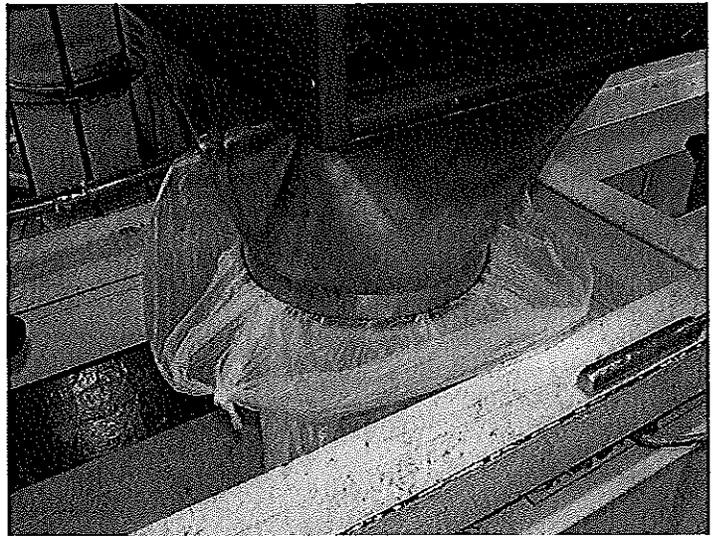
PHOTO #:06 DATE: SEPTEMBER 12, 2010  
TAKEN BY: AMY JANKOWIAK FILE No.:P9120012  
DESCRIPTION: SCREEN PRESS SCREENINGS TO BAG

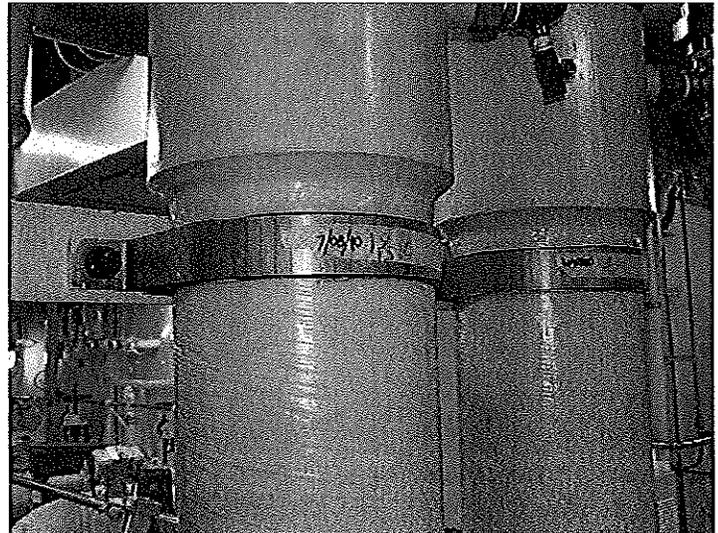
PHOTO #:14 DATE: SEPTEMBER 12, 2010  
TAKEN BY: AMY JANKOWIAK FILE No.:P9120022  
DESCRIPTION: MEMBRANE FILTERS CLEANING DATES NOTED

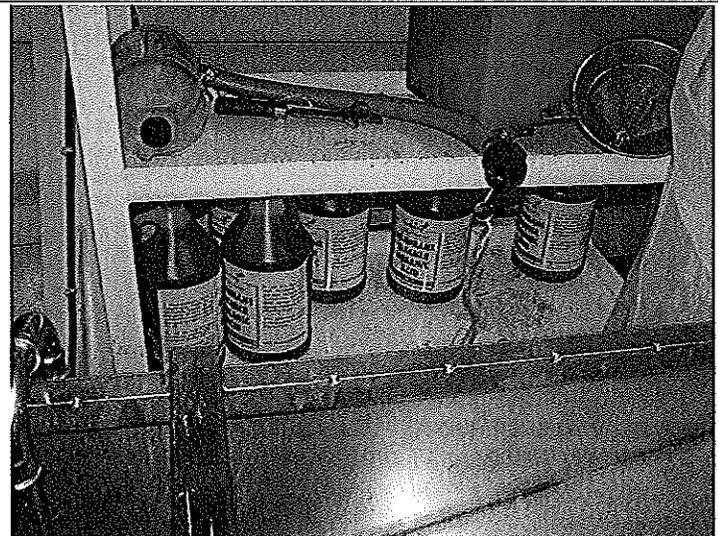
PHOTO #:16 DATE: SEPTEMBER 12, 2010  
TAKEN BY: AMY JANKOWIAK FILE No.:P9120024  
DESCRIPTION: MEMBRANE FILTERS CLEANING CHEMICALS  
(MEMBRANE CLEANER ORGANIC ACID)

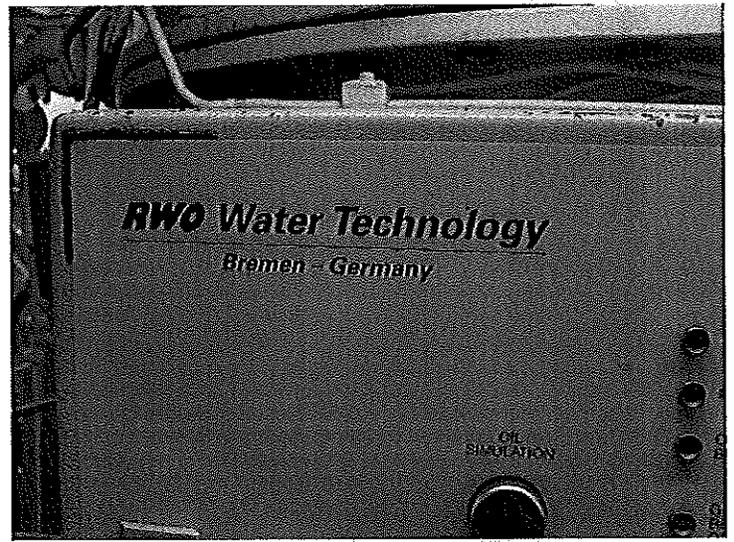
PHOTO #:18 DATE: SEPTEMBER 12, 2010  
TAKEN BY: AMY JANKOWIAK FILE No.:P9120026  
DESCRIPTION: OILY WATER SEPARATOR

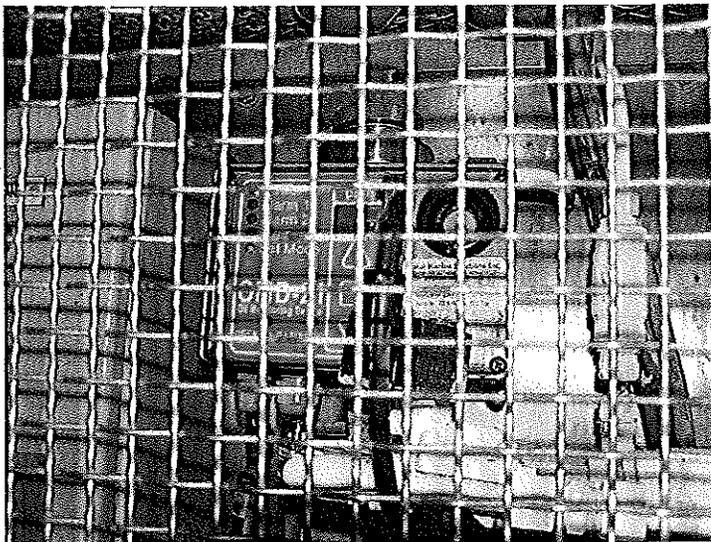
PHOTO #:19 DATE: SEPTEMBER 12, 2010  
TAKEN BY: AMY JANKOWIAK FILE No.:P9120028  
DESCRIPTION: OILY WATER SEPARATOR WHITE BOX

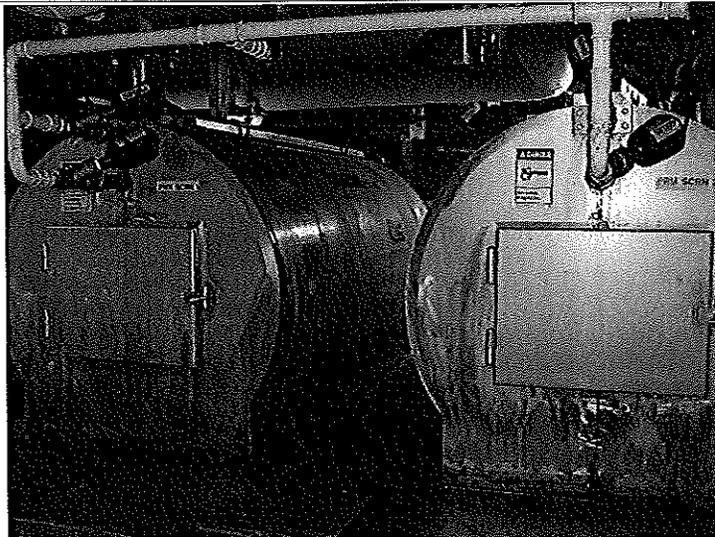
PHOTO #:11 DATE: SEPTEMBER 20, 2010  
TAKEN BY: AMY JANKOWIAK FILE No.:P9200011  
DESCRIPTION: PRIMARY SCREENS

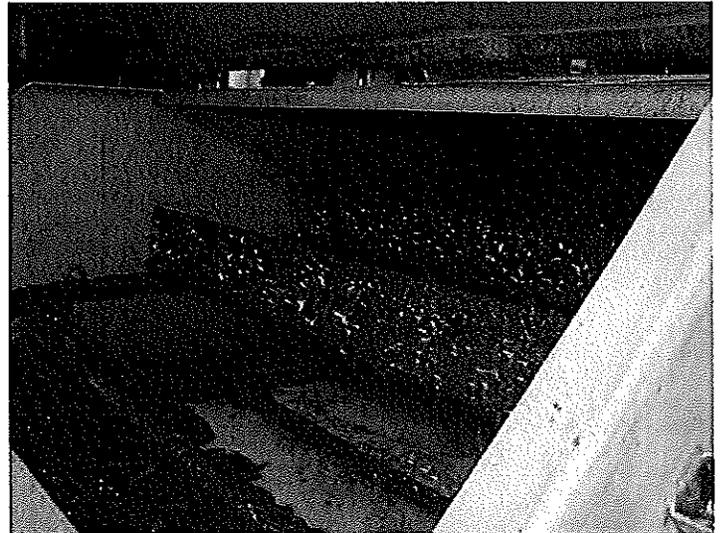
PHOTO #:13 DATE: SEPTEMBER 20, 2010 13  
TAKEN BY: AMY JANKOWIAK FILE No.:P92000  
DESCRIPTION: DISSOLVED AIR FLOTATION (DAF)

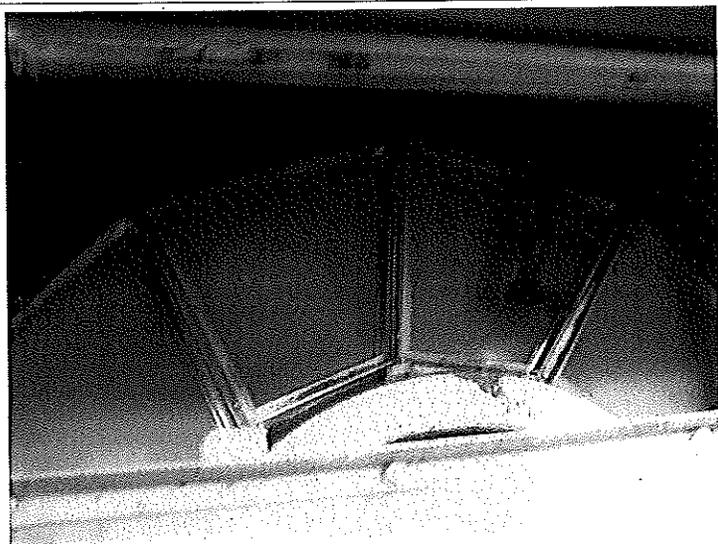
PHOTO #:17 DATE: SEPTEMBER 20, 2010  
TAKEN BY: AMY JANKOWIAK FILE No.:P9200017  
DESCRIPTION: VIEW INSIDE OF POLISHING FILTER

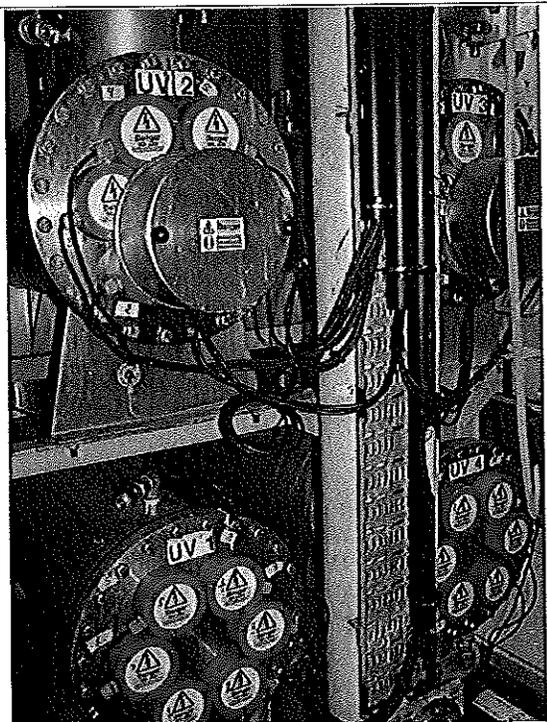
PHOTO #:19 DATE: SEPTEMBER 20, 2010  
TAKEN BY: AMY JANKOWIAK FILE No.:P9200020  
DESCRIPTION: ULTRAVIOLET DISINFECTION UNITS

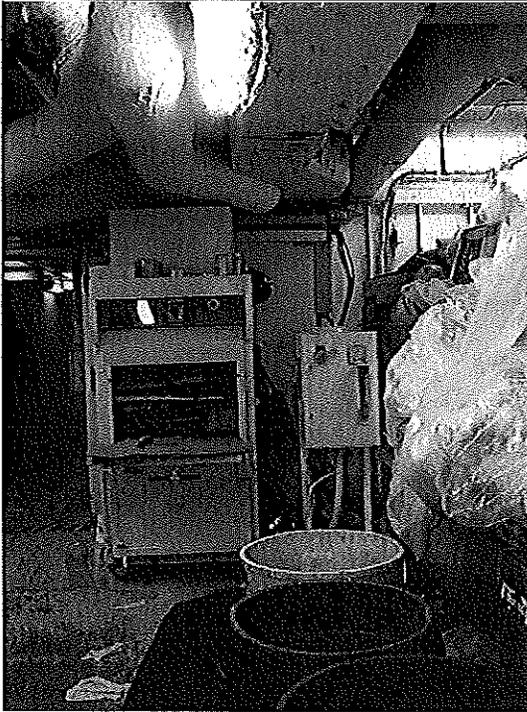
PHOTO #:28 DATE: SEPTEMBER 20, 2010  
TAKEN BY: AMY JANKOWIAK FILE No.:P9200031  
DESCRIPTION: GLASS CRUSHERS

Materials such as aluminum (photo #25), tin (photo #26), cardboard (photos #24 and #29), paper, glass (photo #28), some plastics, and scrap metal are recycled (photo #24). Some papers, some plastics, some biohazardous materials, sharps, expired medications and narcotics and oily rags are incinerated. Incinerators are used when the vessel is greater than four nautical miles from port. Ash (photo #27) is offloaded as hazardous waste.

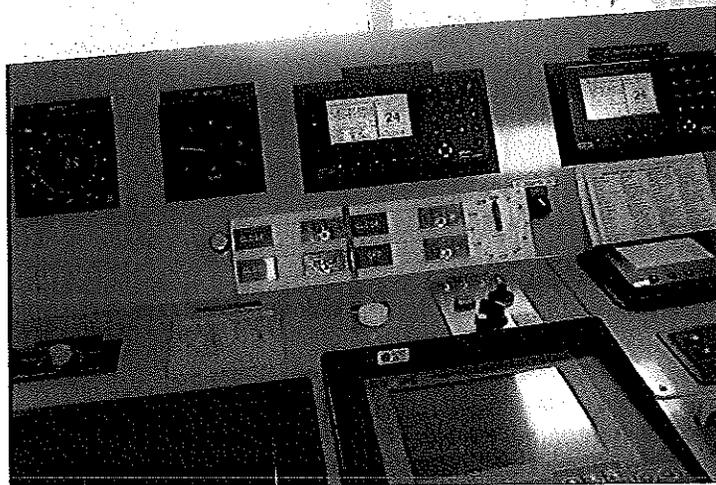
PHOTO #:01 DATE: SEPTEMBER 24, 2010  
TAKEN BY: AMY JANKOWIAK FILE No.:P9240001  
DESCRIPTION: BRIDGE – DISCHARGE VALVE DISPLAY

Only upon verification of location between the Bridge (photo #01) and the Engine Control Room (ECR) (photo #18), will a discharge occur at greater than 12 nautical miles and outside of MOU waters and outside of the Olympic Coast National Marine Sanctuary. The Bridge authorizes the discharge. The latitude and longitude coordinates are recorded in the *Sewage and Graywater Discharge Record Book* and in the deck log. There is an overboard valve monitoring system (photo #02) on the bridge and the ECR has lights monitoring discharges. The date, time and location of both the start and the stop of the discharges are recorded, along with port location, effluent type, volumes, and speed. Discharges are tentatively scheduled ahead of time by matrix (photo #03), but are locations are always verified prior to discharges. All

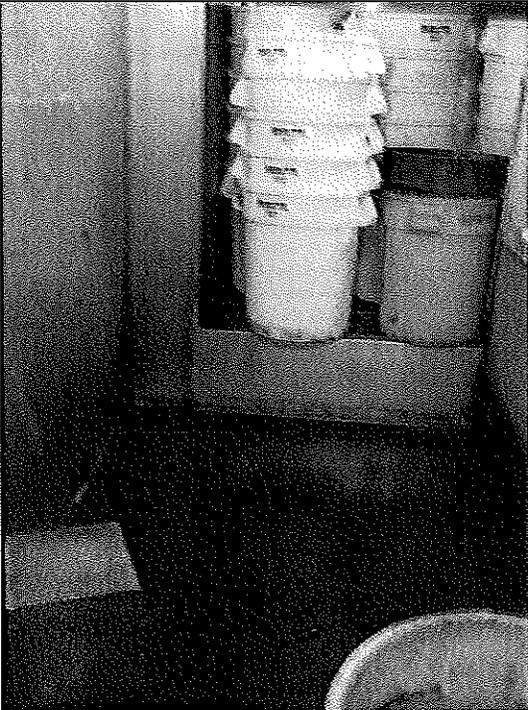
PHOTO #:12 DATE: SEPTEMBER 24, 2010  
TAKEN BY: AMY JANKOWIAK FILE No.:P9240016  
DESCRIPTION: FOOD WASTE FROM PULPERS

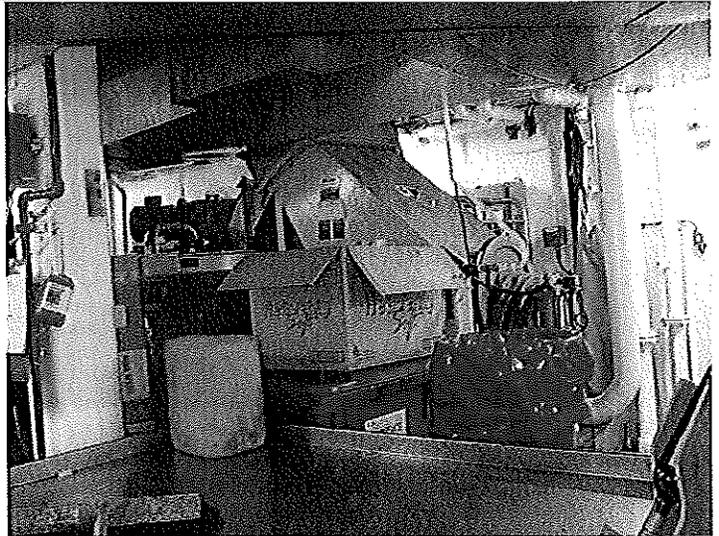
PHOTO #:15 DATE: SEPTEMBER 24, 2010  
TAKEN BY: AMY JANKOWIAK FILE No.:P9240019  
DESCRIPTION: SOMAT PRESS FOR FOOD WASTE

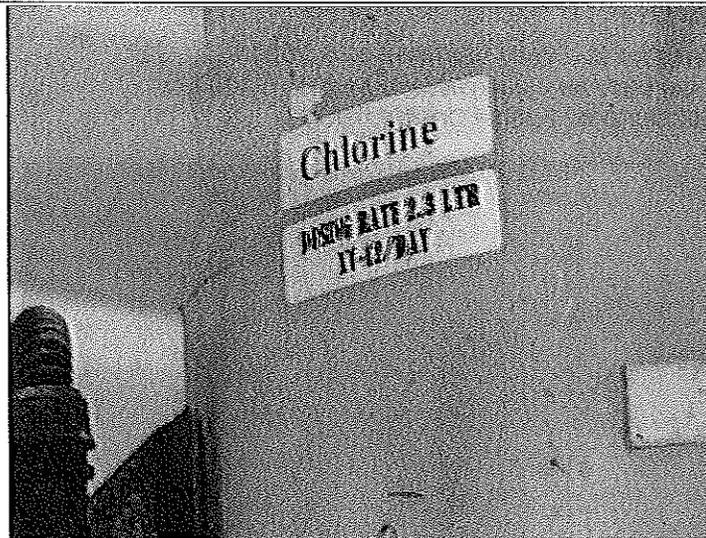
PHOTO #22 DATE: SEPTEMBER 24, 2010  
TAKEN BY: AMY JANKOWIAK FILE No.:P9240027  
DESCRIPTION: MSD CHLORINE ADDITION

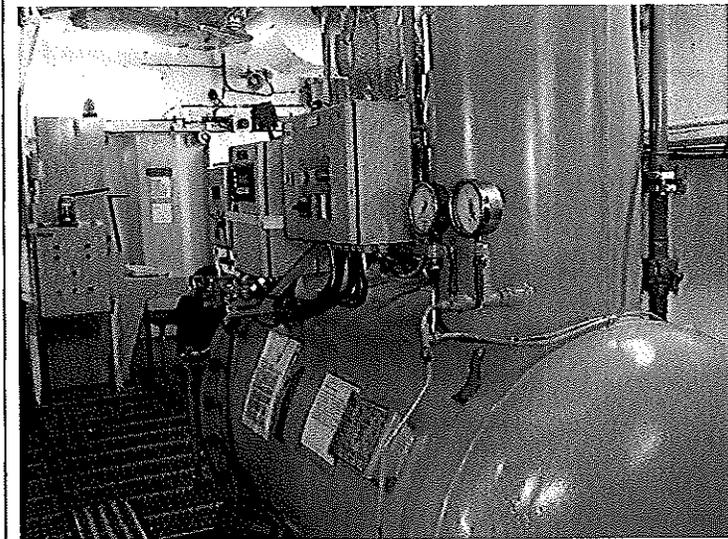
PHOTO #:25 DATE: SEPTEMBER 24, 2010  
TAKEN BY: AMY JANKOWIAK FILE No.:P9240031  
DESCRIPTION: OWS FACET 50 PPM SYSTEM

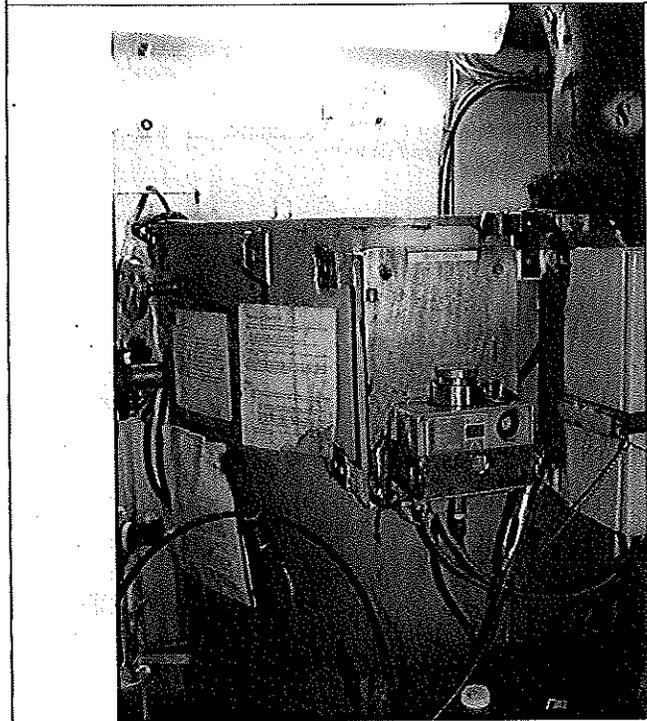
PHOTO #:27 DATE: SEPTEMBER 24, 2010  
TAKEN BY: AMY JANKOWIAK FILE No.:P9240034  
DESCRIPTION: OWS SERAP 15 PPM SYSTEM

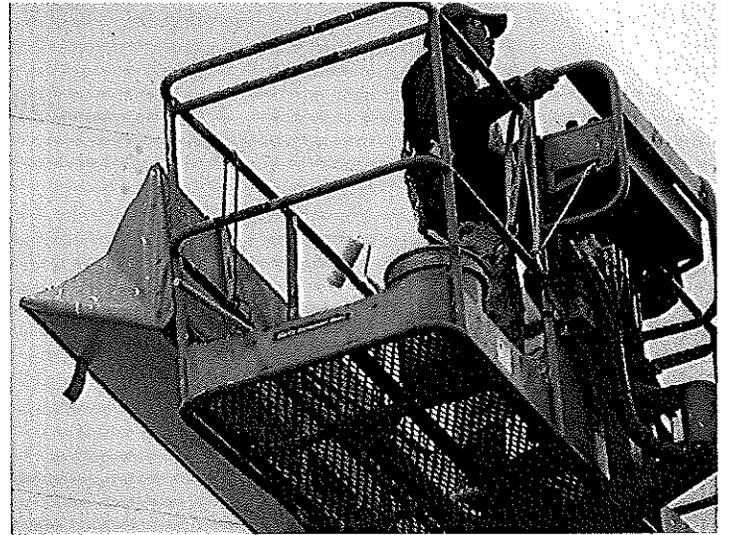
PHOTO #:38 DATE: SEPTEMBER 24, 2010  
TAKEN BY: AMY JANKOWIAK FILE No.:P9240050  
DESCRIPTION: CHERRY PICKER PREP FOR PAINT TOUCH UP ON  
OUTSIDE OF VESSEL
