Asotin Creek Temperature Straight-to-Implementation Vegetation Study

February 2012

Publication No. 12-03-014

Environmental Assessment Program
Eastern Regional Office
Washington State Department of Ecology
Spokane, WA 99205

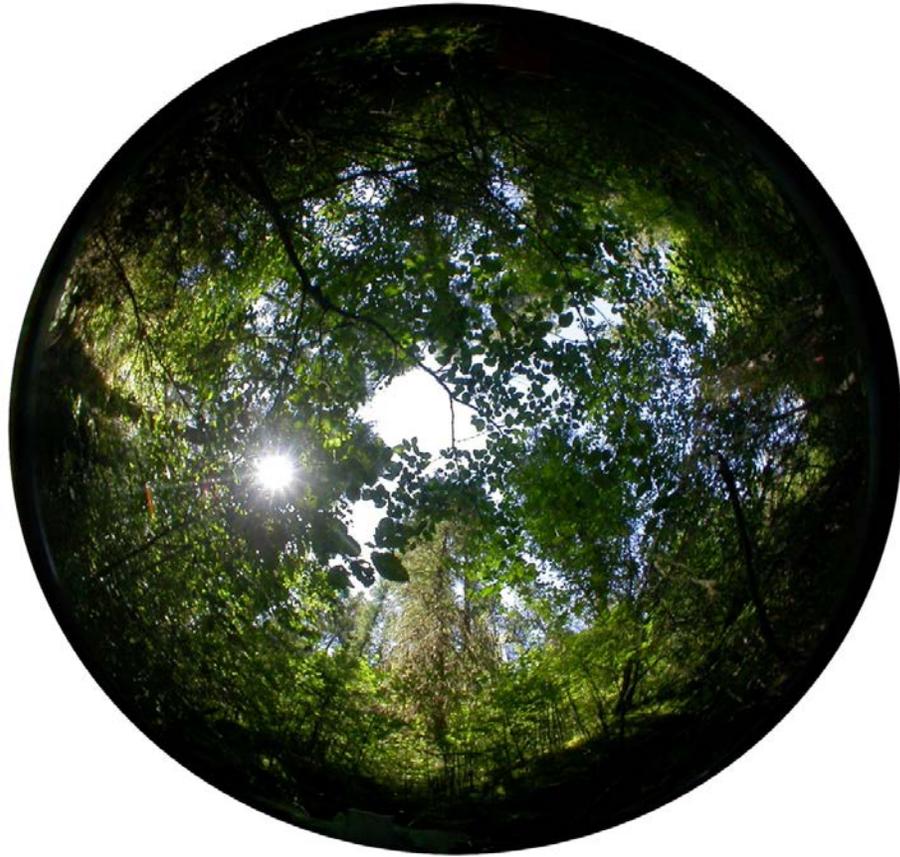
Cover photo: Hemispherical photo of riparian vegetation, taken along Lick Creek about 2 miles upstream of the Forest Service boundary.

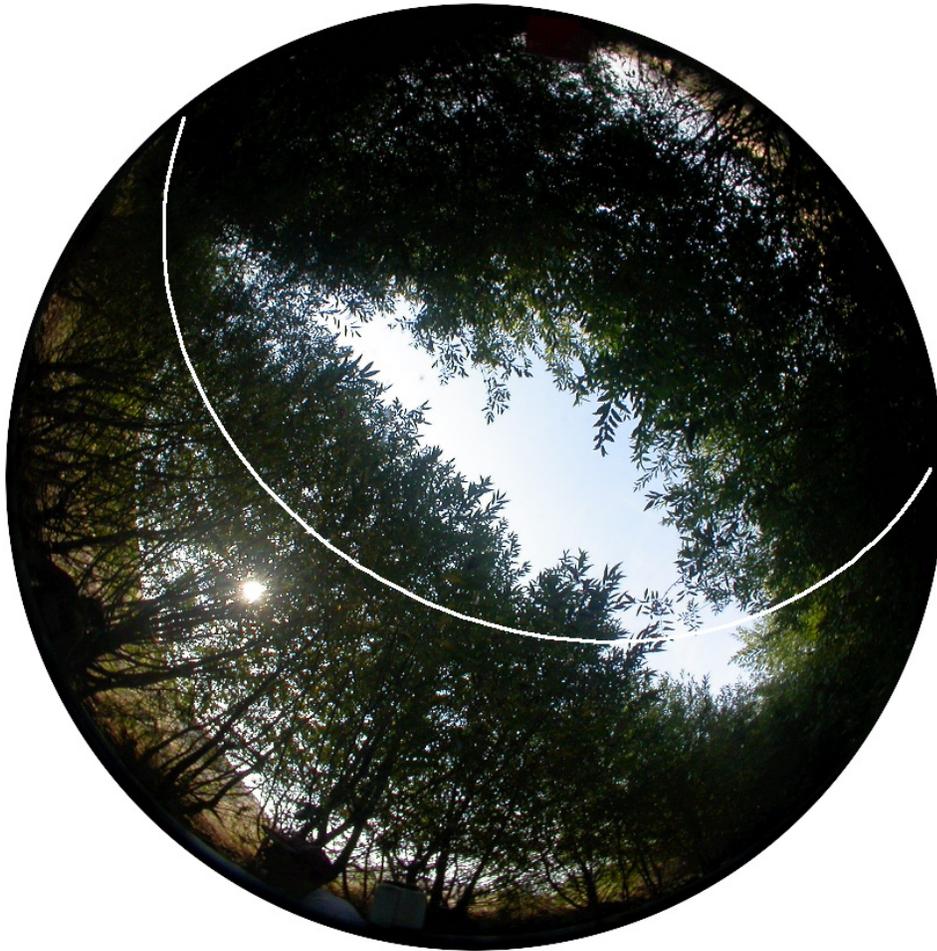
Figure 6. Hemispherical photo of restored vegetation along George Creek, looking skyward from the stream channel.

The white line shows the solar path on August 1st. The vegetation blocks the vast majority of solar radiation through the course of the day.

The planted riparian vegetation at the George Creek and S.F. Asotin Creek meander reconstruction projects is, 4-13 years after establishment, quite effective at blocking solar radiation from the stream (Figure 6). At the George Creek older age class site, current effective shade essentially matches potential shade. Given a few more years of growth it is likely that the George Creek younger age class and S.F. Asotin Creek sites will also reach this point.
