M E M O R A N D U M

March 5, 1981

To: John Bernhardt
From: Tim Determan *TAD*
Subject: Effects of Tamoshan STP Outfall on Water Quality at Silver Spit, Budd Inlet

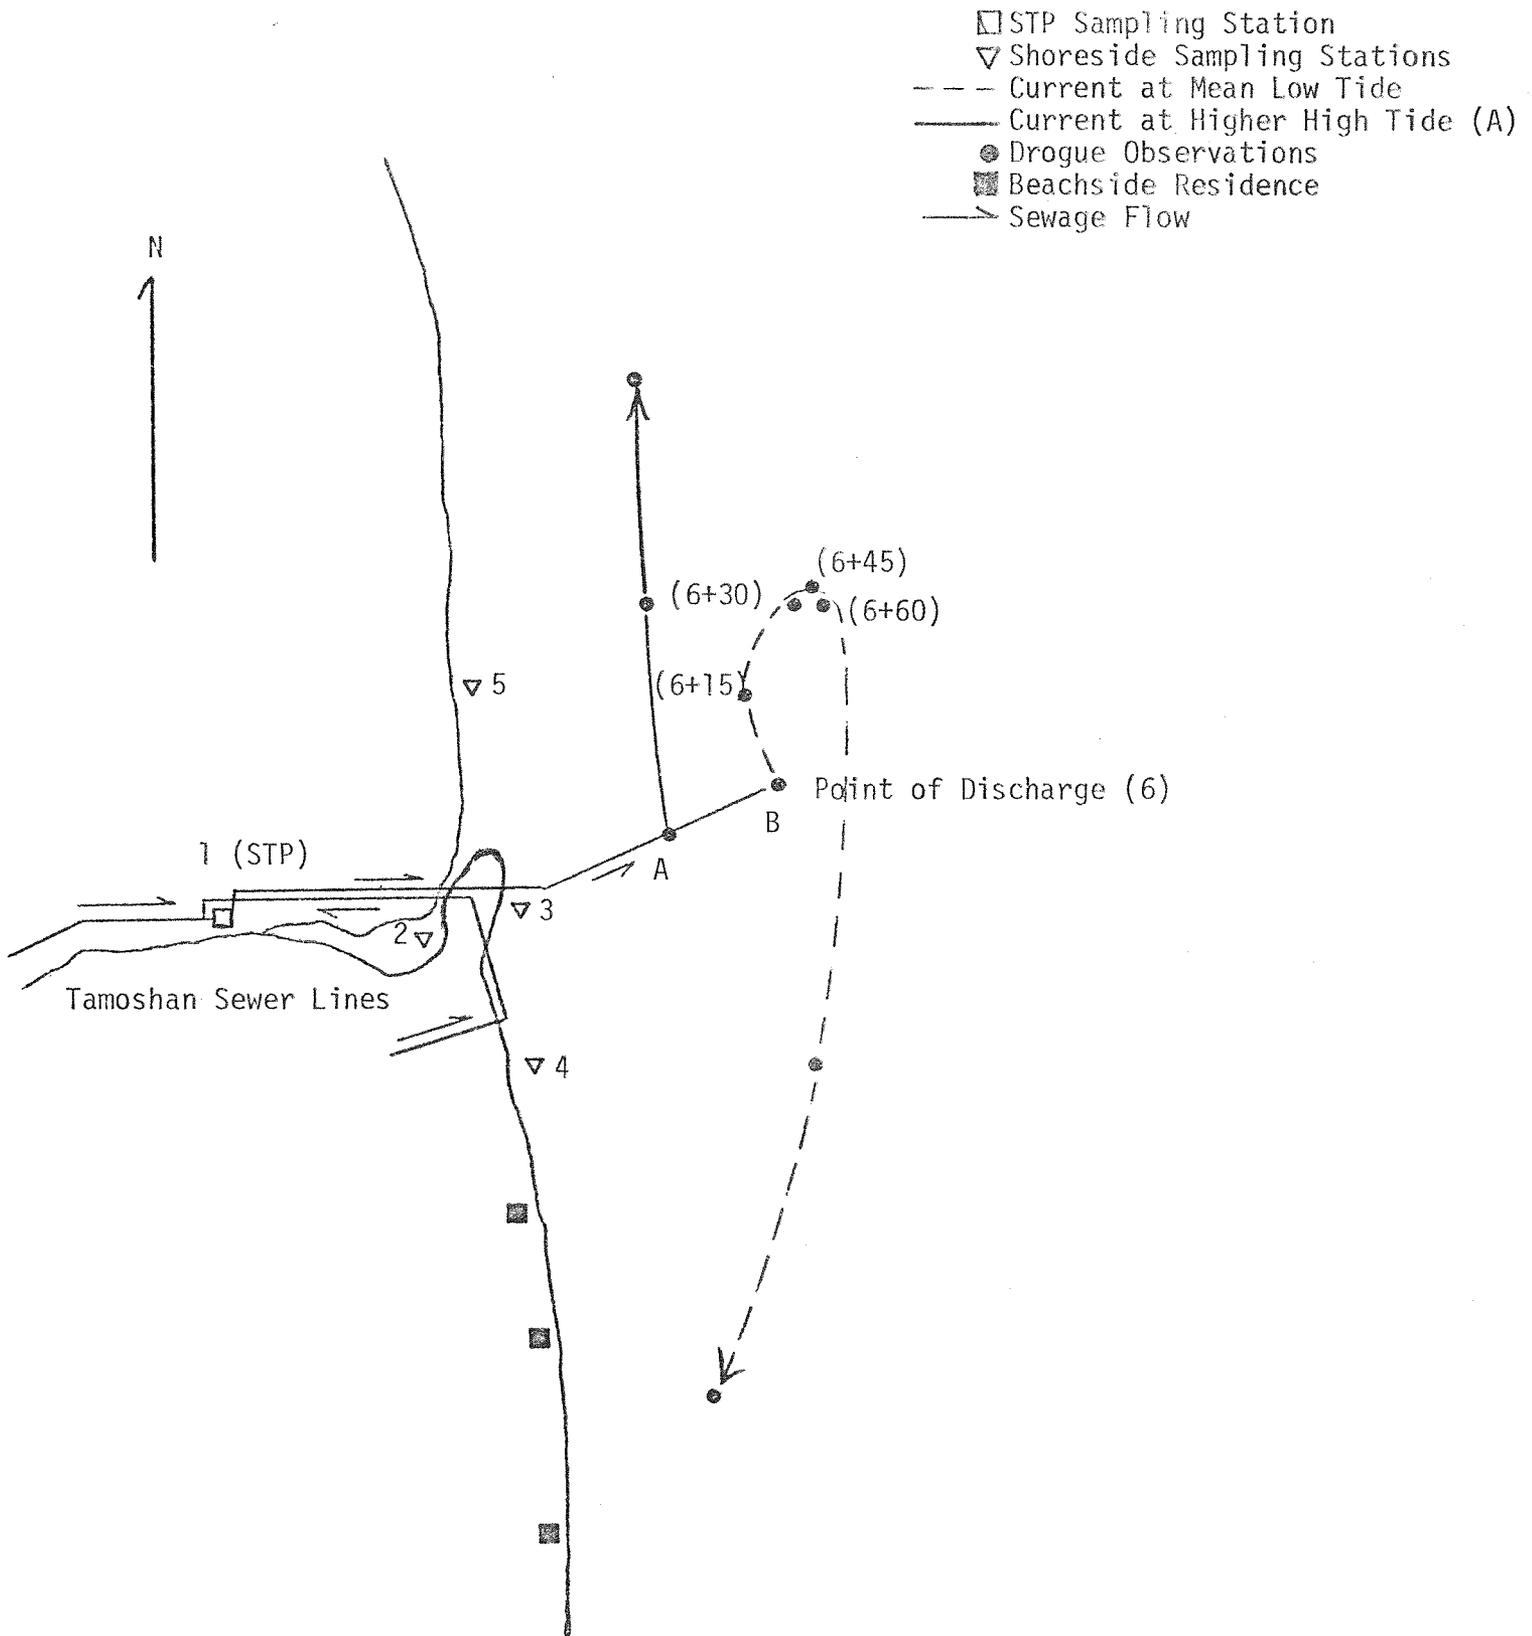
Figure 1. Sampling stations and drogue tracks obtained during two tide stands at Silver Spit, Budd Inlet. Also shown are beachside residences and sewer collection and outfall lines of the Tamoshan STP.

Two sampling surveys were conducted during higher high and mean low tide stands. These surveys were carried out on separate days. Weather conditions were similar on both occasions. Rainfall and surface runoff were minimal; skies were partly cloudy and winds were very light. Station locations are shown on Figure 1. Near-shore stations were sampled on both occasions. During higher high tide, the salt pond was full and a sample was taken near its upper end. During mean low tide drain period, a sample of the pond outflow was taken at the mouth.

In order to locate the outfall and tag the receiving water mass, 250 mls of Rhodamine WT dye were dumped into the outfall line through a manhole downstream from the wet well. The dye was then entrained in the discharge during the next pumping cycle. During higher high tide, we did not observe the emergence of any dye into Budd Inlet. We located a section of white plastic outfall line in shallow water during a search for the dye. We followed the line seaward until it appeared to end in approximately 3 m of water. We marked the spot with a buoy (A in Figure 1), shot bearings into order to fix the location, and dropped a patch of dye under the assumption that we had located the outfall. We sampled over time while we followed the dye patch. Unfortunately, the assumed site of the outfall was not correct. However, the dye data are summarized in Figure 1.

On another day during mean low tide, the procedure was repeated. In this case, the dye emerged approximately 20 minutes following onset of the STP discharge cycle. The point was marked, initial sample taken, and bearings taken on the location (B in Figure 1). In addition, a drift drogue was launched into the dye cloud. Samples and bearings were taken from the drogue at 15-minute intervals for one hour. Current observations are shown in Figure 1. We found good agreement between dye cloud and drogue behavior.

Figure 1 shows results of current data obtained during higher high and mean low tide stands. The higher high tide data were taken about one hour after slack flow conditions and northward flow was about 0.14 m per second. The data taken at mean low tide show tidal flow reversal. The initial flow was northward at 0.07 m per second. After 45 minutes the flow reversed and passed close to the discharge point after 120 minutes. After an additional hour, measurements showed a current speed of about 0.1 m per second. A definite shoreward component was evident.

According to the plot of our field bearings, the location of the discharge appeared to be about 100 m offshore or nearly half the distance shown in the design drawings. The high density and compact nature of the emergent dye patch suggested lack of a diffuser. The outfall line may be broken at this point, or the absence of a diffuser altogether.
