STATUS OF THE WATER SUPPLY  
AT THE DEPARTMENT OF WILDLIFE'S  
GREEN RIVER REARING PONDS,  
NEAR KANASKET, WASHINGTON

Linton Wildrick

Open-File Technical Report 94-06

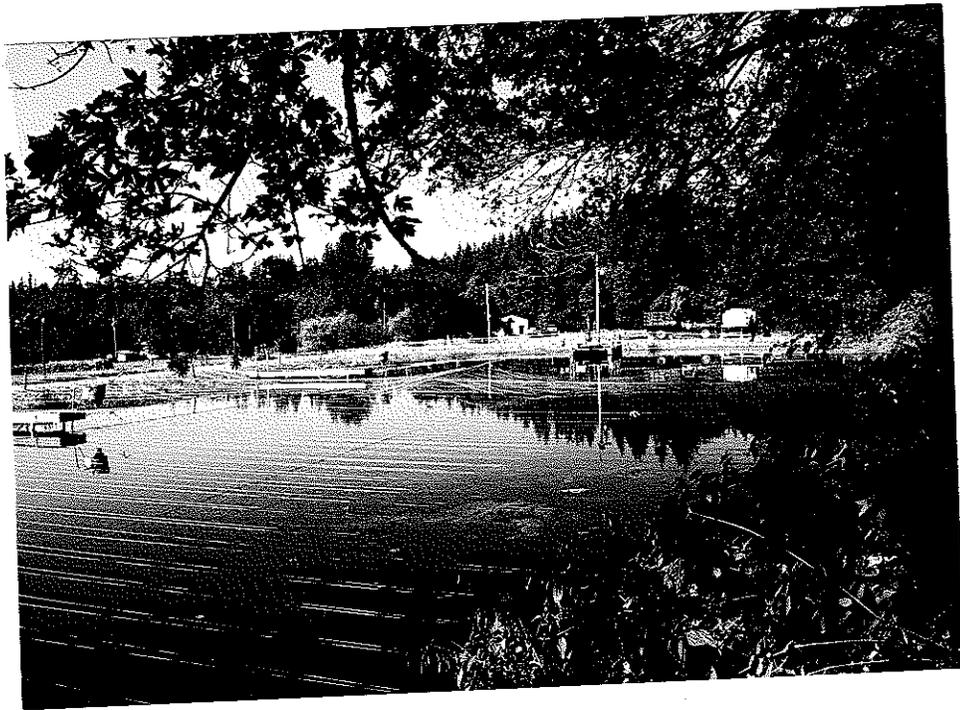
Photo 1. View west from base of bluff across Upper Pond.

The Upper Pond (Photo 1) covers about 0.4 acre to a maximum depth of 12 to 13 feet and drains to the west into the Lower Pond. The pond's surface lies at elevation 109 feet, that is, about 5 to 9 feet higher than the former ponds. At this elevation, the Upper Pond submerges 7 or 8 of the springs which fed the former ponds. A discharge pipe through the eastern embankment of the Upper Pond drains to a small creek flowing eastward into the Green River (Photo 2). This drain operates only when the manager wishes to empty the Upper Pond. Several springs discharging from the glacial sediments and some leakage from the Upper Pond create a small, perennial creek which flows eastward into the Green River (Photo 3).

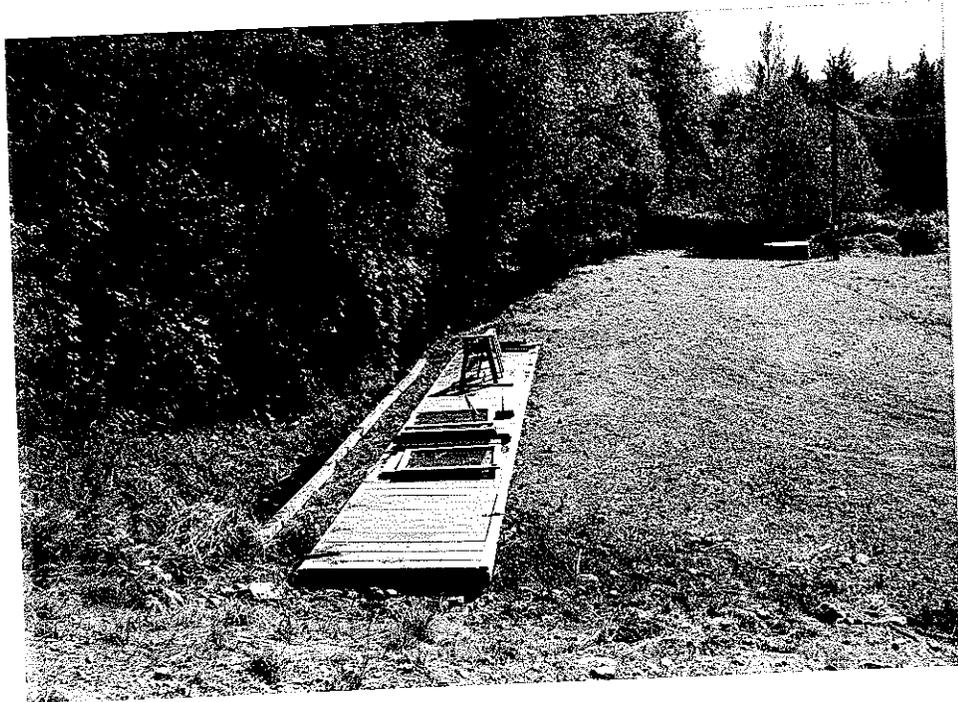
Photo 2. View looking east at drain device for Upper Pond. Green River located about 100 feet beyond end of parking area.

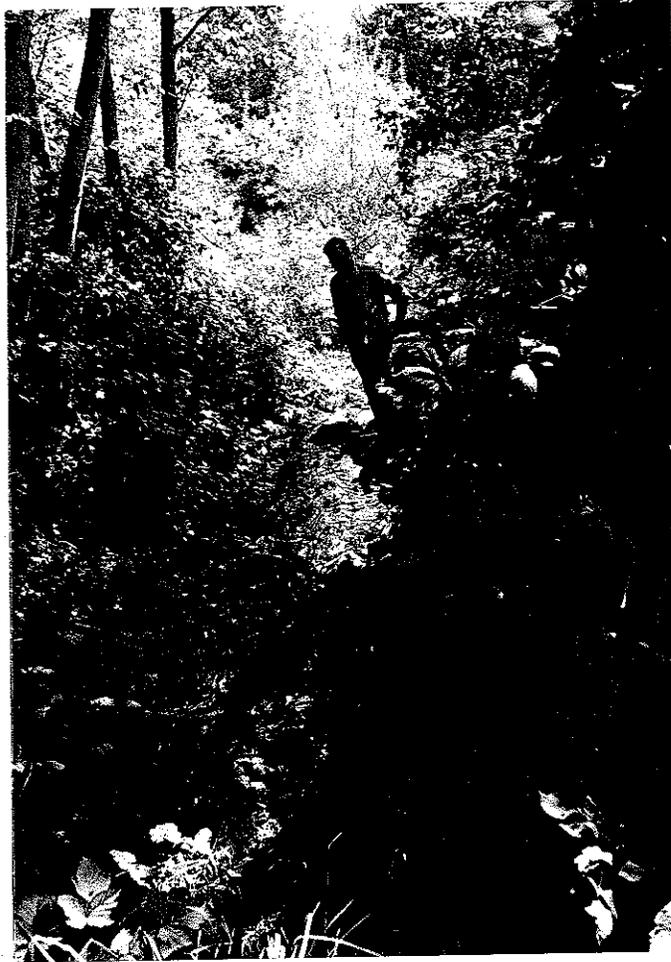
Photo 3. View looking east along small stream draining from Upper Pond and from springs along base of bluff.

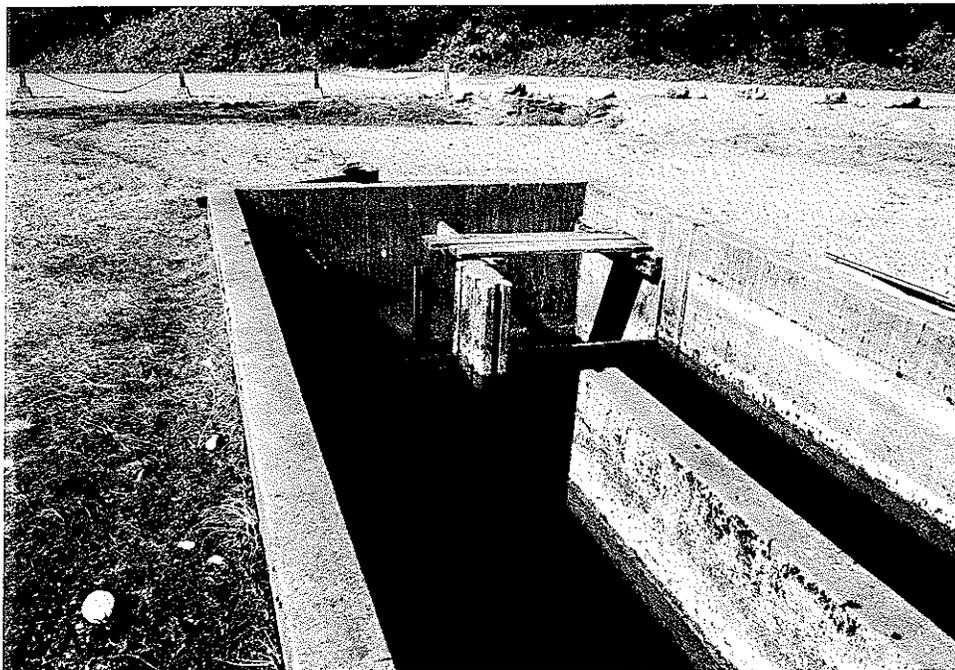
Photo 6. Double, sharp-crested weir and dropbox at west end of flume.

At its west end, the Lower Pond discharges into a drop box and culvert which leads to a concrete flume (Photo 5). At the downstream end of the flume, a dual, sharp-crested weir (Photo 6) discharges into another drop box and buried culvert. The culvert then discharges westward, forming the headwaters of Spring Creek, which flows only a few hundred feet before joining the Green River.

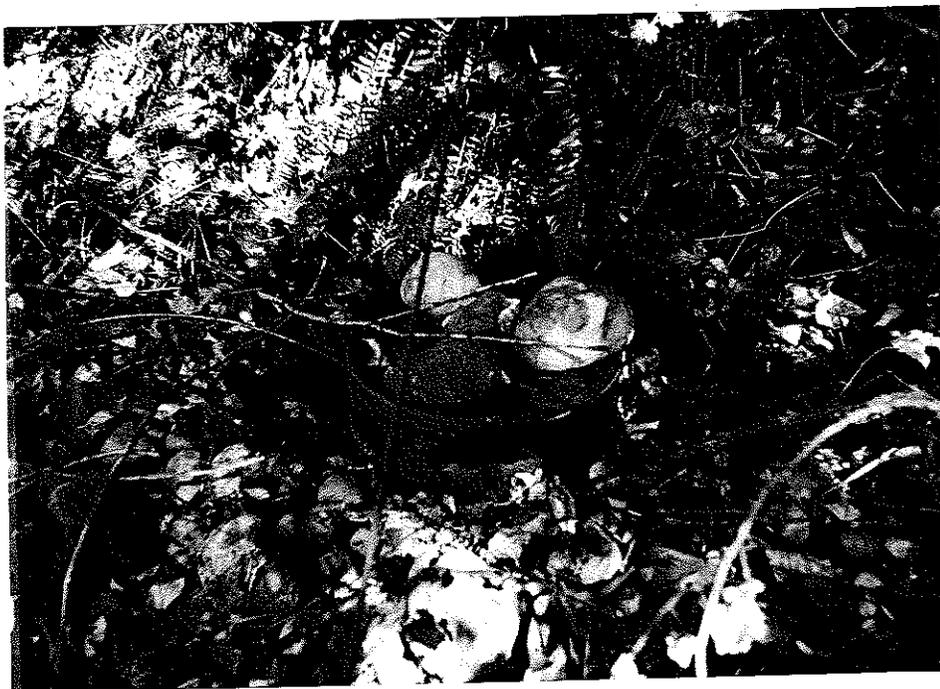
Photo 7. Top of metal drum surrounding Wolschlagel Spring #1.

At Wolschlagel Spring #1, a metal barrel, about 20 inches in diameter and partially buried in the gravelly sediment, prevents debris from blocking the flow (Photo 7). From the barrel, the water courses eastward through a 6-inch iron pipe (Photo 8) to a concrete reservoir (Photo 9) located at the base of the bluff and adjacent to the east end of the Upper Pond. I observed flow from the reservoir's overflow pipe into the pond. The Topographic and Grading Plan indicates two springs, located about 10 feet apart, in the approximate location of the current spring. A 6-inch-wide wooden flume carried water from the spring at elevation 122 and a 6-inch-diameter iron pipe carried water from the spring at elevation 120. The latter is probably the present-day Wolschlagel Spring #1 and the iron pipeline may be the same as indicated on the Topographic and Grading Plan.
