SEISMIC UPGRADES CONCEPT DESIGN REPORT

Dayton High School – Gym

Dayton School District 2

June 2019

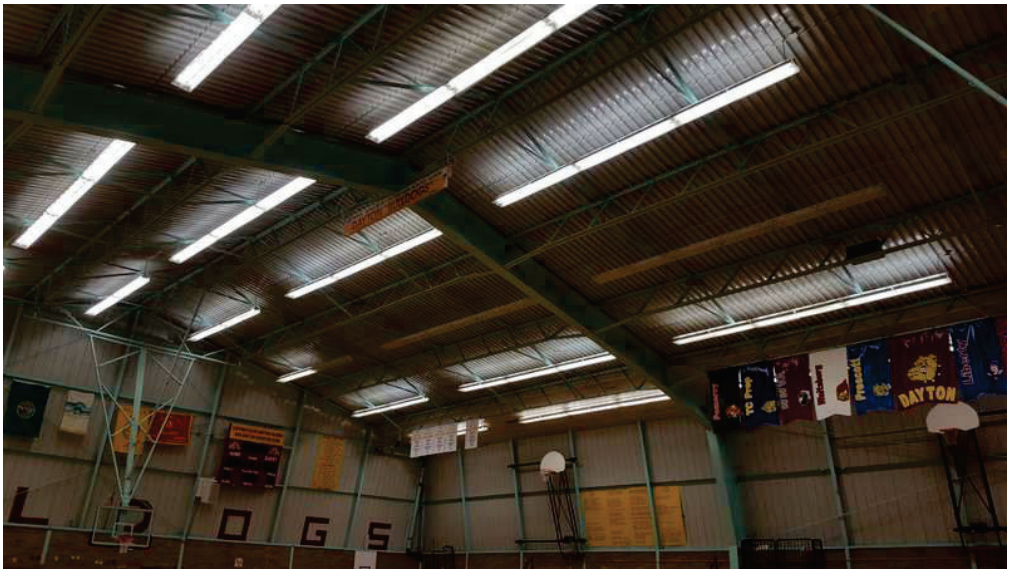
Figure 1-1. Gymnasium, looking east at one of two moment frames.

Figure 1-2. Gymnasium, looking northeast at one of two moment frames.

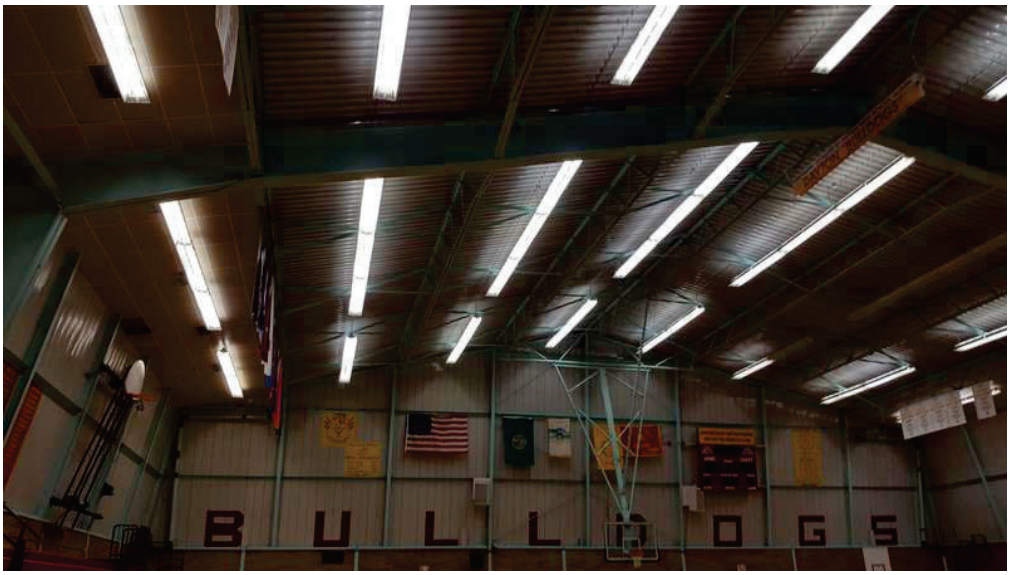
Figure 1-3. Gymnasium, looking northeast.

Figure 1-4. Moment frame panel point close-up.

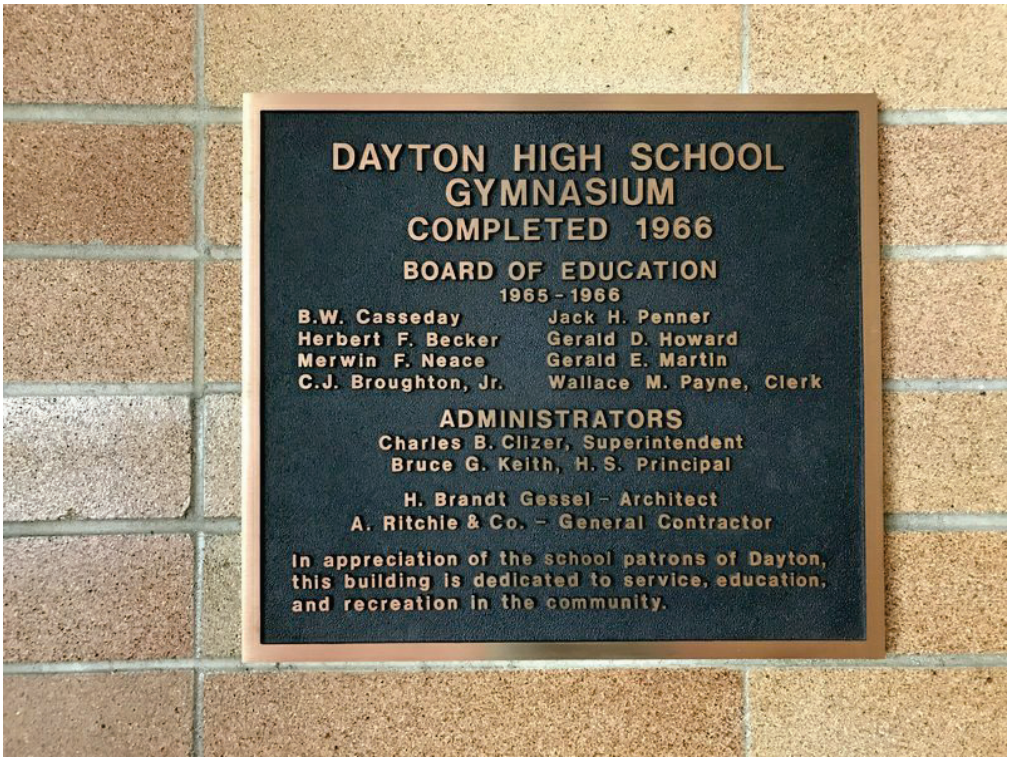
Figure 1-10. Plaque denoting the building completion date.
