Subject: Department of Natural Resources Washington Geological Survey, School Seismic Safety Assessment Project, Contract No. AE 410 - Seismic Evaluation for **Harrington School District**

1. Harrington Elementary and High School, Main Building

1.1 Building Description

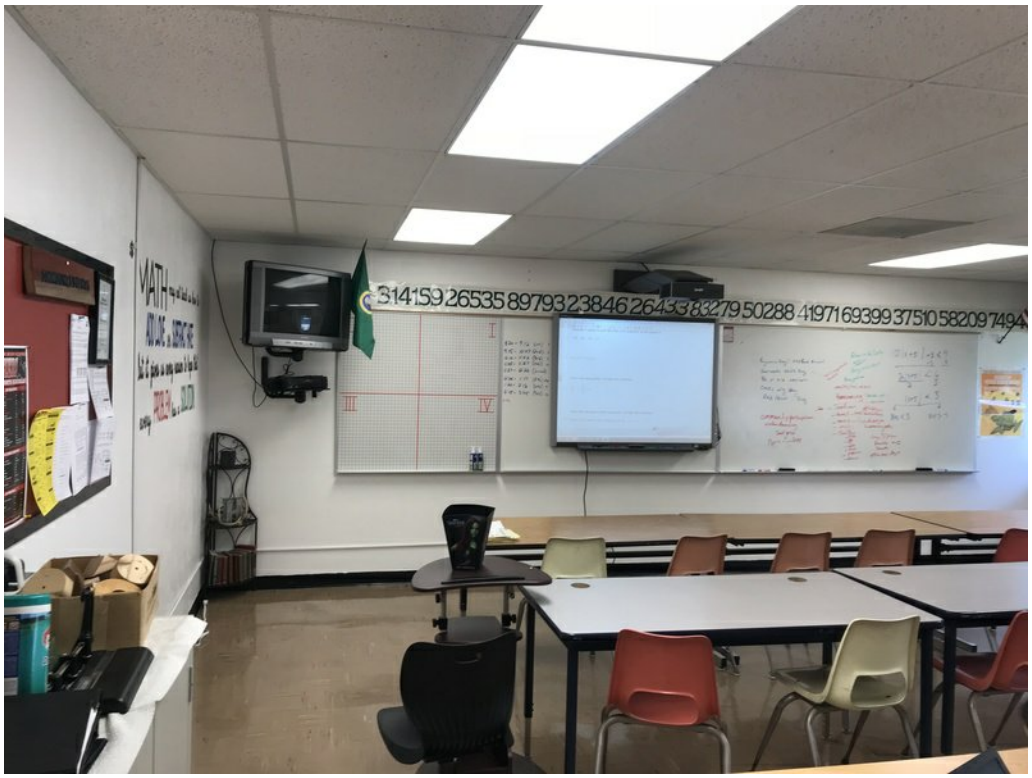
Figure 1-1. Typical classroom.

Figure 1-2. Bus barn wall with visible cracking.

Figure 1-8. Main entrance.

Figure 1-9. Gymnasium.

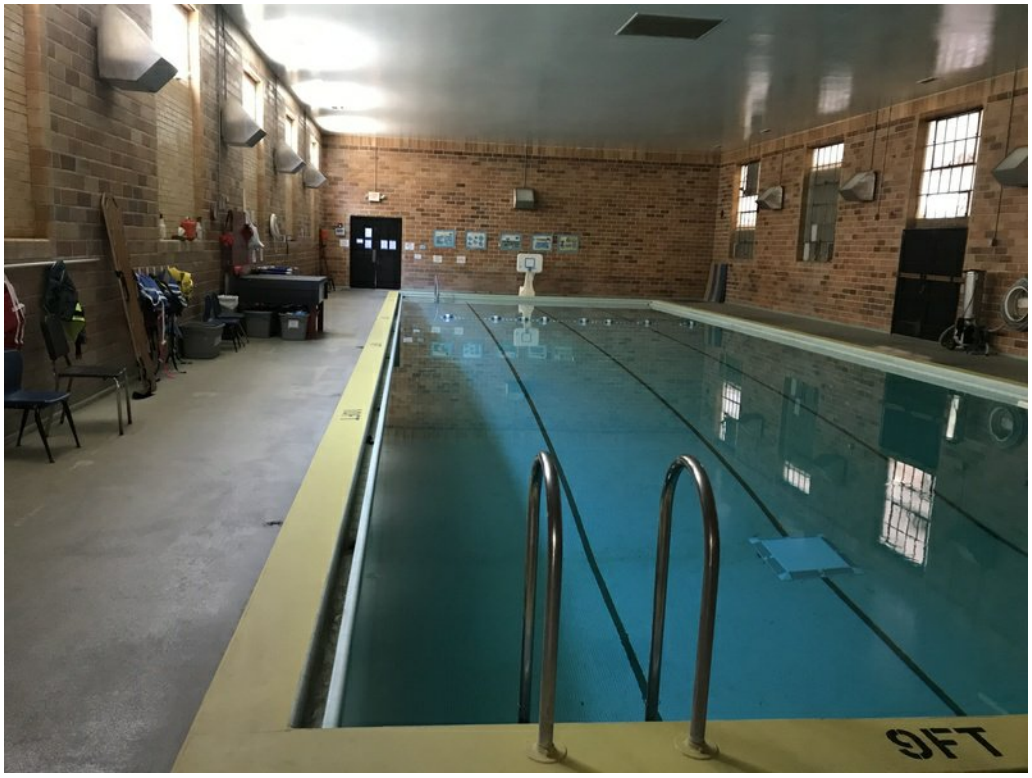
Figure 1-10. Pool area at core of building.
