Subject: Department of Natural Resources Washington Geological Survey, School Seismic Safety Assessment Project, Contract No. AE 410 - Seismic Evaluation for **Morton School District**

School Buildings Evaluated in the Morton School District

1. Morton Elementary School, Gymnasium
2. Morton Elementary School, Main Building
3. Morton Junior Senior High School, Gymnasium
4. Morton Junior Senior High School, Main Building
5. Morton Junior Senior High School, Shop

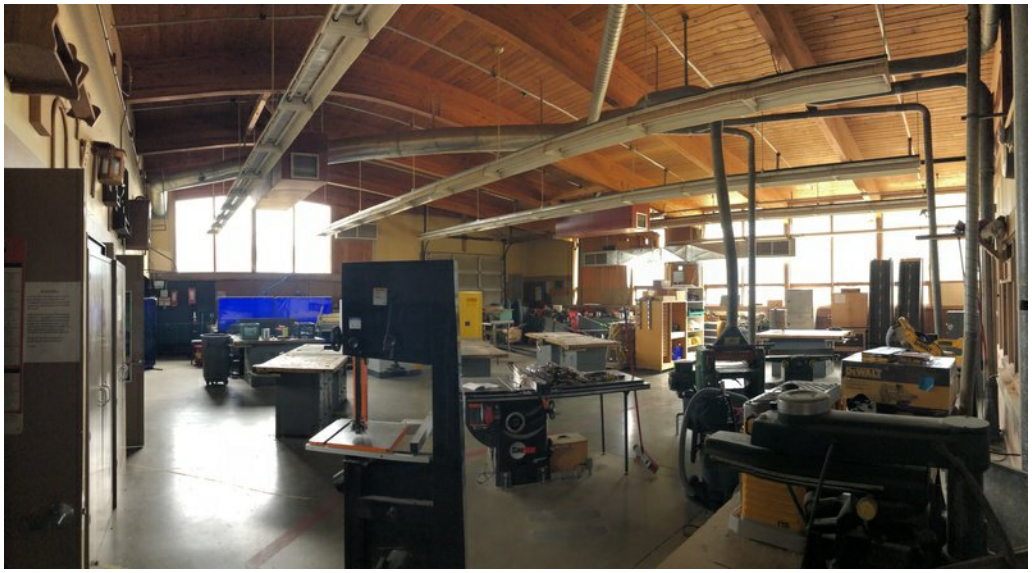
Figure 1-3. URM Wall in Boiler Room Likely Unbraced

Figure 1-4. Classroom Space

Figure 1-5. West Classroom

Figure 1-6. West Classroom - East Interior with Mezzanine in Back
