Subject: Department of Natural Resources Washington Geological Survey, School Seismic Safety Assessment Project, Contract No. AE 410 - Seismic Evaluation for **Ridgefield School District**

1.1 Building Description

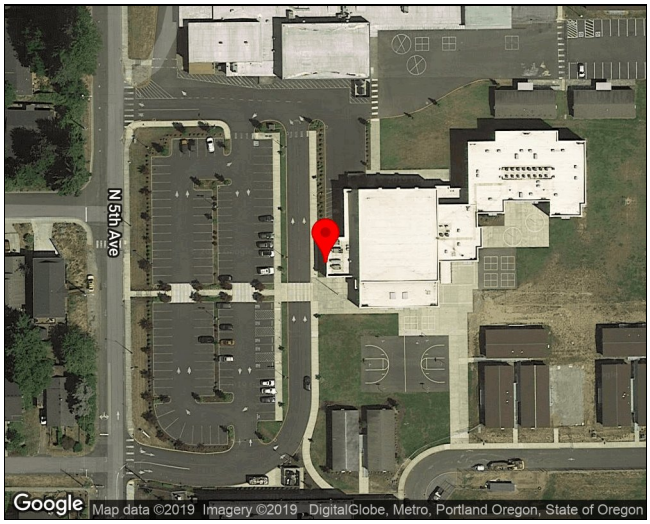
The Union Ridge Elementary School Covered Play Area is a one-story wood-framed structure. The building is constructed on level ground and is located in Ridgefield, Washington. The 1993 building is rectangular in plan, roughly 34 feet by 64 feet, with a roof height of approximately 20 feet. The covered play area was included in the 1993 modernization of the elementary school. The roof system is composed of 5/8-inch T&G plywood sheathing over wood joists and glulam beams. The lateral system in the transverse direction is wood shear walls with plywood sheathing. There is no building type available in ASCE 41-17 for the lateral system in the longitudinal direction, which is composed of HSS columns. The HSS columns are spaced at 30’-0” on center. The structure shares the site with the main elementary school building to the south and another covered play area. The second covered play area’s lateral system is HSS columns as well.

Structural System	Description
Structural Roof	No visible signs of corrosion, damage, or deterioration.
Structural Floor(s)	No visible signs of corrosion, damage, or deterioration.
Foundations	Unknown.
Gravity System	No visible signs of corrosion, damage, or deterioration.
Lateral System	Corrosion of plywood sheathing at base of plywood shear walls is evident due to water damage and infiltration.

Deficiency	Description
Load Path	Non-complaint in longitudinal direction. No seismic-force-resisting system in longitudinal direction to transfer seismic forces from the diaphragm to the foundation. The addition of lateral force resisting elements, such as cantilevered steel columns or frames, in the longitudinal direction may be appropriate.
Redundancy	No shear walls in the longitudinal direction. The addition of lateral force resisting elements, such as cantilevered steel columns or frames, in the longitudinal direction may be appropriate.
Diagonally Sheathed and Unblocked Diaphragms	Unblocked diaphragm. Diaphragm strengthening through the addition of blocking and additional diaphragm nailing may be appropriate to mitigate seismic risk.

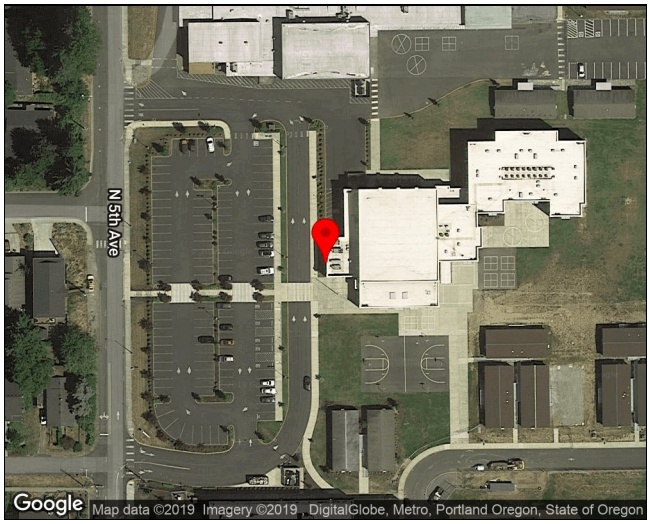
The Union Ridge Elementary School building is a one-story concrete and wood-framed structure. The building is constructed on level ground and is located in Ridgefield, Washington. The 1952 building is L-shaped in plan, roughly 340 feet by 340 feet, with a roof height of approximately 14 feet. The elementary school underwent a modernization in 1993. Original building construction consists of 8-inch concrete walls and wall piers. Wood-framed walls were added in the 1993 modernization. The multipurpose room is wood-framed and rectangular in plan, 94 feet by 60 feet, with a maximum roof height of 28 feet. The exterior walls on the north and west sides contain mostly windows for the entire length. The roof system is a mixture of diagonal sheathing and Tectum roof panels over wood framing. The building shares the site with Valley Ridge Middle School to the south, a covered play shed, and a playground to the east.

Structural System	Description
Structural Roof	Minor damage and corrosion of ceiling finishes evident.
Structural Floor(s)	No visible signs of corrosion, damage, or deterioration.
Foundations	Unknown.
Gravity System	Cracking evident in wood beams.
Lateral System	No visible signs of corrosion, damage, or deterioration.

Deficiency	Description
Torsion	Building has eccentric stiffness. Further investigation is required to determine torsional effects on the lateral system. Strengthening of the lateral system through the addition of new shear walls may be appropriate to mitigate seismic risk.
Overturning	Ratio of least horizontal dimension of seismic-force-resisting system to building height is greater than 0.6Sa. Additional overturning resistance, such as additional footings, hold-downs, and shear walls, may be appropriate to mitigate seismic risk. Further investigation is required.
Shear Stress Check	Pseudo shear stress is greater than 1000 lb/ft. The building likely requires wood shear wall strengthening or the addition of new wood shear walls. Further investigation is required.
Other Diaphragms	Tectum roof deck at gym. Diaphragm strengthening at gym may be appropriate to mitigate seismic risk, such as installing plywood sheathing.

Unknown Item	Description
Load Path	No original drawings. Unknown load path from roof to original concrete shear walls to footing. Unknown if out-of-plane detailing exists at original concrete exterior walls. This item requires further investigation to make a final determination and to develop a mitigation recommendation, if necessary.
Liquefaction	The liquefaction potential of site soils is unknown at this time given available information. Very low liquefaction potential is identified per ICOS based on state geologic mapping. Requires further investigation by a licensed geotechnical engineer to determine liquefaction potential.
Slope Failure	Requires further investigation by a licensed geotechnical engineer to determine susceptibility to slope failure.
Surface Fault Rupture	Requires further investigation by a licensed geotechnical engineer to determine whether site is near locations of expected surface fault ruptures.
