WASHINGTON
STATE HIGHWAY COMMISSION
DEPARTMENT OF HIGHWAYS

PSH No. 12, L-764
South Bend Vicinity
Station 19+50 to Station 32+00

General Conditions

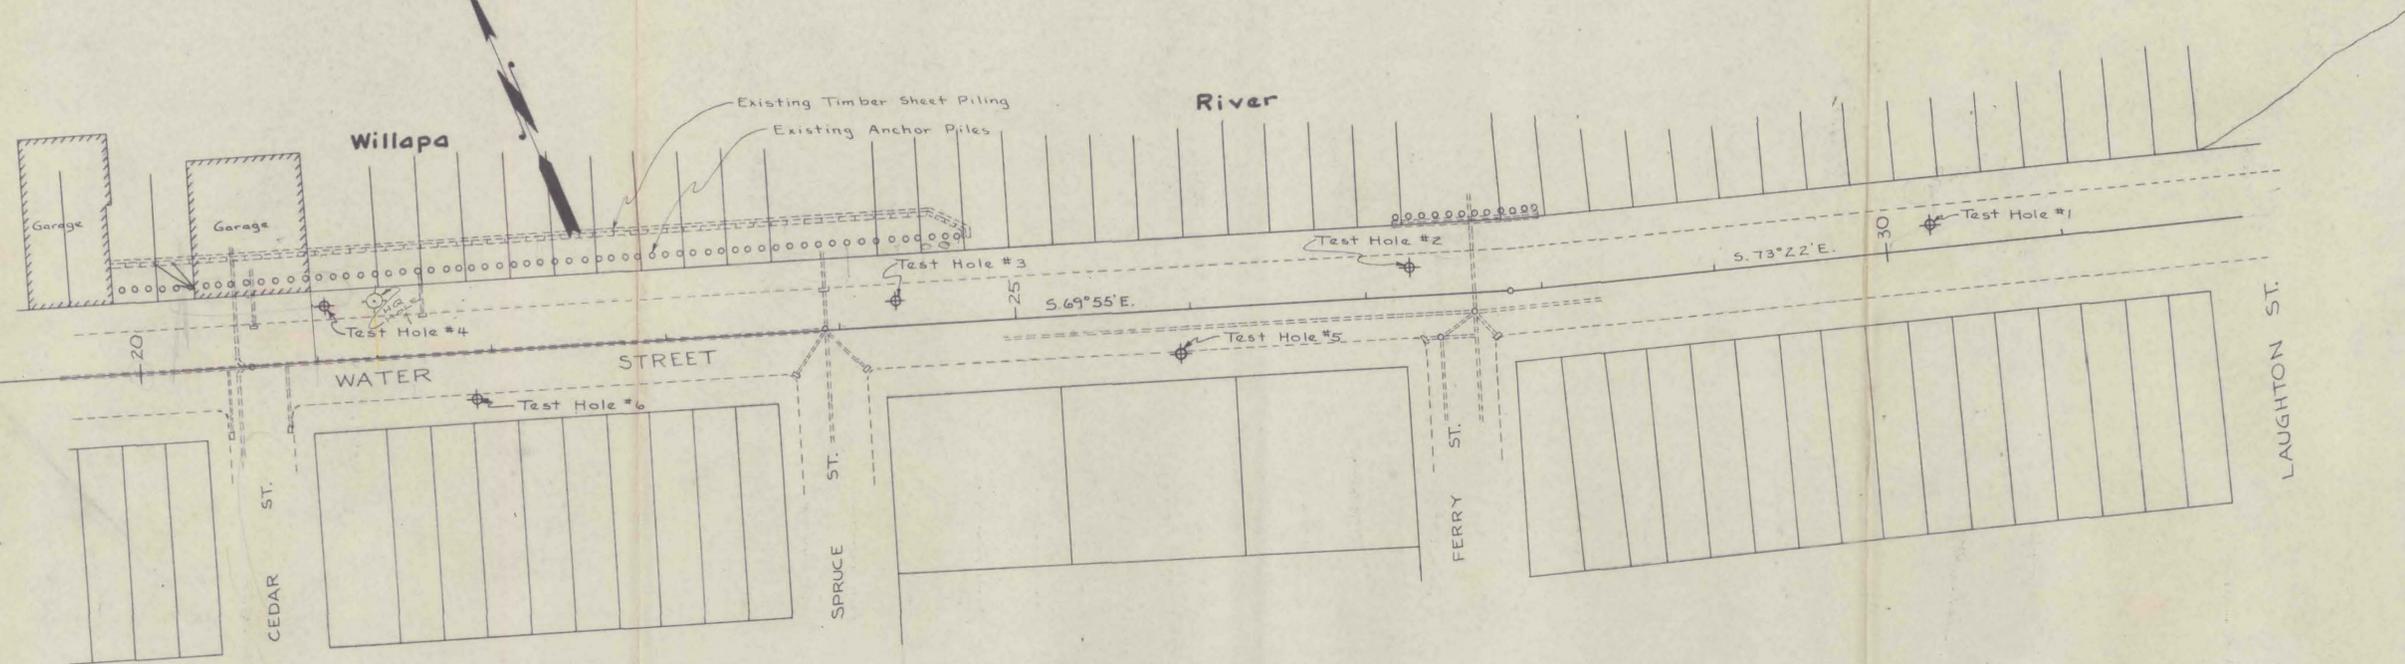
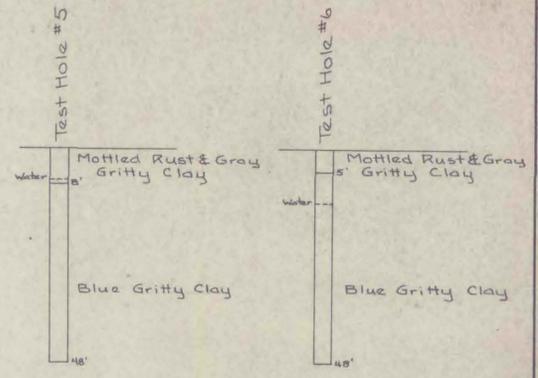
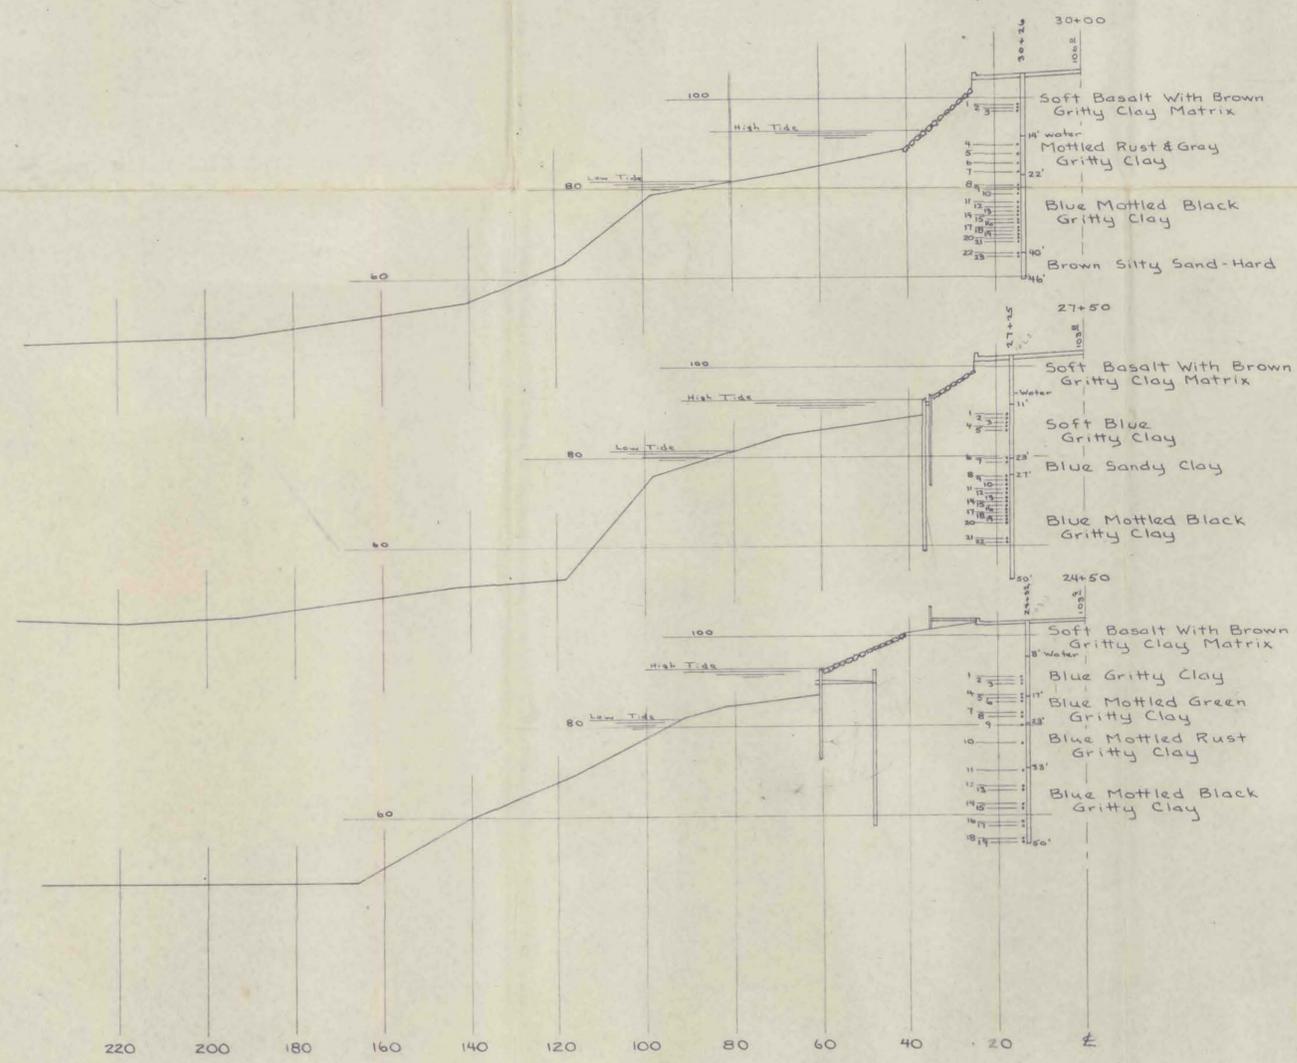
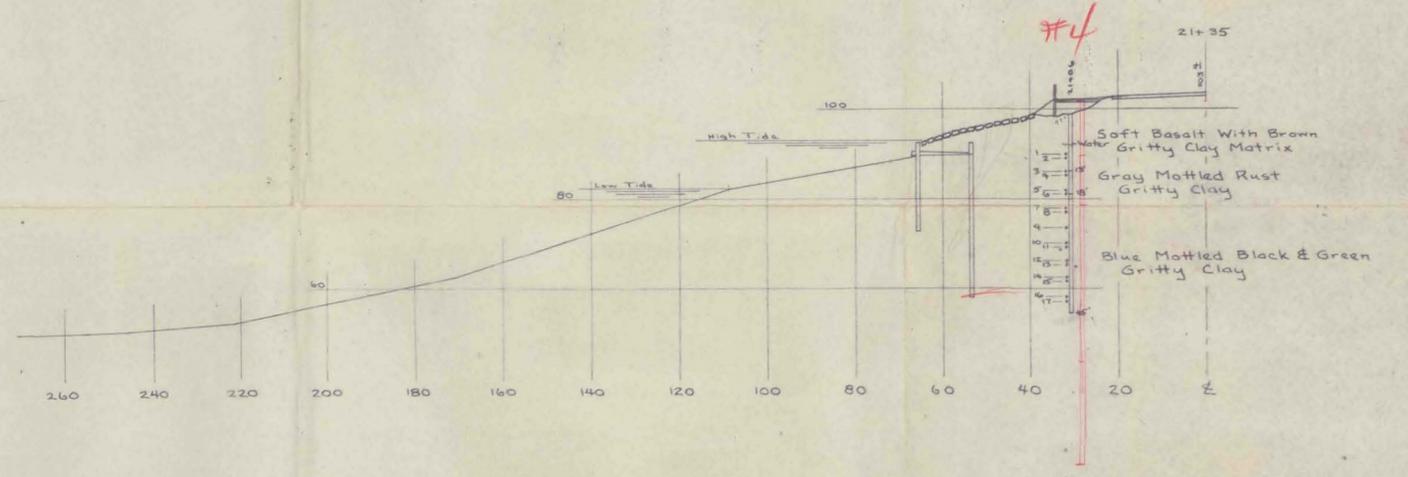
P.S.H. No. 12
SOUTH BEND VICINITY
 PACIFIC COUNTY
 Job No. L-764

To determine the nature and characteristics of the foundation soil in this area, six test holes were drilled and undisturbed samples taken, the location of the holes and the depths at which the samples were extracted are shown on the attached drawing.
