**SURFACE AND SUBSURFACE INFORMATION SUMMARY
ABERDEEN LANDSLIDES
ALDEN ROAD, BELMONT STREET,
AND COUNCIL CREST
ABERDEEN, WASHINGTON**

City of Aberdeen
200 E. Market Street
Aberdeen, Washington 98520

AGRA Earth & Environmental, Inc.
11335 N.E. 122nd Way, Suite 100
Kirkland, Washington 98034-6918

7-91M-11693-A

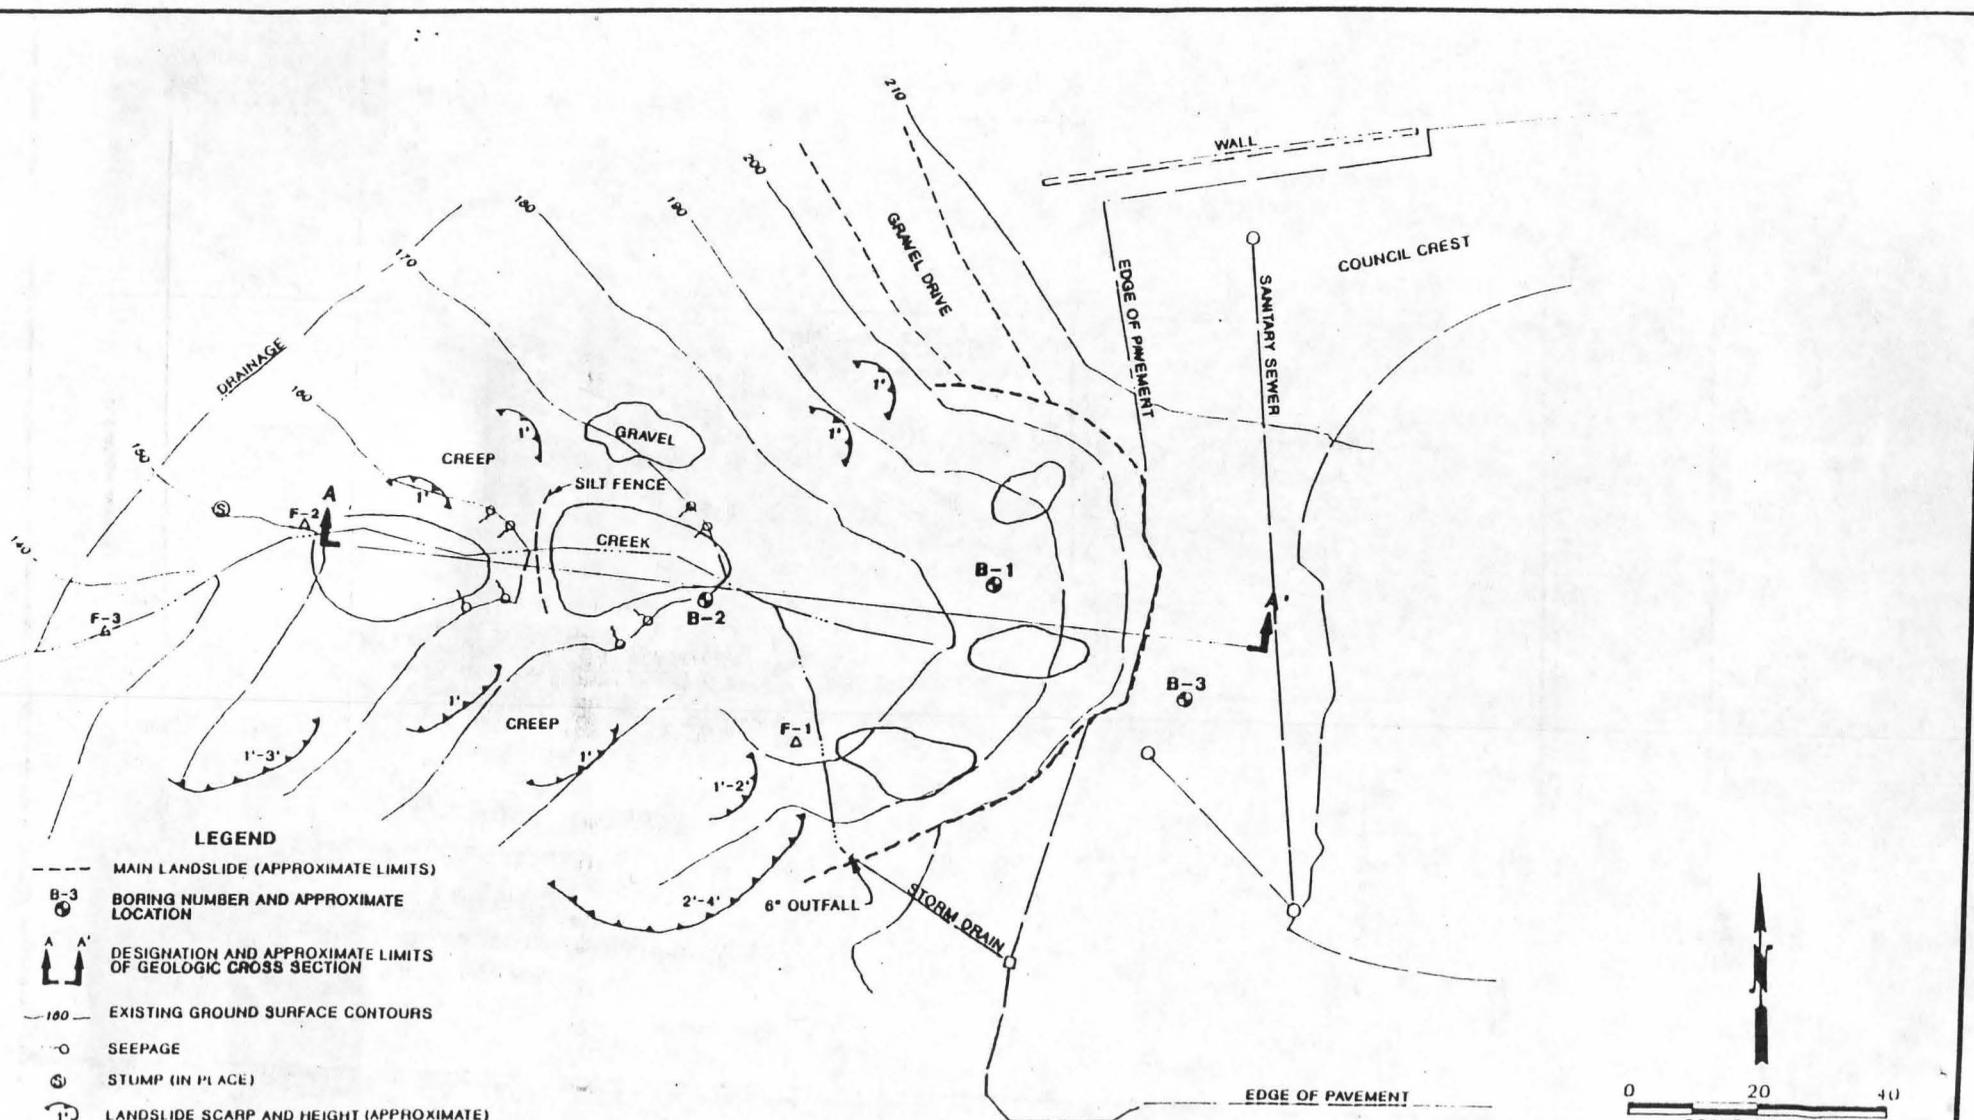
FIGURE 9

Our on-site explorations, borings B-1 through B-3, revealed fairly uniform soil conditions (Figure 9). Borings B-1 and B-2 encountered a very soft to soft sandy silt with some organics (landslide debris) to depths of 1 foot and 4 feet, respectively. These soils mantled a medium-dense, moist to wet, silty fine sand with some clay to depths of 5 and 5½ feet, respectively, before encountering dense, moist, silty fine sand with some clay (weathered sandstone). Boring B-2 was terminated in these dense soils a depth of 6½ feet. In boring B-1 these dense soils continued to a depth of 9½ feet where they overlie a very dense, moist, silty fine sand with some clay (sandstone) to the full depth of our exploration of 21½ feet.
