**GEOTECHNICAL ENGINEERING STUDY**  
**Proposed Fairbanks Residence**  
**2817 Magnolia Boulevard West**  
**Seattle, Washington**

This report presents the findings and recommendations of our geotechnical engineering study for the site of the proposed Fairbanks residence in Seattle, Washington.

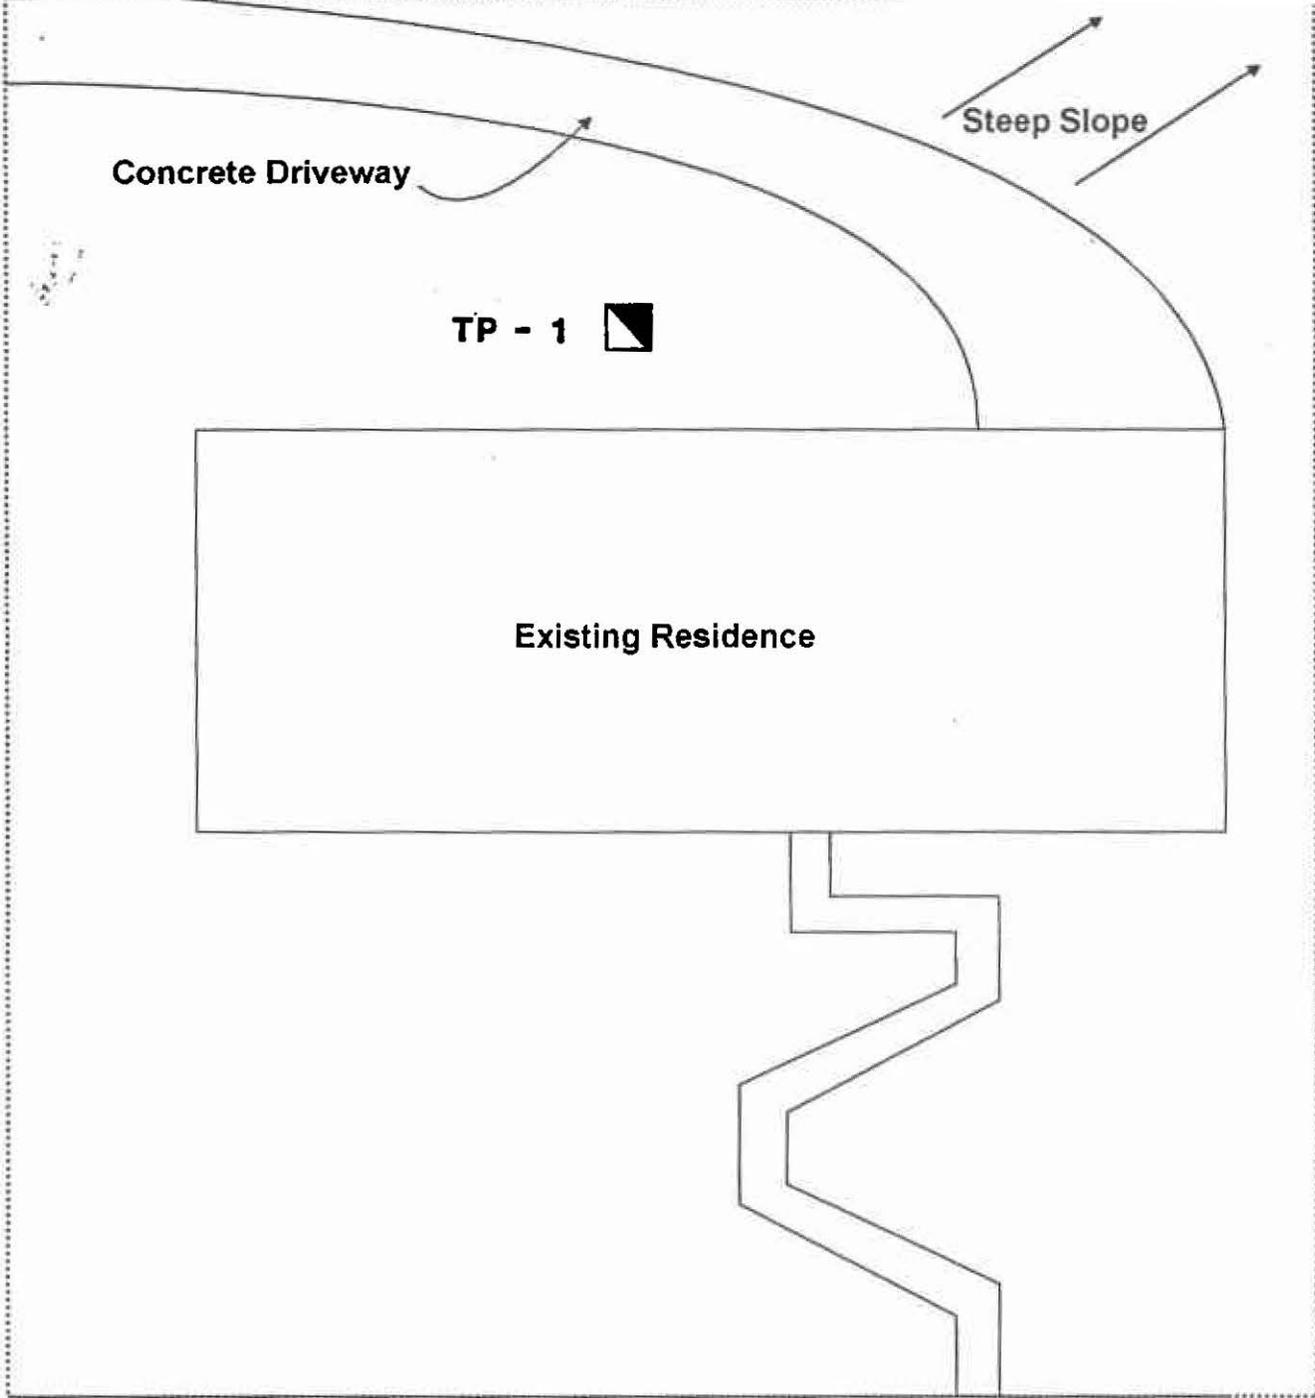
<b>Job No:</b> 99107	<b>Date:</b> June 1999	<b>Not to Scale</b>	<b>Plate:</b> 2
-------------------------	---------------------------	---------------------	--------------------

Steep Slope

TP - 1

**SITE PLAN**  
2817 Magnolia Boulevard West  
Seattle, Washington

The subsurface conditions were explored by excavating one test pit at the approximate location shown on the Site Exploration Plan, Plate 2. The field exploration program was based upon the proposed construction and required design criteria, the site topography and access, the subsurface conditions revealed during excavation and drilling, and the scope of work outlined in our proposal.

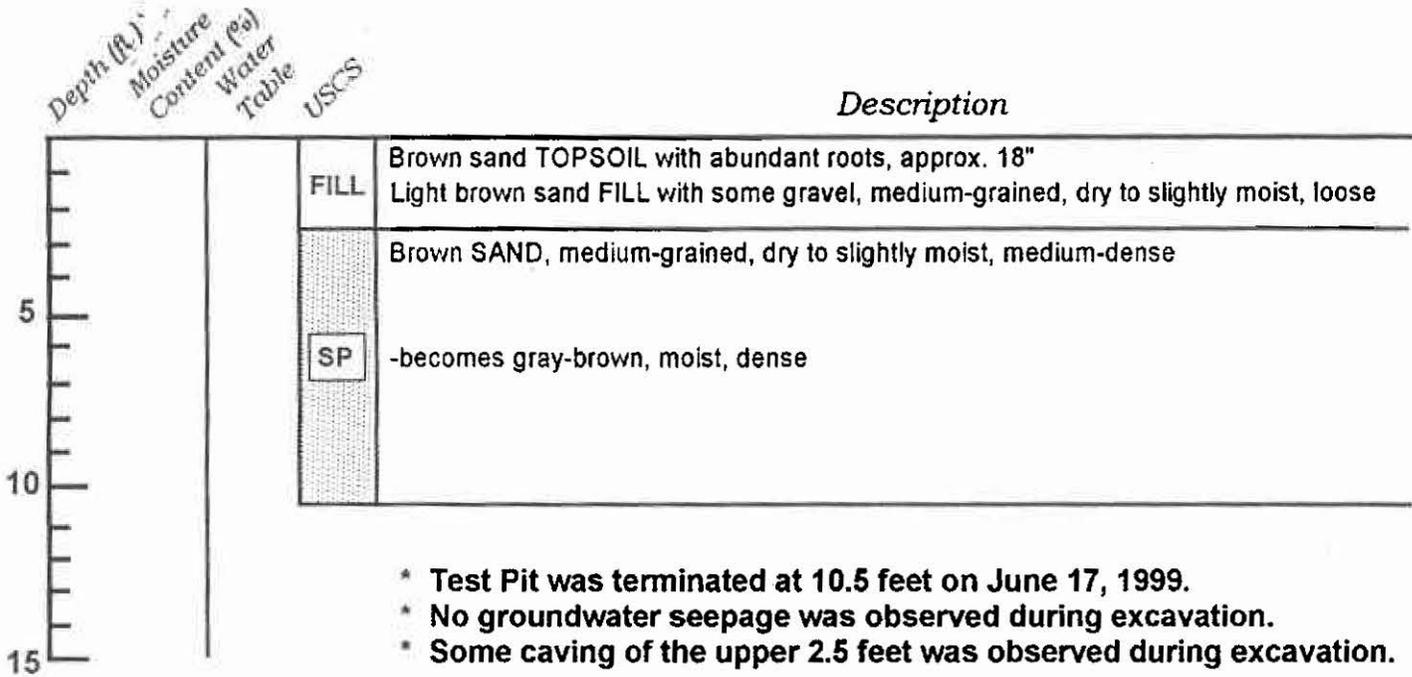
Job No: 99107	Date: June 1999	Logged by: EMT	Plate: 3
------------------	--------------------	-------------------	-------------

# TEST PIT 1

**TEST PIT LOG**  
 2817 Magnolia Boulevard West  
 Seattle, Washington

The subsurface conditions of the proposed building site were explored with one test pit that encountered approximately 2.5 feet of loose, gravelly sand topsoil and fill overlying medium-dense to dense, native sand. The proposed residence may be supported on conventional foundations bearing directly on the native, medium-dense to dense sand. Depending on final grading, some overexcavation may be necessary to reach the competent sand.

The test pit was excavated on June 17, 1999 with a rubber-tired backhoe. A geotechnical engineer from our staff observed the excavation process, logged the test pit, and obtained representative samples of the soil encountered. "Grab" samples of selected subsurface soil were collected from the backhoe bucket. The Test Pit Log is attached to this report as Plate 3.
