GEOTECHNICAL ASSESSMENT REPORT

SAN JUAN COUNTY TRANSFER STATION REDEVELOPMENT FRIDAY HARBOR, WASHINGTON

Project No. 09-154
April 2010

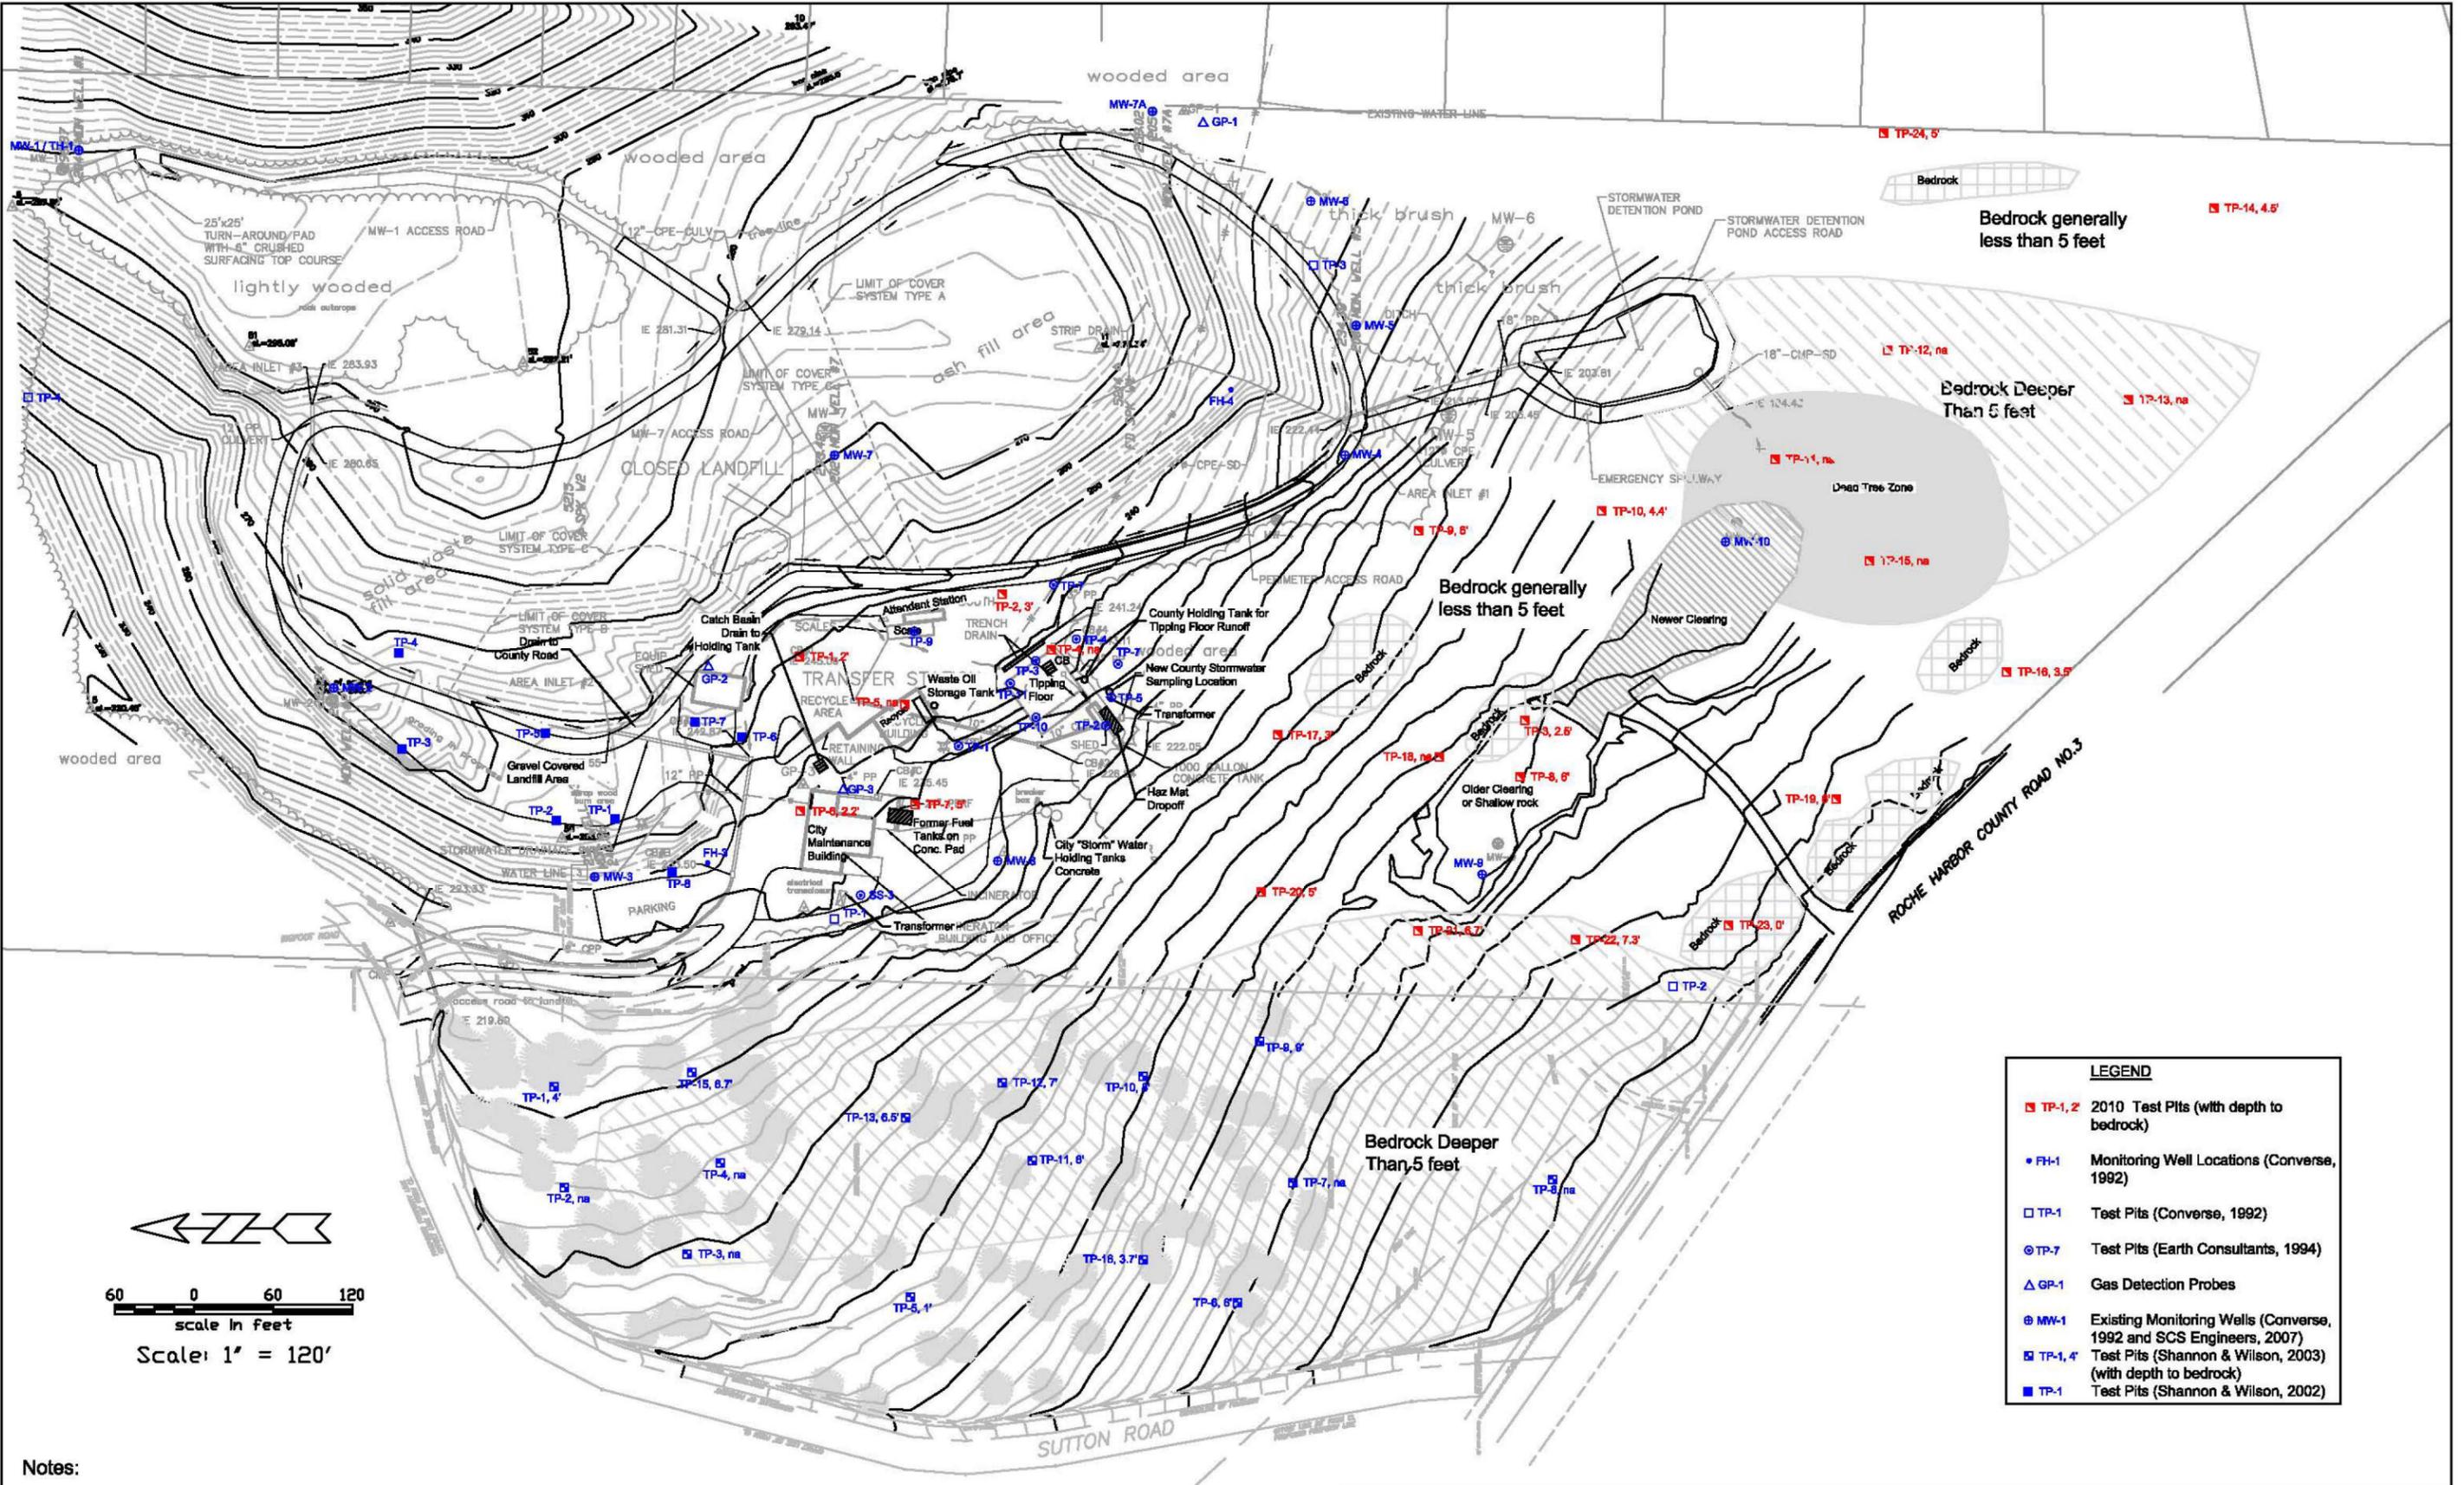
1. Base map provided by Floyd Snider, January, 2010. Elevations are based on the NAVD83 datum.
2. Test pit locations for 2010 are approximate and based on the relative locations of known site features.
3. Logs for the 2010 Test Pits are located in Appendix A. Test pits TP-1 to TP-8 contain environmental and sampling information. Test pits TP-9 to TP-24 were advanced for geotechnical purposes.
4. Test pit and boring logs for prior explorations are located in Appendix B through Appendix E.

Previous geotechnical studies for the site include work by Converse Consultants (1992), Earth Consultants (1994), Shannon & Wilson (2002 and 2003), and SCS Engineers (2007). The Converse and the Earth Consultants studies included test pits and monitoring wells in the area of the present Transfer Station. The 2002 Shannon & Wilson study focused on conditions in the vicinity of the existing transfer station whereas their 2003 study focused on conditions underlying the parcel west of the transfer station, which is now owned by the County. The SCS study included the logs of monitoring wells drilled adjacent to and down gradient of the landfill. The locations of the explorations are shown on Figure 2 and logs of the explorations are presented in Appendices B, C, D, and E.

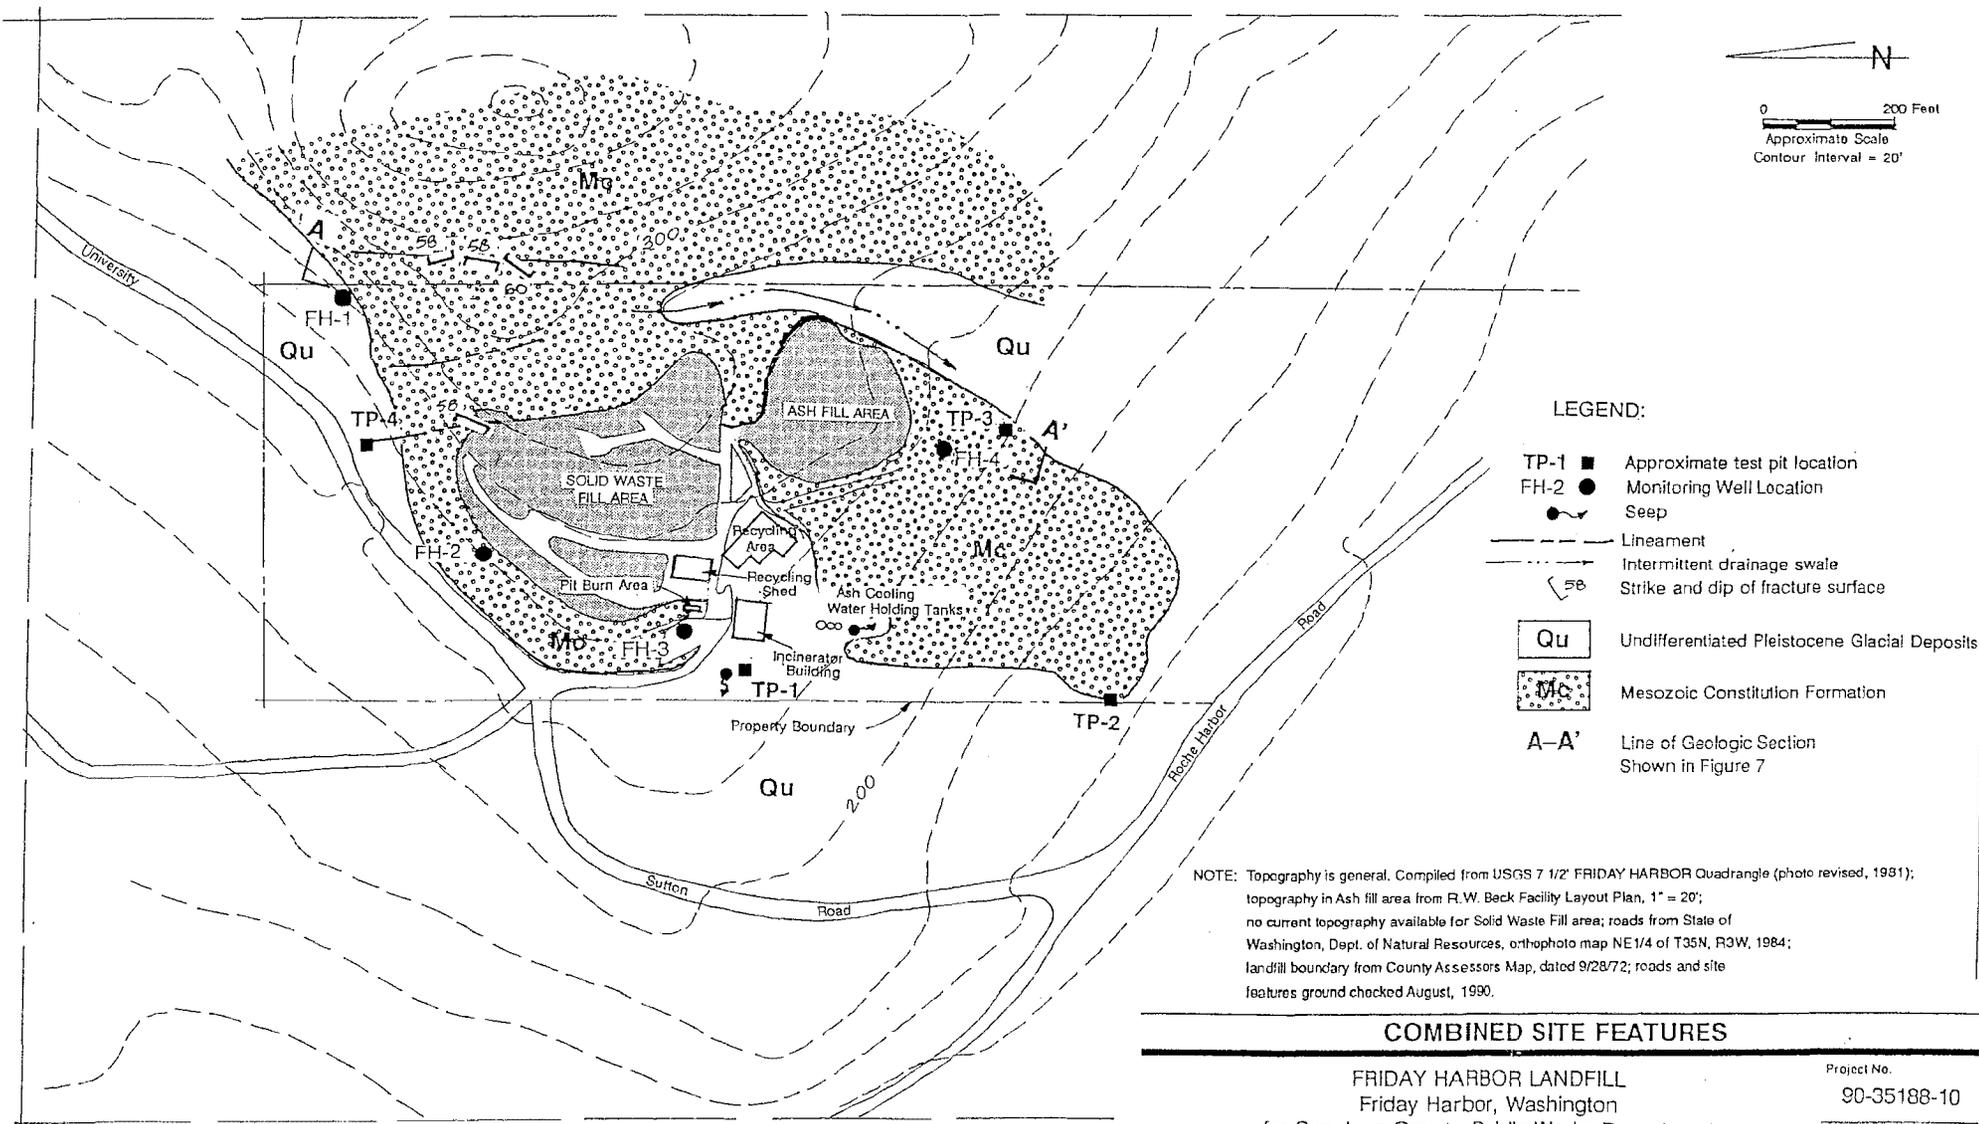
- TP-1 ■ Approximate test pit location
- FH-2 ● Monitoring Well Location
- Seep
- Lineament
- - - Intermittent drainage swale
- 58 Strike and dip of fracture surface
- Qu Undifferentiated Pleistocene Glacial Deposits
- Mc Mesozoic Constitution Formation
- A-A' Line of Geologic Section
Shown in Figure 7

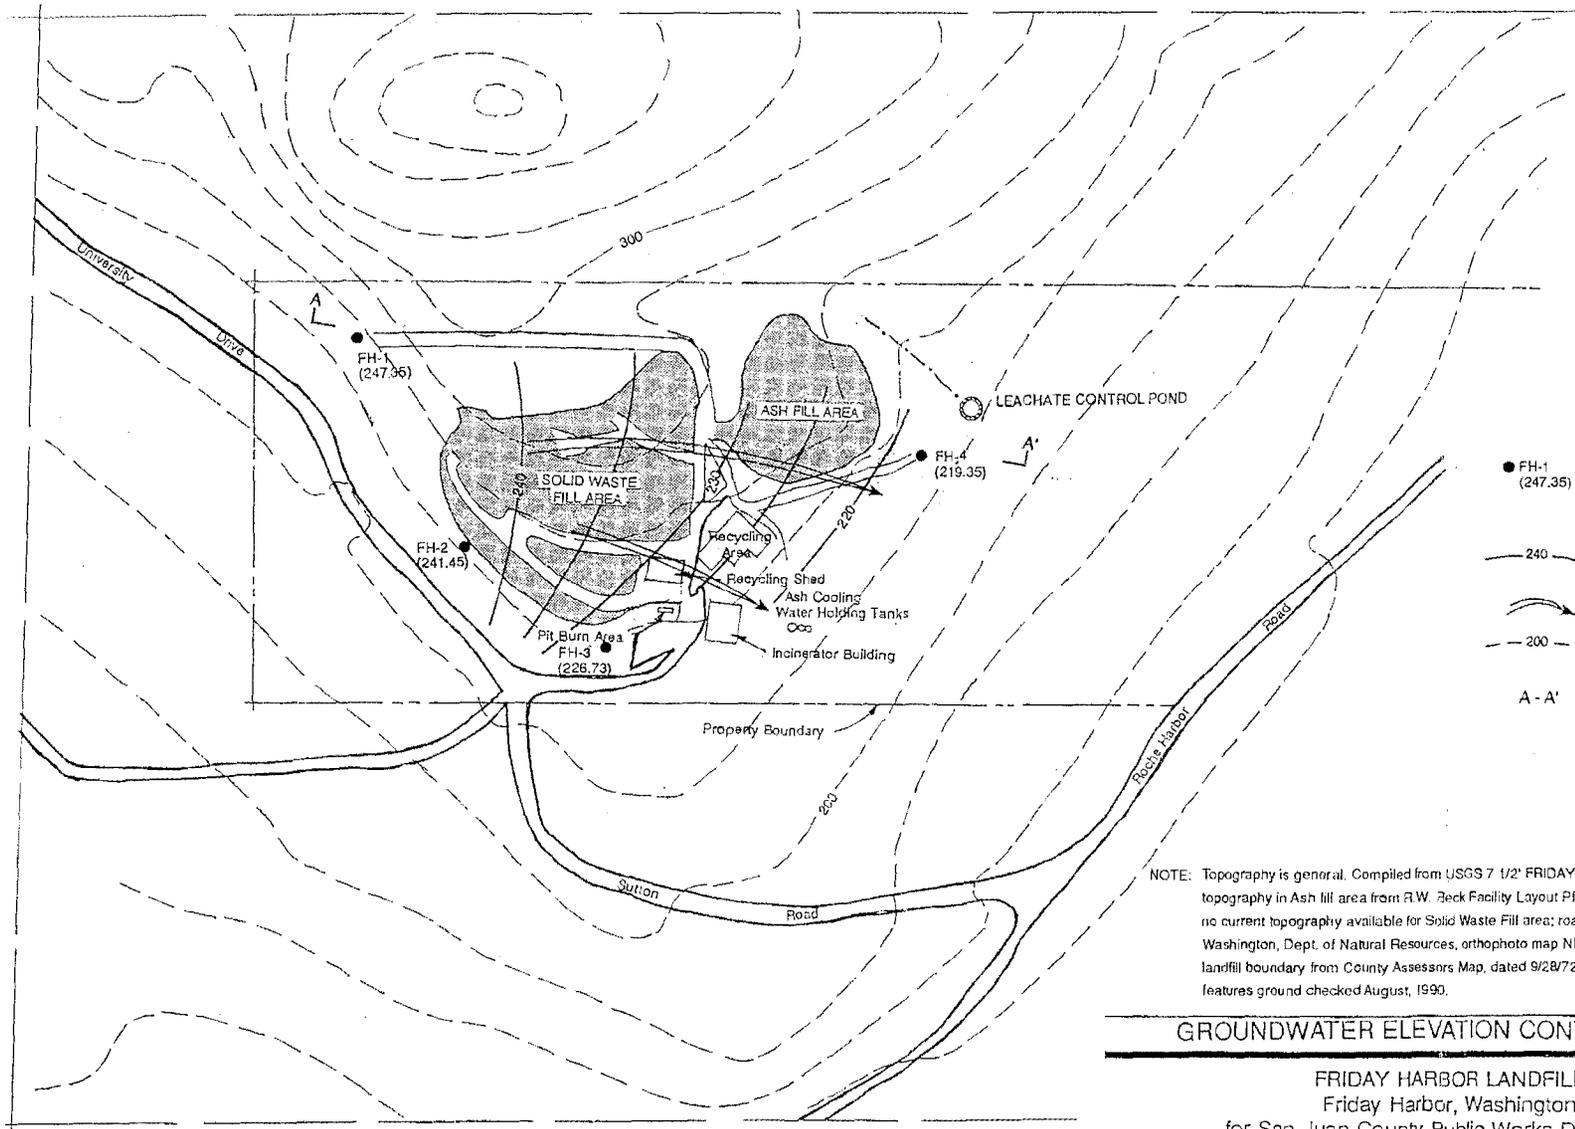
- FH-1 (247.35) Monitoring Well Location and No. with Static Water Level; Elevation (in feet above MSL) Measured 1/9/91
- 240 — Interpolated Contours of Potentiometric Surface (in feet above MSL)
- Inferred Groundwater Flow Direction
- - - 200 - - - Generalized Topographic Contours. See Note Below
- A - A' Line of Geologic Section Shown in Figure 7.

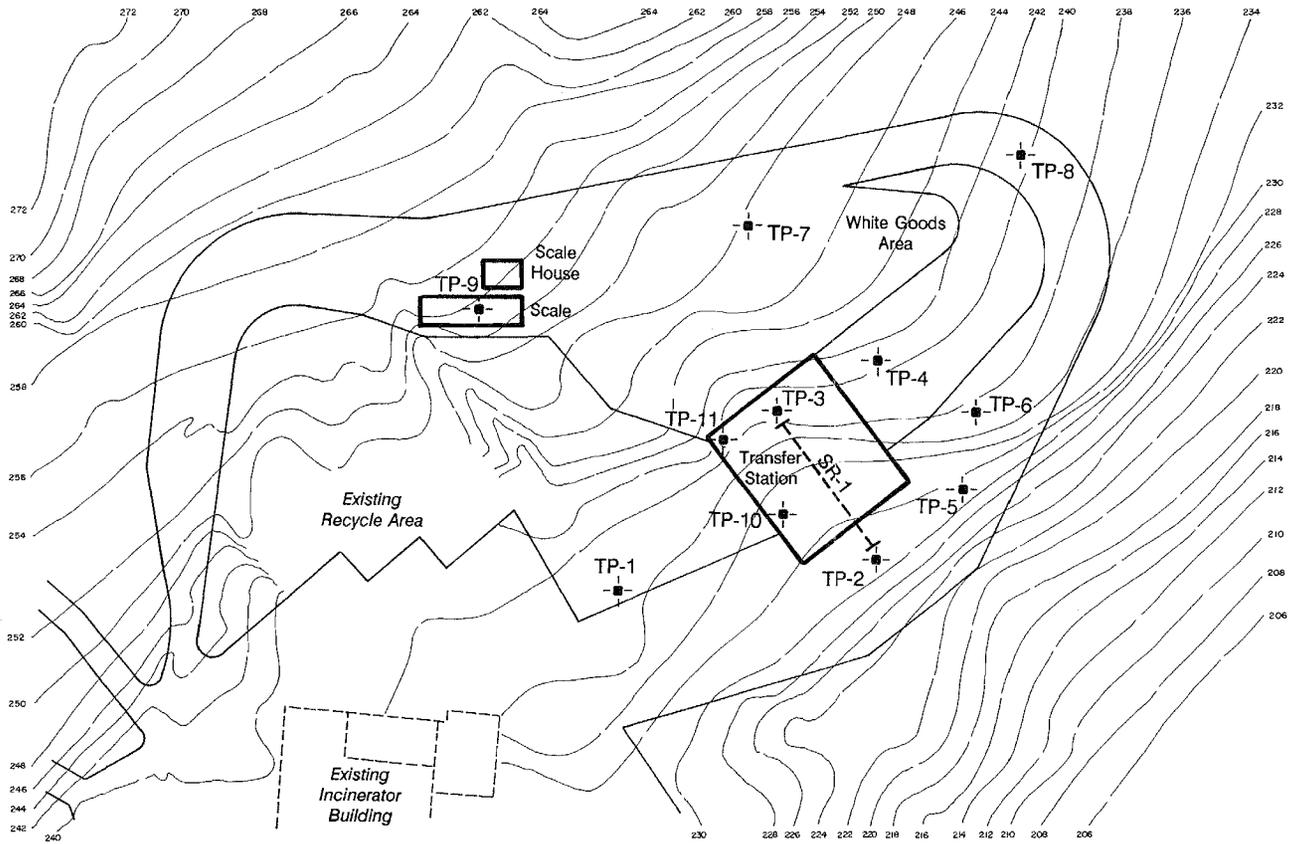
- TP-1-⊕ Approximate Location of ECI Test Pit, Proj. No. E-6515, Apr. 1994
-

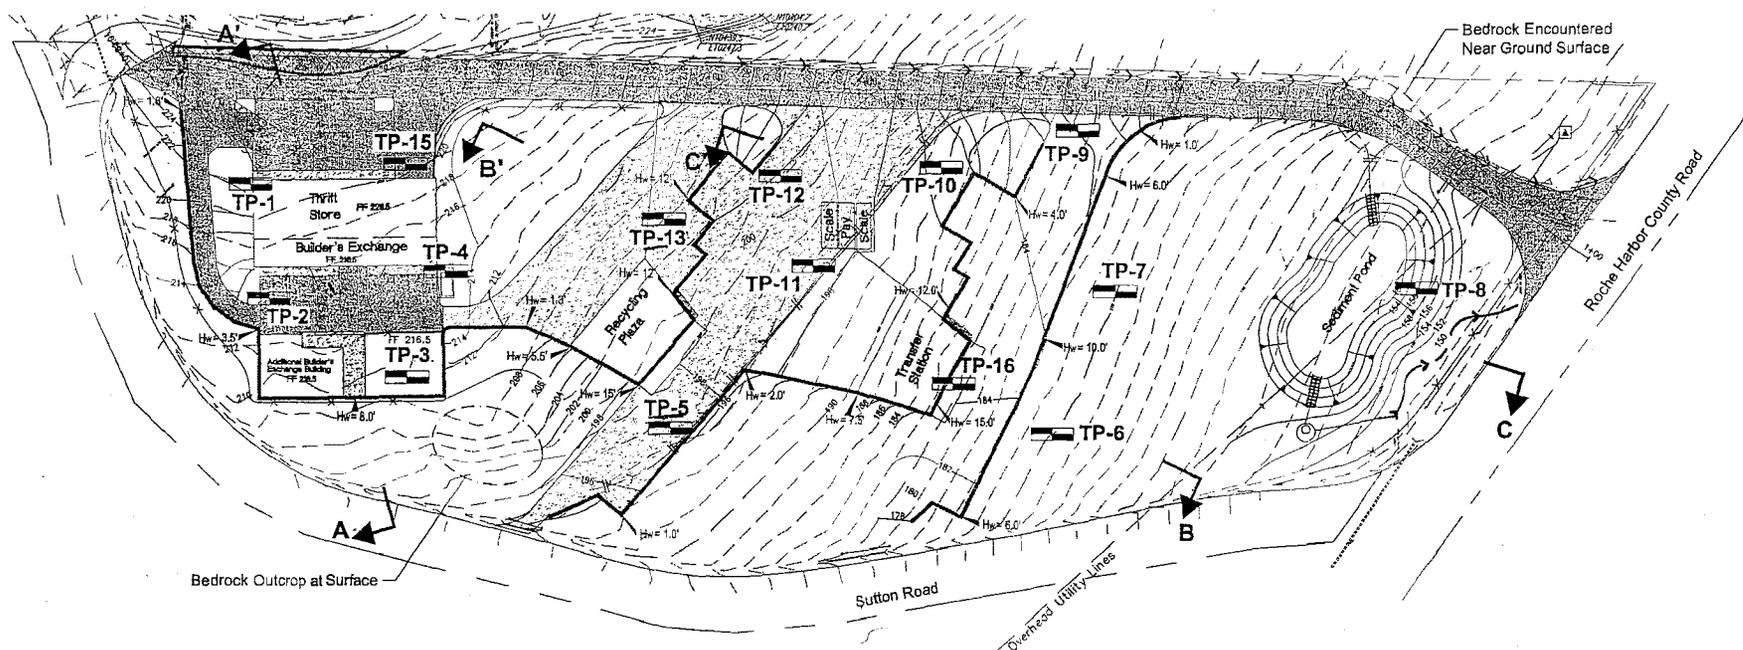
- Existing Ground Surface Contour
- Proposed Ground Surface Contour
- Proposed Retaining Wall Location with Approximate Wall Height in Feet
- Proposed Temporary Silt Fence Location
- Stormwater Line
- Test Pit Designation and Approximate Location
- Generalized Subsurface Profile (See Figures 4 through 6)

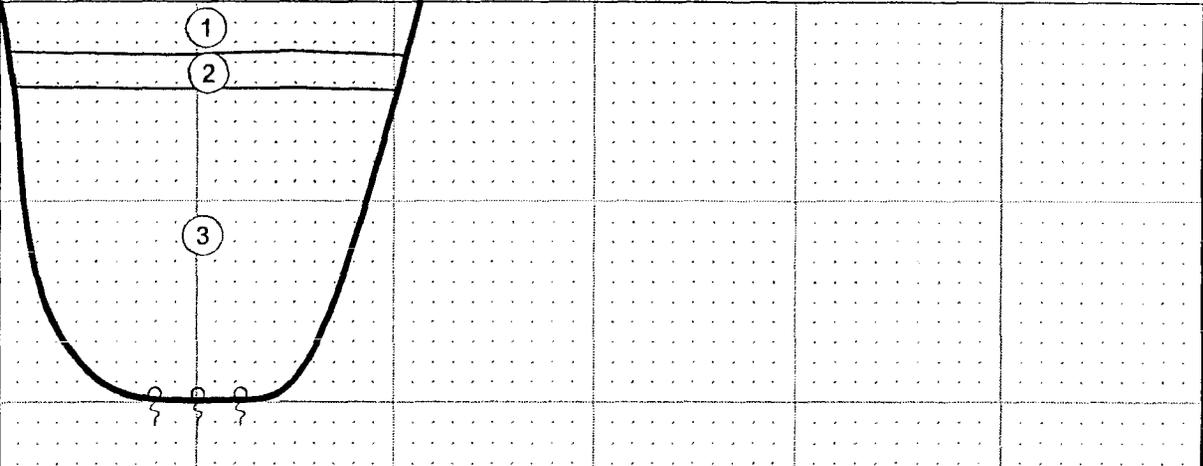
FIG. A-7

SOIL DESCRIPTION	Ground Water	% Water Content	Samples	Depth, Ft.	Not to Scale				
<p>① Loose, dark brown, silty SAND; organics; (Topsoil/Duff).</p> <p>② Soft to stiff, brown and red, slightly sandy and gravelly, silty CLAY to clayey SILT; moist; scattered cobbles; gravel and cobbles subrounded; (Weathered Glacial Till).</p> <p>③ Very dense, brown, silty, gravelly SAND; moist; scattered cobbles; gravel and cobbles subrounded; (Glacial Till).</p>

<p style="text-align: center;"><u>NOTES</u></p> <ol style="list-style-type: none"> 1. Bottom of test pit at 4.0 feet. 2. Refusal at top of bedrock. 3. Seepage observed at 4.0 feet. - Standing water in base of excavation after 40 minutes. 4. No caving observed.

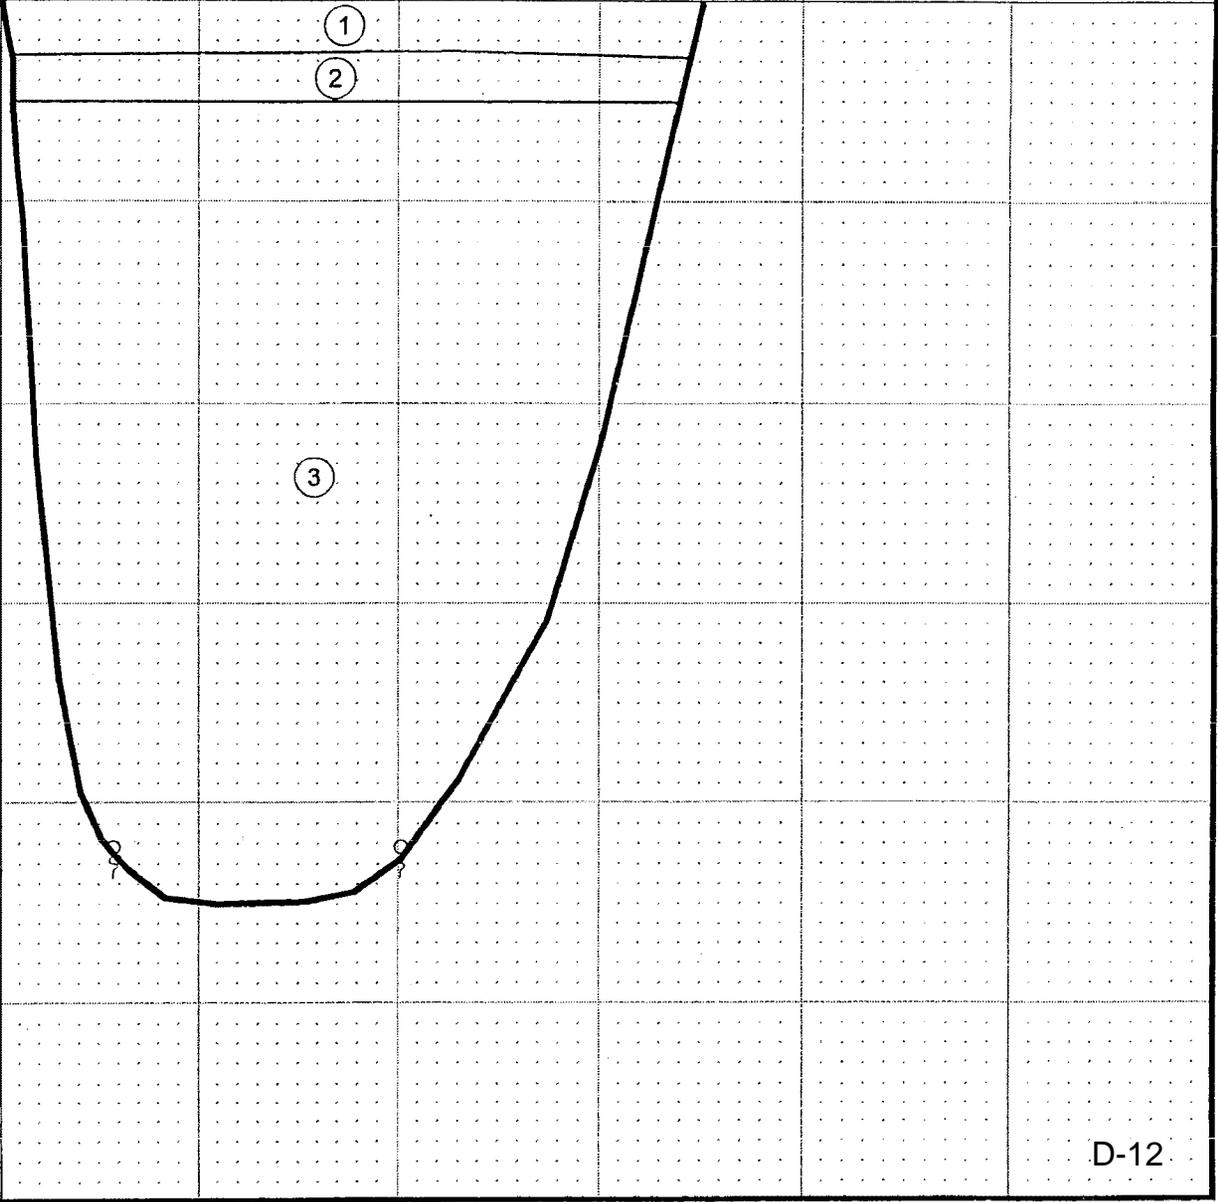
FIG. A-9

<p><u>NOTES</u></p> <ol style="list-style-type: none"> Bottom of test pit at 9.0 feet. Bedrock not encountered. Seepage observed at 8.5 feet from $\frac{1}{2}$" thick clean sand seam. No caving observed.

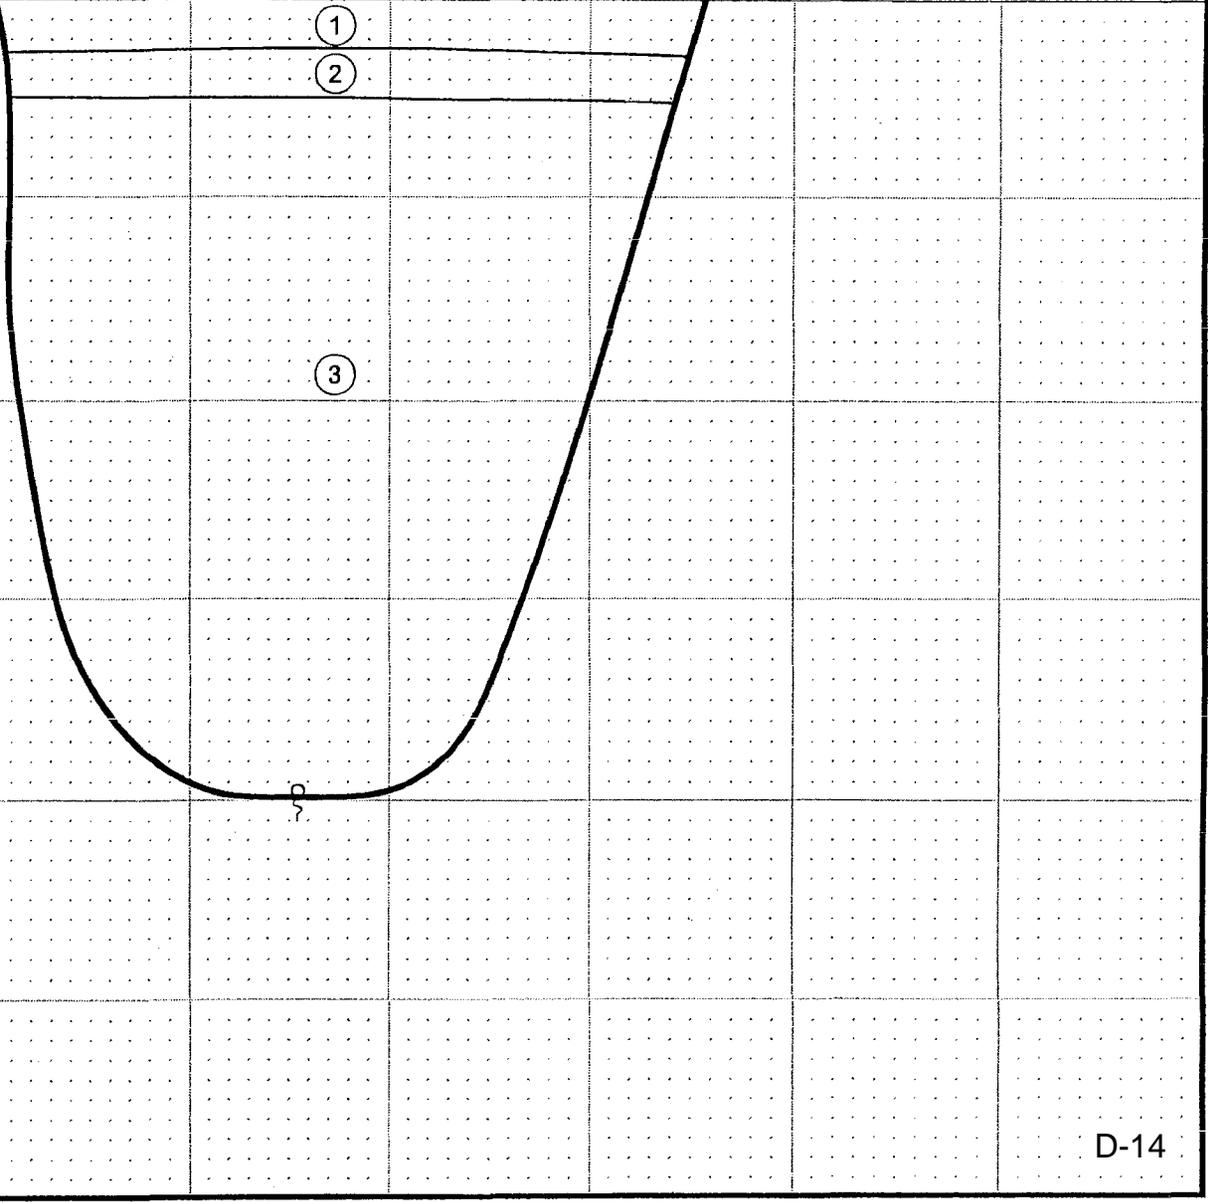
FIG. A-11

<p><u>NOTES</u></p> <p>1. Bottom of test pit at 8.0 feet.</p> <p>2. Refusal at top of bedrock.</p> <p>3. Seepage observed at base of excavation.</p> <p>4. No caving observed.</p>

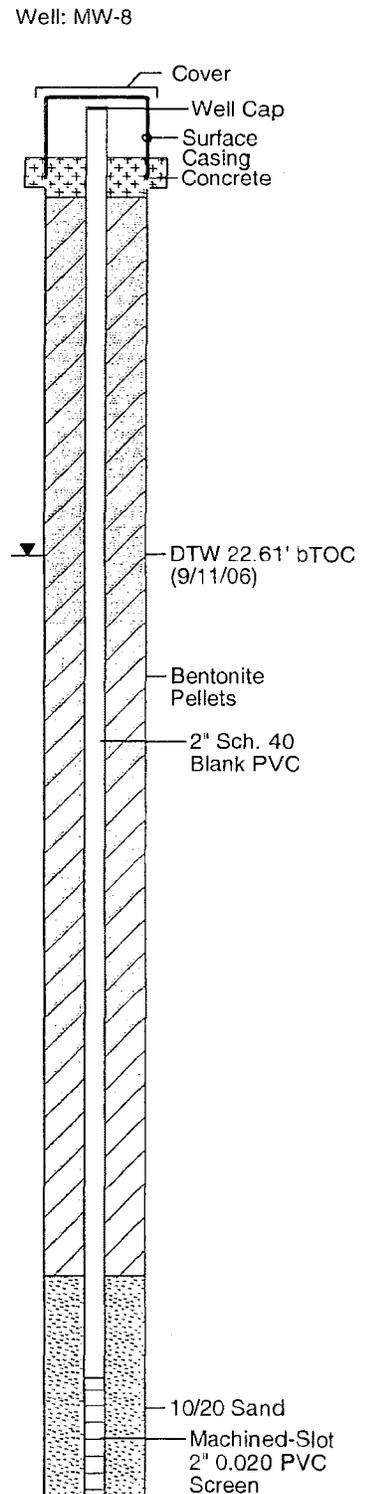
Depth (ft)	USCS	Graphic	Sample Type	Remarks	Sample ID	Sample
			<input type="checkbox"/> Cuttings Sample DESCRIPTION			
0			Gravel, weeds at ground surface; edge of gravel driveway			
5	SW		Dry, black, gravelly, fine to coarse-grained SAND - ash-fill material	Driller comments "soft drilling"	MW-8 5'	
10			BEDROCK: Dry, brown/grey, weathered bedrock; cuttings are retrieved as chips, largest are size of fingernail; volcanic-clastic sandstone and mudstone is preliminary identification	Driller notes change in drilling at 9-10' bgs to harder feel; indicates bedrock	MW-8 10'	
15					MW-8 15'	
20			BEDROCK: Color changes to grey, bedrock appears to be metamorphic, most likely a schist (green); Notable minerals are quartz (banding) and mica; possibly part of the Constitution Formation		MW-8 20'	
25					MW-8 25'	
30			Cuttings appear to be the same material and moisture content as at 25' bgs	Driller notes change at ~30' bgs possible moisture	MW-8 30'

35					MW-8 35'	
40					MW-8 40'	
45				Driller notes some moisture in cuttings	MW-8 45'	
50					MW-8 50'	
55				Driller notes moisture at 57-58' bgs (dust sticks to side of cuttings container)	MW-8 55'	
60					MW-8 60'	
65					MW-8 65'

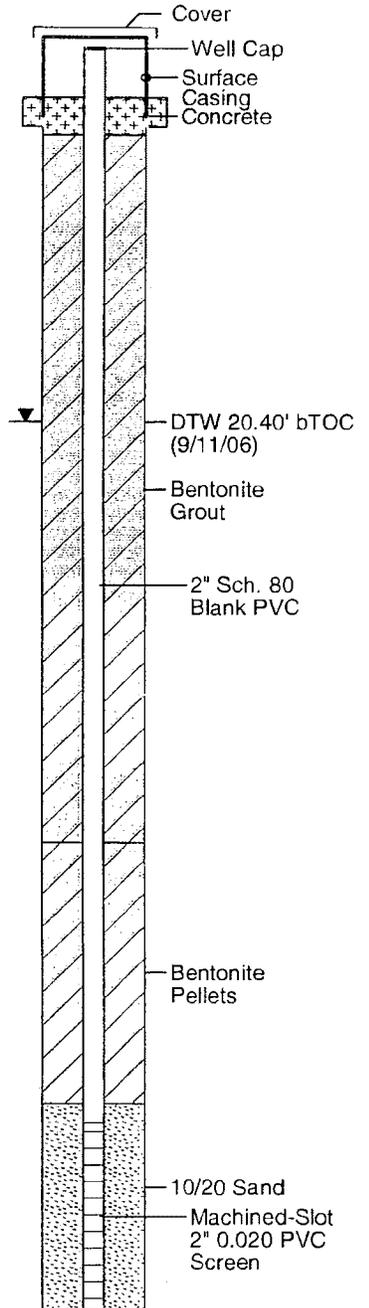
Well: MW-9

42						
44					MW-9 50'	<input type="checkbox"/>
46						
48					MW-9 55'	<input type="checkbox"/>
50						
52					MW-9 60'	<input type="checkbox"/>
54						
56				Rested ~10-15 mins. and had 3-4 ft. of water in borehole; open to 65' bgs, pulled rod, blew out hole at 09:15; 3' water in borehole at 09:45, rising at ~0.10' per min.	MW-9 65'	<input type="checkbox"/>
58			BEDROCK: Cuttings color change (darker); rock chips are smaller; possible gneiss (black w/ quartz banding)			
60						
62						
64			BEDROCK: Back to schist			
66						
68						
70						
72
