WA-CR-1040

TREETOP, WENTACHEE WASTEWATER TREATMENT PLANT
CLASS II INSPECTION

by
Don Reif

Washington State Department of Ecology
Compliance Monitoring Section
Olympia, Washington 98504-6811

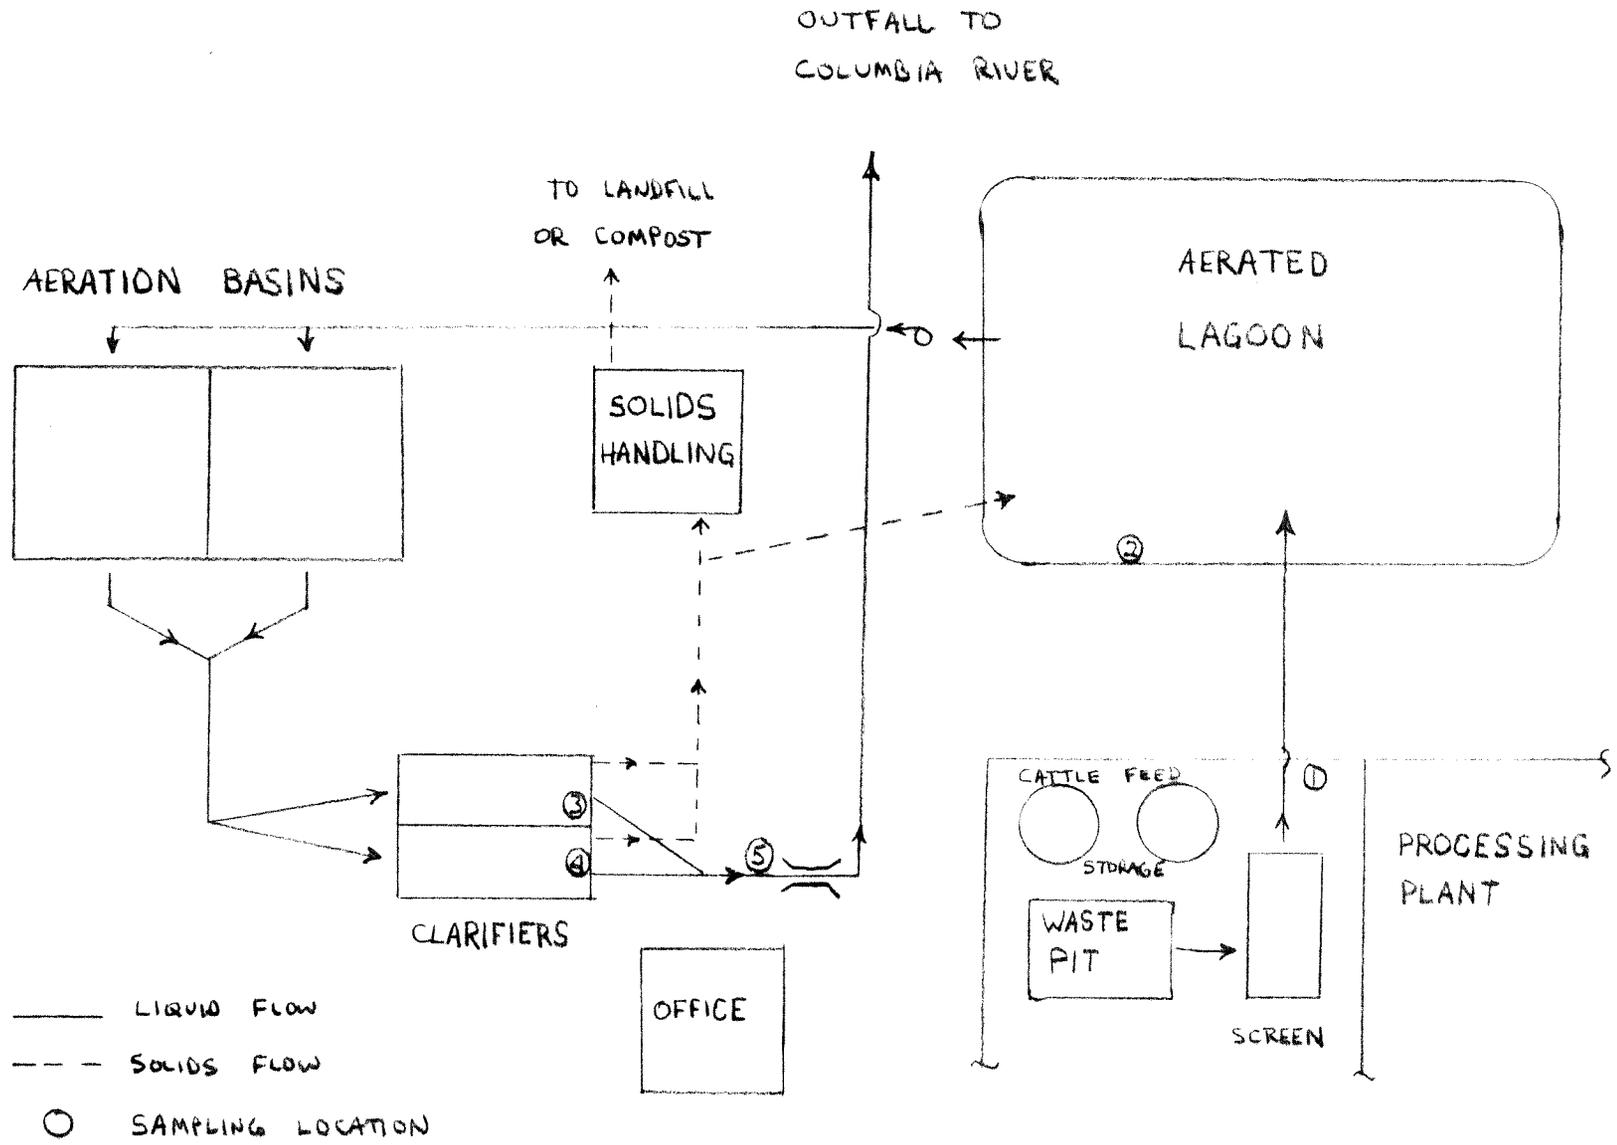
Figure 2. Treatment Plant Schematic with sampling locations:
Treetop, Wenatchee Class II Inspection- March 15-16, 1988.

At Wenatchee, Treetop produces dehydrated and frozen apple products from the processing of low grade apples. Washing, cutting, slicing, and cooking of the apples results in a high BOD, high suspended solids waste. Processing solids are screened, dewatered, and removed for cattle feed. The remaining wastewater is treated in an extended aeration activated sludge system (Figure 2) after adding nutrients: nitrogen (as a urea/ammonia mixture) and phosphorus (ammonium polyphosphate). Final effluent is discharged to the Columbia River
