-SITE CHARACTERISTICS

-SOIL SERIES

-SOIL LOGS

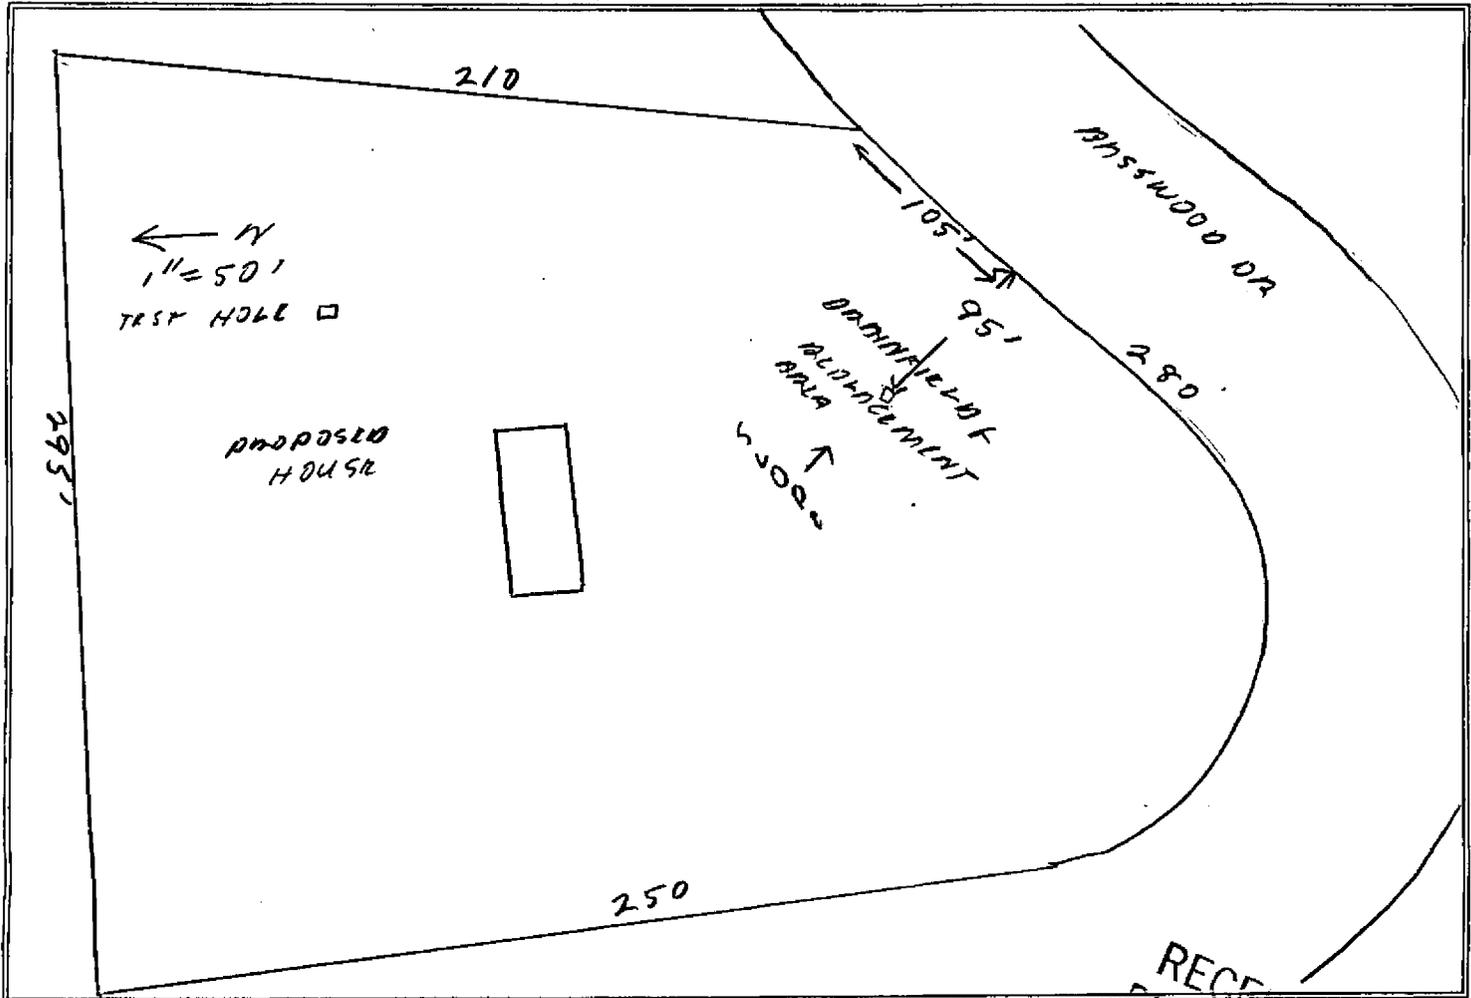
Topography: General Topographic Characteristics South Facing Slope  
 Drainage Characteristics: Well Drained  
 Slopes: General 0 - 12 %; Proposed Drainfield Location 12  
 Geology: Type of Bedrock & Depth No Data  
 Vegetation: Logged Off  
 Distance to, and type of, nearest surface water: NA  
 (If Less than 250 Feet)  
 Distance to nearby wells: NA  
 (If Less than 250 Feet)  
 Distance to public sewers: NA  
 (If Less than 500 Feet)  
 Other structures on property: NA
