Washington State School Seismic Safety Assessments Project

# SEISMIC UPGRADES CONCEPT DESIGN REPORT

South Bend High School –  
Koplitz Field House  
South Bend Public Schools

June 2019

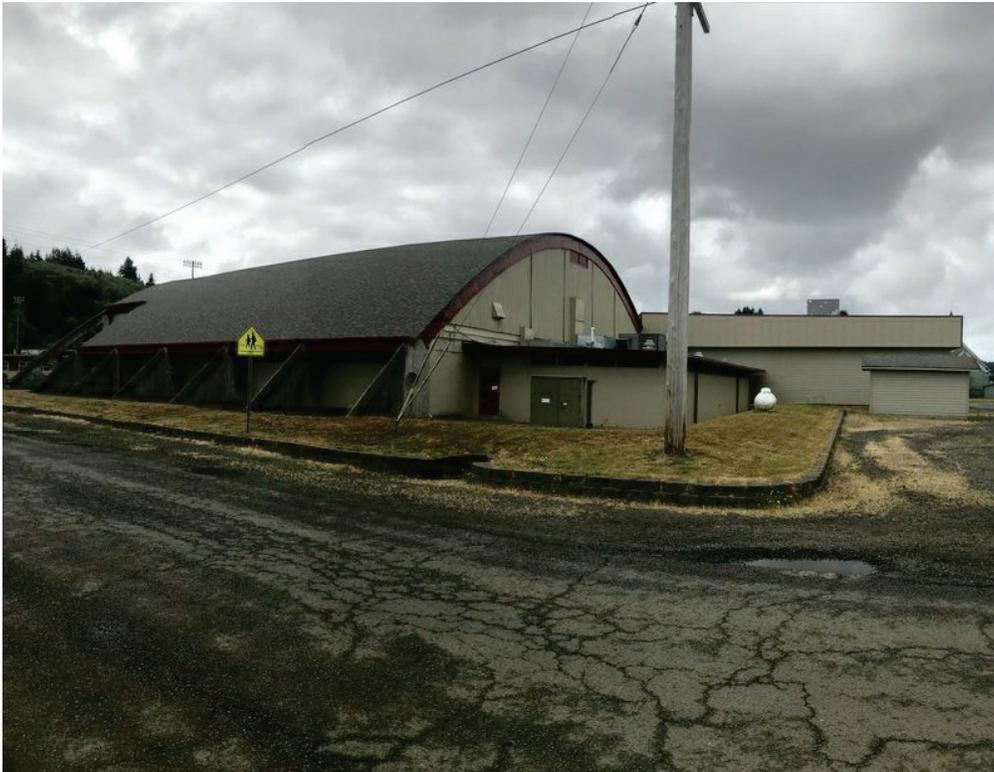
Figure 1-3. South Bend Field House - Northeast Exterior

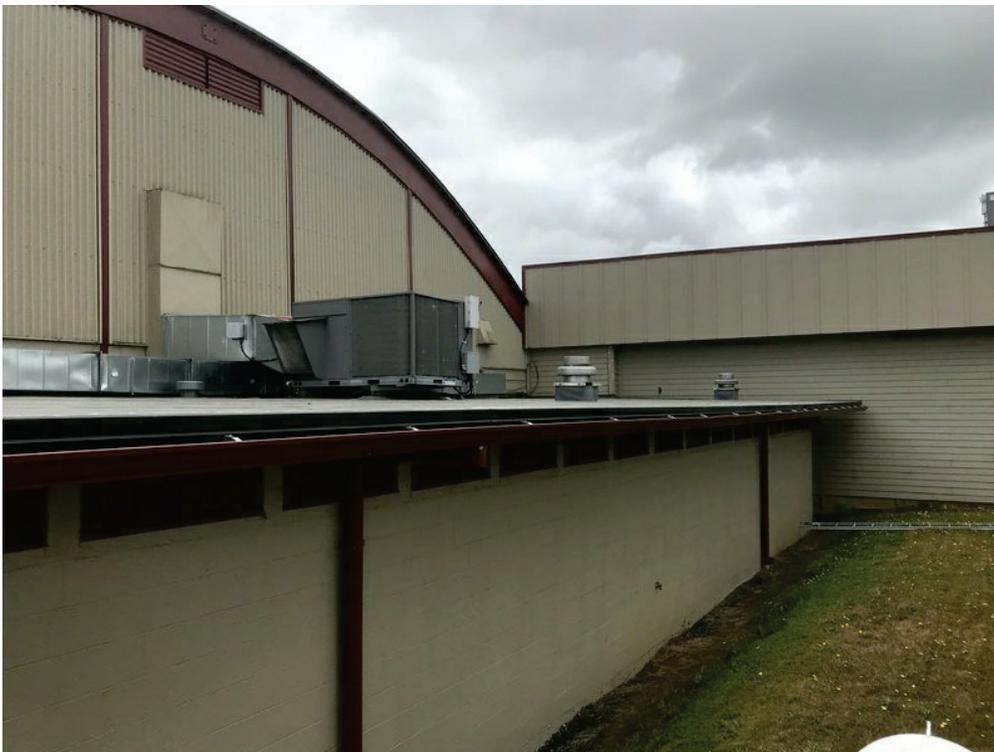
Figure 1-4. Mechanical Equipment on North Roof

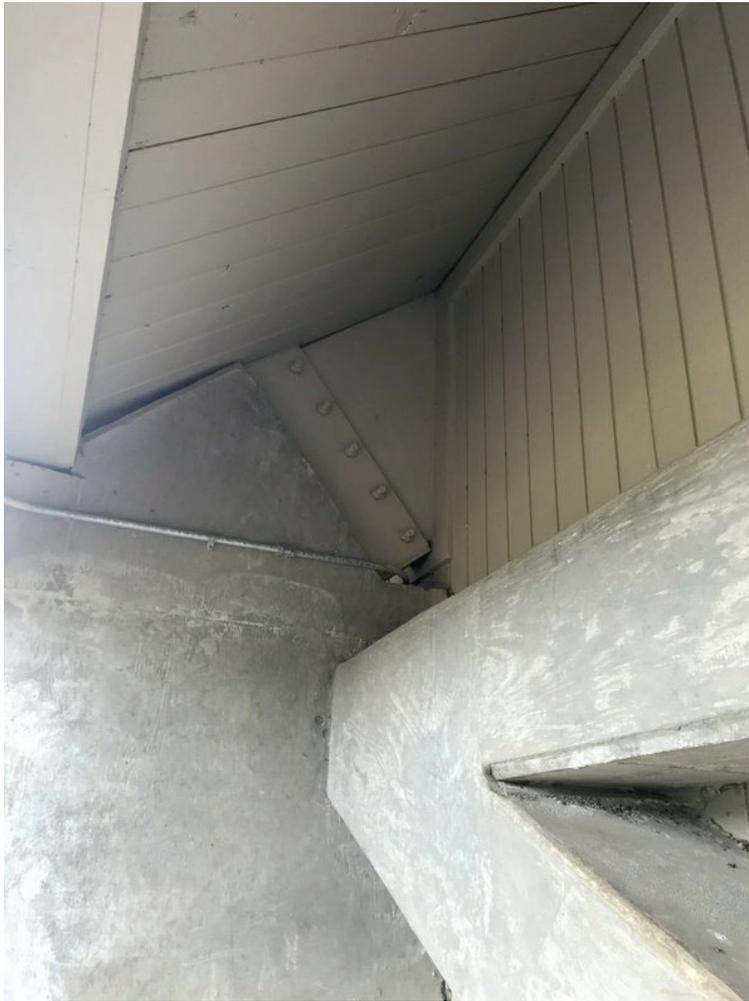
**Figure 1-5. Concrete Braced Frame with No Connection to Diaphragm or Shear Walls**

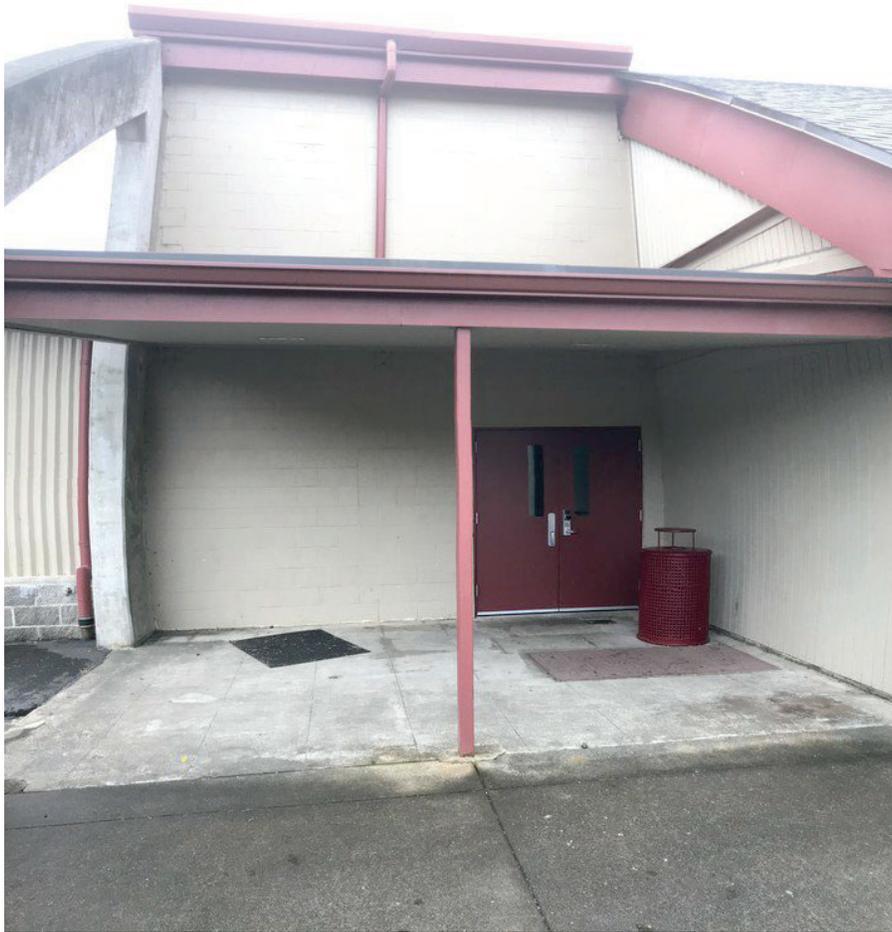
Figure 1-6. Lower Roof at East Entrance

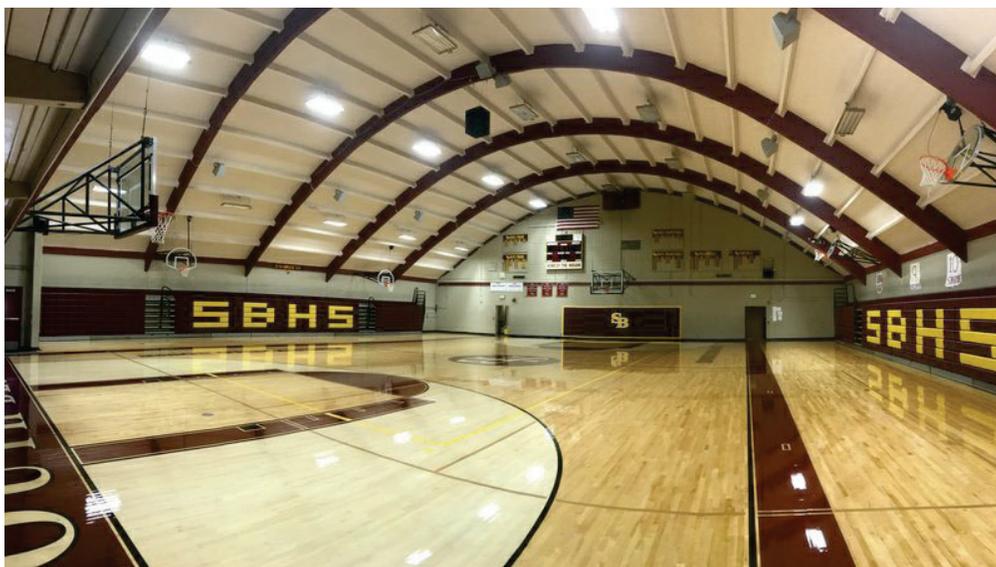
Figure 1-7. Gymnasium with Glulam Arches

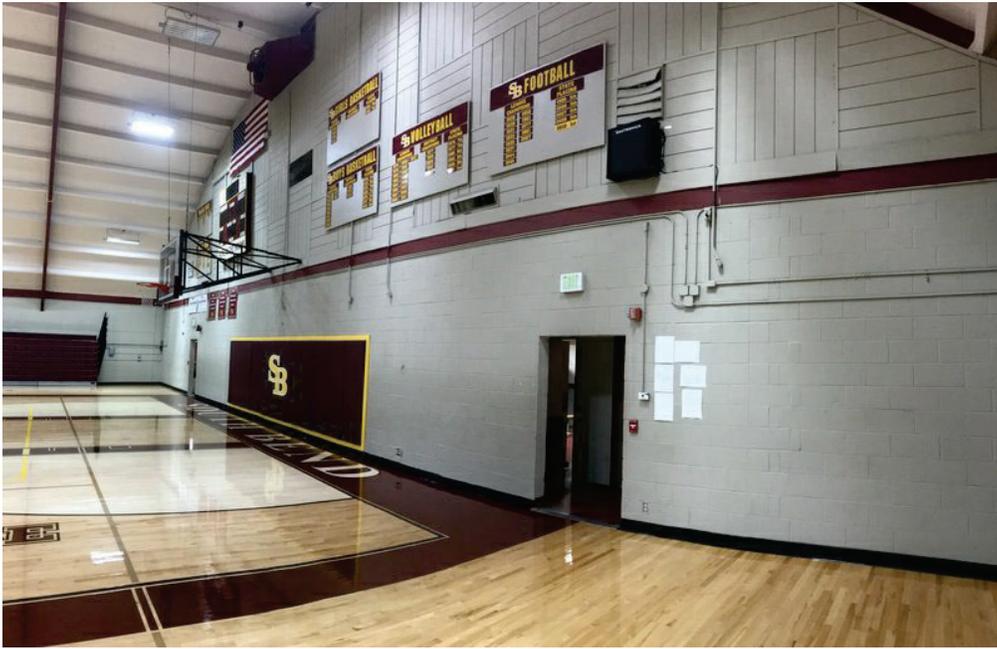
Figure 1-8. CMU Wall at North End of Gymnasium with Wood-Framed Wall Above
